DUTCH  
SAFETY BOARD

# Shipping Occurrences Report

November 2015 - April 2016

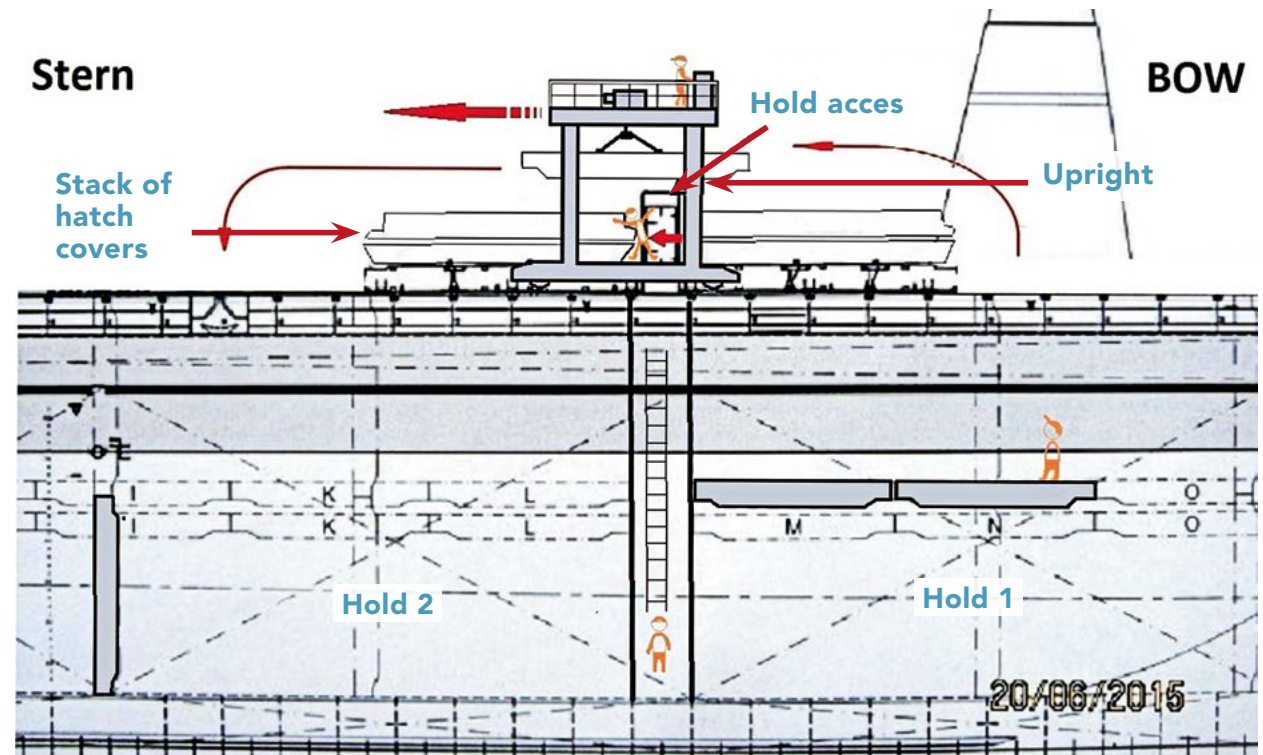
At the end of the afternoon, the hatch-cover crane was carrying a pontoon to cargo hold 2 when one of the crew members in cargo hold 2 decided to leave his working area. He then climbed up the ladder of the starboard midship hold entrance to the deck gantry. When stepping over the sill to exit the gantry, he presumably tripped and fell forwards. As a result, he fell between the rear column of the hatch-cover crane and the hatch covers that were piled up next to the gantry.

The accident on board the Beauforce was influenced by the following factors:

- Use of the midship entrance while the hatch-cover crane is in operation was not procedurally

Illustration of the accident with the hatch-cover crane. (Source: Focus Shipmanagement)

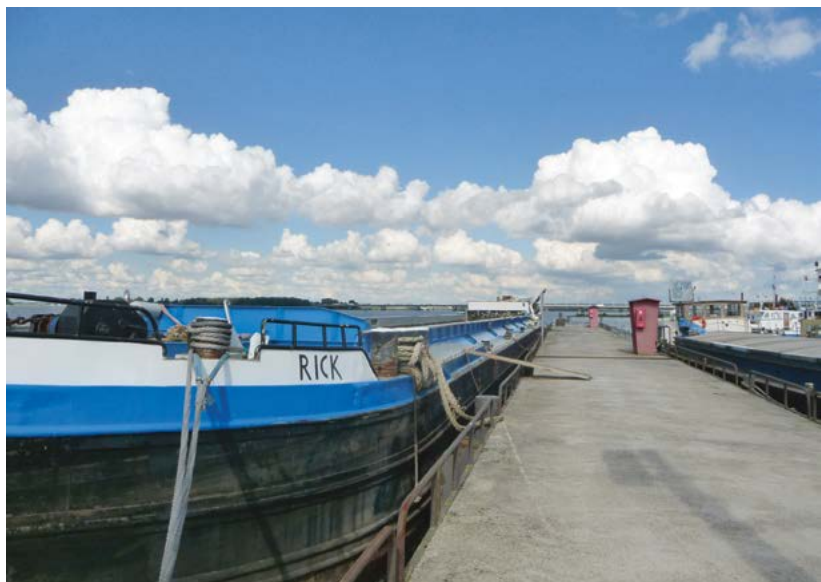
Measurement of the Rick.

The Rick was capsized by 'a fateful series of events'. The movement of the ship, a minor collision with the sand dredger and a shifting cargo caused the ship to capsize. Collisions occur every now and then, barges have to manoeuvre and shifting cargoes are not abnormal. However, all of these circumstances amplified each other in the same direction and the Rick was not stable enough to cope with it. During loading, the Willem was flooded with water, which caused the ship to become more unstable and to capsize. The Dutch Safety Board assumes that the Willem could have been saved if a watertight partition had been installed between the compartments.

During the conversion of the capsized barges the Rick and the Willem, no calculation was conducted to assess whether they were strong and stable enough for open water. According to the calculations carried out by the Dutch Safety Board, the Rick's stability was 'not ample'. The same would have applied for the Willem if the ship had been in good condition, but it had been poorly maintained and leaks made it even more vulnerable. Both ships were being loaded on open water with semi-fluid spray sand, a heavy load that is difficult to manage if it starts shifting.

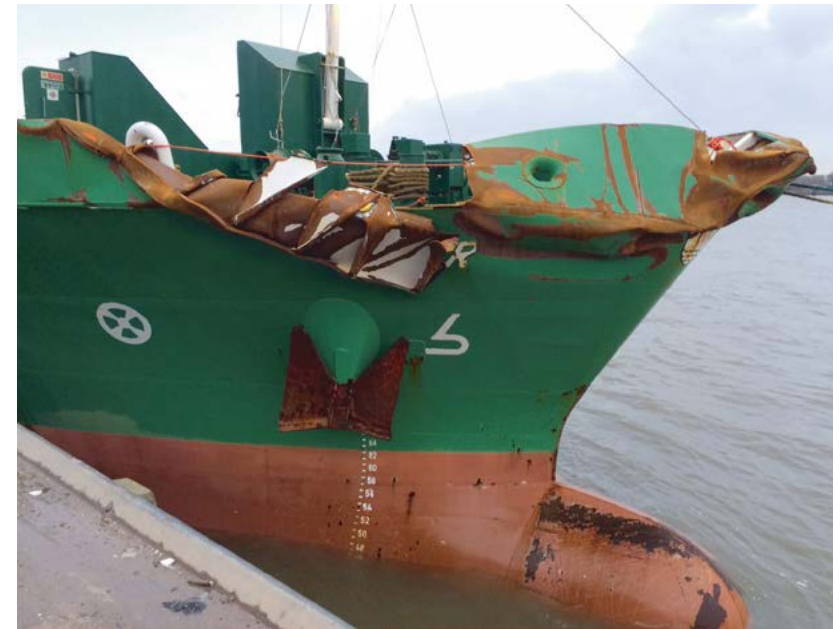
In the afternoon of 8 February, a collision took place between a product tanker and a freighter at anchorage 4 East (off the coast near Ouddorp). The collision took place during stormy weather (gale force 8 – 9). Both ships had been anchored near each other for some time, waiting for a mooring berth to become available in the port of Rotterdam. At this anchorage, the captains select a suitable place to drop anchor themselves. The crew had heard about the approaching storm via weather channels. As a result of the storm, the anchors of several ships, including both ships involved in the incident, began to drag. The captain of the product tanker decided to start the engines and raise the anchor. Soon afterwards, the product tanker collided with the freighter. Both ships were badly damaged. The product tanker suffered a 15-metre-long breach at the level of the engine room.

Damage to the freighter as a result of the collision. (Photo: Shipping company)

The freighter's bow was damaged above the waterline. No one was injured. After the collision, the freighter immediately entered the port of Rotterdam. The product tanker remained at sea for another day, entering the port of Rotterdam the day after the storm. Both ships had to go to a shipyard for repairs.

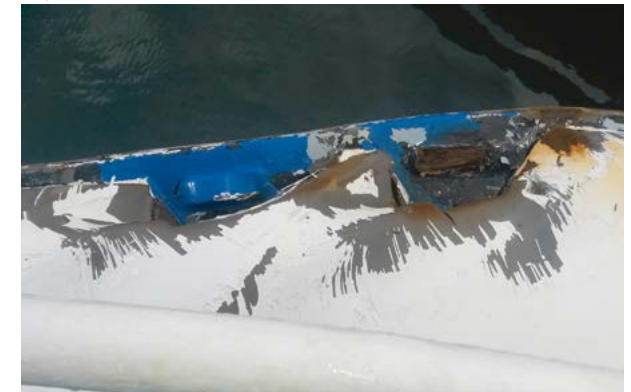
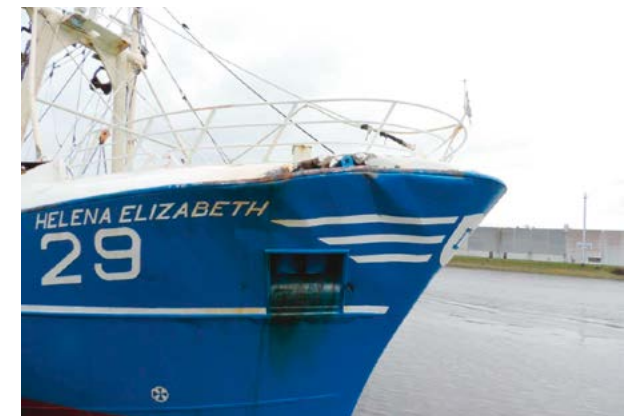
On Tuesday 24 November 2015, a collision occurred between the Norwegian oil tanker Stavfjord and the Dutch trawler TX-29 Helena Elizabeth. The collision occurred in the traffic separation scheme near Den Helder. As a result, the starboard bow of the TX-29 was damaged and it lost its fishing gear. The Norwegian tanker continued sailing with unknown damage.

Damage to TX-29. (Photo: Human Environment and Transport Inspectorate (ILT))

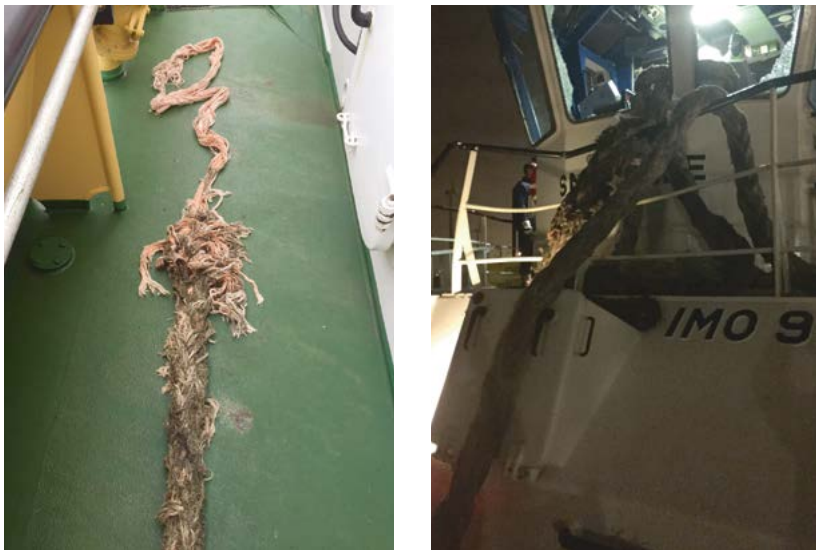
Snapped towage connection and damage to ship. (Photo: Boskalis)

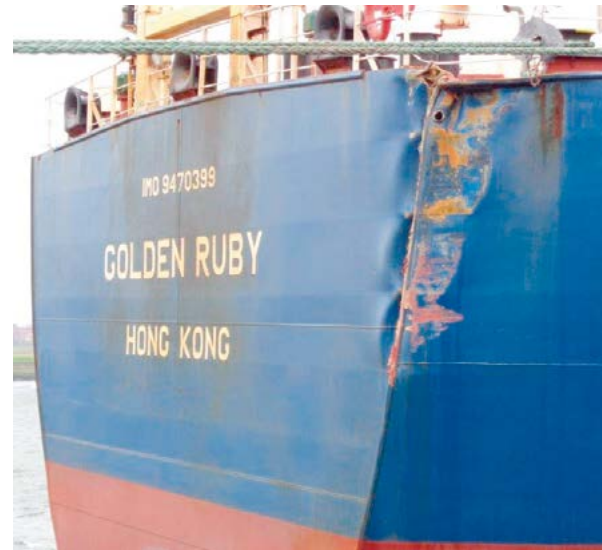
In the Buitenhaven in IJmuiden, a collision occurred between the bulk carriers Golden Ruby and Frontier Island, both sailing under the flag of Hong Kong. At the time, the Golden Ruby was mooring at the Tata Steel outer quay. The ship performed a manoeuvre that caused a collision with the Frontier Island, which had already moored. The Golden Ruby sustained a considerable dent in its stern, while the Frontier Island's stern was breached.

Dent in the stern of the Golden Ruby. (Photo: Human Environment and Transport Inspectorate (ILT))

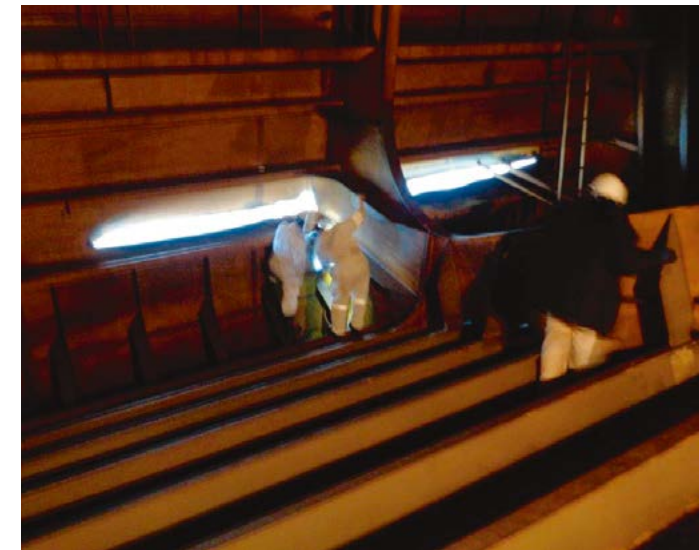
Breach in the stern of the Frontier Island. (Photo: Human Environment and Transport Inspectorate (ILT))

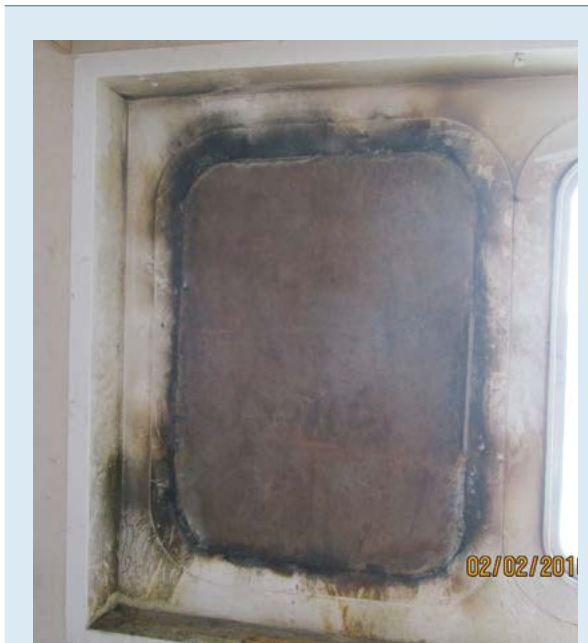
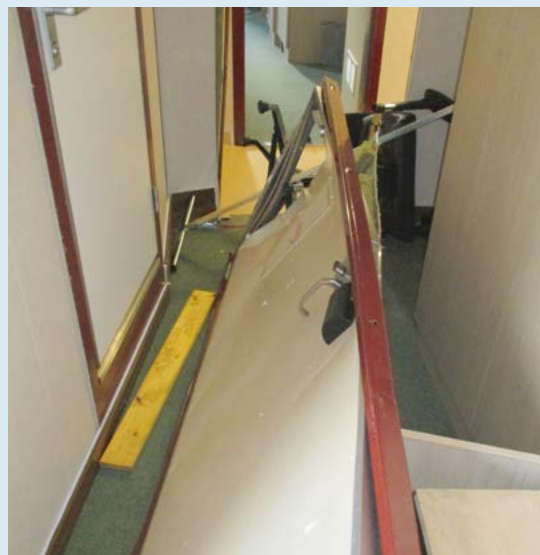
On Monday 1 February 2016, on its voyage to the Canary Islands, the Fairmaster ran into exceptionally bad weather off the north-west coast of Ireland. Gale force 11 had been reported, with an extremely heavy swell. As a result, the ship collided with an extraordinary wave, resulting in water in the forecabin, two broken windows and a large amount of water in the accommodation areas. In the accommodation areas, damage was caused to doors and bulkheads. When closing the windows during the bad weather, the boatswain sustained an injury to his hand. Following consultation with the Radio Medical Service, this injury was treated on board.

Photos of the damage on board the Fairmaster. (Photos: Jumbo Shipping)

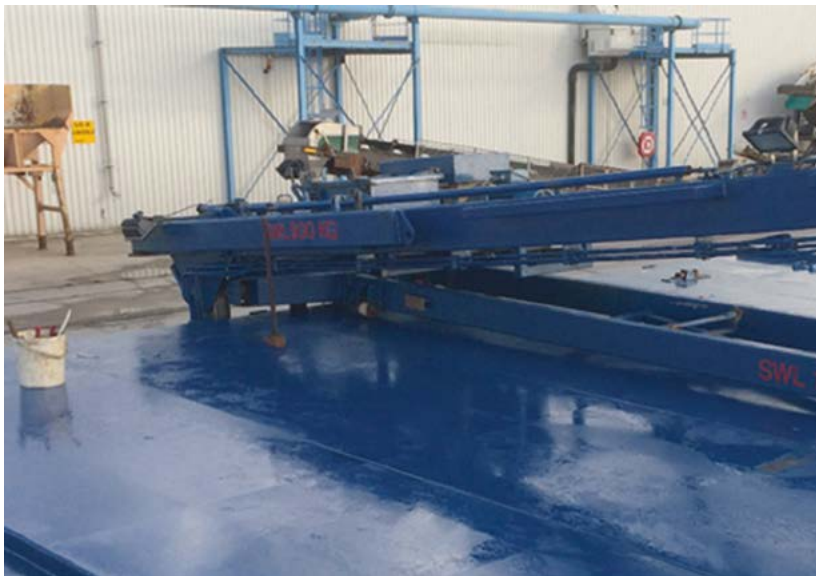
Position of the hatch-cover crane after the incident. (Photo: the Bock Maritiem)

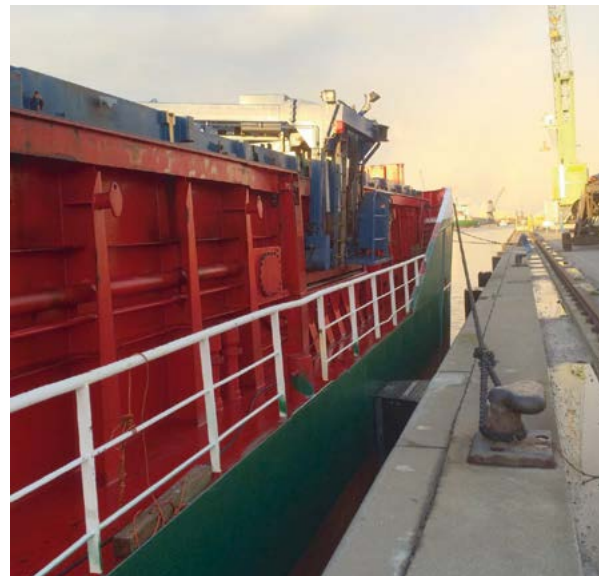
Position of the hatch-cover crane on the starboard side. (Photo: the Bock Maritiem)

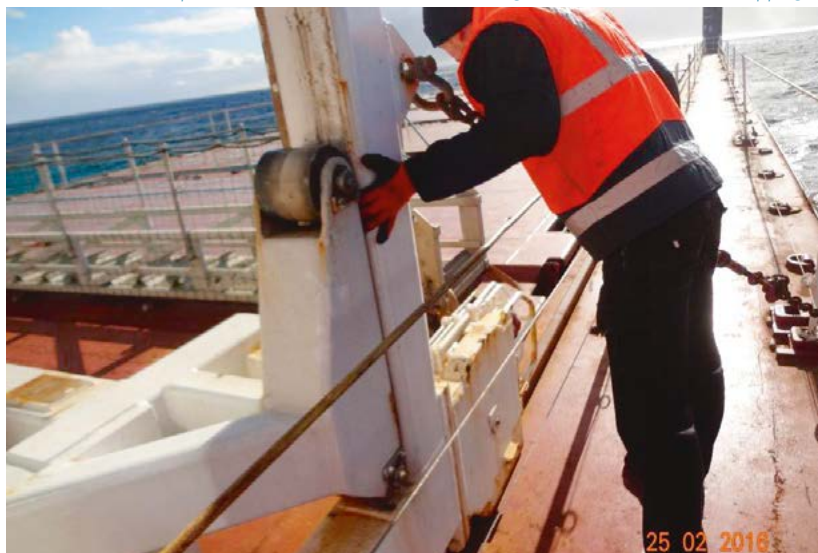
At 04:05 pm, the Dutch freighter Abis Dover was in the port of Amsterdam when a crew member was injured while the hatch to the cargo hold was being closed. To seal the hold, the crew were using the hatch-cover crane to move hatches from the stern into the correct position above the hold. Three crew members were performing this operation: the crane driver, one crew member on the port side of the hatch-cover crane and one crew member on the starboard side. The crew member on the port side was ensuring correct positioning of the hatches above the hold. Communication between these crew members was conducted via walkie-talkies. The crew member on the port side tripped over a dovetail that was welded to the deck and grabbed hold of the column of the hatch-cover crane to regain balance. At that moment, the hatch was lowered and the crew member's glove was trapped between the moving roller and the column. As a result, the crew member lost the top of his index finger.

Reconstruction of the position of the crew member's hand during the incident. (Photo: Abis Shipping)

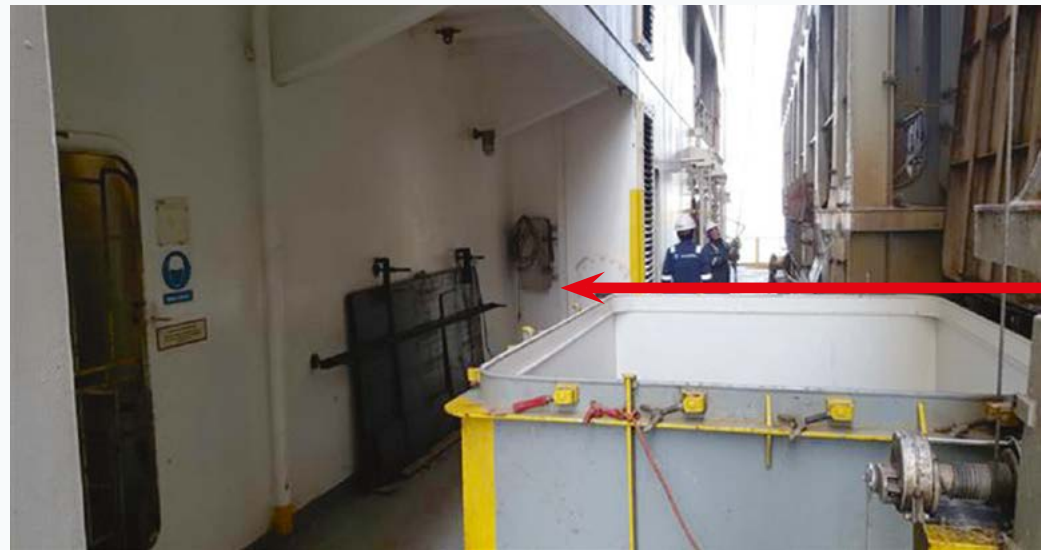
The Dutch container ship Maersk Kalmar was approaching the Chinese port of Xingang. With the aid of the monorail, crew members were moving heavy steel plates from beside the accommodation area on the starboard side to a specially equipped storage area in the engine room. During the execution of this task, the decision was made to store the plates on deck instead, against the rear of the accommodation area. The plates that had already been moved were in too vertical a position, causing them to fall. This happened when a prop was removed in order to move the next plate into position. One crew member was trapped between the fallen plates and the edge of the hatch to the engine room. The other crew members pulled the plates off the victim with the aid of chains. The ship then sailed into port as quickly as possible and the crew member was taken to the hospital. The crew member sustained three damaged vertebrae as a result of the accident.

Position of the plates: the lashings were not in place at the time of the accident.
