DUTCH
SAFETY BOARD

Quarterly Aviation Report

April - June 2017

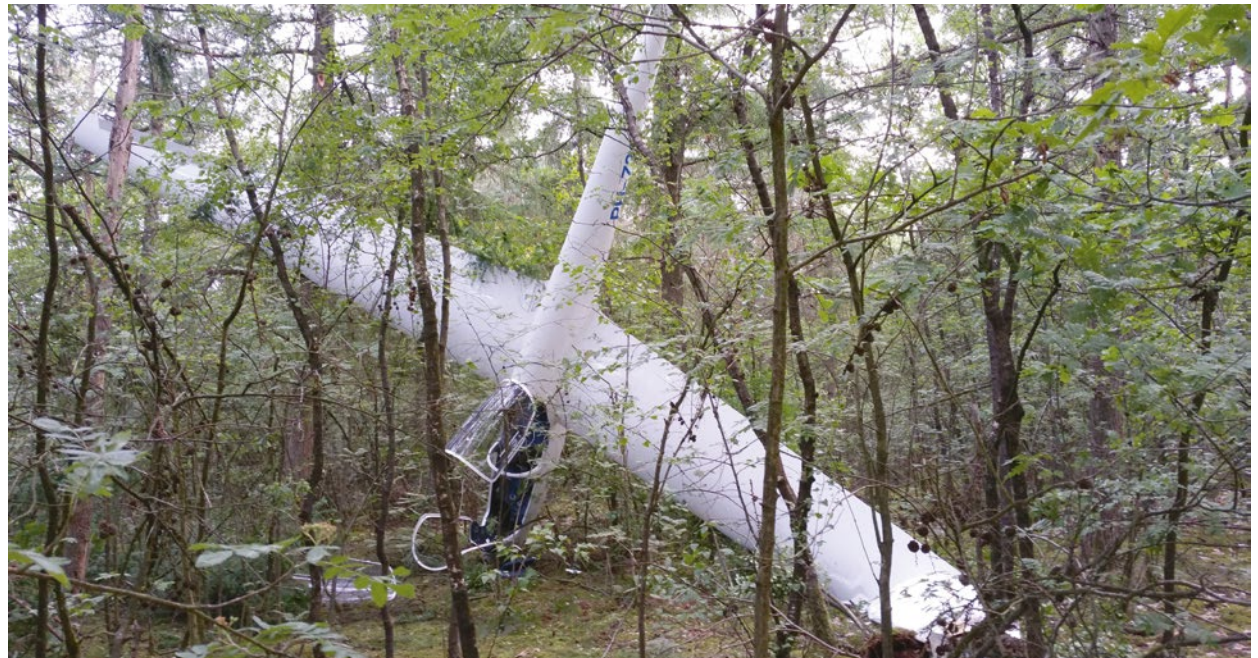
During a winch launch for a flight shortly after sunrise, both persons on board the ASK-21 (a trainee and an instructor) lost sight of the ground. Once they released the glider from the winch, the crew circled above the presumed location of the glider airfield. The crew only regained ground visibility at low altitude. At that moment the ASK-21 had drifted from the glider airfield to such a distance that a landing there was no longer possible. The instructor decided on landing in the treetops of the forest that surrounds the glider airfield. The glider dropped through the treetops and came to a stop hanging in the trees. Both occupants remained unharmed. The glider was heavily damaged.

The glider after landing in the trees. (Photo: Aviation police)

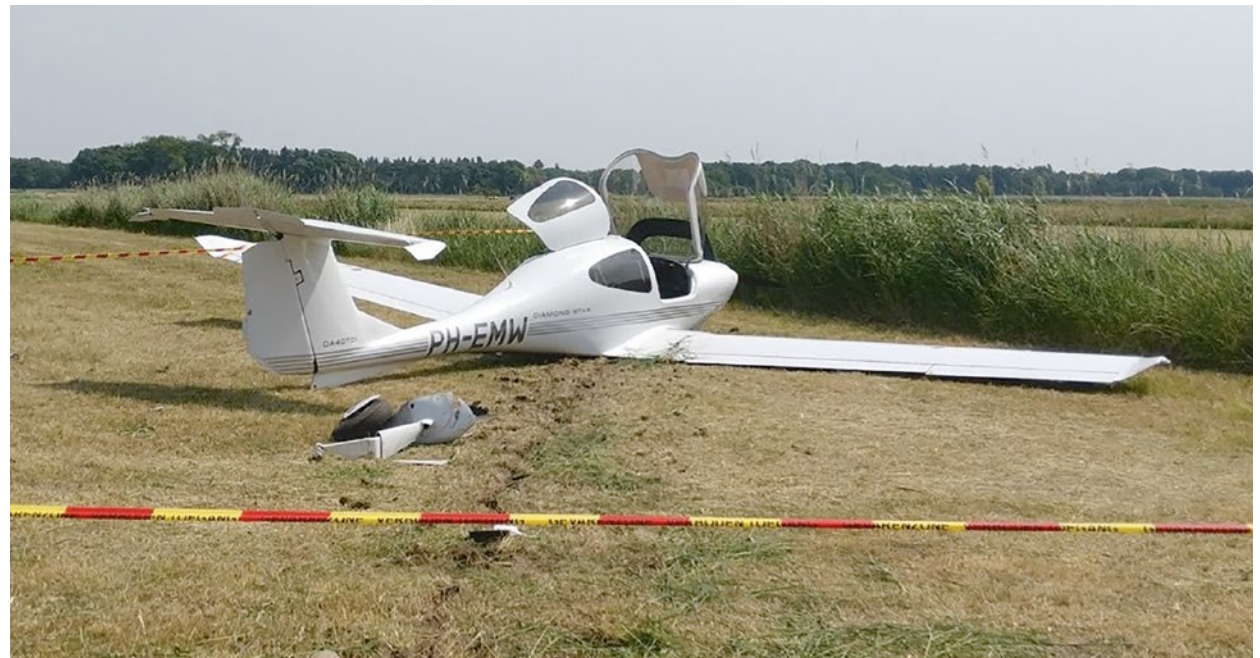
The Diamond DA-40, with a pilot and a passenger on board, had been flying from Eindhoven Airport under visual flight rules. After a flight time of approximately 25 minutes, when the pilot initiated the approach at Eindhoven, the engine failed to deliver the required power. The remaining engine power proved too low to remain at altitude. The pilot therefore decided to make an emergency landing in a meadow. After landing, the aircraft crossed a ditch, causing the undercarriage to break off and the propeller to hit the ground. Both occupants remained unharmed.

The Dutch Safety Board is investigating the cause of the failure of the engine to deliver the required engine power.

The PH-EMW after the occurrence. (Photo: Commander)

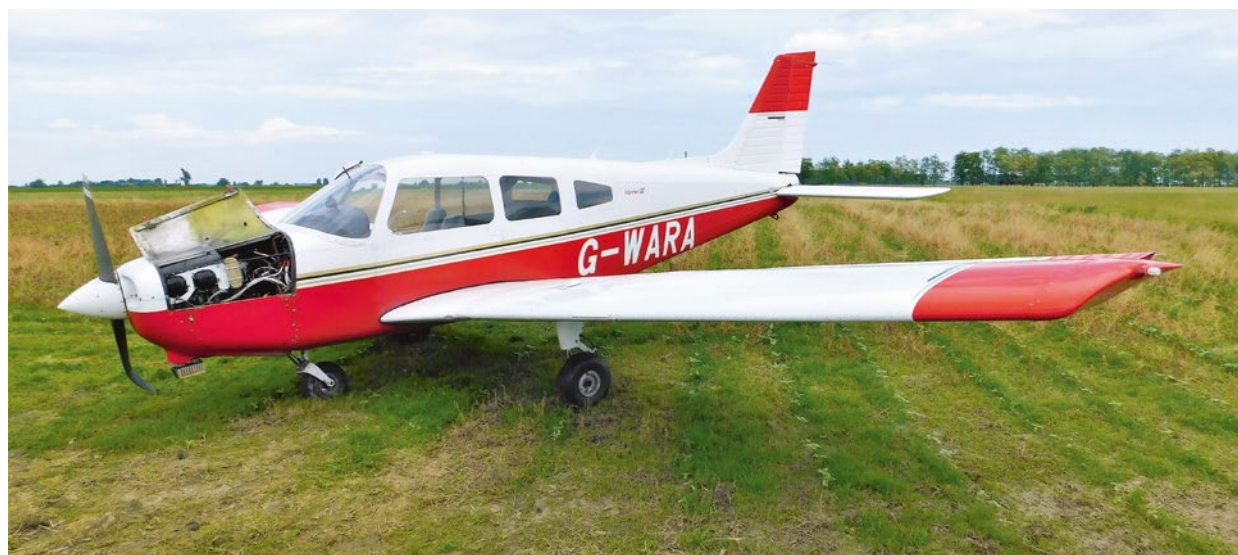
The Piper Cherokee, with the pilot and a passenger on board, was on a flight from Oradea International Airport (in Romania) towards Brno-Tuřany Airport (in the Czech Republic). During the flight, the electrical system of the aircraft failed. The pilot decided to make a precautionary landing in a meadow. The propeller, nose landing gear and the engine mounting sustained damage during the landing. Both occupants remained unharmed.

The G-WARA after the precautionary landing. (Photo: TSB)

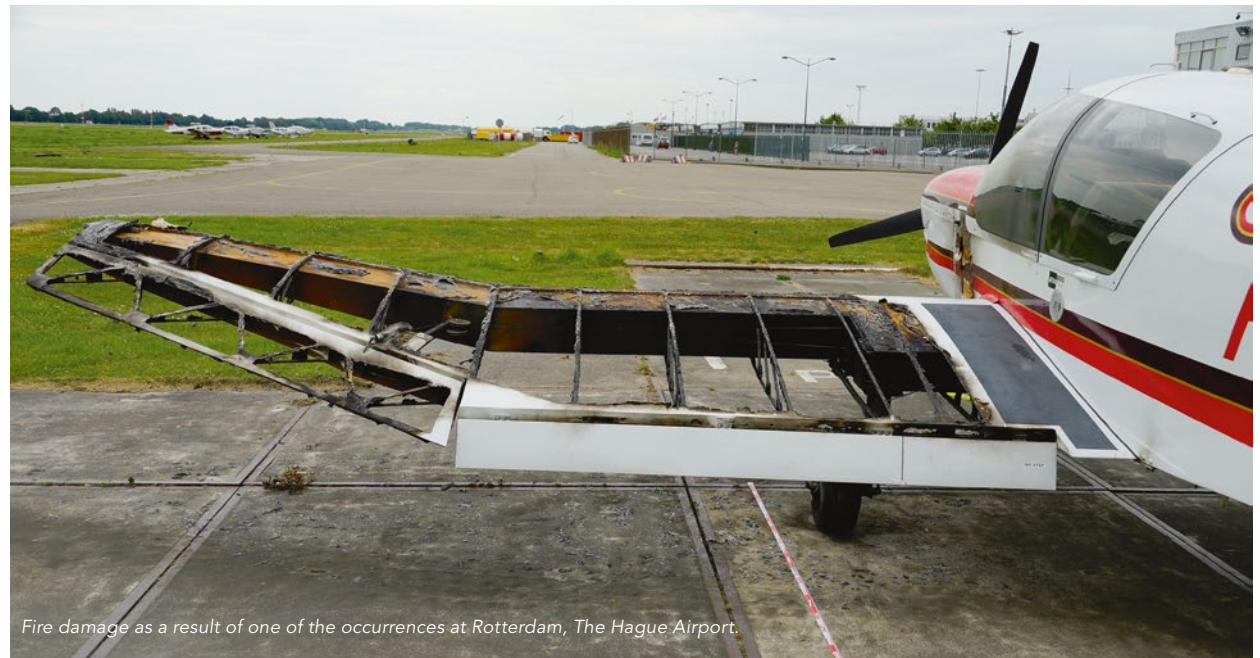
Fire damage as a result of one of the occurrences at Rotterdam, The Hague Airport.

The investigation revealed, in both cases, that the heat source of the fires was the brake unit of the left-hand main landing gear. As a result of friction between the brake disk and the brake pads, the brake disk became excessively hot. It remained unclear what caused this friction: neither technical nor operational causes could be ruled out.

The heat in the brake unit was so severe that it was able to start a fire in the wing construction. The wing construction of this type of aircraft consists of wood, covered with polyester material. It was found that no fire-resistance certification requirements exist for wing covering materials. The combination of wood and non fire-resistant synthetic covering material enabled rapid development of the fire.

In the course of the investigation, it was discovered that at least 21 similar occurrences with the same aircraft type had been reported to France's aviation accident investigation bureau since 1988, the latest fire being in July 2016. All of these resulted in substantial damage to the wings, and some even in the loss of the entire aircraft.

Advise the manufacturer of the Apex DR400 to improve the aircraft's brake unit, to prevent overheating of the brake disk as a result of friction between the brake disk and brake pads.

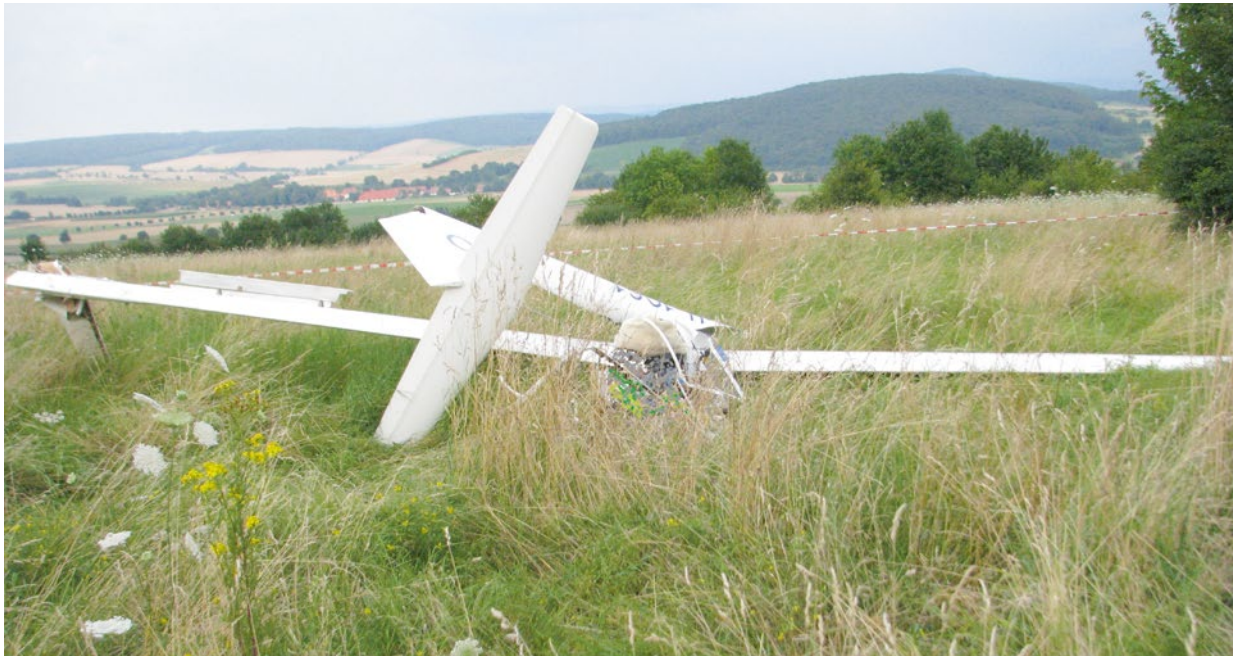
The LS4 made a winch launch from runway 18 from the glider airfield in Sultmer Berg (Germany) at about 16.00. According to eye witnesses, the glider made a steep climb as soon as it became airborne and then began to oscillate around its vertical axis. The glider reached an altitude of 50 to 70 metres, after which it banked over its left wing and crashed. The pilot was fatally wounded. The glider was destroyed.

During the investigation no technical defects were identified in the control systems. The elevator trim was found to be in a tail-heavy position.

*Accident site of the PH-1061.
(Photo: BFU)*

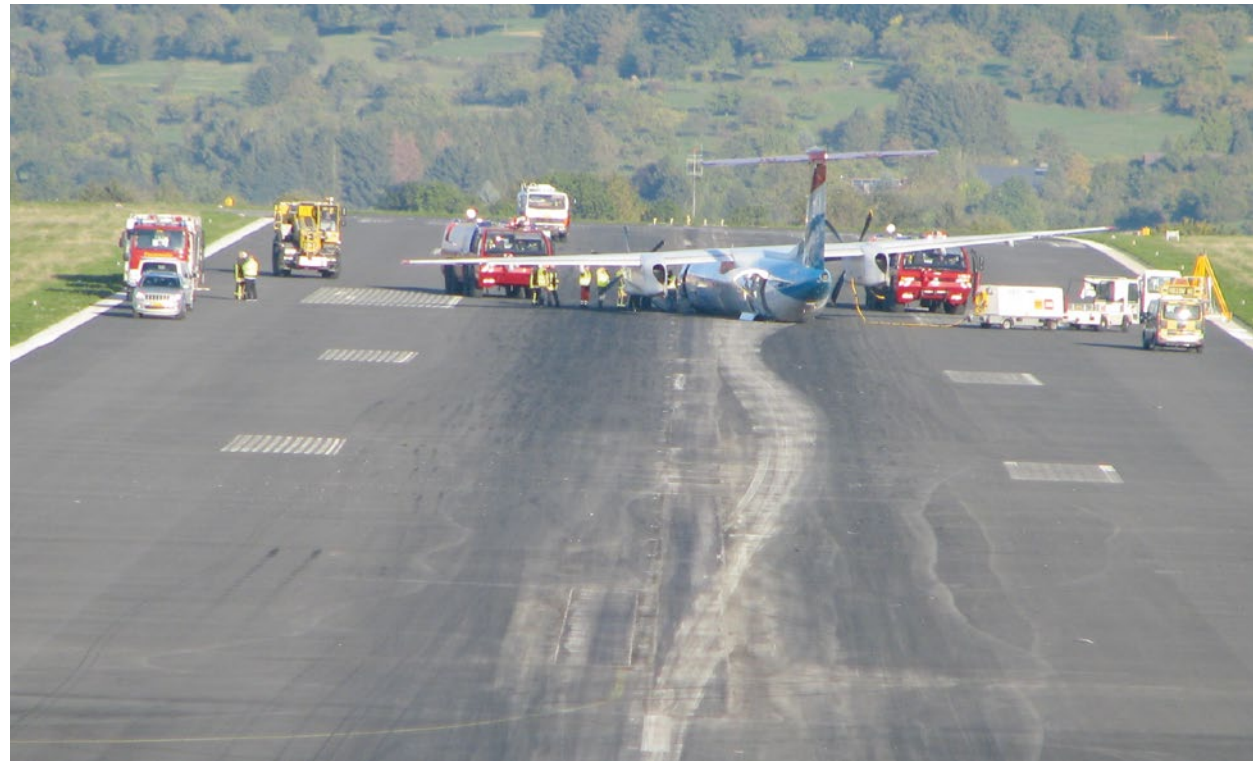
The position of the LX-LGH after it came to a halt. (Photo: BFU)

aircraft collapsed. The fuselage collided with the runway and the nose of the aircraft consequently came down again. The aircraft slid along the runway where it finally came to a stop. Smoke development in the cabin led to the aircraft being evacuated immediately by the cabin crew. There were no injuries. The aircraft was heavily damaged.

The investigation showed that while passing the rotation speed, the pilot not flying (PNF) had mistakenly set the handle for the landing gear in the 'UP' setting. The design of the landing gear system resulted in the retraction of the landing gear when the nose landing gear lifted from the runway during rotation. When the tail of the aircraft came into contact with the runway, the nose of the aircraft came down. Initially, the pilot flying (PF) moved the control column further back in an effort to lift-off from the ground. However, the nose of the aircraft had been forced down due to the tail strike. Therefore, the wings failed to generate sufficient lift to allow for lift-off. When the pilot flying realised what had happened, he reduced the engine power and concentrated on keeping the aircraft on the runway.

After the accident, the aircraft manufacturer adjusted the system logic for retracting the landing gear. This adjustment became mandatory under an airworthiness directive. The landing gear can now only be retracted if

the handle for the landing gear is selected in the 'UP' setting and when both the nose landing gear and the main landing gear have lifted off the ground.

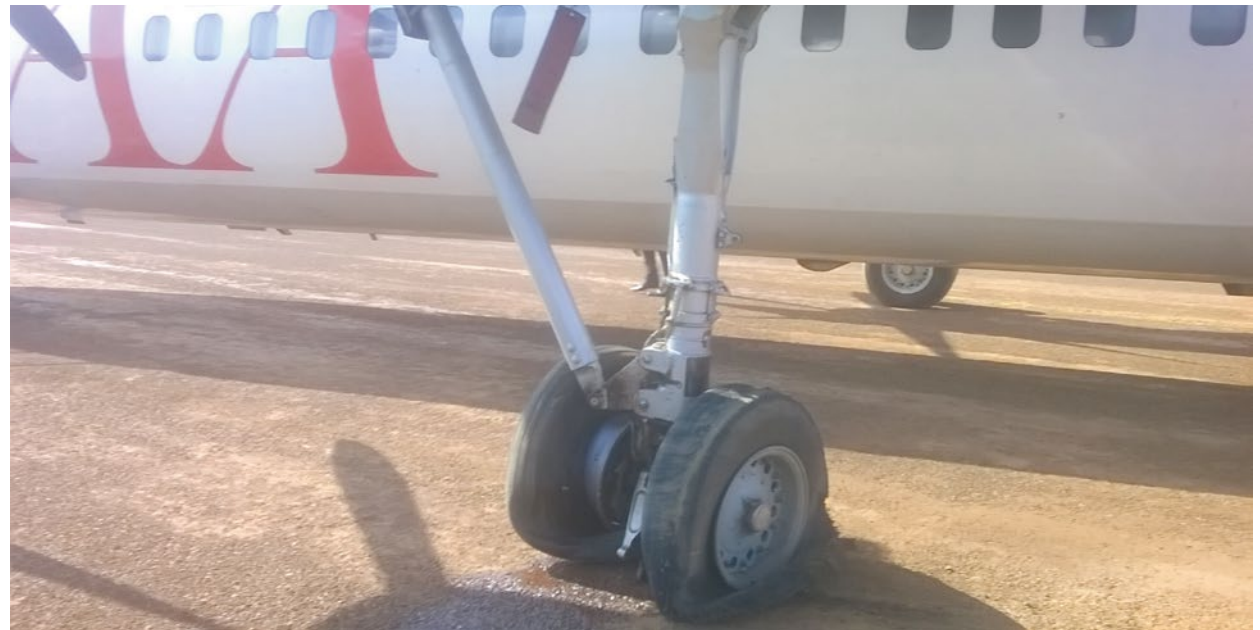
miles from the landing runway, the crew selected the landing gear down. An 'ANTI SKID FAULT' warning was displayed on the annunciator panel at the same time. The crew continued with the approach and set the flaps at setting 35, as prescribed by the abnormal checklist when the anti skid protection is inoperative. The co-pilot, who acted as the pilot flying, had difficulties setting the power levers in the ground idle detent after landing. Because of this, the aircraft decelerated slowly. For this reason the co-pilot applied more pressure to the pedal brakes. As a result, both tyres on the left main landing gear blew. The Fokker 50 came to a halt at about 250 metres before the end of the runway. The wheels of the left main landing gear had also turned 90 degrees relative to the longitudinal axis of the aircraft. The occupants disembarked the aircraft in the normal way. There were no injuries.

Position of the left main landing gear after the occurrence. (Photo: BPEA)

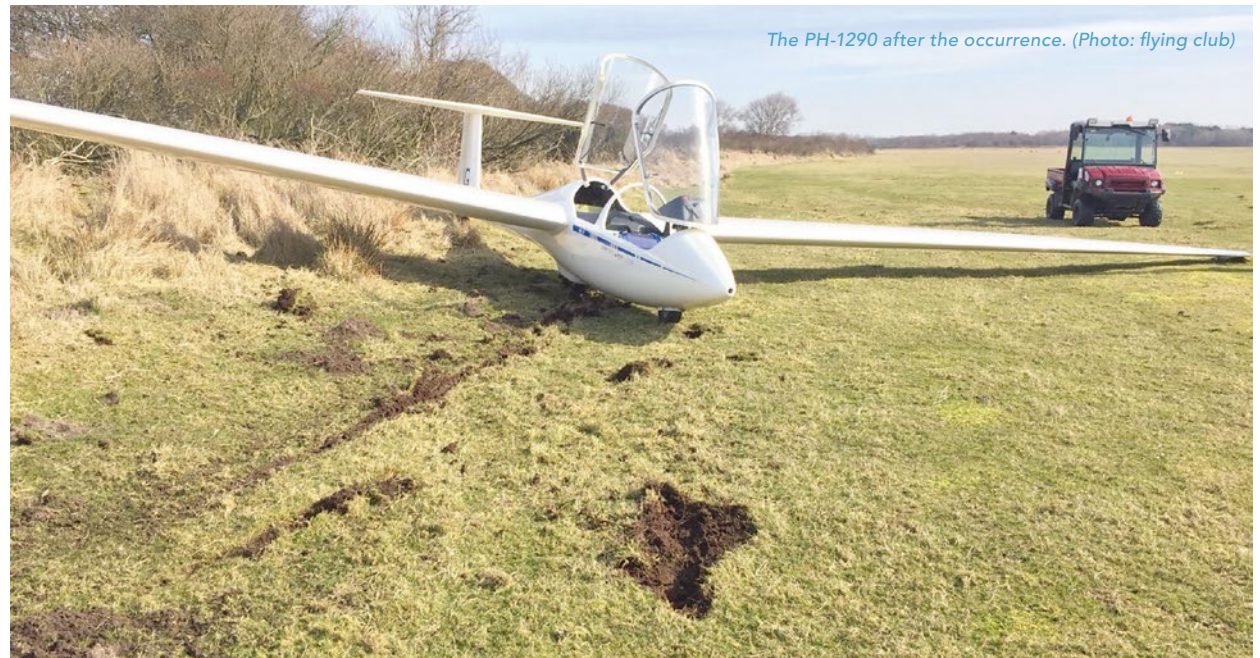
The PH-1290 after the occurrence. (Photo: flying club)

The instructor and the trainee both gave a generally similar statement regarding the approach to the target landing field. The trainee failed to adequately correct for the crosswind when approaching the target landing field. He estimated the wind speed to be 4 Bft (11 to 15 knots). This was higher than the estimate of the instructor, who estimated 4 knots. The Royal Netherlands Meteorological Institute (KNMI) reported a wind speed of 8 knots. The instructor declared that he assumed that he still had enough room for correction to allow the trainee to continue flying for as long as possible. He declared that up to that point he had had four pleasant flights that day, he was fit and alert and was already thinking about the debriefing. Because of this, he may not have noticed that the distance between the flight path and the bushes to the north of the landing field became insufficient to allow for a safe landing. When the instructor did realise this, it was already too late; the left wingtip struck the bushes.

The accident could occur because the trainee failed to correct for crosswind during the final approach, which caused the glider to strike a few bushes to the north of the landing strip. The instructor did not give the instruction to correct for drift and failed to take corrective action. Inadequate attention and lack of recent glider flying experience, by both the instructor and the trainee, may have contributed to the outcome.

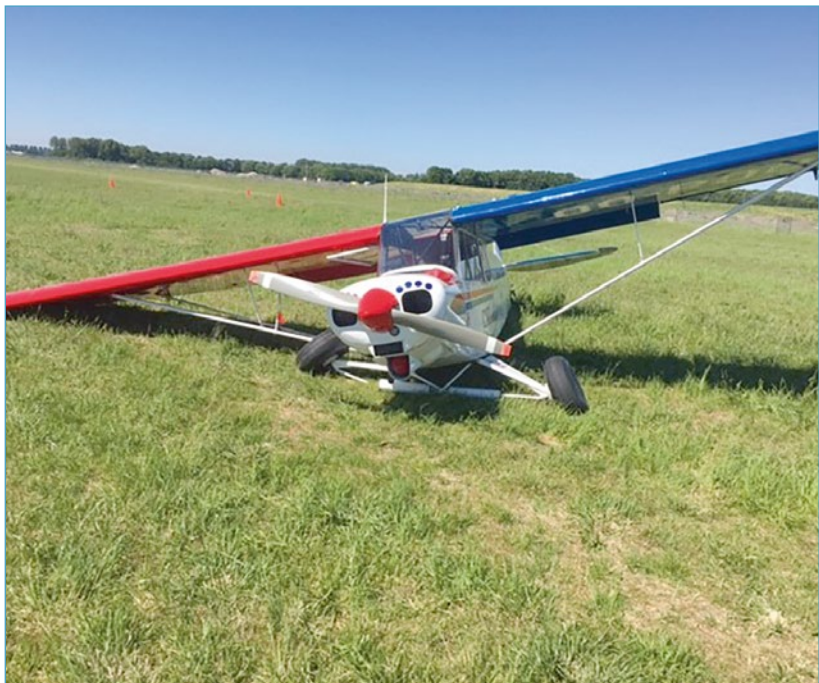
The OO-POU after the incident. (Photo: Lelystad Airport)

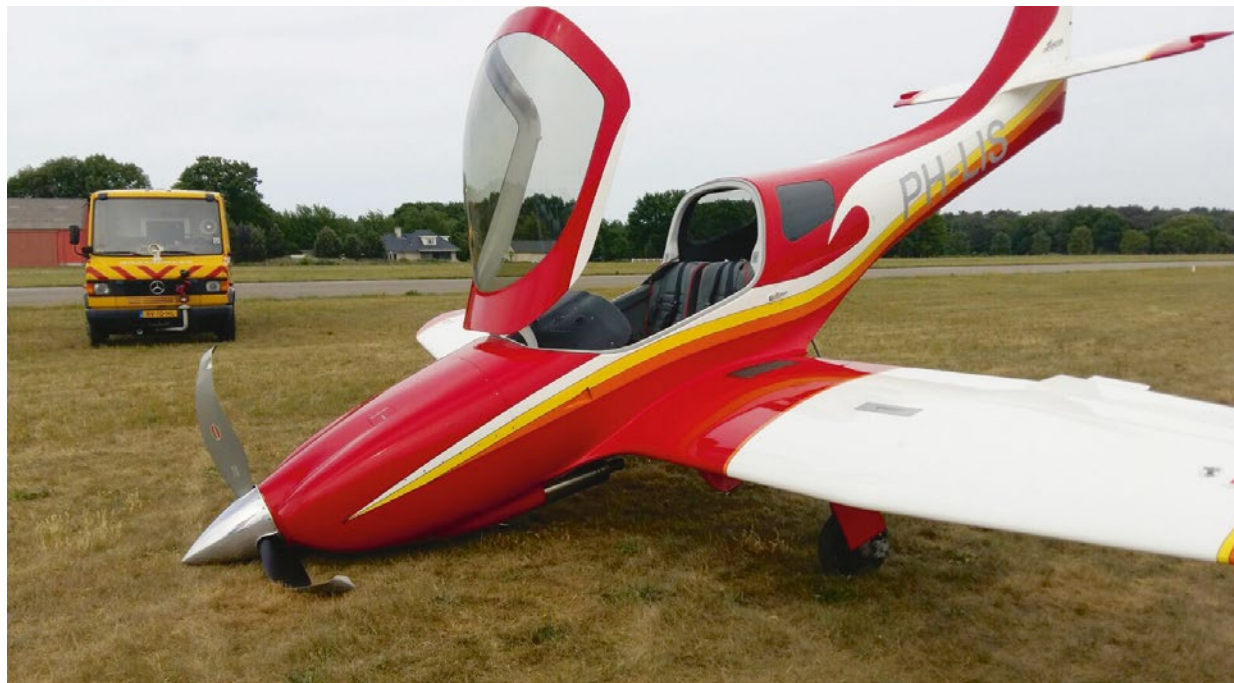
The PH-LIS after the emergency landing. (Photo: Aviation Police)
