DUTCH  
SAFETY BOARD

# Loss of separation over Uitgeest

*The Hague, May 2013*

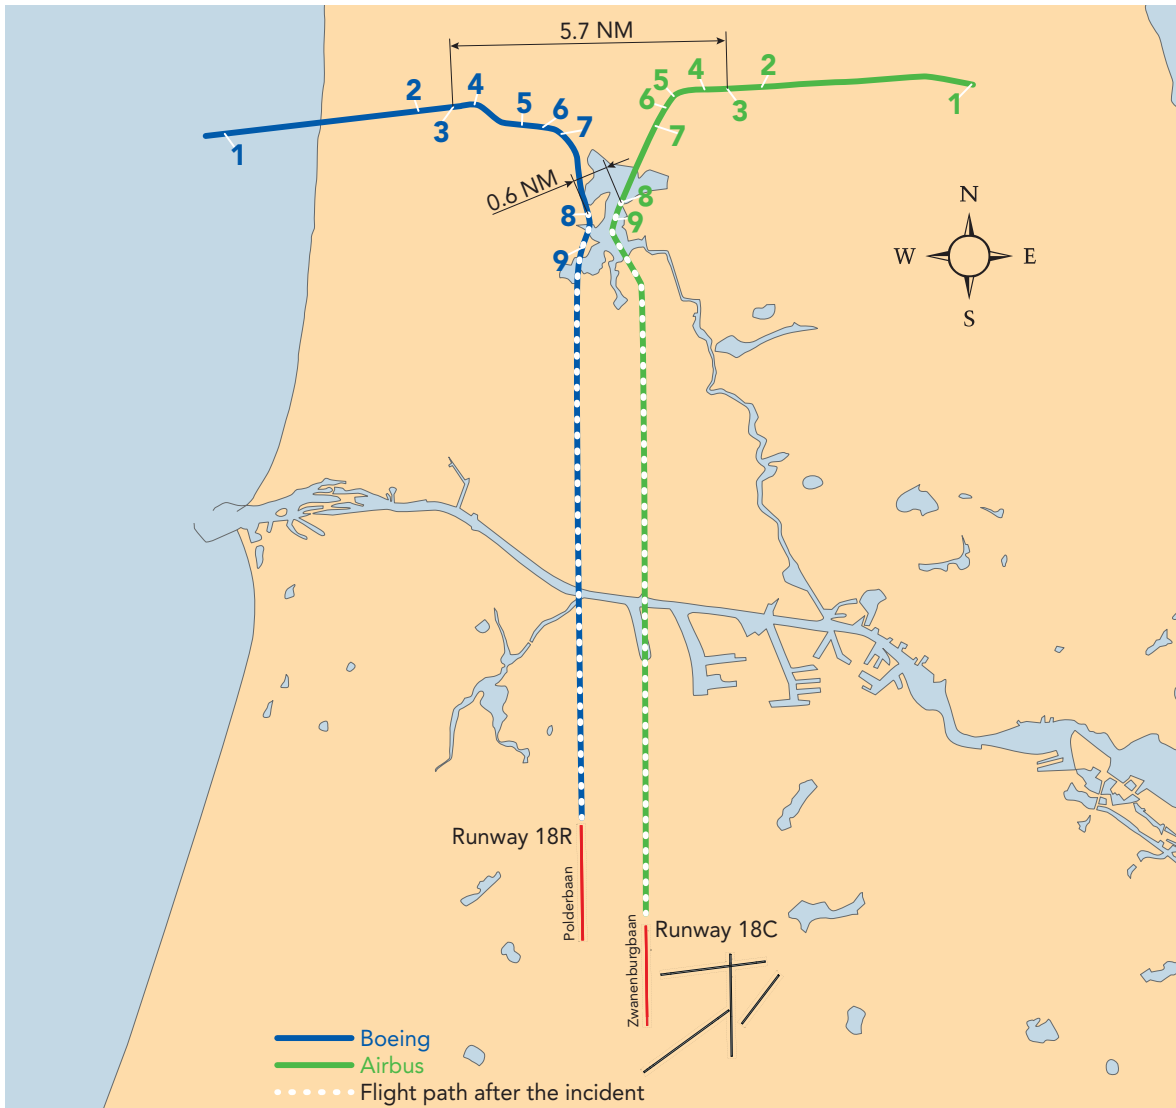
Figure 3: Overview of the approaches of both aircraft to Schiphol Airport

The Airbus continued on heading 210. The ATC controller for runway 18C warned the Airbus crew of the presence of the Boeing. The Airbus crew stated they had the Boeing in sight (figure 3, 6). At that time the Airbus was approaching the final radial<sup>5</sup> for runway 18C. When the ATC controller asked the crew whether they had the Boeing in sight, the crew confirmed again and asked if they could start the approach to runway 18C (figure 3, 7). The ATC controller then gave the crew a new heading of 160 to bring them back to centreline and cleared them for the approach (figure 3, 9).

Position	Time	Boeing	Position	Airbus
1	06.41:39		1	Airbus is given a heading of 270 and cleared to descend to 2000 feet
2	06.42:51	Boeing is given a heading of 160	2	
3	06.42:55	Air traffic controllers recognize the conflict. Distance aircrafts 5.7 NM, altitude difference 100 feet. Boeing is given a heading of 360	3	
4	06.43:01		4	Airbus is given a heading of 210
5	06.43:15	Boeing is given a heading of 160	5	
6	06.43:29	Boeing confirms visual contact with Airbus	6	
7	06.43:34		7	Airbus confirms visual contact with Boeing
8	06.44:08		8	Minimum distance between Boeing and Airbus 0.6 NM 0 feet.
9	06.44:12		9	Airbus is given a heading of 160

TCAS generated a 'traffic advisory' at 06.43:35 (during 4 seconds) and again at 06.43:49 (during 5 seconds). The minimum distance between the two aircraft during the approach was 0,6 NM (1,1 km, figure 3, 8). No collision warning (RA) was given by either system.

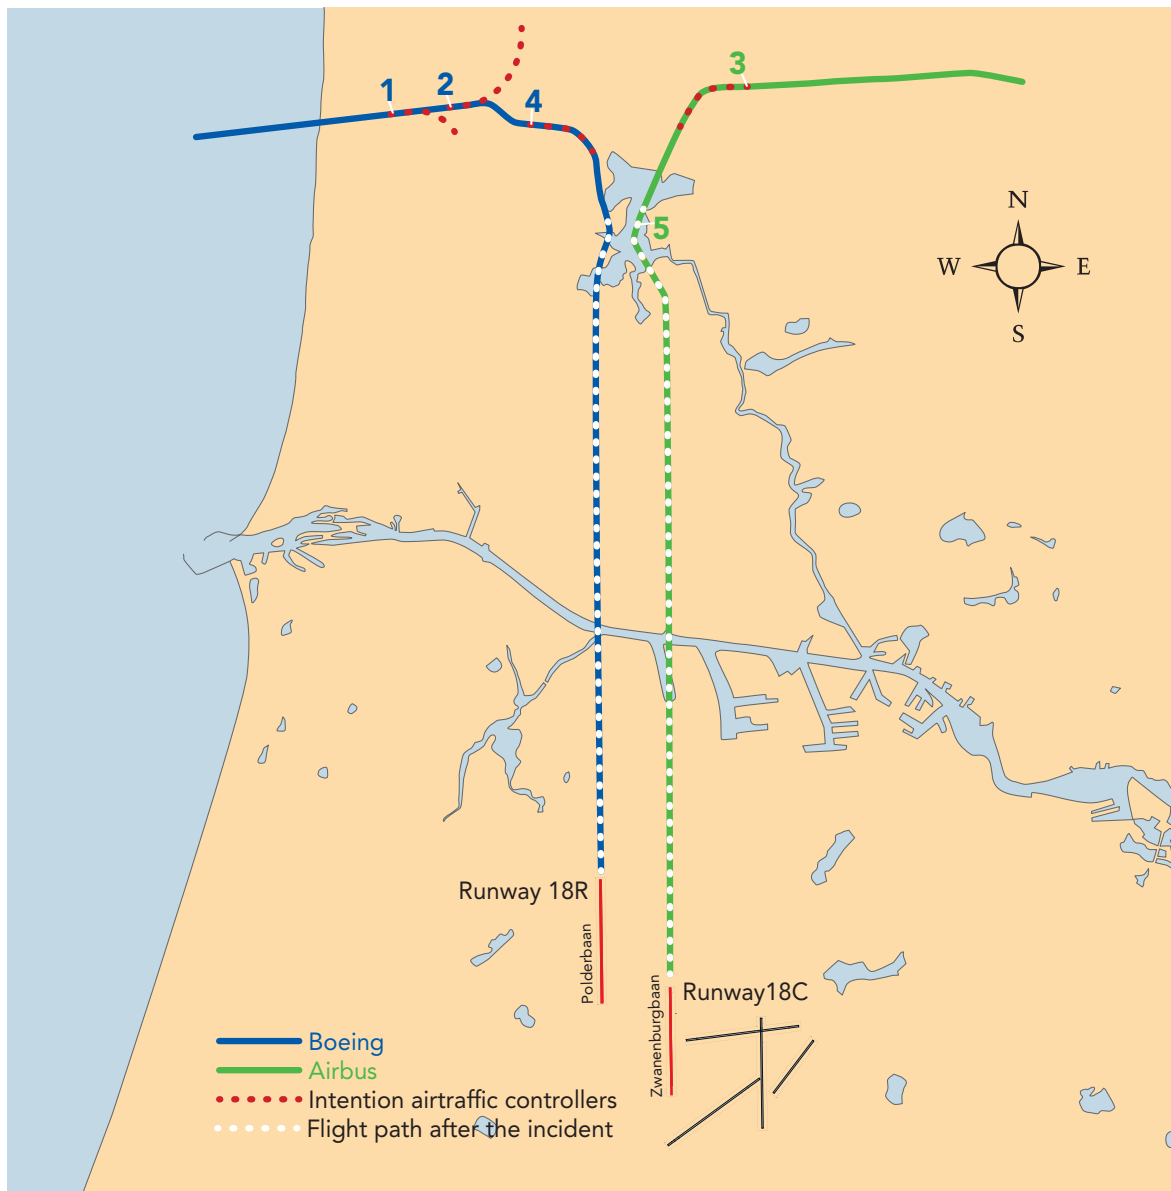
Figure 6: ATC heading instructions and crew confirmation (2,3 NM and 1,9 NM)

Heading changes from 160 to 360 and then to 160 again are considered extreme changes, especially during approaches. The crew was given heading changes to the south, followed by a turn to the north and then southbound again. The ATC controller did not expect the Boeing crew to turn as quickly as they did, and was already turning towards heading 160 when he told them to steer 360, and towards 360 when told to turn to 160 again. The radar images shown to the ATC controllers has a 5 seconds lag time. This lag is due to system design and is not preventable. Because of radar lag time and the short time between the given instructions the ATC controller was unaware of the fact the crew was already turning to the instructed headings. According to the ATC controller, there was a no, or very short time between the given instructions. The fact that there was little or no delay between the given instructions indicates the ATC controller was looking for a solution for the loss in separation between the two aircraft. The first heading correction did not give him the expected result. Interpreting the radar imagery he concluded the heading correction towards 360 would take too much time (a full 360 degree turn takes 2 minutes, a left turn towards 360 heading would take approximately 30 seconds), resulting in an even shorter distance between the two aircraft.

Position	Time	Boeing	Airbus
1	06.42:51	Boeing is given a heading of 160	
2	06.42:55	Boeing is given a heading of 360	
3	06.43:01		Airbus is given a heading of 210
4	06.43:15	Boeing is given a heading of 160	
5	06.44:12		Airbus is given a heading of 160

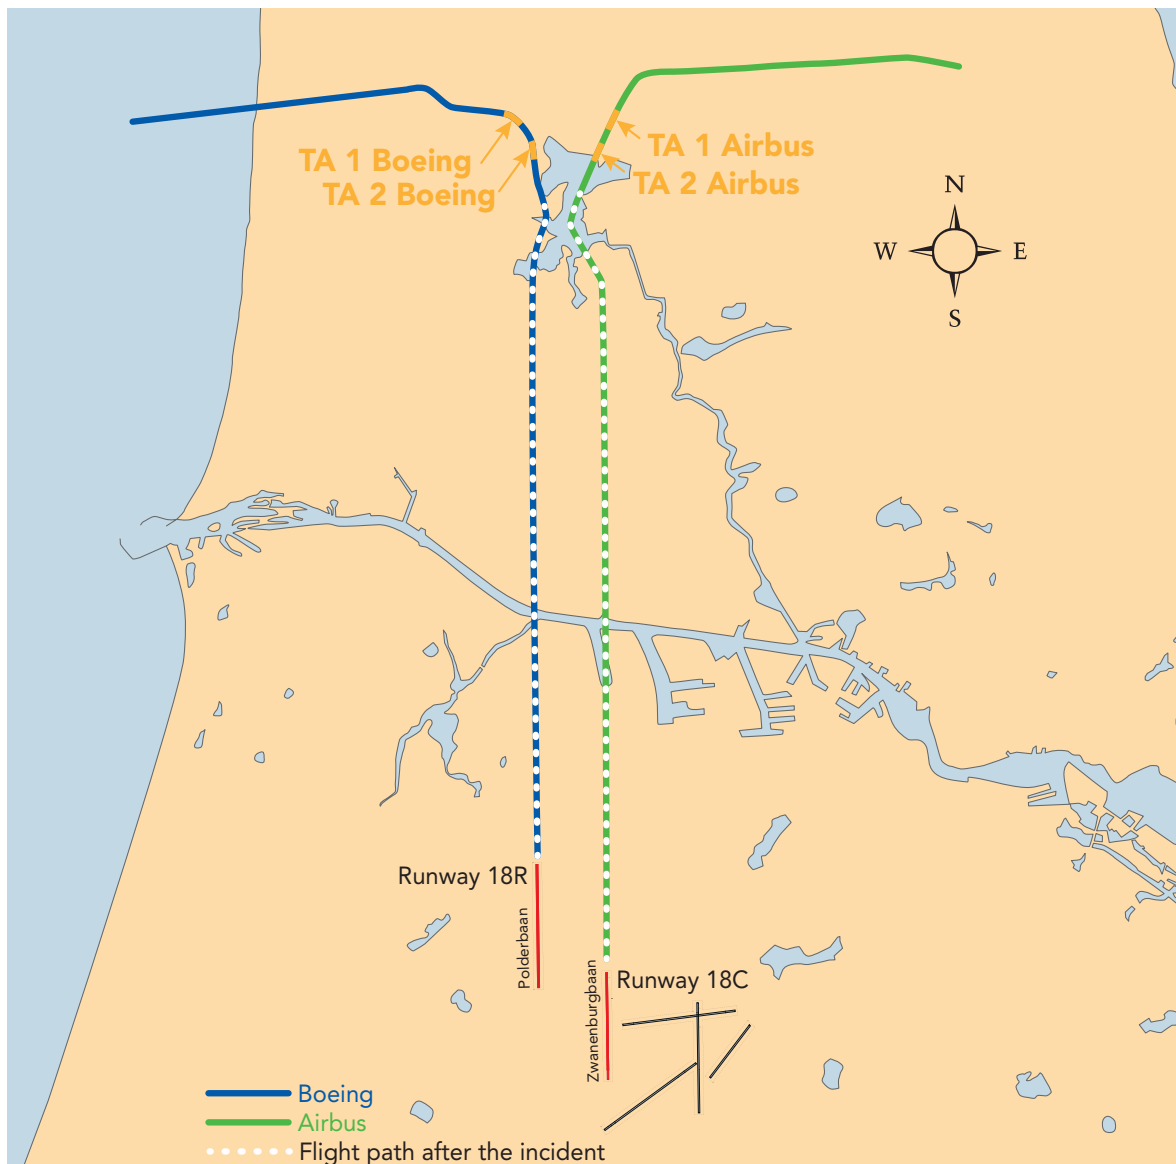
Figure 7: Position of aircraft during TA warnings

The crew of both aircraft were given two TCAS 'traffic advisory'-warnings (figure 8). Crews were prepared to take the necessary actions if needed (evasive manoeuvre in case of 'resolution advisory'). Until the moment of the first TA warning, both crews were following ATC instructions.
