EXPERT REPORT

Report Concerning 60mm Mortar Accident Investigations

30th September 2020

This report was commissioned by **[REDACTED]**, Public Prosecution Service,
East Netherlands Office.

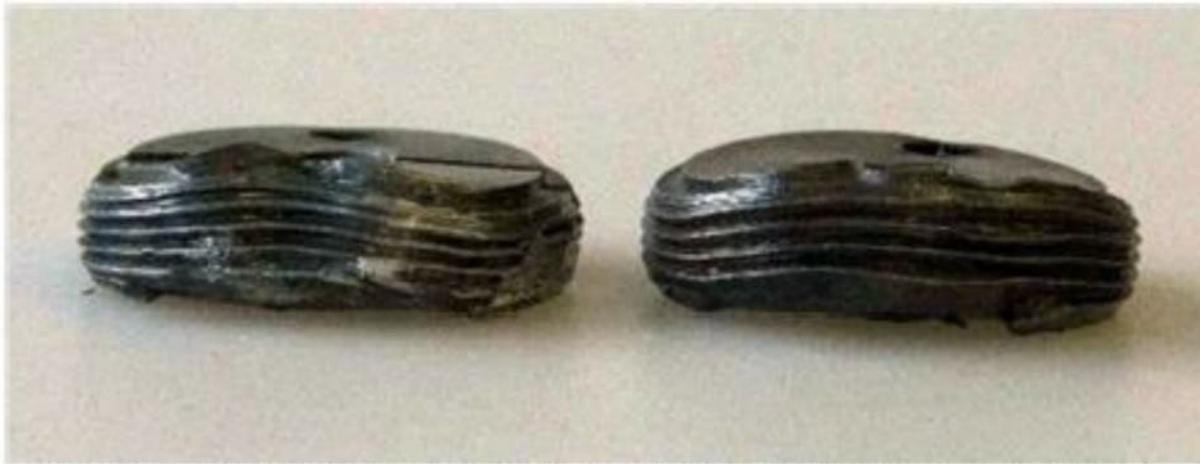
During their considerations, KC W&M, identified a very close similarity between the explosive train interrupter plate, which they call the cover plate, identified by DSB (and TNO) as evidence remaining from the accident fuze and the same component recovered from an externally initiated explosive demolition. This is demonstrated in the Figures 8 and 9; it should be noted that the cover plate, on the left side, and attributed to the accident, had been sectioned for forensic examination. The KC W&M attribution for this component was additionally reinforced by an error in the DSB report where it was stated that this component was recovered from an

Figure 8: Left explosion train interrupter plate; DSB-report; right explosion train interrupter plate; controlled destruction. (Picture KC W&M)

Figure 9: Left explosion train interrupter plate; DSB-report; right explosion train interrupter plate; controlled destruction. (Picture KC W&M)

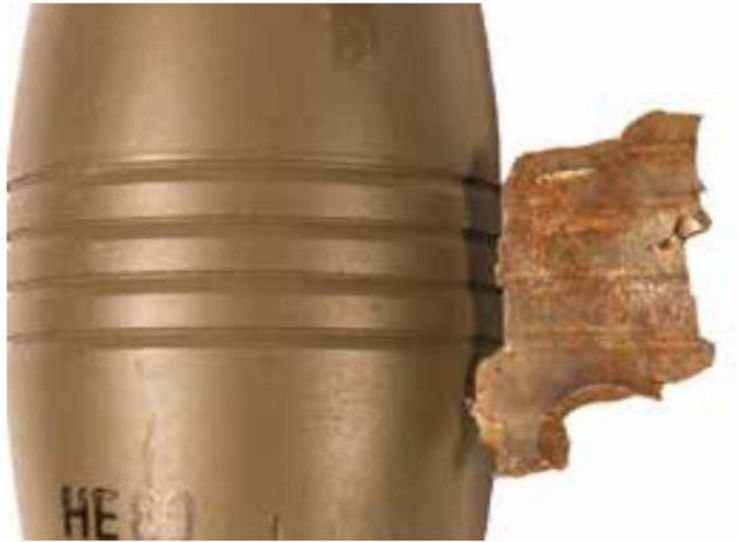
Figure 11: Imprint on the fragment of the launch tube, originating from the grooves on the shell casing when the main charge explodes. Figure illustrates the steel fragments produced during detonation of an HE 80 mortar round. (Picture: TNO)

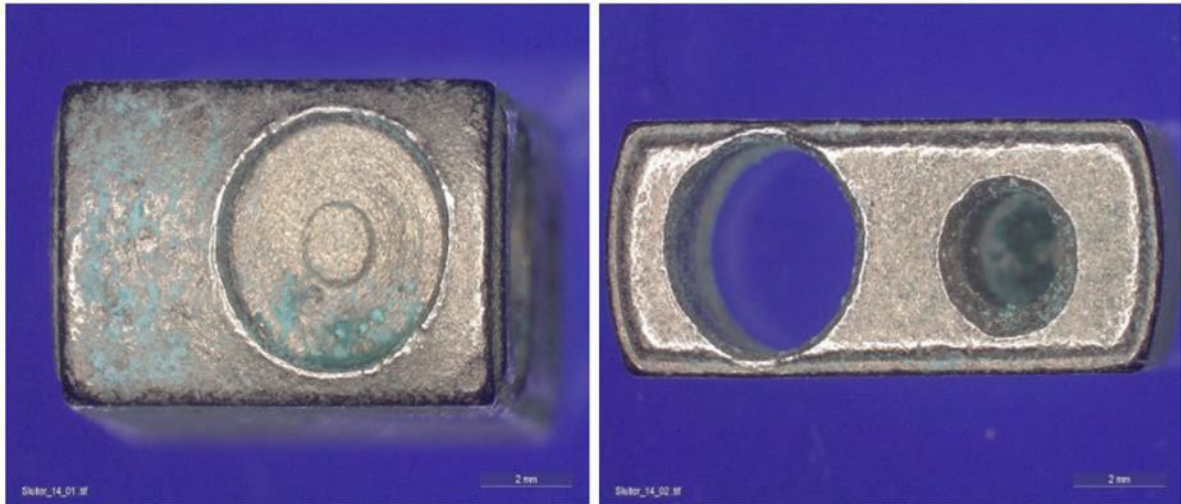
Figure 13: Optical micrographs of slider. Corrosion is visible on the side wall and in the recess for the slider spring (left) and on the top, on the edge of the hole for the detonator and on the edge of the recess for the firing pin (right). (Picture: TNO)

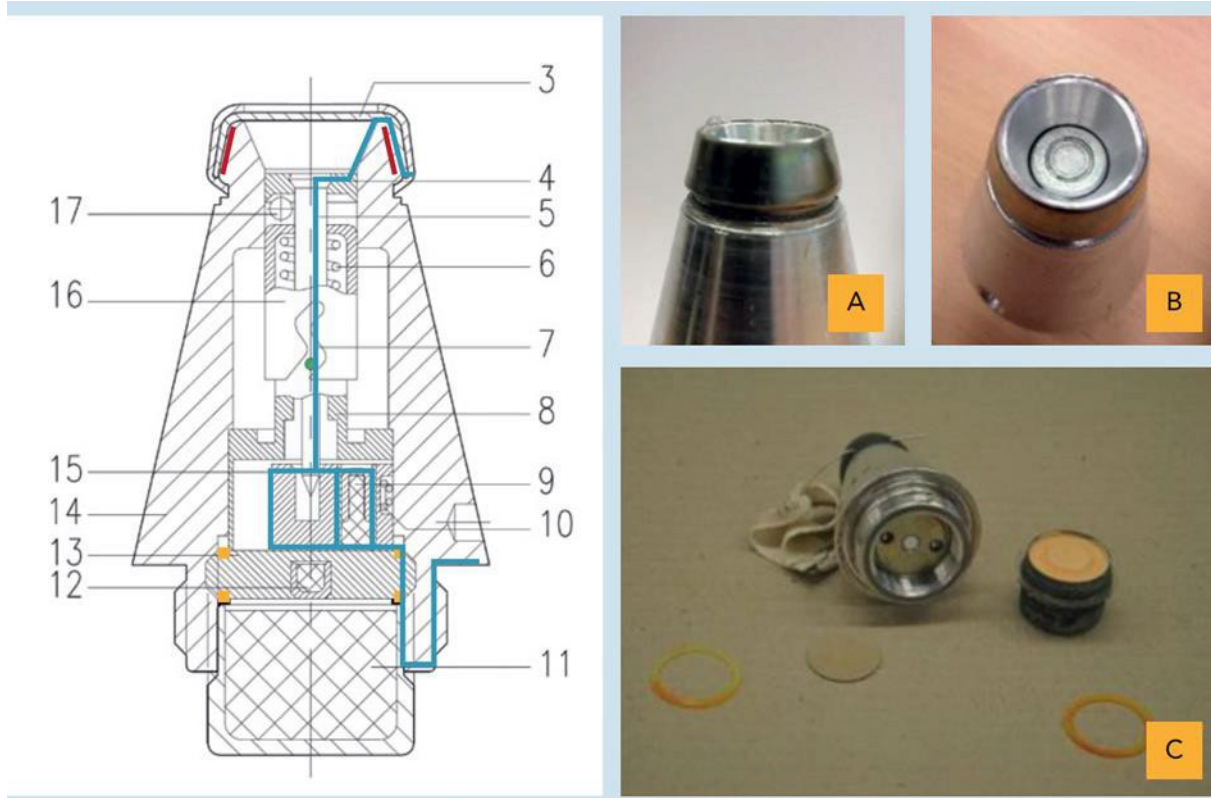
Figure 15: Cross section of the fuze with potential routes (blue) for moisture penetration via the adhesive layer (red) and sealing rings (yellow). Picture A: adhesive layer for the membrane, picture B: opening between the firing pin and the housing. Conclusion is that moisture ingress more likely via top of fuze. (Source: TNO)

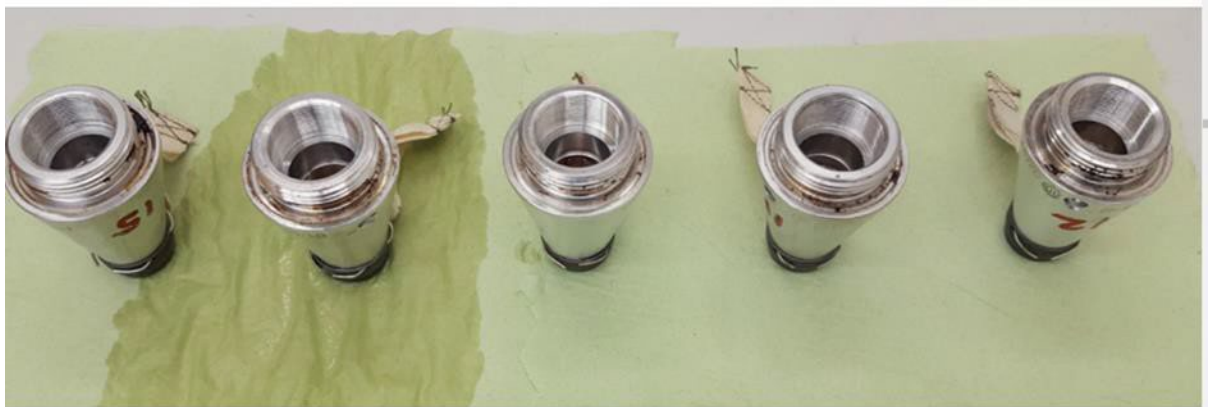
Figure 16: Filling the top of the M6-N fuze with water to show leakage. The adhesive layer of one of the five fuzes tested is leaking after a drop test from about one metre height with random impact orientation. (Picture: TNO)

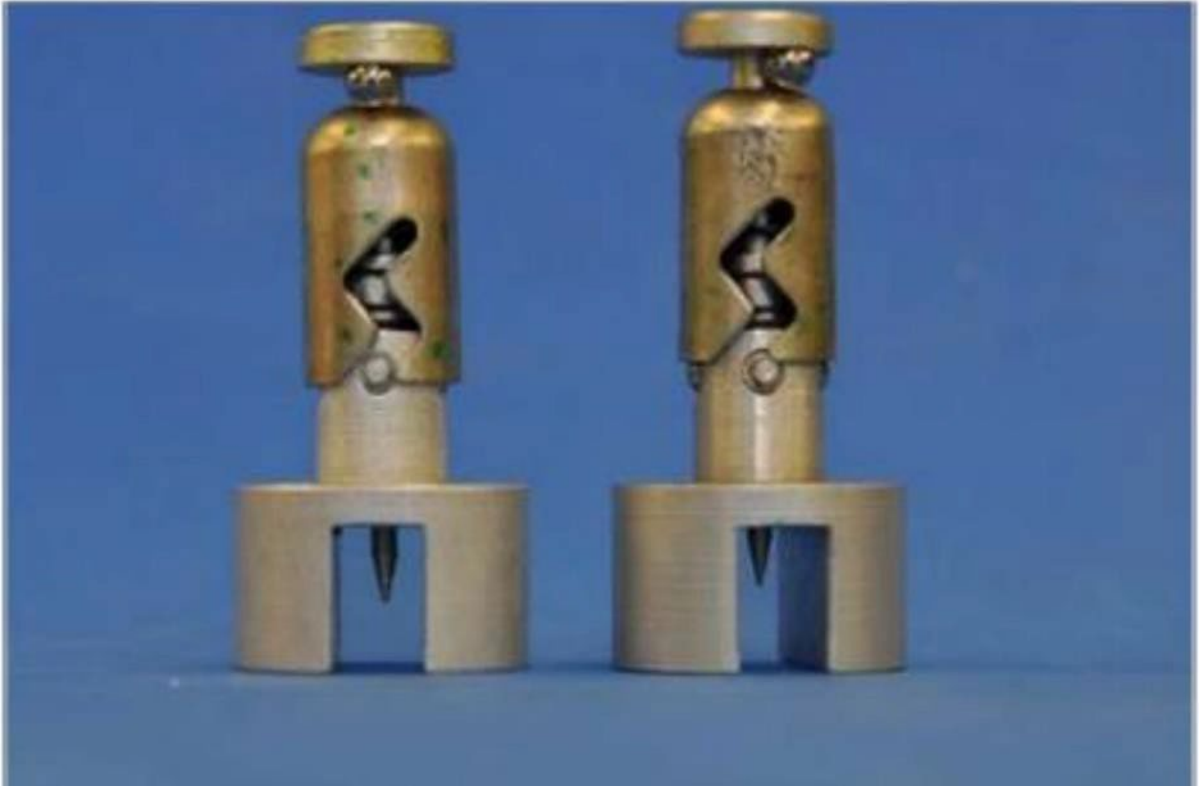
Figure 25: Combination firing pin and non-return valve; left correct; right incorrect (Photo: KC W&M)
