**Theme study into fire safety onboard inland
navigation passenger ships**

The Hague, June 2008

THE DUTCH SAFETY BOARD

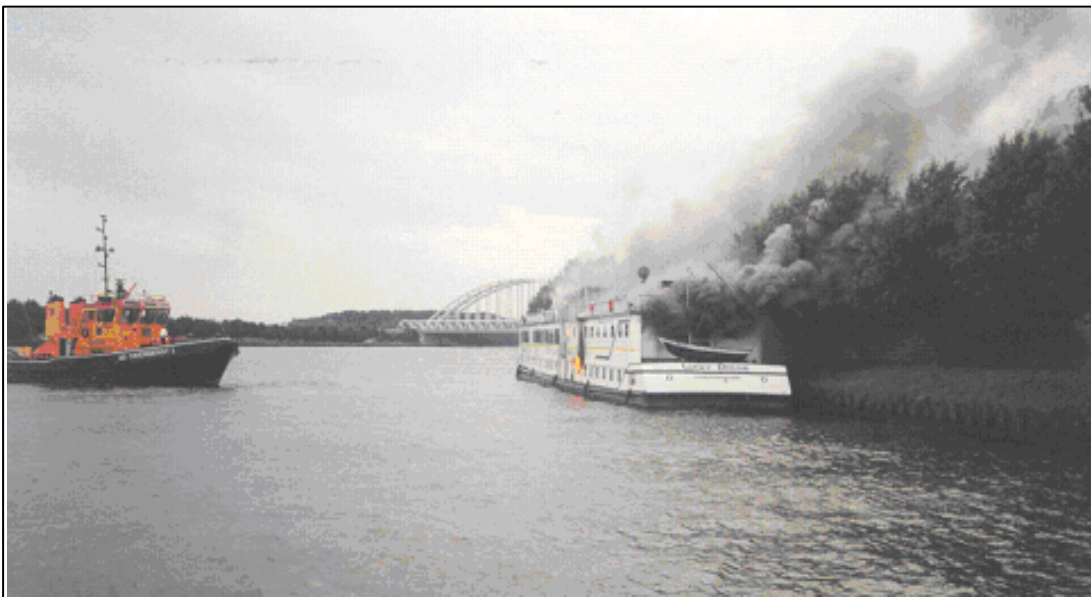
Figure 1: On the right of the photo, the burning passenger ship. On the left, a ship of the Amsterdam Port Authority, also a fire-extinguishing ship (source unknown).

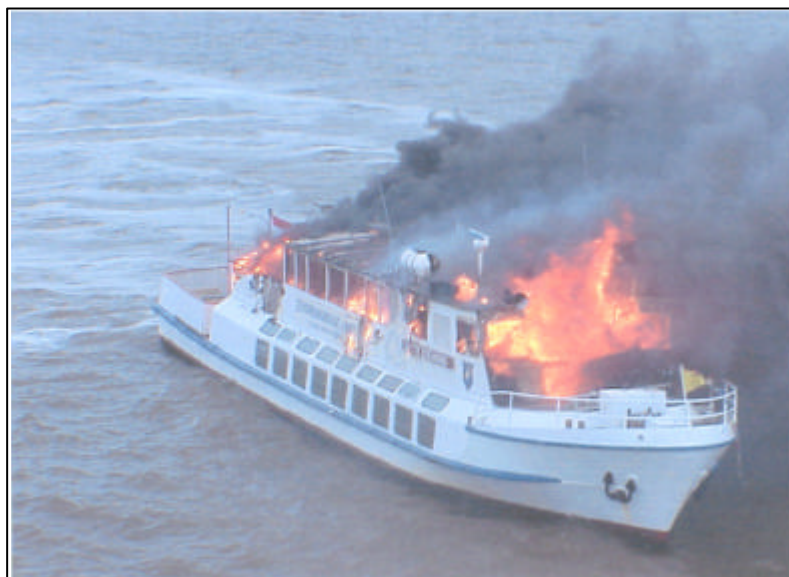
*Figure 2: A burning passenger ship on the Wadden Sea
(Source: Royal Netherlands Navy).*

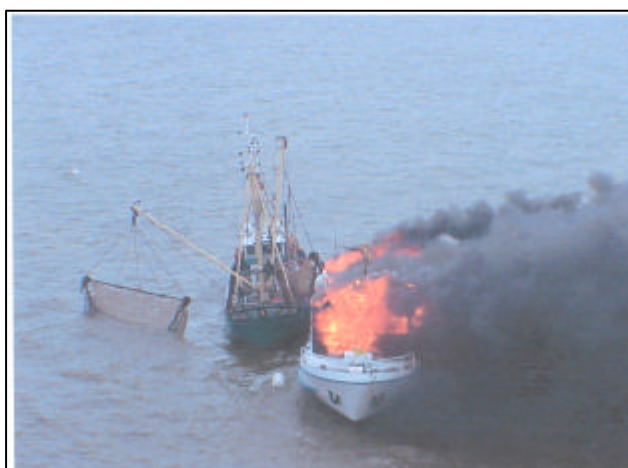
A day cruise ship was sailing on the Wadden Sea with 31 passengers onboard. During the journey, a fire broke out. Attempts by the crew to tackle the fire with an extinguisher were unsuccessful. The passengers onboard were gathered on the afterdeck. It was not possible to moor in good time, as the ship was sailing on open water, far from the wharf or any harbour. The captain climbed up the aluminium superstructure in order to throw the four life rafts situated there overboard so that they would be ready for use. When he threw the first raft overboard, however, it failed to open out and was therefore unusable. He did not have the opportunity to throw the remaining three rafts into the water, as in the meantime; the deck had literally become so hot under his feet that his shoes had become stuck to the aluminium deck. A short time before the flames spread to the upper deck, it was possible to transfer the passengers to a fish cutter that had rushed to assist the ship.

Figure 3: The evacuation of passengers to a fish cutter on the Wadden Sea. Next to the burning passenger ship it is possible to see the unopened (and unusable) life raft (Source: Royal Netherlands Navy).

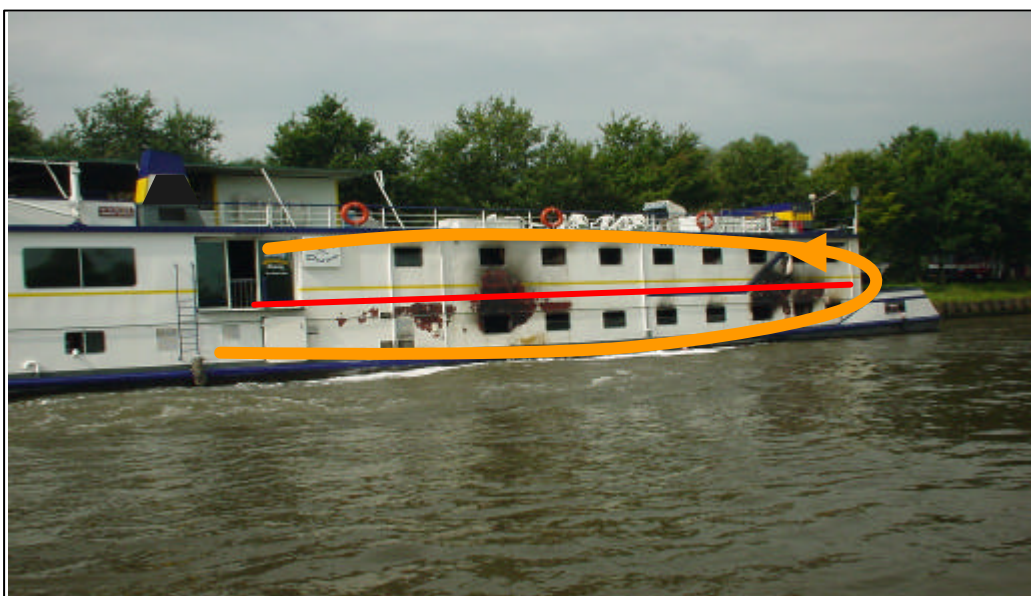
Figure 4: The steel deck is shown in red, the path of the fire in orange: the fire started in the engine room, spreading across the lower deck where the cabins for both the crew and passengers are situated, to the middle deck, where further passenger cabins are situated (Source: Dutch Safety Board).

On the 18th of August 2001, a fire broke out in the engine room of a hotel ship. At the time, the ship was sailing in the region of the Muiderbrug on the Amsterdam-Rhine Canal. The fire spread via the door of the engine room. This was possible as the door could not be closed adequately, as well as due to the ventilation ducts leading towards the stern. In the stern, the fire spread via a wooden section in the otherwise steel ceiling towards the upper deck, then travelling back towards the fore part of the ship as far as the reception area. The fire was able to spread to the successive areas via the non fire-resistant cable transits for the electric cables and due to the presence of flammable materials in the walls and doors (see Figure 5). The entire stern, consisting of two decks housing the cabins for passengers and crew, eventually completely burned out.

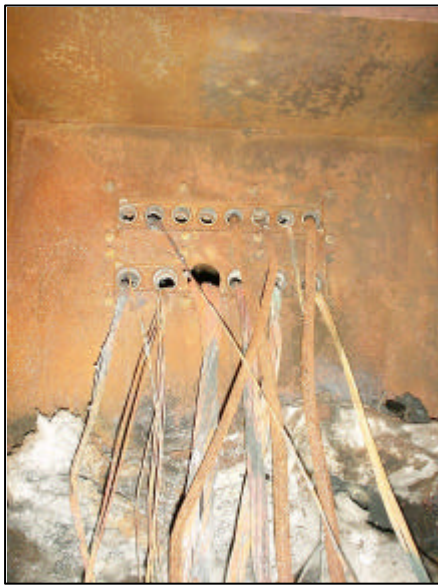
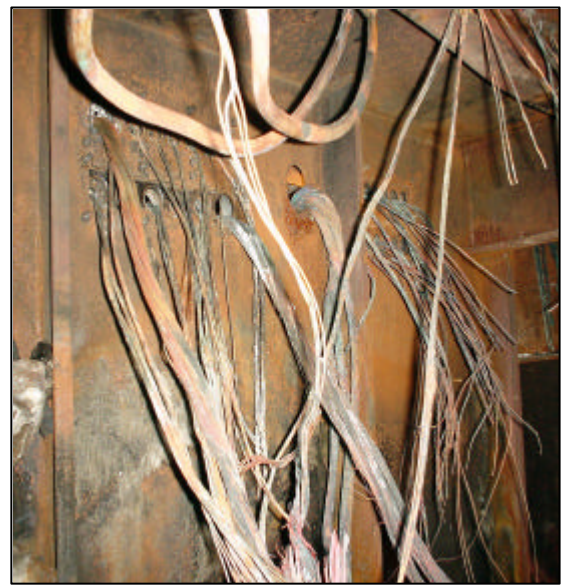
Figure 5: Photographs of the cable transits after the fire. The openings shows that the cable transits were not designed to be fire resistant (Source: Dutch Safety Board).

Cable transits through decks or partitions must be designed in such a way that they do not have a negative impact on the closure and fire-resistant properties of the compartments. In order to delay the fire from spreading, more stringent requirements have also been imposed in relation to the fire-retardant effect of the interior and upholstery, such as furniture, curtains and wallpaper. These new requirements apply to newly constructed ships, alterations (not replacements!) or conversions of (part of) the ship. In the case of ships that have already been put into commission, these requirements will enter into force no later than on renewal of the Certificate of Inspection after 1 January 2045.
