**Explosion on board a two mast clipper,
Medemblik, 8 June 2006**

The Hague, August 2007 (M2006SV0608-02)

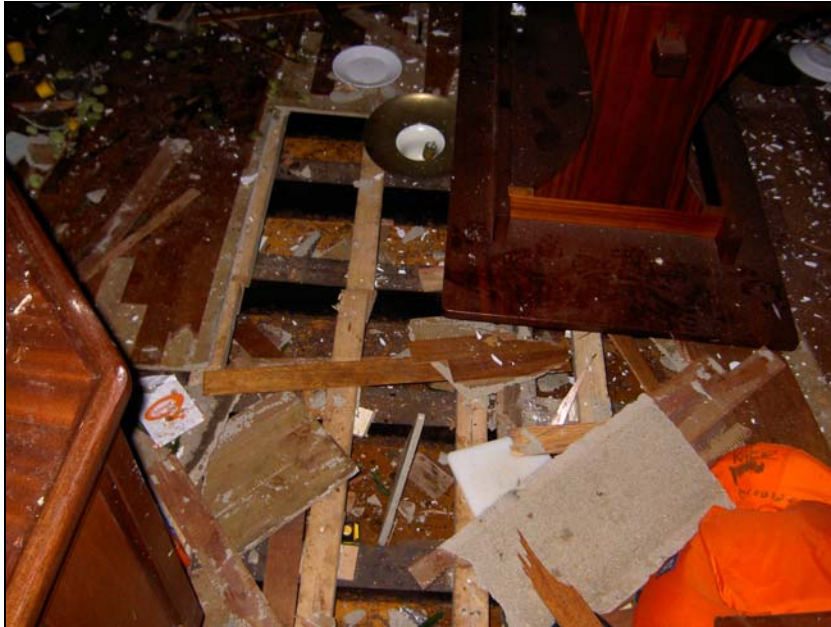
On the basis of the damage assessment and other information, the police and the Dutch Safety Board established that the explosion was due to an accumulation of gas under the floor. On the basis of this observation, the Dutch Safety Board put forward two hypotheses about the cause of the gas accumulation. These hypotheses have been detailed in two scenarios that are described in the following sections.

Figure 5: *Damage after the explosion, floor of the living quarters (Photo: Dutch Safety Board).*

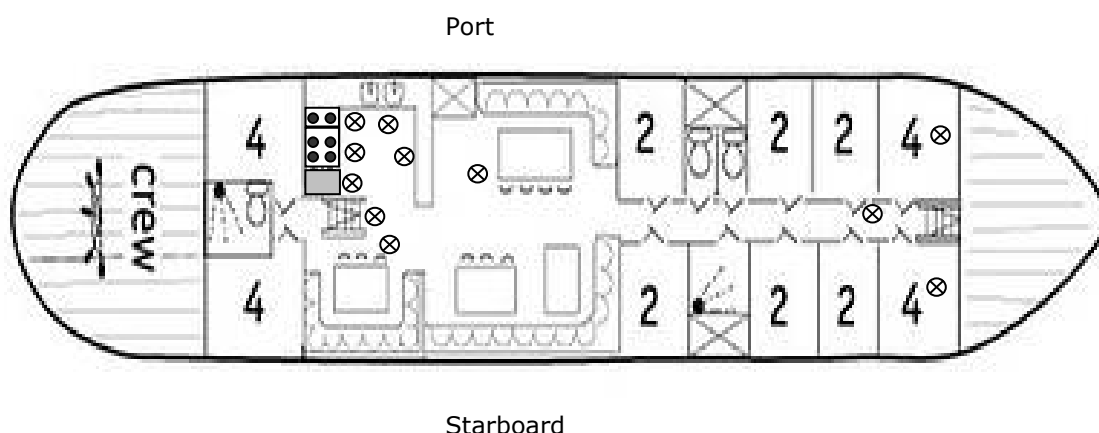
Witness statements were used to make a sketch of the positions of the pupils at the time of the explosion (figure 6). The four seriously wounded pupils who had to be taken to the hospital after the explosion were on the stairs and by the cooker. The injuries, mainly complicated fractures of the ankles, provide clear evidence that the explosion came from under the floor.

Figure 6: *Top-down view, showing position of pupils*

- *The circles containing crosses indicate the positions of the pupils that were on the ship at the time of the explosion.*
- *The four most seriously wounded pupils were in the galley and by the stairs to the rear of the ship, which is also the exit.*

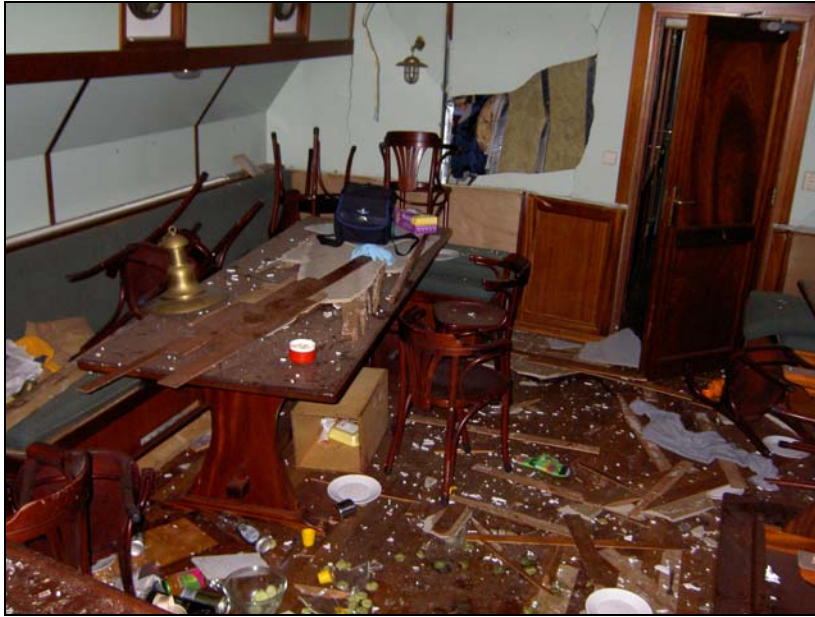
The door of the cooker's oven compartment was open and the left hinge was broken.²¹ The cooker's control knob and one of the cooking rings were missing. These knobs were found on the floor of the galley section. The floor was also covered with other loose objects such as leftovers, glass, footwear and toiletries.

Figure 7: *Damage to the interior on the port side, view towards the bow of the ship (photo: Dutch Safety Board)*

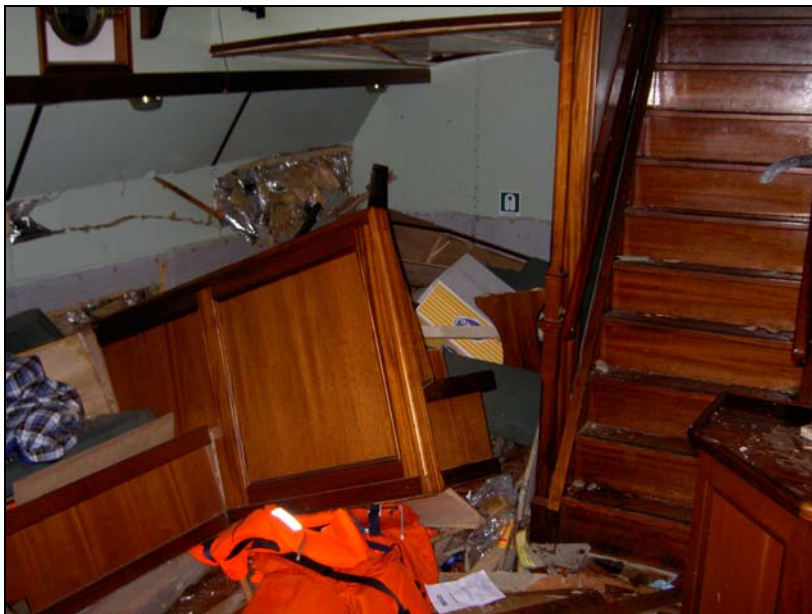
Figure 8: *View past the stairs on the starboard side towards the stern (photo: Dutch Safety Board)*

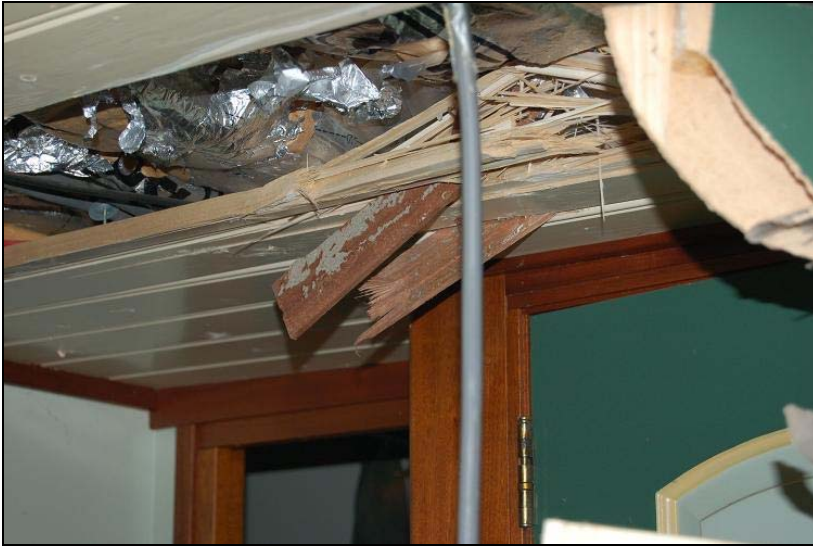
The floors in the below-deck areas of the ship were made of laminate strips that were glued to the subfloor.²² The subfloor was secured to wooden beams on the floor structure in the ship's living quarters. Under the floor of the cabins at the rear of the ship there were cables and connections for electrical equipment, various pipelines for drinking water and shower water and for hot water for the convector heaters, and pipes for the drainage of sewage water from showers, toilets, washbasins and the galley. In the living quarters, although these cables and pipes were fitted above the floor they were concealed behind the benches and in kitchen cupboards. The shower and toilet areas had tiled subfloors.

Figure 9: *Damage to the ceiling. Parts of the laminated floor have bored themselves into the ceiling (photo: TNO Construction and Service)*

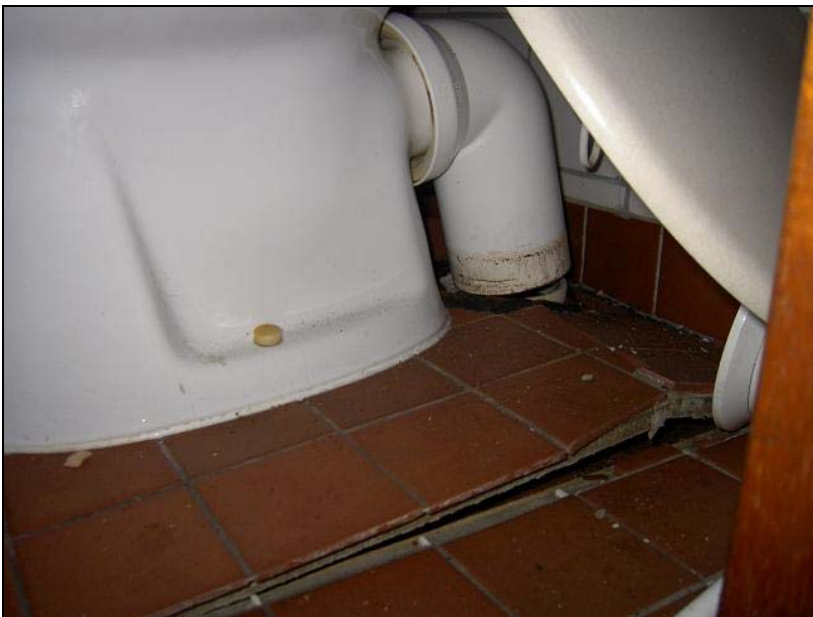
The toilet to the rear between the two cabins was torn loose from its fittings by the force of the explosion and now had cracks in it (see figure 10). The floor and wall in that toilet also had cracks in them and some components that had come loose. The adjoining cabin on the starboard side had been greatly damaged. For instance, one of the double bunks had been ripped off the wall. The damage to the cabin on the starboard side turned out to be greater than the damage to the cabin on the port side that adjoined the living quarters.

Figure 10: *Toilet that had been fitted on top of the sewage tank. The way in which the floor has been forced upwards can clearly be seen. (photo: TNO Construction and Service)*

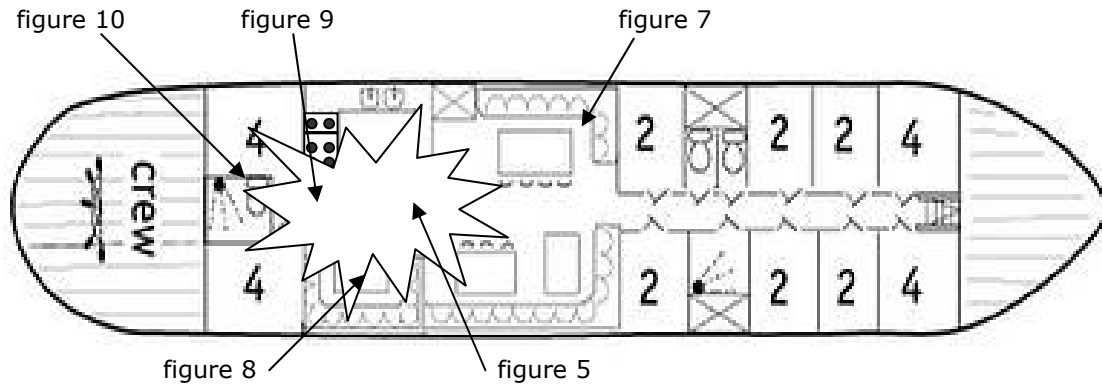
Figure 11: Top-down view of explosion, including viewpoint of photographs/figures

The pattern of damage provides sufficient evidence for assuming that the damage was caused by an accumulation of an explosive mixture under the floor. The greatest damage was found in the middle of the below-deck area under the stairs and on the starboard side. Given the damage assessment, the centre of the explosion was located near the cabinet under the stairs that lead off the ship. Note that the centre of the explosion is not necessarily the place where the gas mixture ignited.

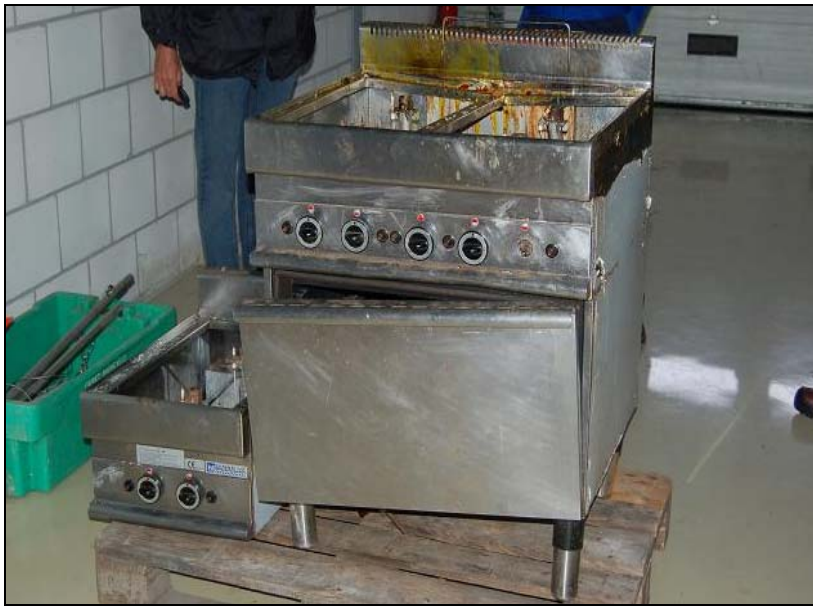
This investigation found no evidence of defects in the gas equipment that could explain an accumulation of gas under the floor. The report by KIWA Gastec to the NFI only mentions a very slow leak from the pipe, which may have been caused by the explosion.

Figure 12: Cooker ready to be taken away for further investigation, with those control knobs present having been turned to the off position (Note: The oven knob is the 3rd from left - a gas burner knob on the right is missing) (photo: TNO Construction and Service)

The cooker's performance was then examined a few weeks later in the laboratory. This investigation revealed that all the cooker knobs were working properly, apart from the oven knob. What was interesting about this knob was that when partially pushed in it could be turned without having to push the knob in all the way. When testing the knob, it turned out that the gas tap could remain open without the thermoelectric safety device taking effect (see below).

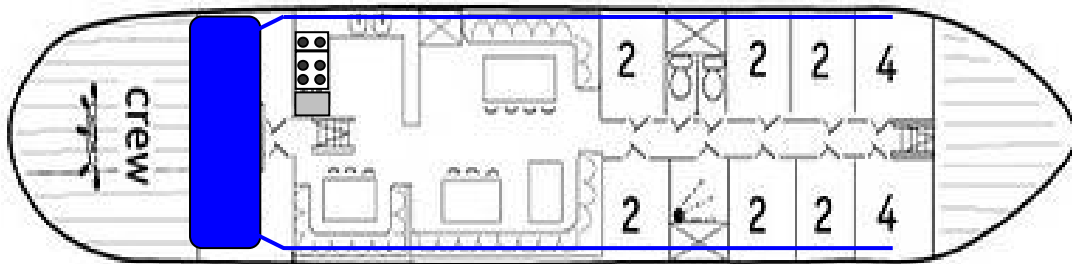
Figure 13: Sewage pipe and sewage tank under the rearmost two cabins, shower and toilet

On board the ship, defects were found in the sewage water system even before the explosion, in addition to the damage resulting from the explosion itself. A section of the PVC sewage pipe fitted by the tank under the floor and that ran above the floor of the recreational area under the benches through to the bow of the ship was tied with tape and partly glued with PVC glue. This joint was not gasproof. No tape was found on the other PVC sewage pipe joints.

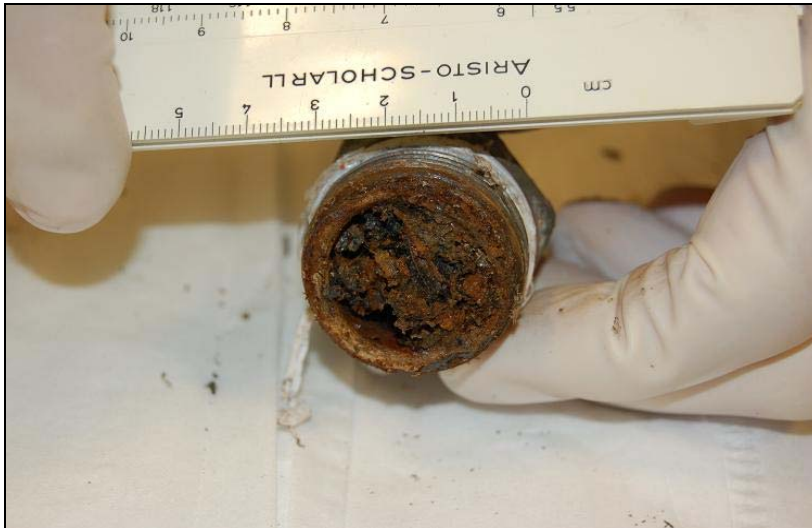
In addition, the aeration/deaeration of the sewage tank ran from the side of the tank to the above-deck area. However, the length of the flexible hose and a lack of support meant that it sagged (see diagrams of sewage tank appendix 2). The ship's movements and the level of fluid in the tank meant that the hose could fill up at its lowest point and silt up, and as a result could no longer function as an aeration/deaeration gap (see figure 14).

Figure 14: Blocked ventilation of the sewage tank (photo: TNO Construction and Service)

1. Given the risks associated with the use of sewage tanks, the Dutch Safety Board recommends that the Transport and Water Management Inspectorate (IVW) make the checking of the installation and maintenance of these tanks part of the system of certification and inspection.

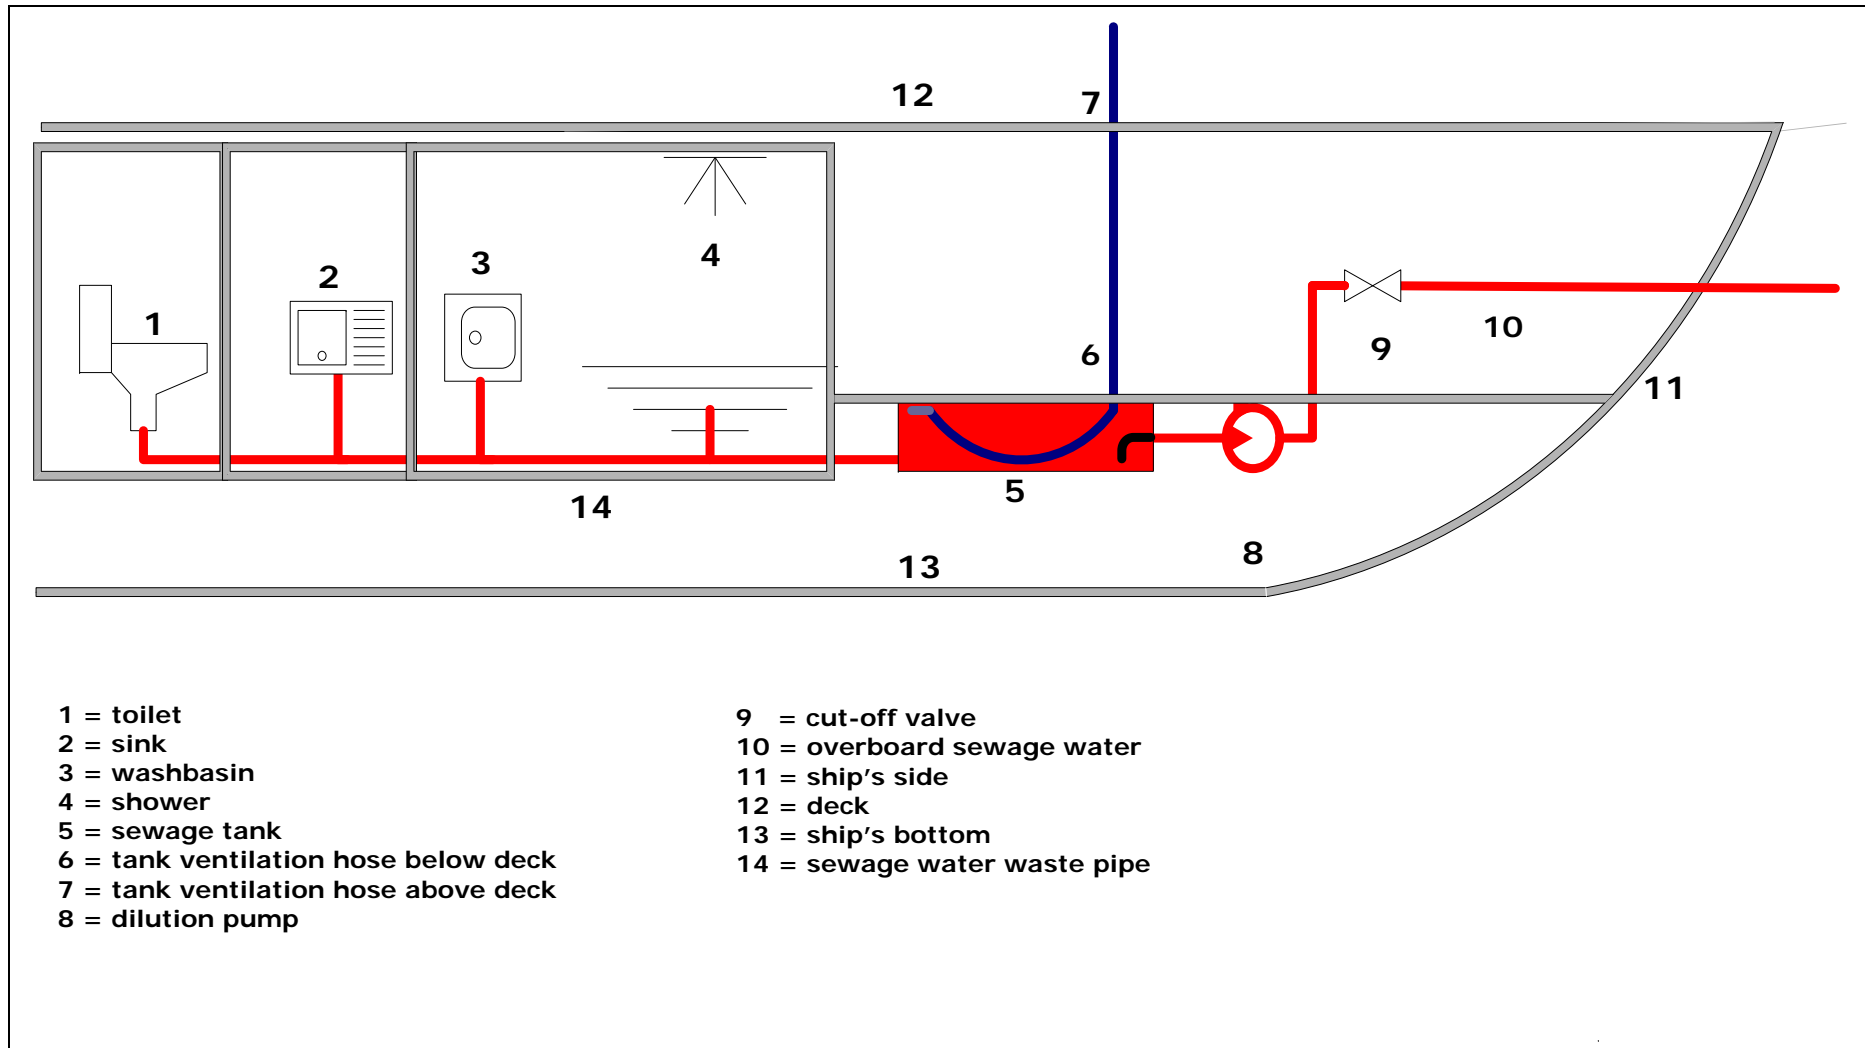
The dilution pump for the drainage of the waste water was fitted above the floor in the side of the tank. This made it impossible to fully empty the tank, leaving behind waste residues in it.²⁸ In the situation described above, it is possible that this residue could produce biogases in the tank and that the blocked ventilation could have meant that these gases looked for a way out via the sewage pipe joints. Each flushing of the toilet added liquid to the tank that expels the gases there.

Figure 2: Simplified diagram of the sewage tank for the drainage of sewage water from the two-mast clipper in question
