DUTCH  
SAFETY BOARD

# Crash NH90 helicopter, Aruba, 19 July 2020

## Findings initial investigation

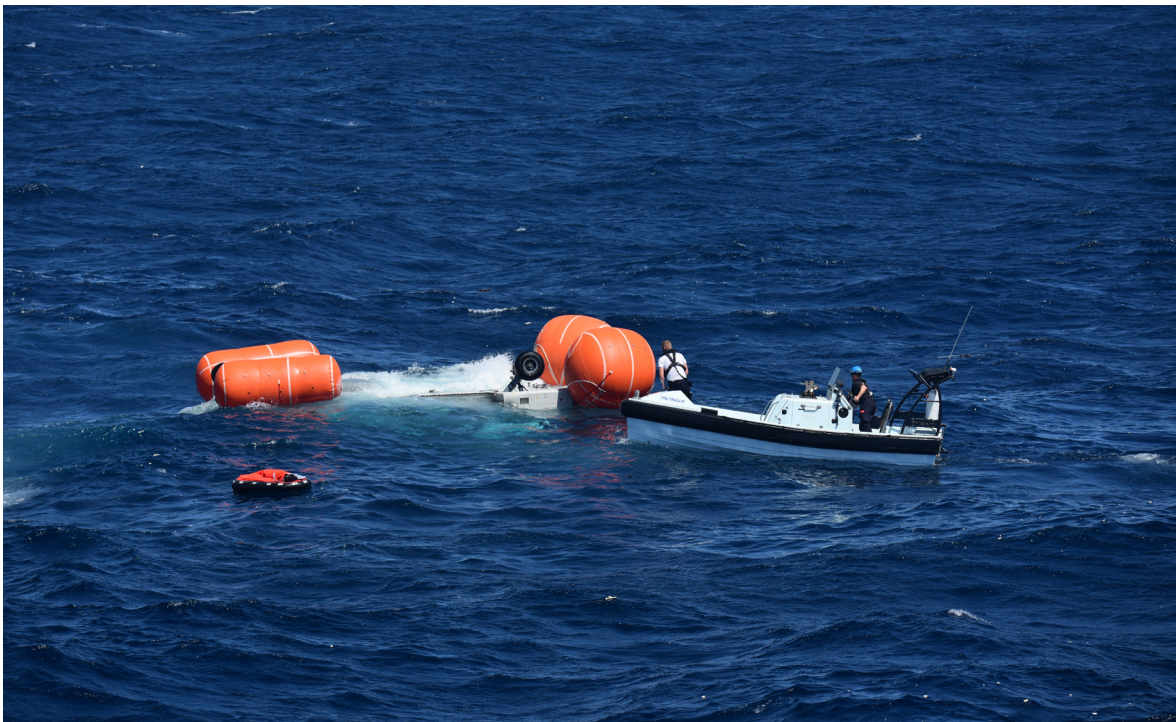
Figure 1: One of the rescue attempts close to the wreck of the NH90. (Source: Royal Netherlands Navy)

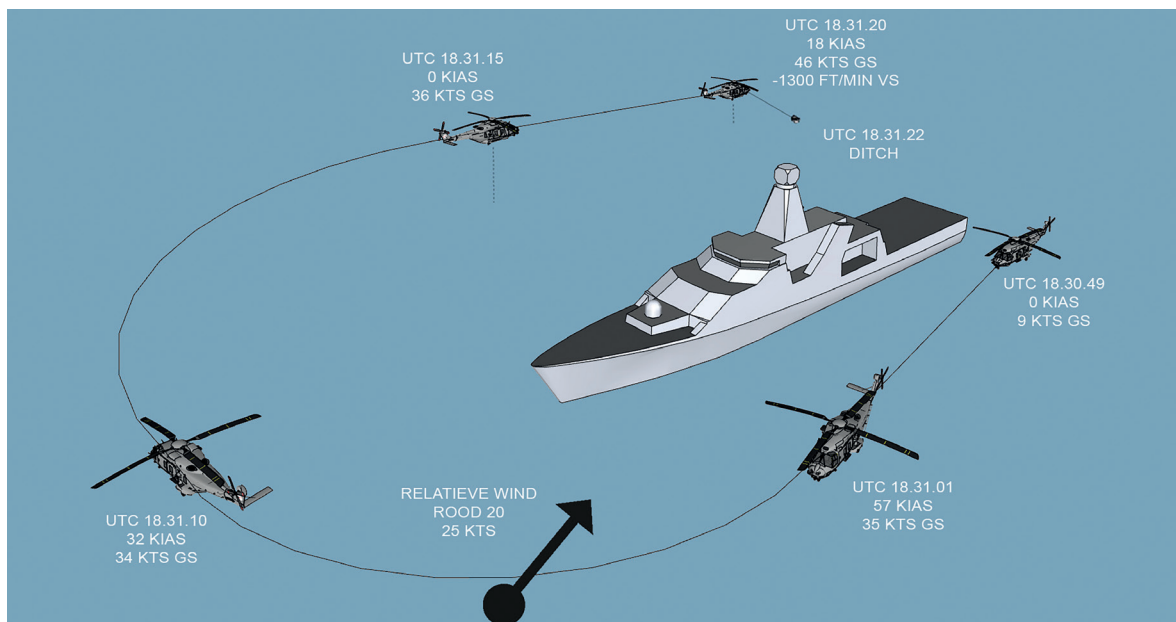
After take-off, the aircraft flew forward, parallel to the ship, at the same height as the bridge. After passing the ship, the helicopter made a wide turn passing in front of the ship, so as to turn to starboard. Initiating the right-hand turn meant that the wind direction relative to the helicopter changed from initially diagonally forward to subsequently a tailwind (downwind). Because the helicopter flew past the ship at relatively low speed, from the moment that the aircraft entered the downwind situation the Indicated Air Speed, IAS) fell to zero knots.

Figure 5: Positions and speeds of the aircraft following take-off through to the moment of impact (Source: IVD)

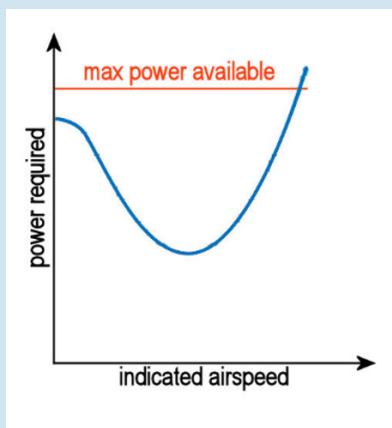
In general terms, at lower airspeeds helicopters require more power and hovering in the air requires a great deal of power. For the NH90 helicopter, the power curve indicates that when flying lower than approximately 80 knots airspeed, more power must be selected in order to maintain the same altitude. The NH90 had more than sufficient power available to maintain a hover in the conditions prevalent at the moment of the occurrence. The interplay of power in relation to speed, while maintaining altitude is more than a matter of merely selecting more power (pulling on the collective). The forward or backward movement of the cyclic pitch control also influences the behaviour of the aircraft.

The figure shows how the required power relates to the speed of the helicopter.

The y-axis shows the required engine power, while the x-axis (in this case) shows the forward (indicated) speed.

The blue line shows the required minimum power appropriate to the current airspeed. The orange line shows the maximum engine power available.

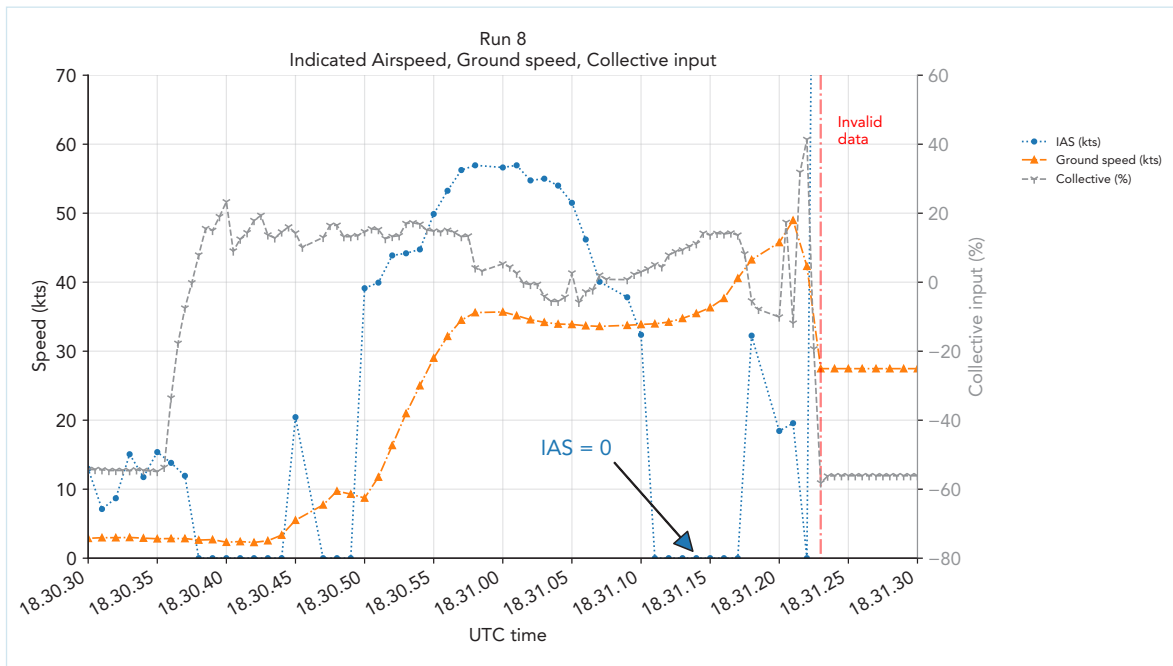
Following the initial analysis of the data, it has been determined that the Indicated Air Speed of the aircraft fell to zero knots as a result of the downwind turn. As a result of this manoeuvre, although the aircraft was flying forward relative to the Earth, relative to the surrounding air it was stationary. As already stated, this situation (a hover) requires a great deal of power. It has been determined that given the airspeed at that moment, the selected amount of power was insufficient to maintain the helicopter at altitude. As a consequence, the helicopter initially started to lose height slowly.

Figure 6: Analysis of the speeds of the aircraft following take-off and input collective. (Source: Dutch Safety Board)

The unexpected downward movement of the helicopter increased considerably over a period of three seconds, and subsequently very quickly transitioned into an accelerated descent. The downward movement was experienced by the crew members in the rear of the aircraft as a drop.

The uncontrolled descent was initiated by the combination of decreasing speed and the insufficient engine power setting selected at the moment.

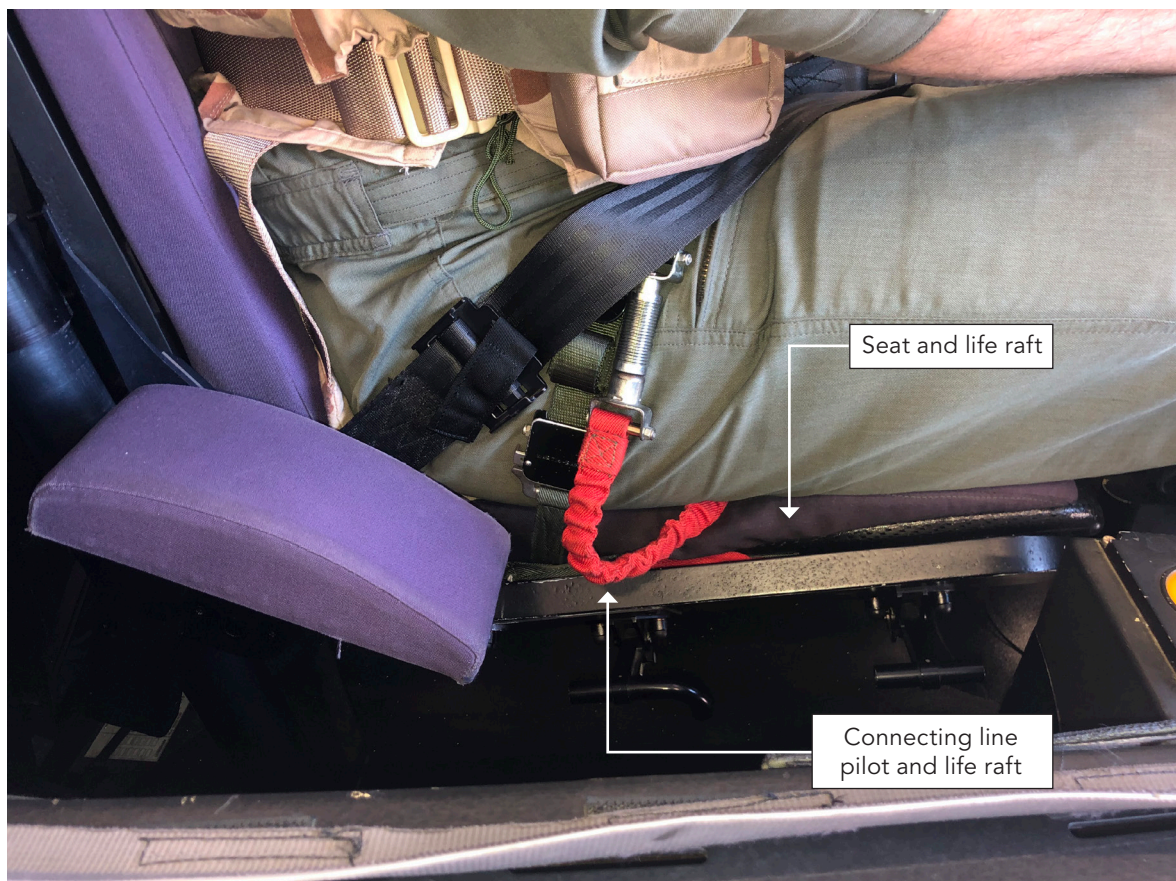
Following the impact, the pilot was able to independently escape from the aircraft, but she was subsequently discovered unconscious under water, outside the aircraft. She turned out to have been entangled with the helicopter by a connecting line (see Figure 7).

Figure 7: Example of the seating position of the pilot on the seat and life raft with connecting line. (Source: Dutch Safety Board)

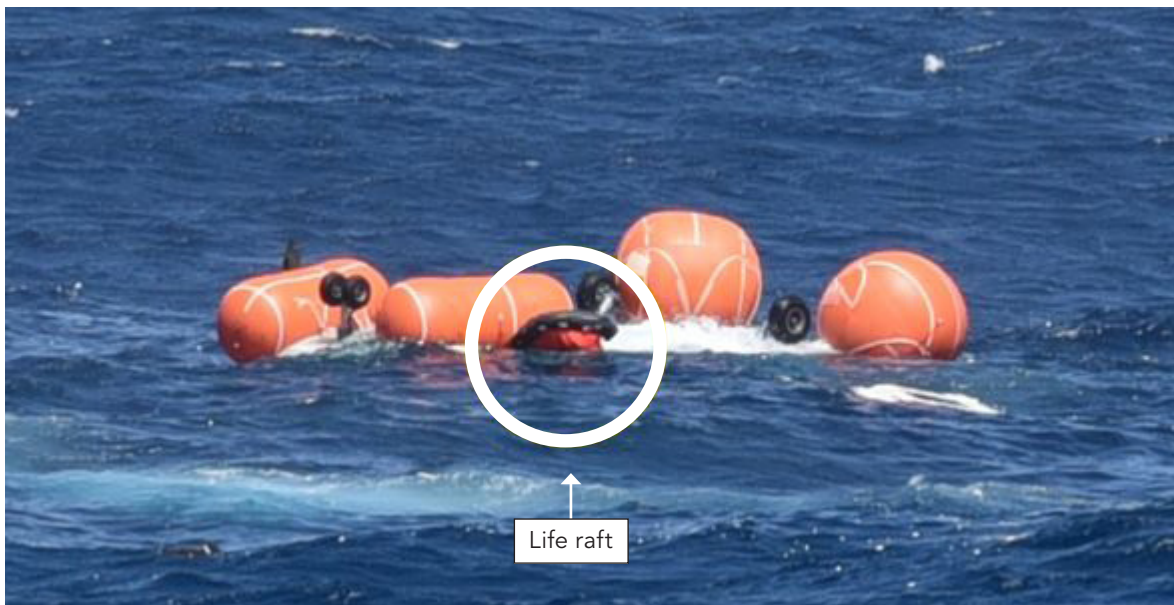
Photographs taken ten minutes following the crash from HNLMS Groningen (Figure 8) show that the pilot's life raft did deploy but remained in position since it was joined to the pilot. The life raft will in fact only be activated if the connecting line between the pilot and the life raft is pulled with some force.

It was not until the connecting line between the pilot and the life raft was cut (approximately 21 minutes after the accident) that the life raft floated away, and the pilot was released from the helicopter.

Figure 8: The aircraft, floating upside down, approximately 10 minutes after the impact. (Source: Royal Netherlands Navy)

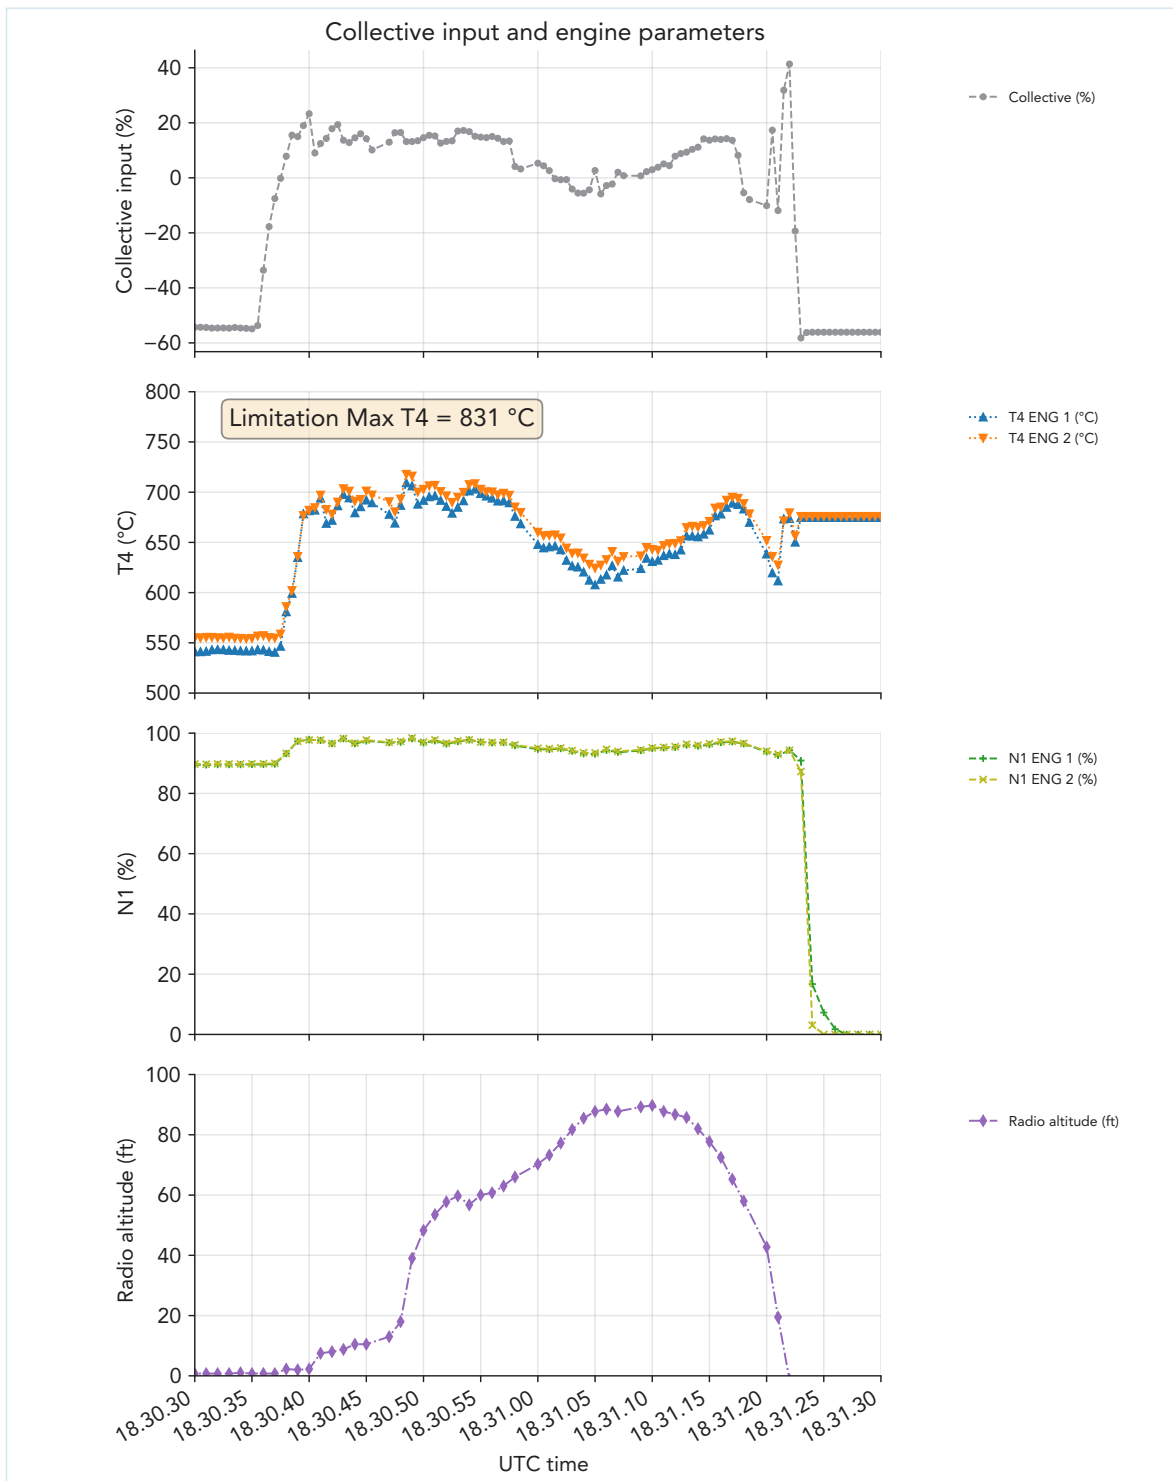
The analysis of the data in phase one of the investigation did not reveal any technical non-conformity with regards to the aircraft. In this investigation, during the first inspection,<sup>11</sup> besides the logbooks, essential parameters, such as the engine speeds and temperatures of both gas turbines, the input from the collective and the required ratio with the delivered torque, were observed. The readout values matched the values expected during a flight, and revealed no deviations in respect of previous flights (see example graph 1 in Appendix B).

Based on the logbooks and the initial analysis of the essential parameters, it has been determined that the aircraft revealed no technical non-conformities.

Graph 1: Example of a number of technical parameter readouts during the last run. Time in UTC. (Source: Readout of data recorder by Dutch Safety Board)

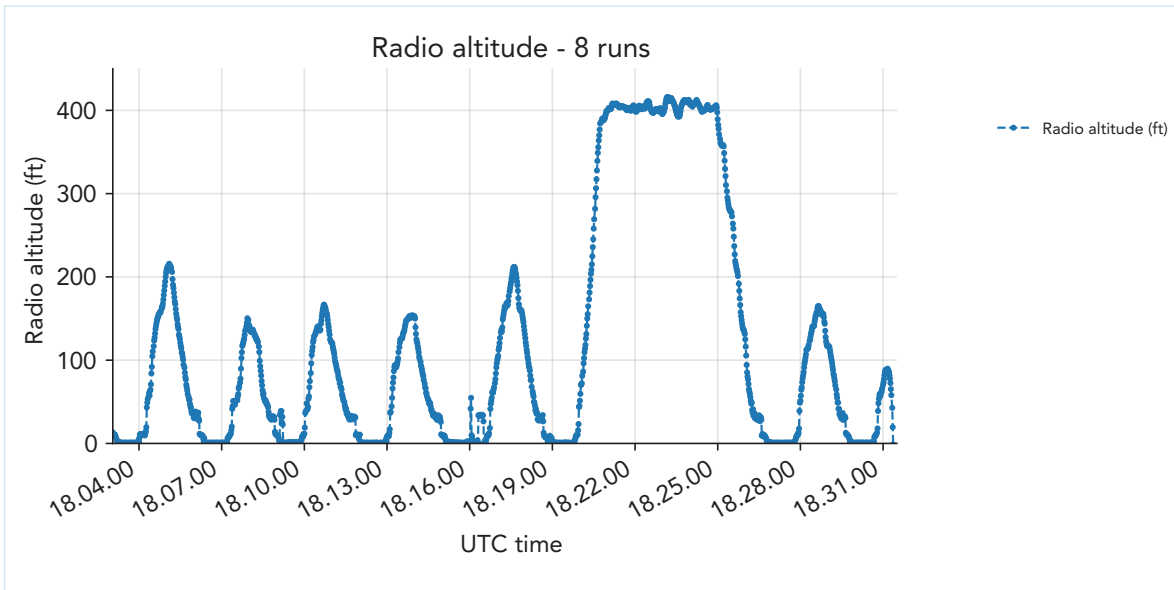
During the eight and final run, following take-off, the pilot flew sideways to port, before initiating a climb (see graph 2 in Appendix B) in order to obtain a clearer view of the foredeck (the forecastle). The aircraft did not ascend higher than approximately 89 feet. During this run, both the Ground Speed (GS) and Indicated Airspeed (IAS<sup>12</sup>) were considerably lower than during the previous flights (see graph 3 in Appendix B), a situation which is both permitted and non-problematic.

Graph 2: Outward flying altitude eight runs. During run 8, the maximum flying altitude was 89 ft. Time in UTC. (Source: Readout of data recorder by Dutch Safety Board)

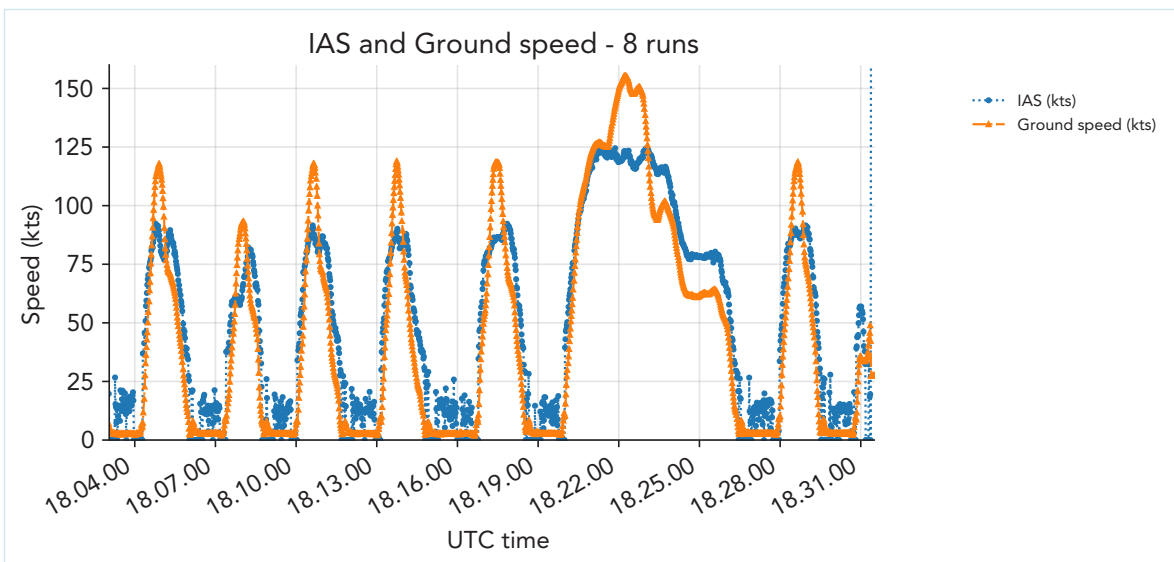
Graph 3: Indicated Air Speed versus Ground Speed during the eight runs. Time in UTC. (Source: Readout of data recorder by Dutch Safety Board)
