DUTCH  
SAFETY BOARD

# Crashed during winch launch

*The Hague, August 2023*

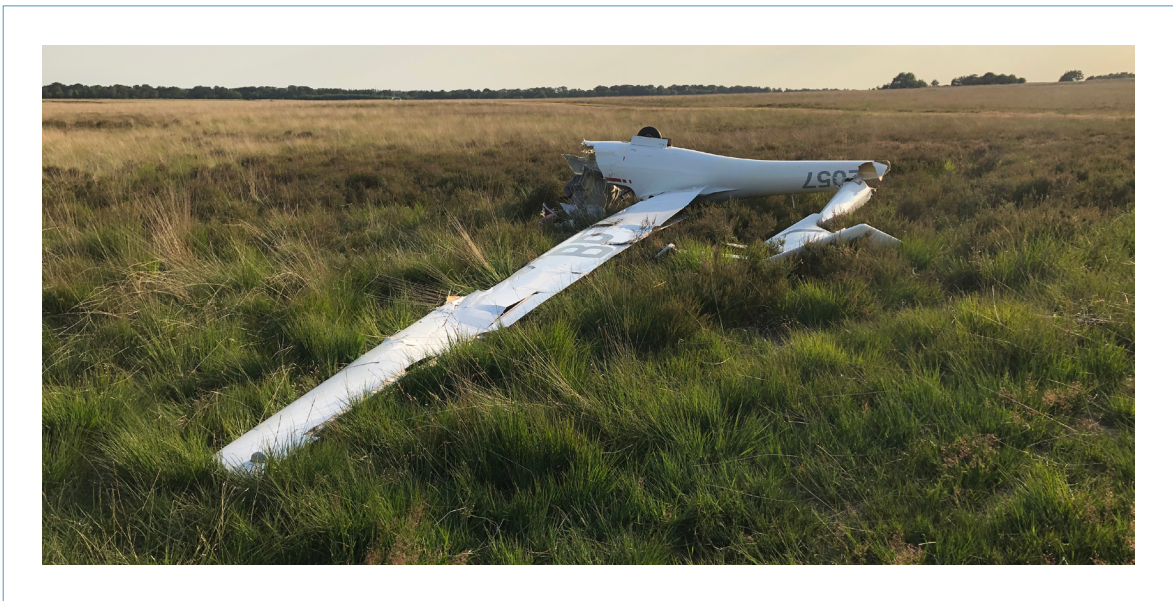
On Wednesday 29 June 2022, the pilot assembled his Rolladen-Schneider LS1-d (hereafter LS1), a single seater glider with registration D-2057. He had performed the inspection of the glider after which he made three short flights with it from Terlet glider airfield by using the winch launch method. At 14.57 hours, he took off from Runway 22L for his fourth flight that day with the LS1 also using the winch launch method. The water tanks in both wings were empty. A blue weak link was used.<sup>6</sup> According to a witness, who had observed the entire flight, the glider immediately made a steep climb after becoming airborne, after which the rate of climb decreased at a height of approximately 20 metres. Two other witnesses also stated to have seen the steep climb. Then, the glider made a slight roll movement to the right followed by a left hand turn with a steep bank angle. Then, the nose of the glider dropped and the glider started to rotate counter clockwise. The glider crashed into the ground and came to rest upside down. The pilot was fatally injured as a result of the crash. The nose and cockpit of the glider were destroyed, the fuselage was broken and the tail had broken off. The glider was damaged beyond repair. See Figure 1.

Figure 1: Accident location. (Source: Dutch Safety Board)
