DUTCH
SAFETY BOARD

Shipping Occurrences Report

November 2017 - April 2018

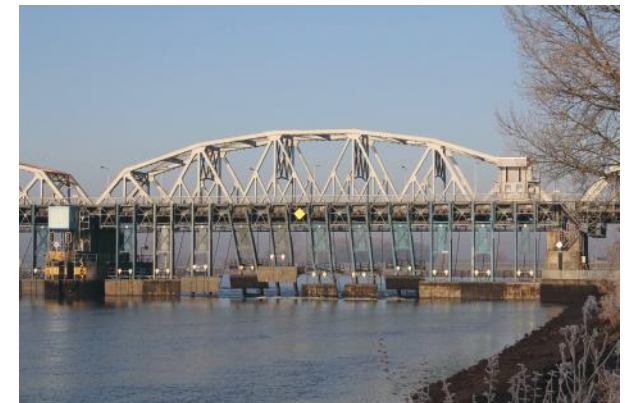
The collision with the weir on 29 December 2016 was a double accident: it was an incident with a vessel loaded with hazardous substances in addition to which the damage to the weir had major consequences for water levels in the Meuse. Although in dealing with the incident and crisis management in Grave the fog represented a complicating factor, the incident response was seriously hindered more particularly by the large number of parties involved and the lack of a combined incident management plan. The Dutch Safety Board therefore recommends that a coordinating safety region be set up and that a joint incident response plan be established, with specific attention for incidents on the water, and at the boundary between safety regions. The Minister of Infrastructure and Water Management is recommended to make a collision analysis for bridges, locks and weirs in the Netherlands, where necessary including measures to minimize the potential consequences. In addition, the obsolete information and monitoring system for shipping should be replaced with an alert feature in the event of incidents involving vessels carrying hazardous materials.

The weir at Grave.

On average, Dutch inland waterways experience dense fog on 15 days a year. This not only makes sailing more hazardous, but also hinders the provision of assistance following an accident. The Dutch Safety Board therefore recommends that the parties reach binding agreements on the transport of hazardous substances in (dense) fog. Transport companies and chemical companies bear primary responsibility for risk management in the transport of hazardous substances. The Board also recommends that Rijkswaterstaat be provided with the legal authority to halt shipping traffic in extreme weather conditions.

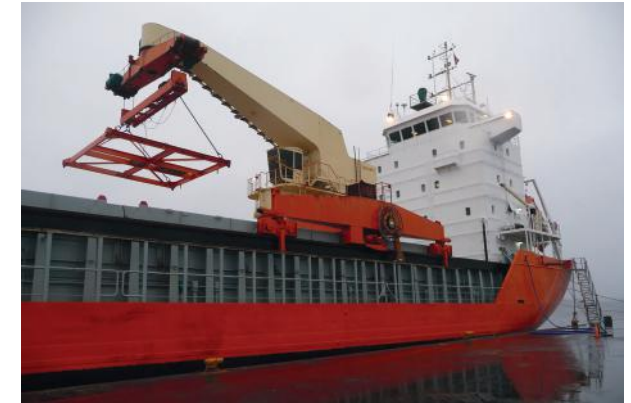
On Wednesday 15 November 2017, the Dutch freighter Lady Christina was moored in the port of Rauma (Finland) where it had unloaded a cargo of china clay. After unloading, the ship was cleaned by the crew. During the cleaning work, the ship's crane moved over the hatch combing, which was cleaned from the crane. At around 9.30 hours local time, a Philippine crew member was found dead, on the port gangway. The crew member was found with a very serious injury to the neck. It was immediately clear that the victim was dead. It is highly probable that the crew member became trapped between the crane moving over the hatch combing and a horizontal structural element in the gangway.

The crane on board the Lady Christina is in fact not a hatch crane. The movement of the crane on the Lady Christina is however comparable to the movement of hatch cranes, and the accident is comparable to accidents involving hatch cranes. A great deal has already been said and written about the use of hatch cranes and accidents. Nonetheless, the Dutch Safety Board would once again like to draw attention to the lessons learned from previous investigations into accidents involving hatch cranes.

Crane on board the Lady Christina.

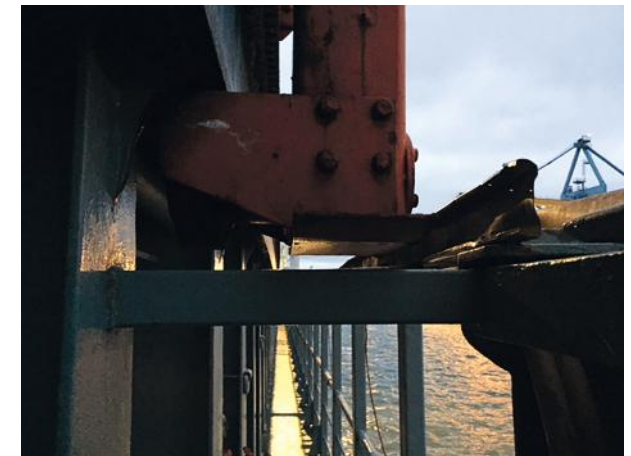
Location where the crew member must have become trapped. (Photo: Wijnne Barends)

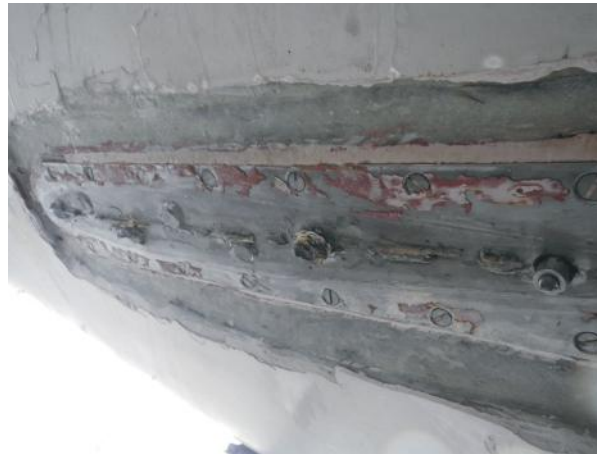
On Saturday 1 July 2017, at around 8.15 hours local time, the Dutch sailing yacht Capella capsized off the Belgian coast during the Light Vessel Race. It was not until 14.38 hours that the Capella was observed floating upside down by a passing tanker. Three of the six crew members died in the incident. Two were immediately located close to the yacht, the third was not discovered until two weeks later. The Belgian Federal Bureau for the Investigation of Maritime Accidents (FIBIMA) conducted an investigation into this accident, and published its report on 4 April 2018.

Broken-off keel bolts Capella. (Photo: Federal Bureau for the Investigation of Maritime Accidents)

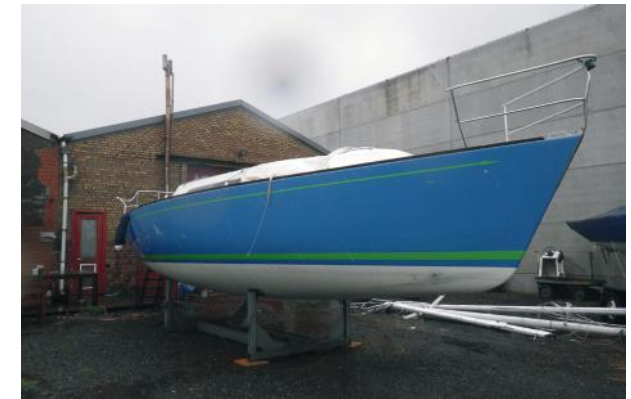
Hull of the Capella. (Photo: Federal Bureau for the Investigation of Maritime Accidents)

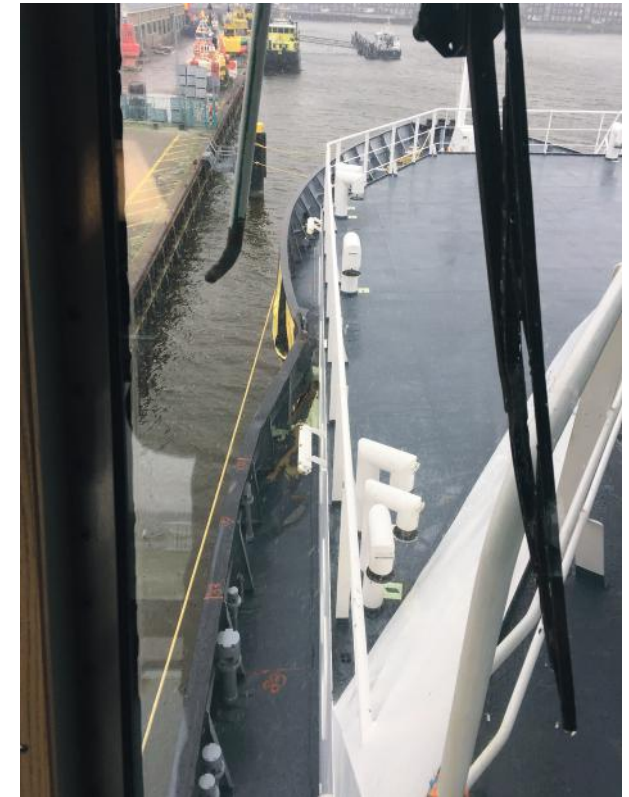
In the morning of 21 January 2018, a Dutch pilot cutter and a bulk carrier sailing under Panamanian colours collided with each other close to the Steenbank. The collision took place shortly after the pilot had been taken off the bulk carrier by another pilot vessel (the SWATH). The pilot cutter suffered severe damage on the portside near the bridge, but took on no water. Two crew members of the pilot cutter suffered minor injuries and were taken to hospital by way of precaution. They were discharged from hospital shortly afterwards. The bulk carrier made anchor in the Schouwenbank anchorage while the pilot cutter and the other pilot vessel sailed to Flushing.

Damage to the pilot cutter.

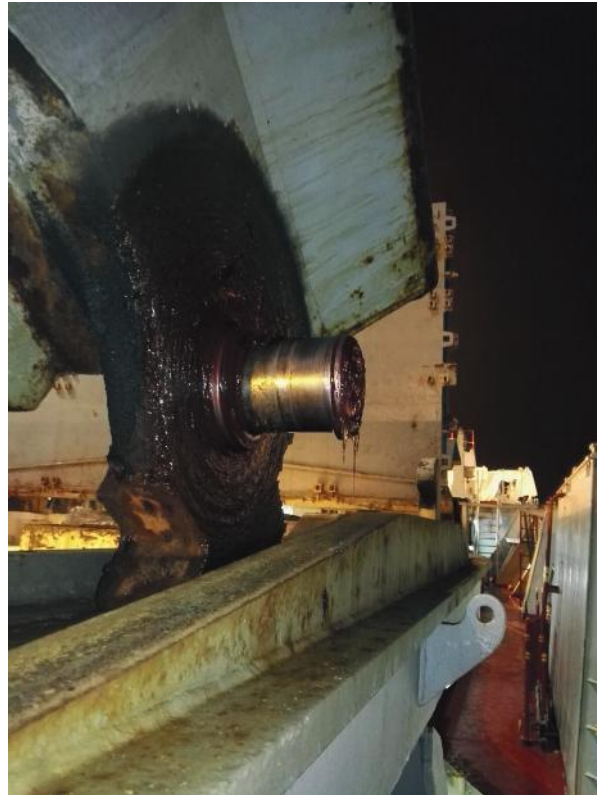
On 9 February 2019, the chief engineer was killed on board a freighter sailing under the Dutch flag. The accident took place during maintenance on a hatch wheel that was in danger of running off its axle. When the hatch was opened, the crew member saw that one wheel was not running in the normal manner. He observed that the wheel in question was not travelling entirely correctly over the coaming and was protruding by several centimetres. The captain and chief engineer were called on deck by the first mate, to examine the situation. The chief engineer intended to hammer the wheel back into the correct position. While carrying out this action, the wheel broke free entirely, and the chief engineer was hit by the wheel. The first mate immediately called the emergency services, but their efforts were to no avail. The chief engineer died from his injuries, on the scene.

Axle of the broken-off hatch wheel. (Photo: Maritime Police)

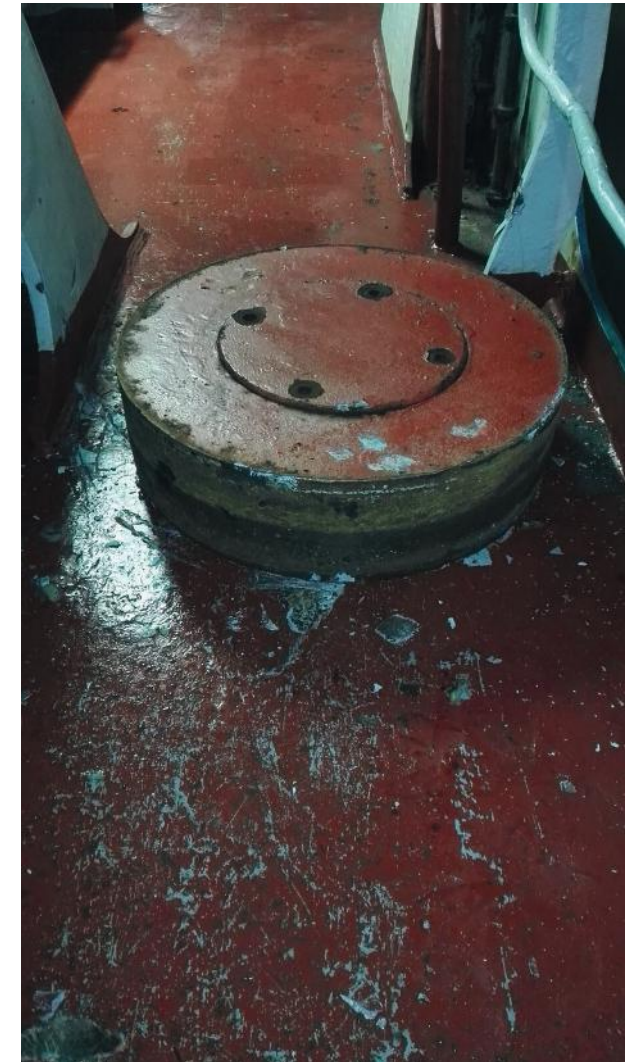
The broken-off hatch wheel in the gangway. (Photo: Maritime Police)

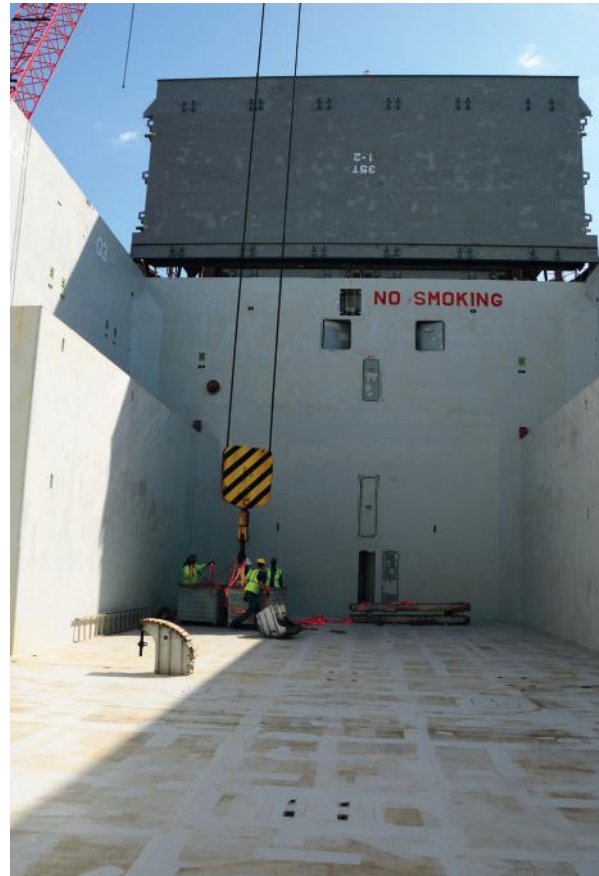
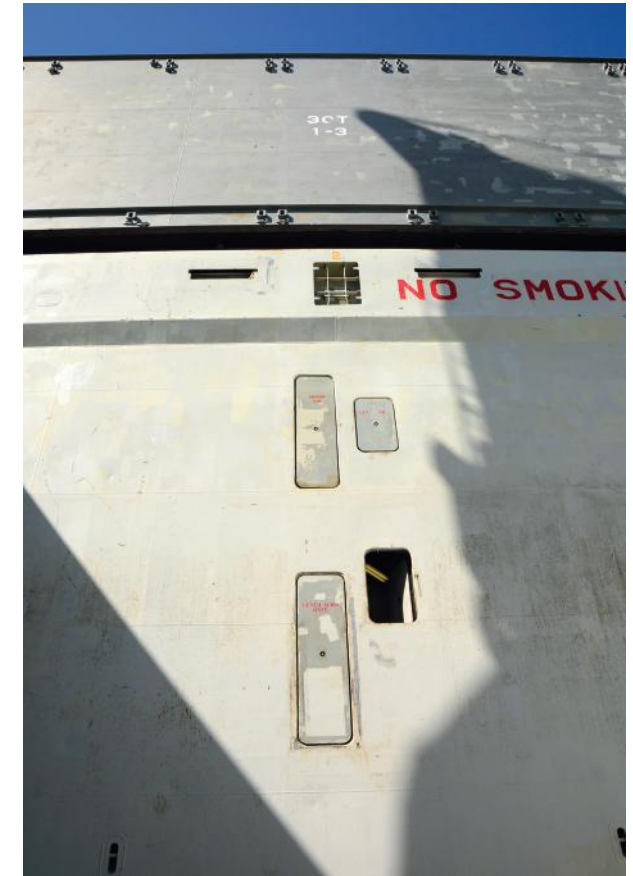
On 16 February 2018, a Dutch dry bulk vessel was anchored close to the Venezuelan port of Puerto Sucre. The vessel was waiting for permission to enter the port to take on cargo. Preparation work was being carried out at the anchorage, in good weather conditions. This included the removal of barges from the holds, using the ship's own cranes. During this work, one crew member decided to collect a number of stacking cones from elsewhere on the vessel that would later be needed for fixing the containers. During his search for these stacking cones, the crew member in question fell into the hold, from height. He suffered severe injuries as a result of the fall. The captain initiated an evacuation. The crew member was carried by ship to a hospital on shore, where he died later that day.

Left and right: Hold into which the victim fell.

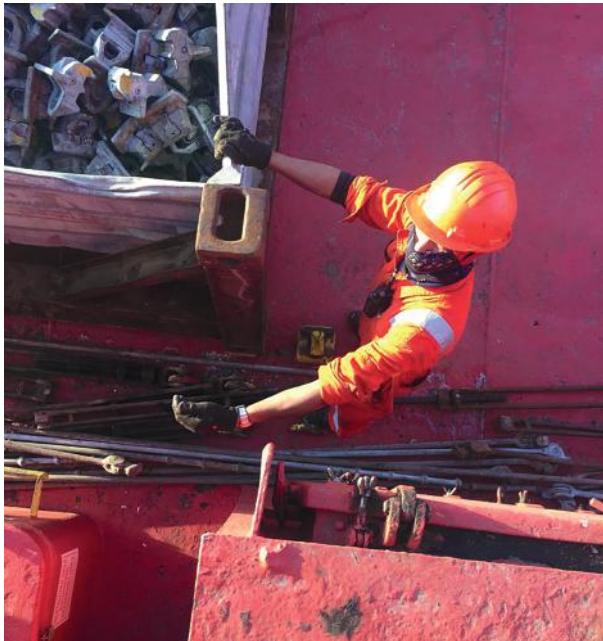
On Monday 1 January 2018, the Dutch freighter Eemsdijk was moored in the port of Mostanagem (Algeria). At midday, during loading and unloading operations, the second mate was at work positioning a flat rack. The flat rack was laden with trays containing lifting gear. The rack was being moved by the ship's own crane. During this operation, the second mate became trapped between the flat rack and a container support, suffering bone fractures in his arm. The circumstances of the accident were discussed with the other crew members during a safety meeting, immediately following the accident.

Container with lifting gear Eemsdijk. (Photo: SCG)

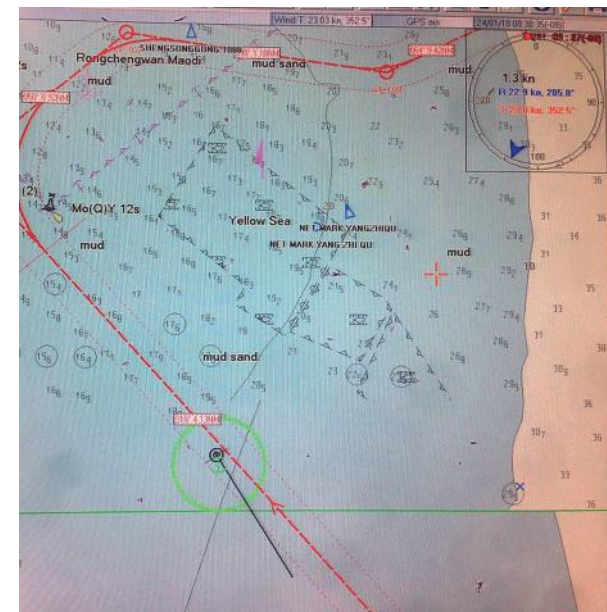
At 22.15 hours, the captain and first mate felt the vessel unintentionally lose speed. In the engine room, the chief engineer saw no immediate unusual indications in the performance of the main engine and the echo sounder indicated that the vessel had not run aground. The captain decided to turn the vessel around, and return along the same route. The chief engineer indicated that values in the engine room were slightly higher than normal, but still within permissible margins. At that moment, the ship received a call from Chengshan Jiao VTS notifying them that the vessel was sailing in a fish farm. In response, the captain shut down the main engine and set anchor. Following an inspection, it became clear that the propeller had become entangled with fishing nets, and at day break, it emerged that other fishing nets were floating around the vessel. The vessel was then towed to Longyan Port. The fish farm was not marked on the chart.

Image from the ECDIS on board the Morgenstond II. (Photo: Crew Morgenstond II)

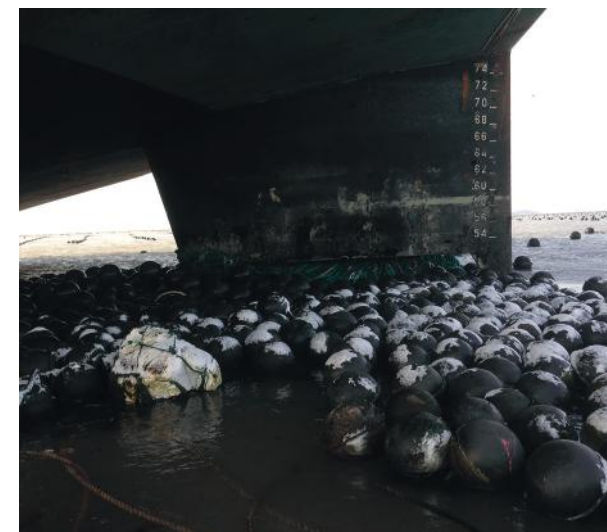
Fishing nets around the propeller. (Photo: Morgenstond II crew)

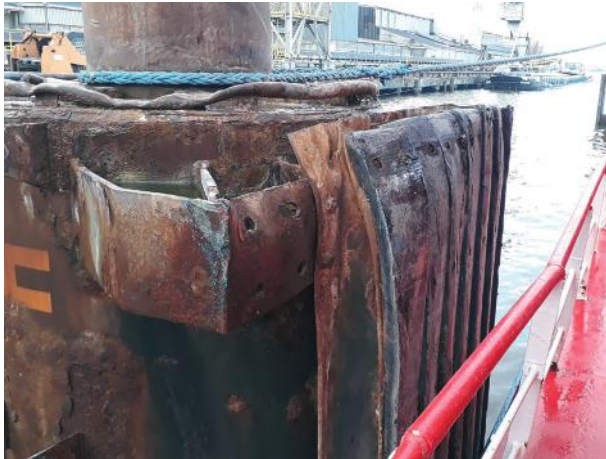
When mooring in the Harbour Basin A, Coenhaven, the Christine collided with a bollard. The vessel was not able to continue before the damage was repaired. The vessel's railing and skin were damaged while mooring against the bollards at the ICL Terminal. The report was not received from the vessel itself, but from the repair team that requested permission to carry out hot work. The ship was towed to the Eggerding Terminal, where the damage was repaired.

Damage to bollard and ship. (Photos: Human Environment and Transport Inspectorate)

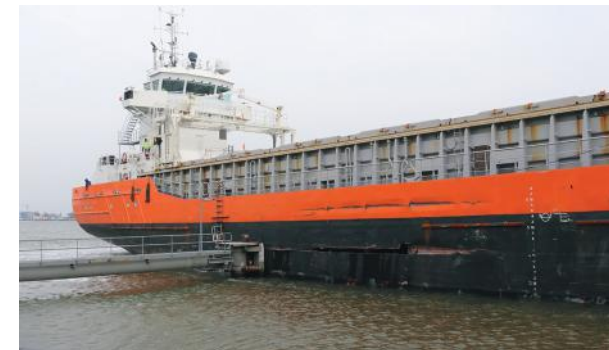
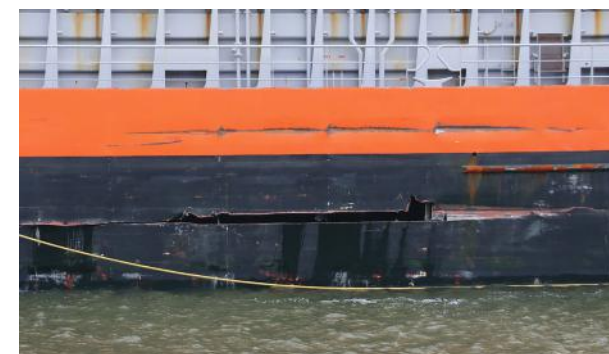
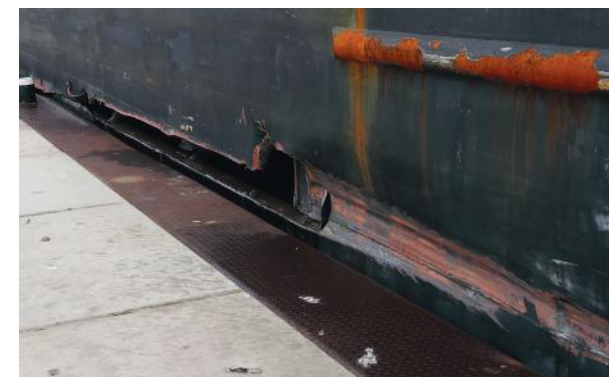
Despite strong easterly winds, force 7 to 8, on 1 March 2018, the Dutch freighter Avalon set sail in ballast conditions, only suitable for good weather. On this occasion, the strong easterly wind was blowing perpendicular to the quayside. The vessel attempted to sail clear of the quayside on two occasions. Following the first failed attempt, the crew did not realize that the weather conditions were too poor to sail in this ballast condition. The idea of taking on more ballast (in the double bottom tanks) was not considered. During the second attempt, the vessel once again failed to anticipate the wind correctly, by taking more space to manoeuvre the vessel. There was also another inland ship behind the Avalon and the propeller effect of that vessel caused further problems. As a result, it was once again not possible to make the turn, and the Avalon was forced to switch hard in reverse. The vessel then collided against a steel bollard, with its starboard stern section. Following the collision with the steel bollard, the vessel was torn open along its starboard side.

Damage to Avalon. (Photo: HVZeeland.nl)

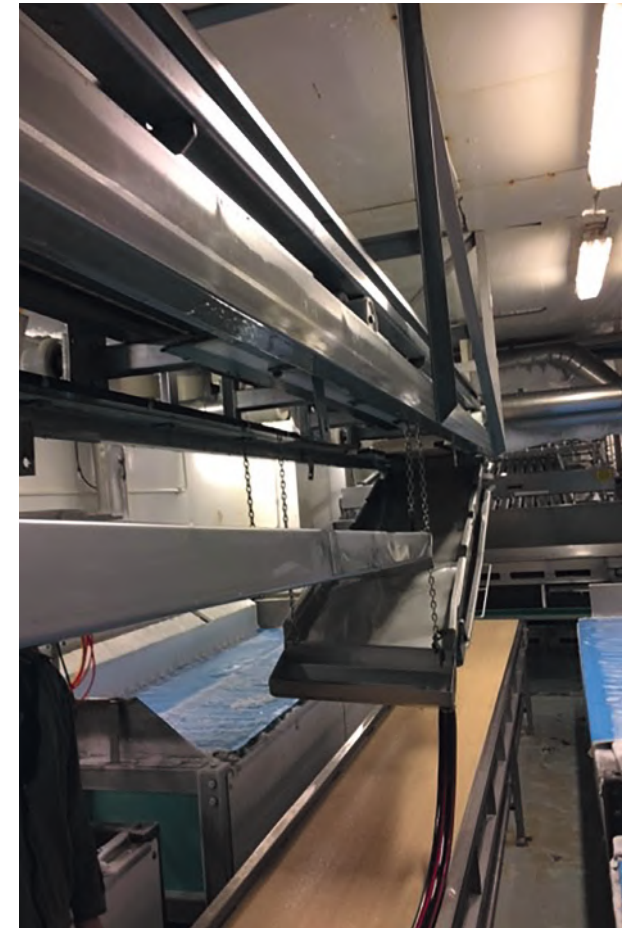
On board the Dutch fishing vessel Annelies Ilena, a crew member suffered severe injuries to his arm. At the time of the accident on 5 April 2018, the vessel was sailing towards the Netherlands, through the English Channel. The Annelies Ilena has a factory on board, for immediate further processing of the fish catch. During cleaning work in the factory, a crew member's hand became trapped in the gearwheel of one of the conveyor belts. The crew member's finger first became trapped, until eventually his whole hand was drawn between the gearwheel and the conveyor belt. Shortly afterwards, the conveyor belt emergency stop button was pressed by another crew member. After disconnecting the conveyor belt and the gearwheel, the crew member could be freed, and taken to the hospital on board the ship. He was then evacuated to hospital by a French navy helicopter.

Gearwheel on board the Annelies Ilena. (Photo: Parlevliet and van de Plas)

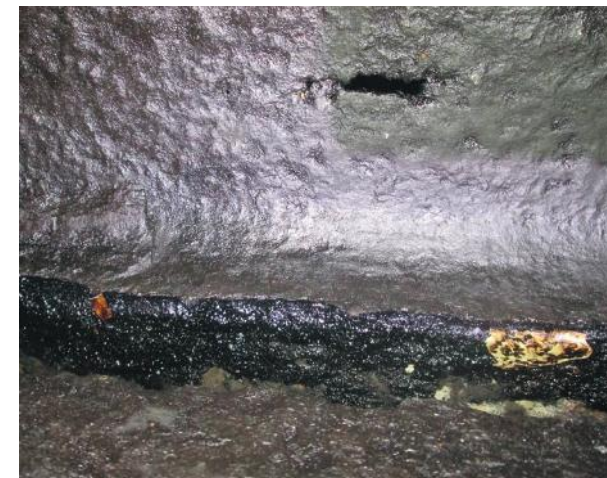
At around 02.30 hours, the first mate entered the ballast tank with full breathing apparatus and discovered that heavy oil was leaking into the ballast tank from the adjacent heavy oil tank. The decision was taken to pump the heavy oil into another tank, so that the tank could be inspected. The inspection revealed a crack in the bulkhead between the ballast tank and the heavy oil tank. The crack was temporarily sealed under the supervision of the classification office, using an epoxy coating, until the crack could be definitively repaired. The operator decided to temporarily decommission both the ballast tank and the heavy oil tank.

Crack in the bulkhead between the heavy oil tank and the ballast tank. (Photo: Iver Ships)

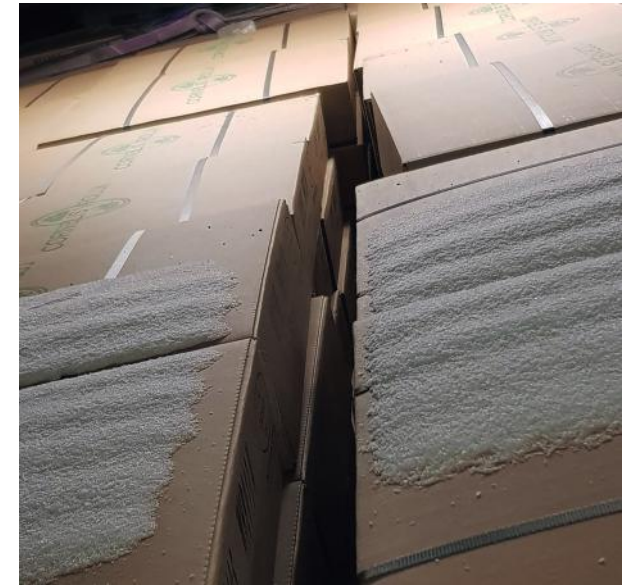
On Monday 23 April 2018, a crew member suffered an injury to his leg on board the Dutch fishing vessel Carolien, while repacking fish. At around 16.30 hours, the crew member had stepped with his right leg into a gap between packs of frozen fish, whereby he twisted his leg. The crew member was in the process of stacking boxes of frozen fish from the ship, onto pallets in the frozen hold. Once a first layer of full pallets is completed, it is practice to walk over this layer, to build up a second layer of pallets of frozen fish, on top. Due to the movement of the ship, gaps eventually occur between the frozen fish on the applets. The crew member stepped into one these gaps and fell over. His lower leg remained trapped in the gap, resulting in a broken ankle. Medical aid was provided immediately on board, and contact was sought with the Radio Medical Service. The victim was eventually evacuated by helicopter from the ship, and transported to a hospital on the Isle of Lewis.

Gap between packs of frozen fish. (Photo: Carolien crew)

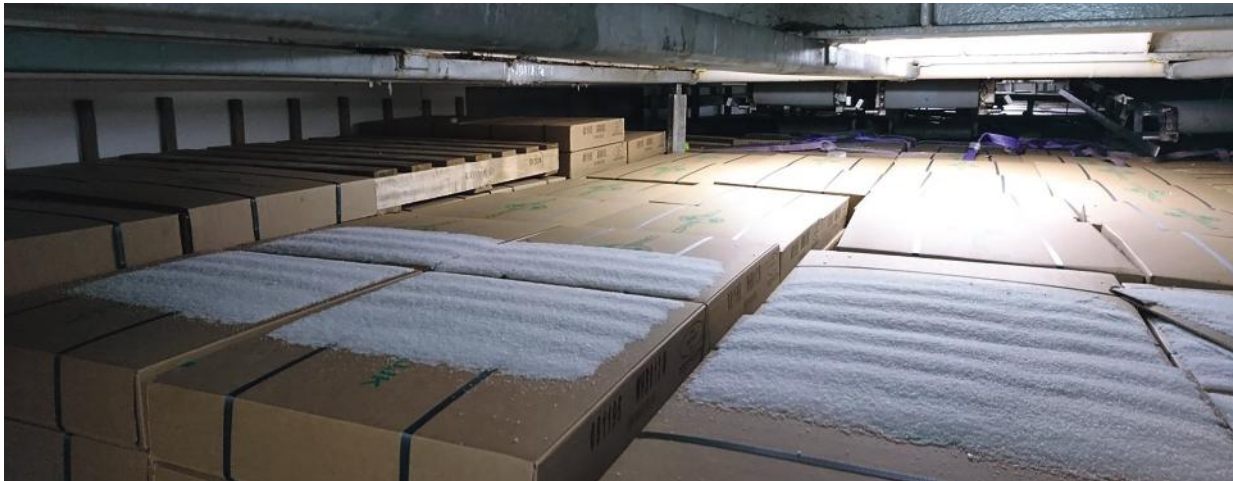
The frozen hold of the Carolien. (Photo: Carolien crew)

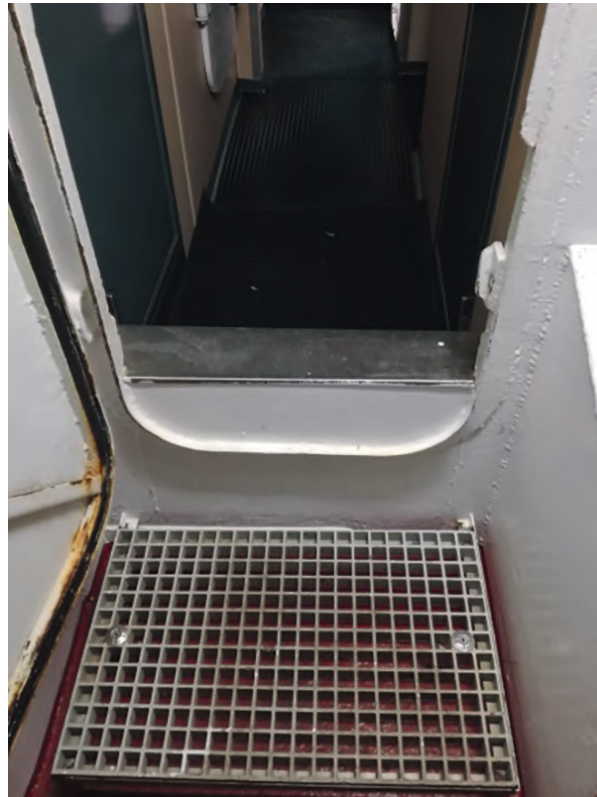
During crew embarkation on Monday 30 April 2018, at around 02:00 hours local time, the captain suffered an unfortunate fall when passing through the starboard accommodation entrance. The fall resulted in a fractured left leg. During the accident, the weather conditions were poor, with heavy rain and hard wind. Due to the placing on board of supplies, stores and personal property, a situation was created in which the passage was narrowed, and it was no longer possible to make the transfer from outside to inside, via a normal entrance/step. The captain placed his foot incorrectly, and on the partially wet surface was unable to step normally, at which point he slipped. The captain was transported by ambulance to the Admiraal de Ruyter hospital in Goes, for treatment. It should be noted that procedures, knowledge and experience acquired by the crew members involved correctly were applied and that the accident was handled in a calm, controlled manner.

Threshold on board the Eemshorn. (Photo: Eemshorn crew)
