DUTCH  
SAFETY BOARD

# Two crewmembers overboard in the Baltic

Ms. Marietje Andrea, Baltic, 5 December 2013

*Den Haag, January 2015*

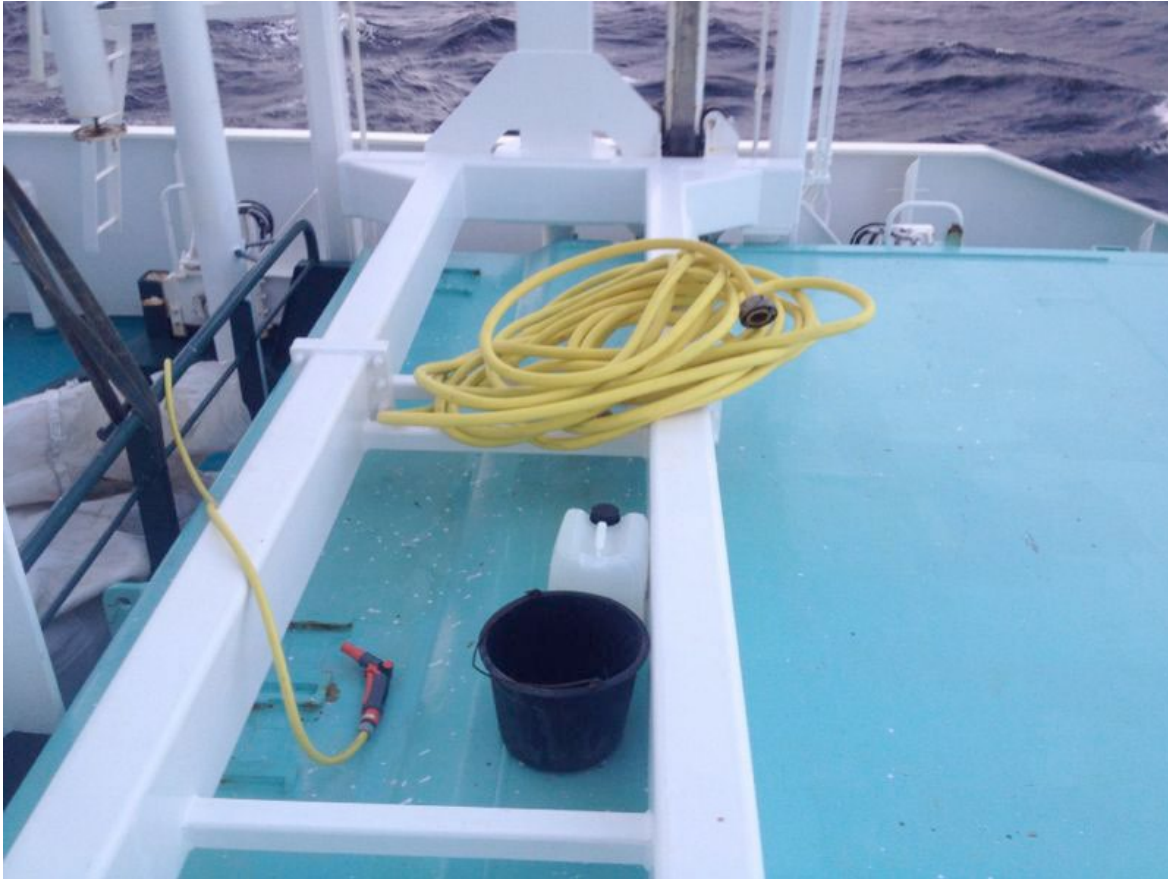
After the sailors were dressed in the overalls, they attached a hose on the aft deck. This hose ensured that there was always a stopcock open to protect the pump if they were to shut off the hose on the foredeck. A second deck hose was ready on the spreader of the hatch crane in order to be brought forward (see figure 2). There were also an empty bucket and a jerrycan with cleaning product ready on the deck hatch.

Figure 2: The situation on deck immediately before the incident. (Source: rederij Danser van Gent)

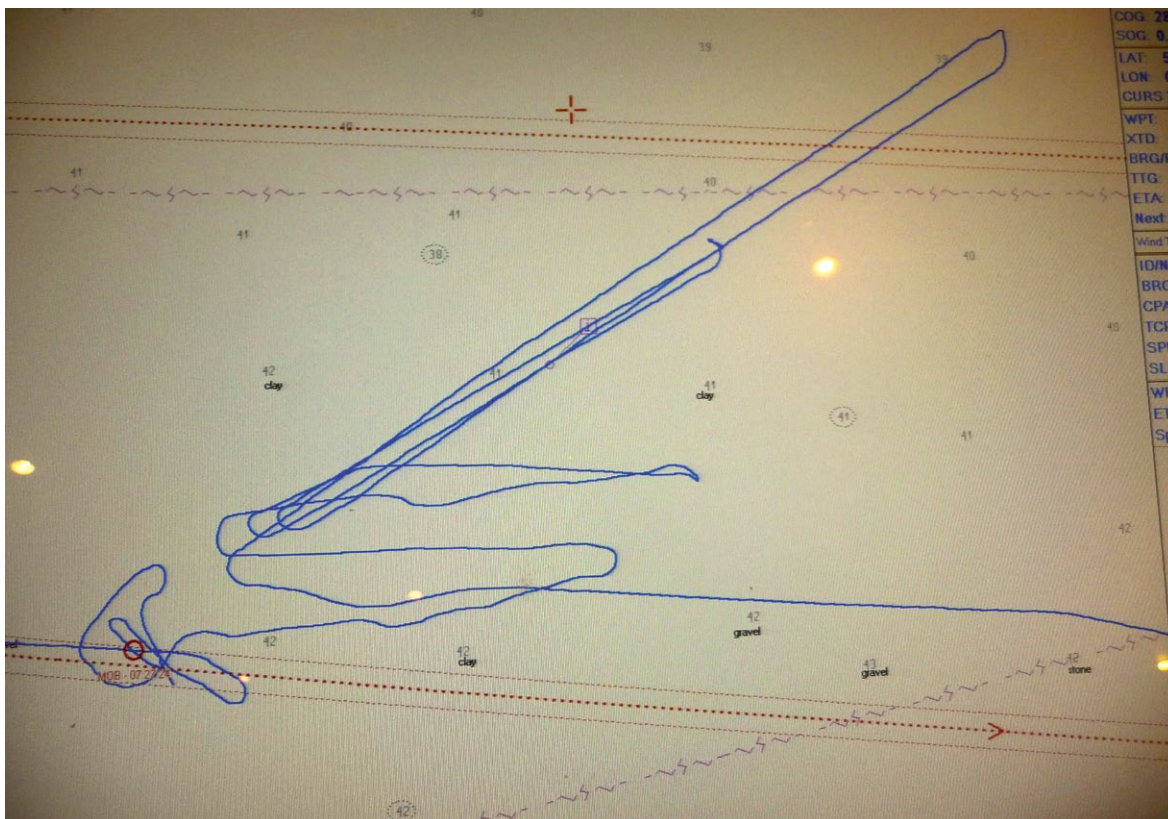
At 08:37:43 (after 11 minutes and 28 seconds) the ship returned to the vicinity of the MOB position. The sailors were not found there. In order to refresh the smoke marker, they threw a second smoke marker into the water at 08:48:13. The rescue helicopter arrived on the scene at 09:05. It then immediately started searching in the vicinity of the lifebelt. At around 09:16 a Swedish coastguard vessel took over the coordination of the rescue operation from the Marietje Andrea.

Figure 3: The MOB location and the Marietje Andrea's search path. (Source: rederij Danser van Gent)

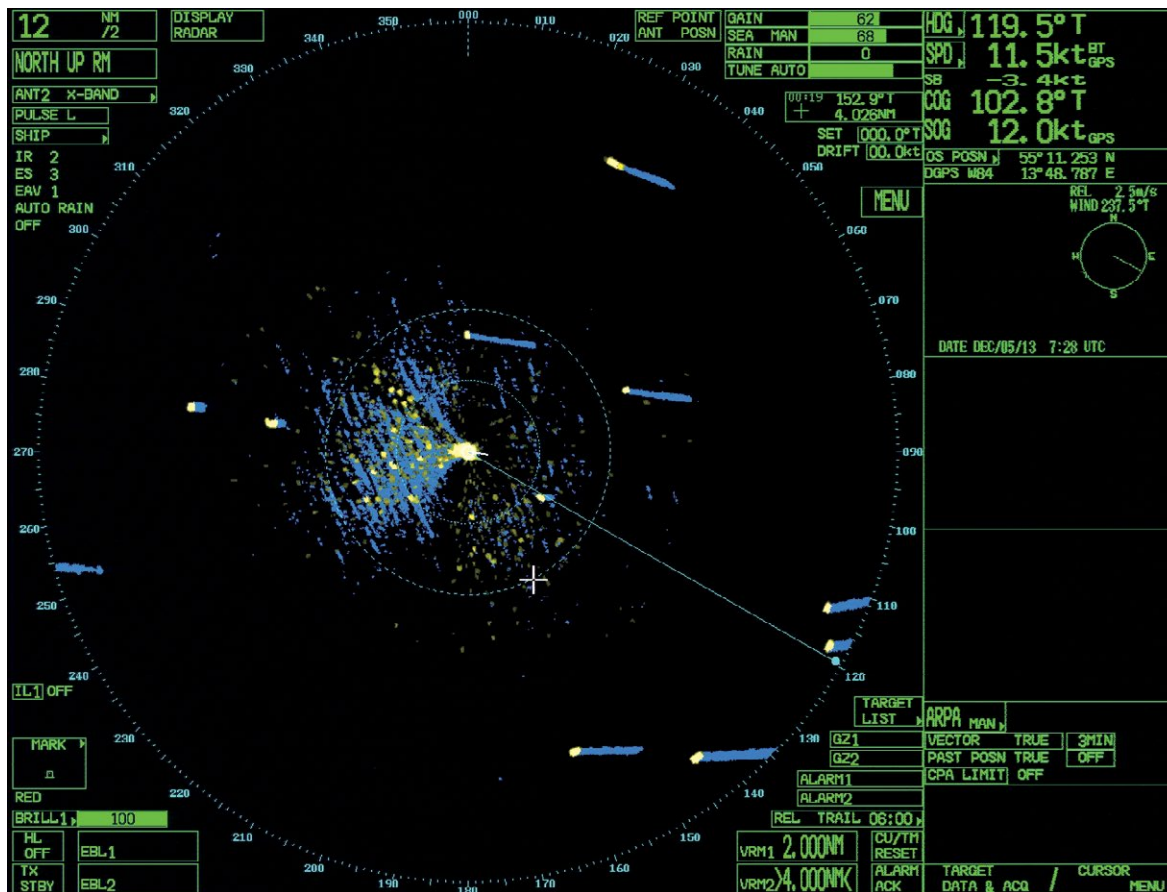
Figure 4: Radar image of the Marietje Andrea at the time of the MOB. With the echoes (including the Delfborg at around 5 miles) of the ships sailing in the vicinity. (Source: rederij Danser van Gent)

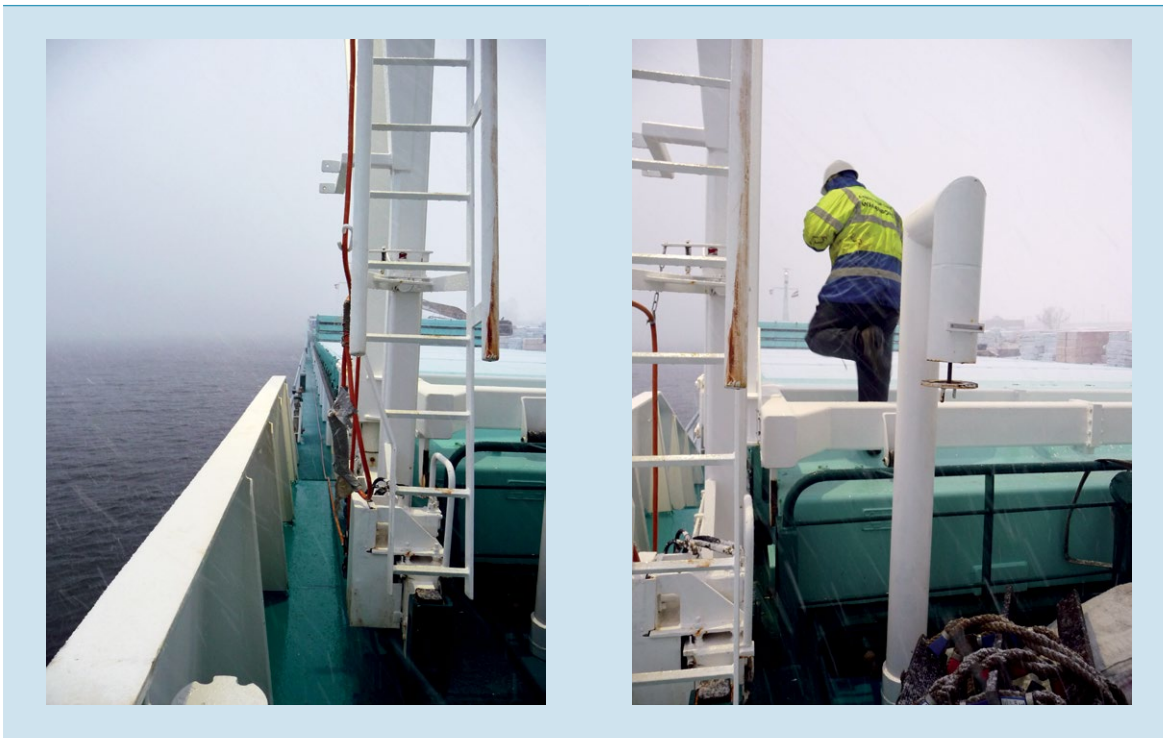
The sailors had two options for the passage to the foredeck. They could walk forwards along the port gangway (figure 5 left-hand photo) or opt for a passage over the deck hatches (figure 5 right-hand photo). The crew have stated that both options were regularly used by the crew. In view of the fact that the cleaning materials (hose, bucket etc.) were found on the spreader of the hatch crane and the routine nature of a passage over the deck hatches, the Board deems it reasonable to assume that the sailors adopted the latter option. All the more because the gangway had a narrowest width of 70 centimetres (by the boarding ladder), which would have made it a difficult passage for the sailors with the stiff and heavy hose.

Figure 5: The two options for a passage to the foredeck. Via the gangway (L) or over the deck hatches (R).  
(Source: Dutch Safety Board)

The ship has a sea rail which is intended to protect the crew against the risk of falling overboard. This rail is 110 centimetres high and offers effective protection against falling when passing along the gangway. However, the sea rail does not offer any protection

from falling when passing over the deck hatches. The deck hatches are approximately the same height, whereby the gangway is narrow. In order to still enable a safe passage over the deck hatches, it was customary on board the *Marietje Andrea* to stretch a guide rope over the deck hatches in bad weather. However, the guide rope had not yet been placed on the morning of the incident. There was no indication that the weather conditions would inherently make a passage over the deck hatches without a guide rope dangerous or irresponsible because of a swaying ship or greater slipperiness. This may have contributed to the fact that additional fall protection for the sailors was not present on the morning in question.

- The risks of a passage over the deck hatches or the risk of falling overboard were been identified as risks onboard. As a result, control measures were lacking. This meant that the obligations under the Arboret (Working Conditions Act) were insufficiently met. There is a need to think about under what circumstances passage over the deck hatches is acceptable, and what safety measures are sensible if the choice has been made to travel over the deck hatches.

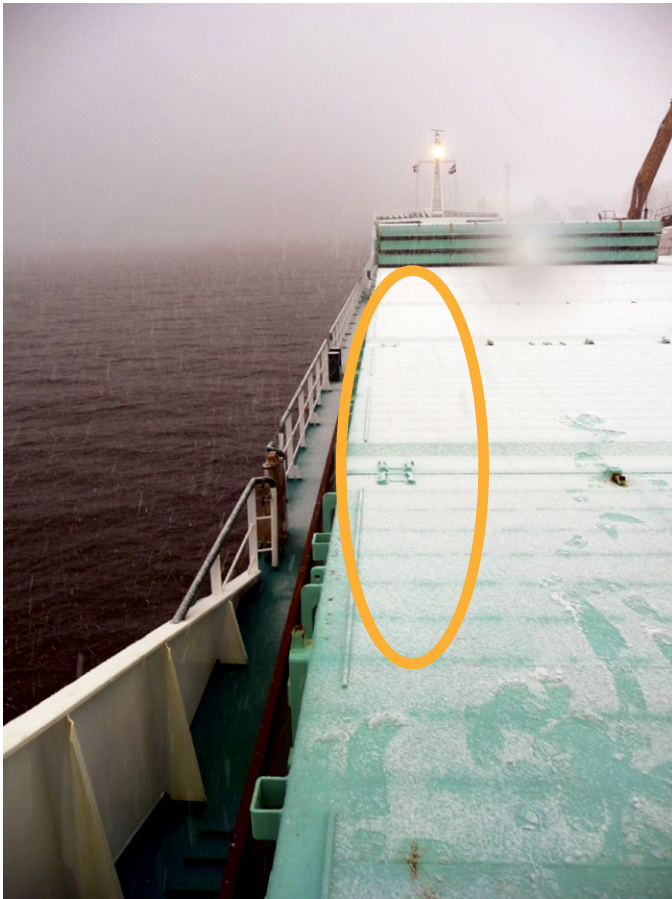
*Figure 6: Suspected last position of the sailors on the deck hatch before they fell overboard. (Source: Dutch Safety Board)*

Following the fall overboard, the first officer saw the sailors very close together (approx. 2 metres). It is very likely that they entered the water at the same time. The speed of the ship was around 6 m/s at the time of the MOB, making it very unlikely that the older sailor jumped in after his young cousin.

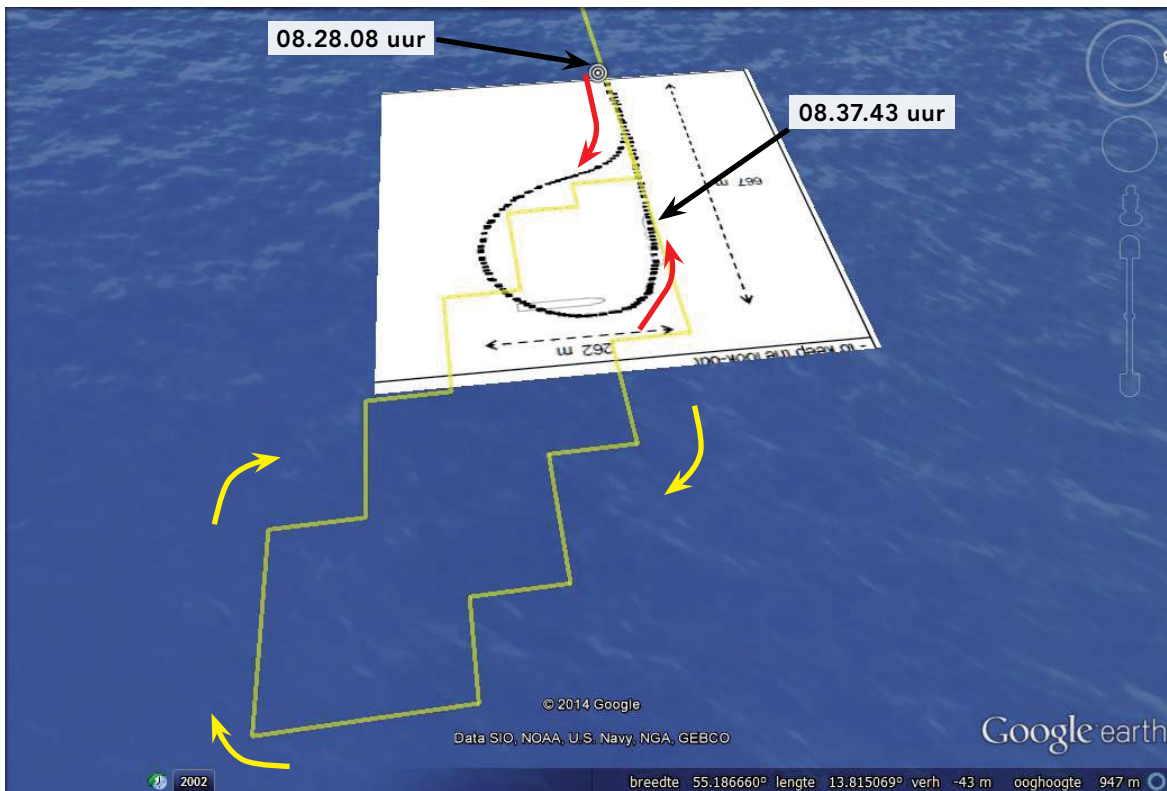
the water, communicated with nearby shipping and the coastguard, alerted the captain and marked the position on the electronic sea chart and in the log. However, the first officer omitted to immediately apply a hard turn to the ship and carry out an MOB manoeuvre. Hence it took two minutes after the MOB before the MOB manoeuvre was initiated. The ship's available turning momentum was thereby not utilised.

Because the turn was not immediately initiated with hard rudder, the turn which the ship finally made cannot be described as either a Williamson turn or an Anderson turn (see figure 7). The distance travelled was long, and the ship did not return to the MOB location on the reciprocal course. Hence it took 11 minutes and 28 seconds before the ship returned to the MOB location. The Marietje Andrea's manoeuvring book, which includes the Williamson turn, indicates that the ship could potentially return to the MOB location in 5 minutes and 16 seconds (established during test journey under ballast conditions and good weather conditions). The manoeuvre which was carried out therefore took longer than necessary.

Figure 8: MOB manoeuvre carried out (yellow line with yellow arrows) in relation to the Williamson turn from the manoeuvring book (black line with black arrows). Yellow line is an analysis of positional data from the VDR. (Source: Google earth)

The temperature of the sea water on 5 December at the site of the incident was around 7 degrees. The manner in which the MOB manoeuvre was performed reduced both the likelihood that the ship could find the missing sailors and their chance of survival in the cold water.
