DUTCH
SAFETY BOARD

Chief mate lost overboard in severe weather

Victoriaborg, Atlantic Ocean, 23 December 2013

The Hague, March 2015

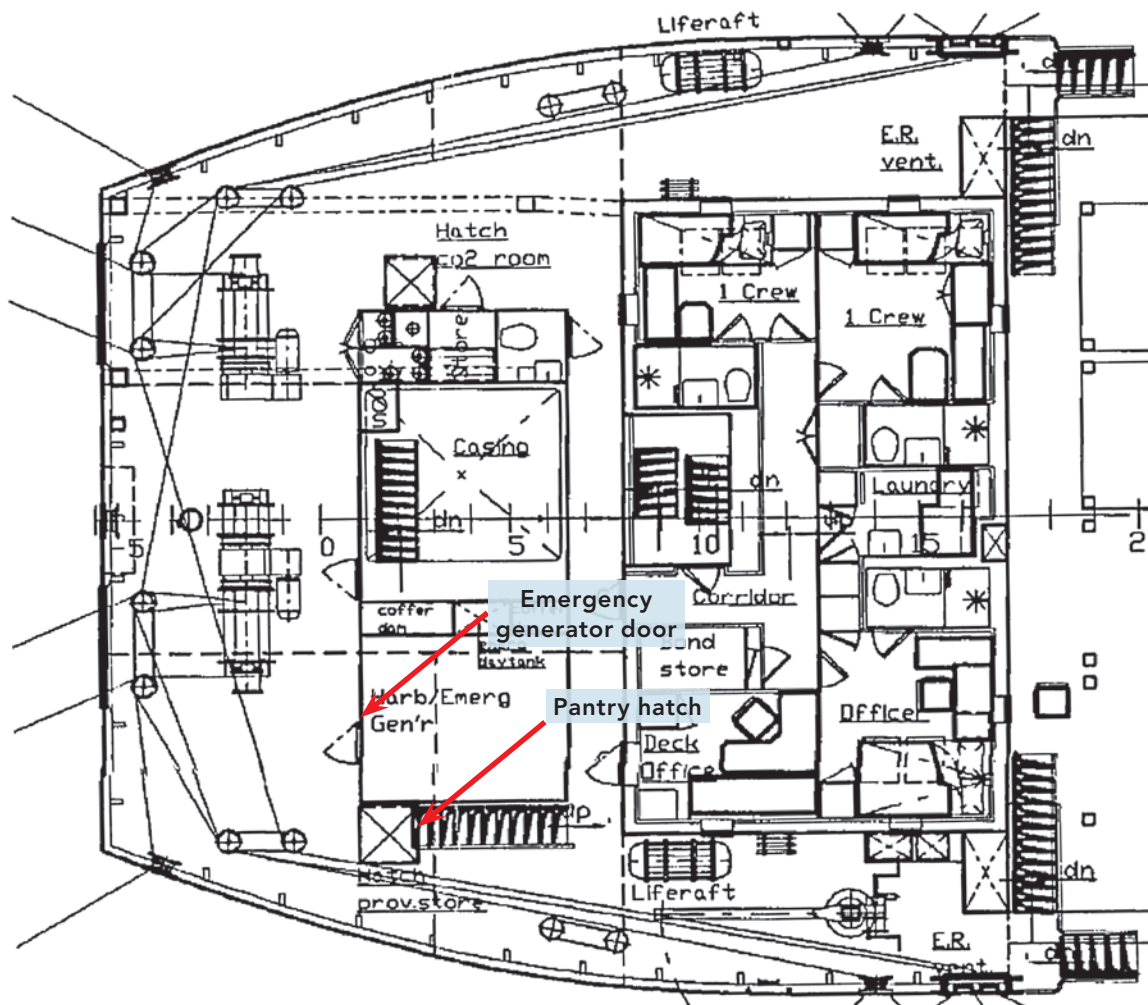
Figure 2: Quarterdeck of Victoriaborg. (Source: Wagenborg B.V.)

With that in mind, he probably wished to inspect the emergency generator room which is located above the pantry. To reach this room, he had to go via the deck. While he was on deck, a wave probably washed over the quarterdeck, carrying the chief mate overboard, thereby leaving the door to the emergency generator room open.

This caused water to enter the emergency generator room. This in turn led to the short-circuit in the emergency switchboard. The short-circuit caused the electrical failure of the emergency lighting, starboard fan and the electric motor of steering pump number 2. This caused a fall down of hydraulic pressure in the steering gear. The other pump was not started in due time. The low hydraulic pressure for a considerable time led to significant damage to the steering gear (see Appendix B). The smoke detector in the emergency generator room was activated by the short-circuit causing the fire alarm.

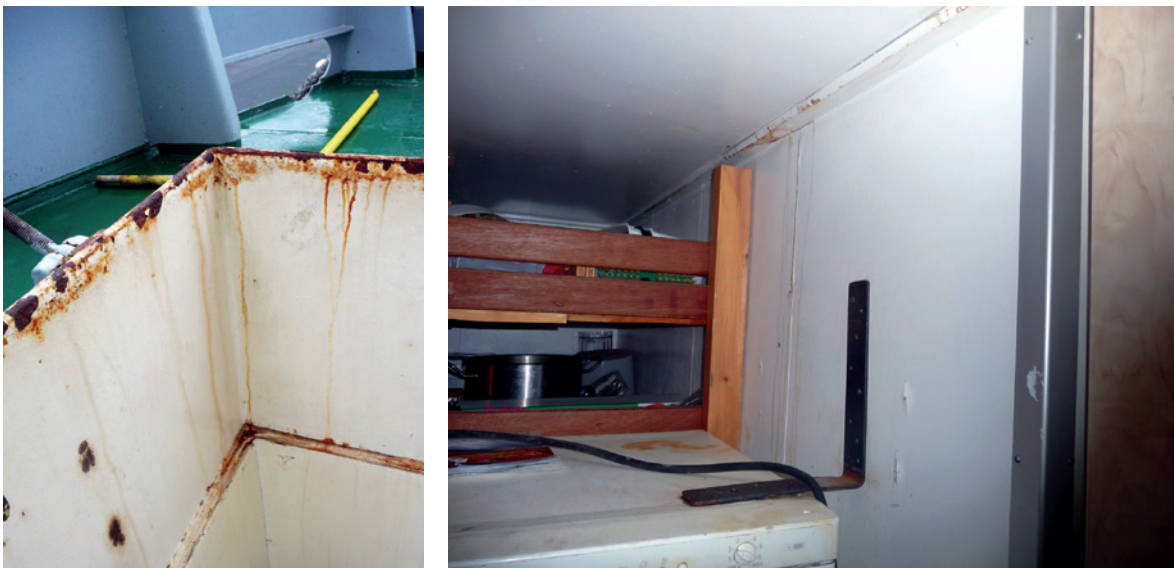
During the search for the cause of the leak in the pantry, the cause of the leak could not be found. It was subsequently observed in port that water must have leaked via the sealing rubbers of the pantry hatch. Traces of seawater were present (see figure 3: left and right). The cause was probably a large volume of seawater on the quarterdeck.

Figure 3 Left: Hatch to pantry.

Right: Pantry ceiling. (Source: Dutch Safety Board)
