DUTCH
SAFETY BOARD

Detached air brake control rod

Rolladen-Schneider LS 4-b glider

The Hague, July 2019

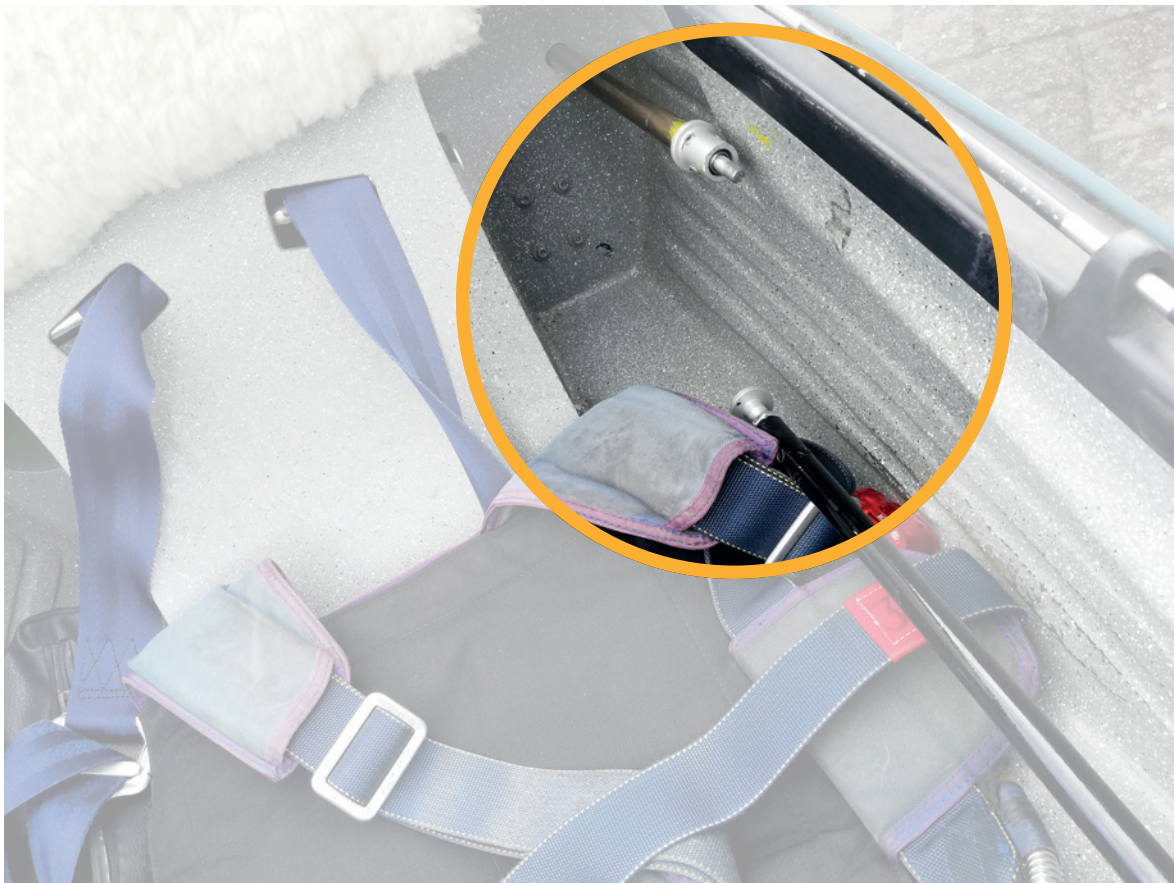
During the winch launch of the Rolladen-Schneider LS 4-b glider, the air brakes opened unexpectedly. The air brake control rod had slipped out of the locked position which was corrected by the pilot. After approximately one hour in the air and flying through mild turbulence, the problem of unlocking air brakes and corrective actions by the pilot recurred several times. At an altitude of approximately 1,100 metres, with the glider still in the vicinity of the airfield, the air brake control rod detached with a loud bang. From that moment on the pilot had little to no control of the air brakes and he decided to return to the airfield. The pilot used his right hand to hold on to the remaining part of the control rod and used his left hand to steer the aircraft. The landing was without any further problems. After the flight, it was found that the air brake control rod had become detached from the rest of the mechanism; see Figure 1.

Figure 1: Detached air brake control rod. (Source: G.A. Metz)

The involved glider was modified on 7 April 2018 in the flying club workshop shortly before the event flight. The bolted connection of the air brake swivel loosened in flight and the air brakes could not be retracted completely anymore. During the subsequent analysis by investigators of the Dutch Safety Board it was concluded that the wrong type of Loctite (243 instead of 638) was used and the Loctite had expired 2 years ago. Furthermore, the weld in the control rod was not removed by a 13.5 mm drill as required by the TN, but with another drill. As a result the control rod was limited in its movement, which caused a bending moment on the air brake control rod junction. The weld inside the rod did not only result in an additional bending moment, but also put pressure on

the threading of the bolt in the swivel. As there was insufficient thread locking on the bolt, combined with the repeated rotational movement of the airbrake handle (needed to operate the airbrakes) the pressure on the threading resulted in loosening of the bolt. Subsequently this led to a complete detachment of the swivel.

The Dutch Safety Board concludes that from a legal point of view the modification can be performed by flying club technicians but that based on practical experience of technicians it appears that the modification instructions must be clear. In addition, these instructions must contain a complete material listing, including retrofit kit parts and required non-standard consumables and non-standard tools. Preferably the modification kit contains not only the retrofit hardware but also the non-standard consumables and non-standard tools.
