DUTCH
SAFETY BOARD

Unsuccesfull emergency landing

The Hague, May 2014

Identification number:	2012084
Classification:	Accident
Date, time of occurrence:	4 August 2012, 11:40 hours
Location of occurrence:	Hollandscheveld
Registration:	D-EGIT
Aircraft type:	Piaggio P149D
Aircraft category:	Single-engine propeller aircraft
Type of flight:	Local flight
Phase of operation:	En route
Damage to aircraft:	Destroyed
Flight crew:	Two
Passengers:	None
Injuries:	One seriously injured, one light injured
Other damage:	Destroyed shed
Light conditions:	Daylight

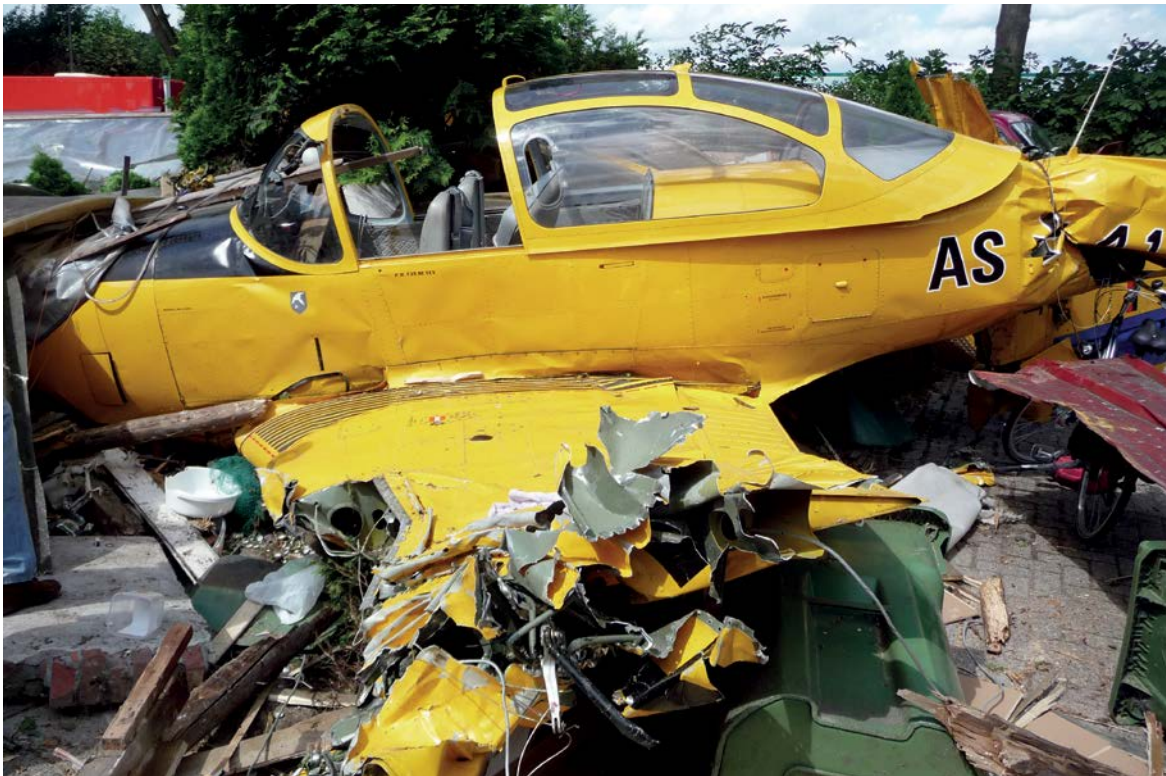
The D-EGIT took off from Hoogeveen Airport (EHHO) on a local flight at 11:20 a.m. There were two people on board, both of whom had a valid pilot's license. After having flown for approximately 15 minutes and at a position south of Noordscheschut, the engine started to run rough. The emergency procedure "engine failure in flight" was executed subsequently. As a part of this emergency procedure, both magnetos were tested, the fuel/air mixture was set to "full rich", the carburetor pre-heater was set to "warm" and the fuel pump was set to "on". None of these measures had any effect. Soon after, the engine stopped and black smoke from the engine compartment seeped into the cockpit. The aircraft was flying at an altitude of approximately 2,000 feet at that time. The co-pilot, who had more flying experience, took over the controls. Fearing a fire, the co-pilot wanted to land as soon as possible. After a mayday call, the co-pilot selected a suitable field for an emergency landing, but overflew this area due to the aircraft's speed and altitude. The aircraft was now heading towards a line of trees. The co-pilot pitched the nose in order to avoid the trees, but failed to avoid a collision. Part of the left wing was torn off, after which the aircraft became uncontrollable and came to a rest in the garden of a residential building. In the process, the aircraft collided with an adjacent shed. The pilot in command was seriously injured, while the co-pilot suffered light injuries. The aircraft was damaged beyond repair.

Figure 2: The aircraft after the accident.

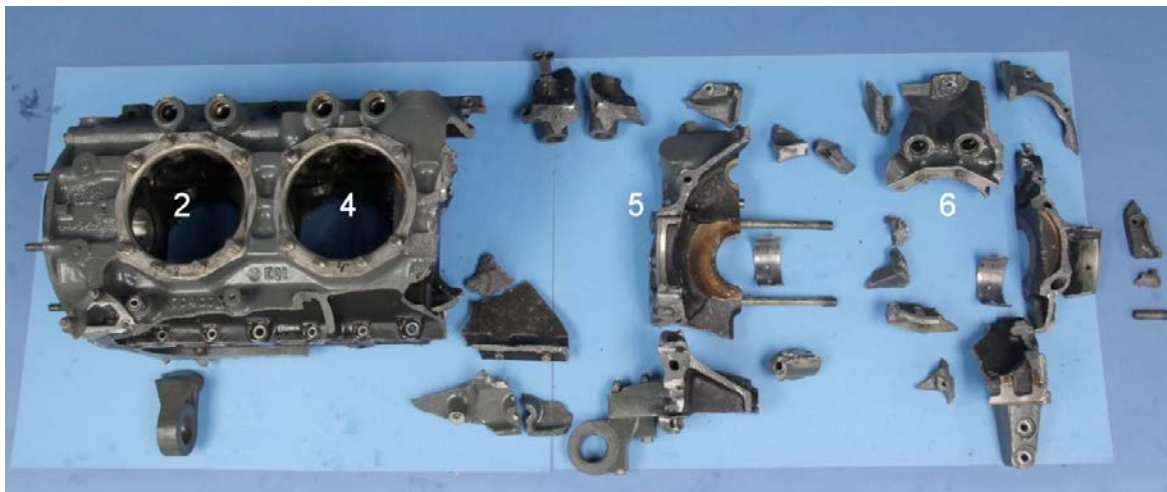
Oil was found on the engine exterior after the accident. Once the aircraft had been salvaged, it became clear that the engine crankcase had sustained a hole near the rearmost two cylinders (numbers 5 and 6). Approximately 8 of the maximum allowed quantity of 11.3 litres (12 US quart) of oil were still in the engine. After removal of cylinder 5, it became clear that the piston was detached from the connecting rod. The crank shaft was still in position in the engine. The engine was disassembled after having been removed from the aircraft. Both halves of the crankcase, the main bearings and cylinders 5 and 6 and their respective pistons and connecting rods were sent to the US National Transportation Safety Board (NTSB) for further examination. This report is partly based on the NTSB investigation.

The upper rear section of the engine crankcase had broken into several pieces, see figure 3.

Figure 3: Overview of the crankcase components. The numbers indicate the cylinder positions. (Source: NTSB)

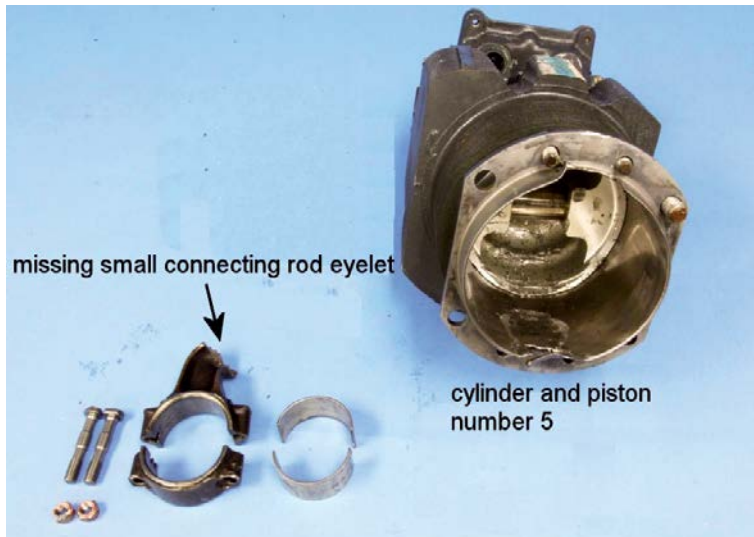
The investigation focused on the number 5 cylinder/piston/connecting rod combination, see figure 4. The connecting rod of piston number 5 had broken off and became detached from the piston. The small connecting rod eyelet connecting the connecting rod to the piston had disappeared and was never recovered. The piston was in the uppermost position in the cylinder. This position could only be reached if the piston was not connected to the crank shaft by the connecting rod. The piston could be rotated manually, moving down was not possible.

Figure 4: Overview of the number 5 cylinder, piston and connecting rod. (Source: NTSB)

The primary cause was the fracture of the piston end connecting rod. The reason for this failure is not known. This part of the connecting rod could not be examined because it was not found after the accident. Due to the failure, the connecting rod could freely move up and down and back and forth in the cylinder causing damage. The connecting rod also came into contact with the edge of the crankcase which consequently got damaged. Most likely the broken upper side of the connecting rod got jammed at sometime, causing an extremely high compression stress on the connecting rod which then collapsed at the weakest (thinnest) section. Finally the engine got locked as a result of consequential damage.

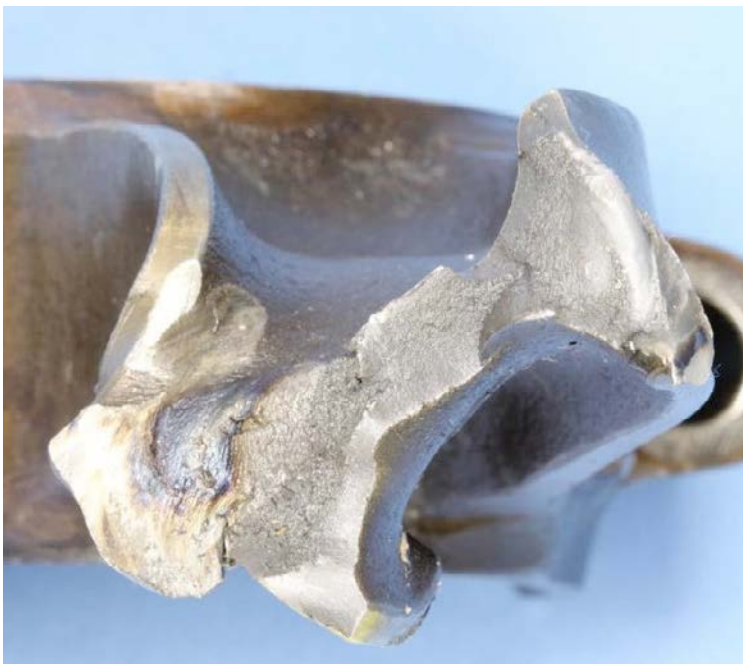
The fractured surface of the number 5 connecting rod was examined, see figure 5. Parts of the fractured surface were relatively shiny, pointing to shearing stress as a result of compression. Other parts of the surface were rough and had a matt grey color, indicating ductile fracturing of a forged steel alloy. The flange section adjacent to the fractured surface was lightly twisted. No evidence was found of any existing faults that could have caused the fracture.

Figure 5: Fractured surface of the number 5 connecting rod. (Source: NTSB)

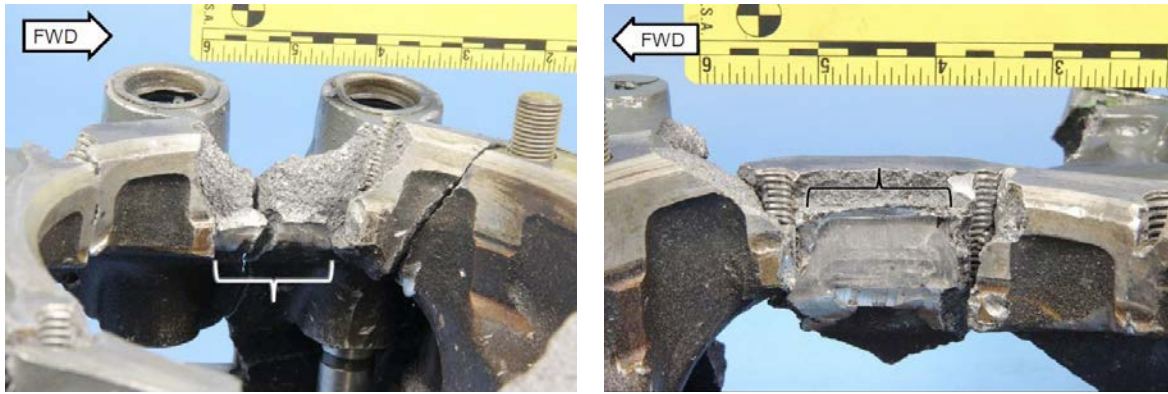
There was damage on the lower and upper side of the number 5 cylinder attachment location on the crankcase. Given the nature and dimensions of the damage, this was caused by the up and down moving connecting rod. See figure 6. Brackets indicate contact damage corresponding to contact with the number 5 connecting rod.

Figure 6: Damage on the upper and lower side of the crankcase. (Source: NTSB)

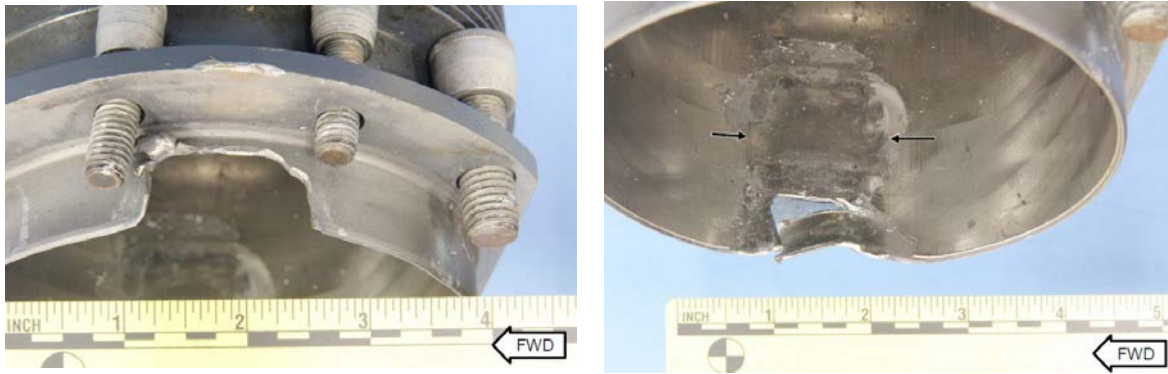
There was damage on both sides of the barrel end of the number 5 cylinder. The width of the damages corresponded to the width of the piston pin end of the connecting rod and was indicative of a repeated movement of the connecting rod against the inside of the cylinder. See figure 7.

Figure 7: Cylinder damage caused by the connecting rod. (Source NTSB)

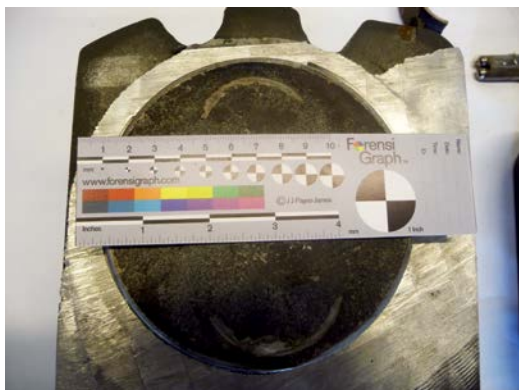
The cylinder with the piston as a whole was cut a few millimeters below the top of the piston. After the cylinder head of the cylinder was removed, the (cut) piston head could be observed. Also, the piston could be removed from the cylinder. On the upper side of the piston imprints of the inlet and outlet valve were visible. See Figure 8.

Figure 8: Upper side of the piston.

Because the piston was not connected to the connecting rod anymore, the piston could move upwards to the cylinder head. At this point the upper piston ring could catch a rear edge, so that the piston could not go down. Since the piston was now at a higher position than was possible during normal operation, the inlet and outlet valve hit the top of the piston when they were in open position. This damage is all consequential damage.

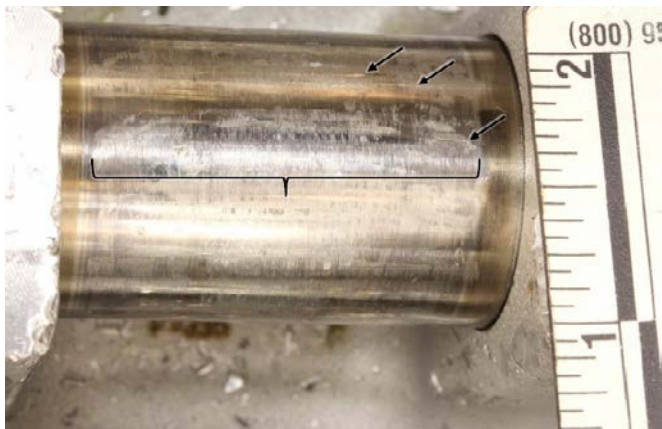
When the piston was removed, the piston pin could be examined. Scuffing and longitudinal contact damage was observed around the circumference. See figure 9. A bracket indicates an area of heavier scuffing, and arrows indicate several linear contact marks.

Figure 9: Damage on the number 5 piston pin. (Source NTSB)
