# Crew member overboard while disconnecting container lashings

MS Freya, Humber, 3 September 2014

*The Hague, November 2015*

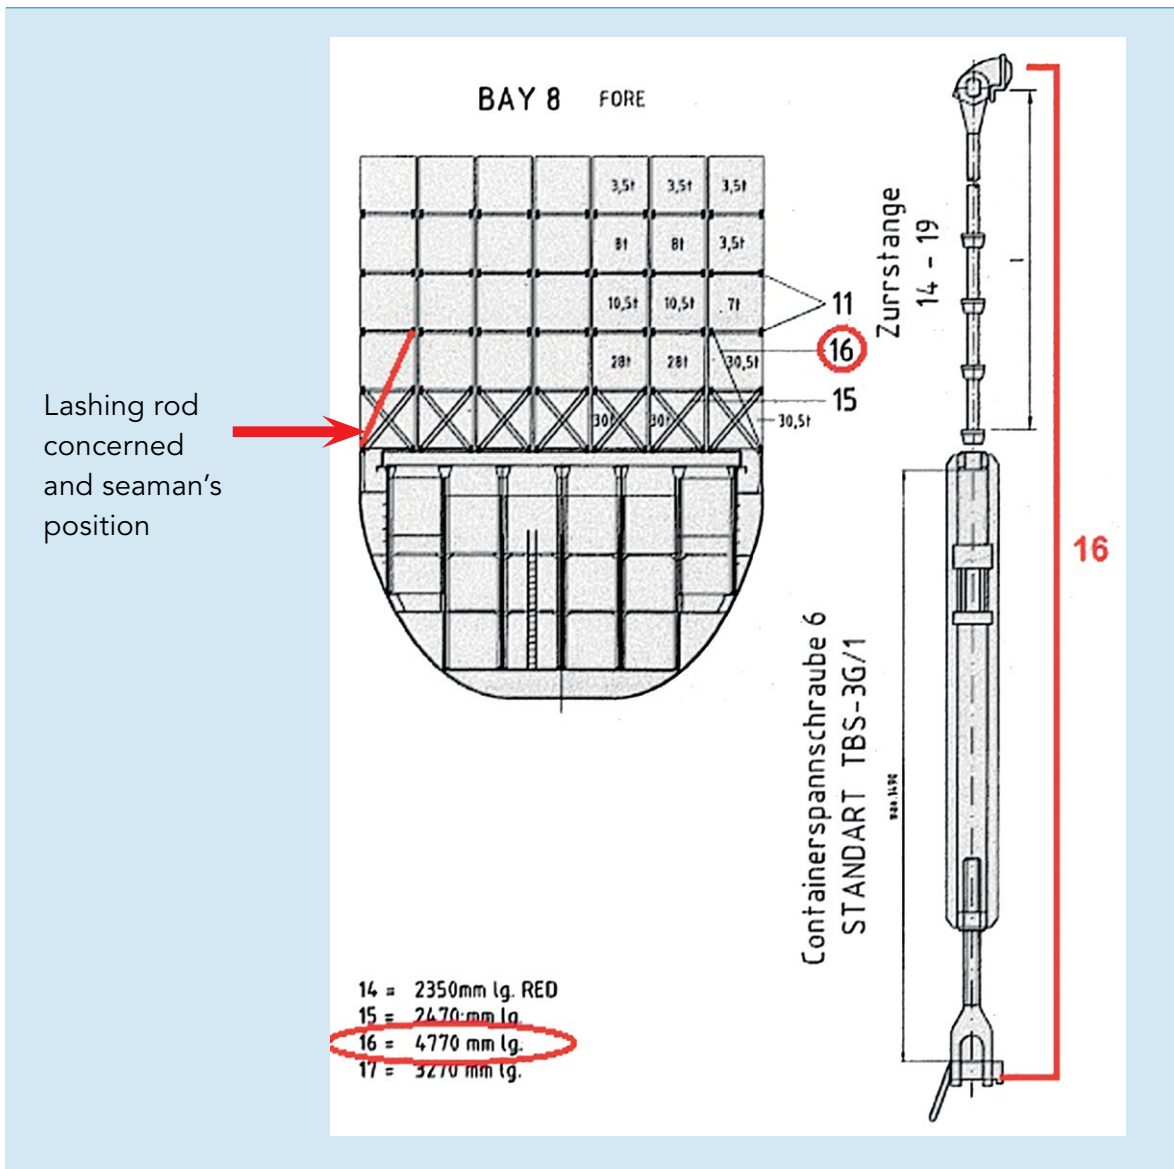
Figure 3: Schematic drawing of the containers in position 2 and the lashing rod concerned. The relevant information is marked red. (Source: Holwerda Shipmanagement B.V.)

Seaman 2 noticed this and instructed seaman 1 to leave the outermost lashing rods until later and continued with his duties. A short while later, seaman 2 looked up again to see seaman 1 balancing with the long lashing rod upright in his hands. Following a brief moment of balance, seaman 2 then saw the lashing rod fall overboard. Seaman 1 initially kept his balance, but fell overboard a short while later (around 20:50 hours).

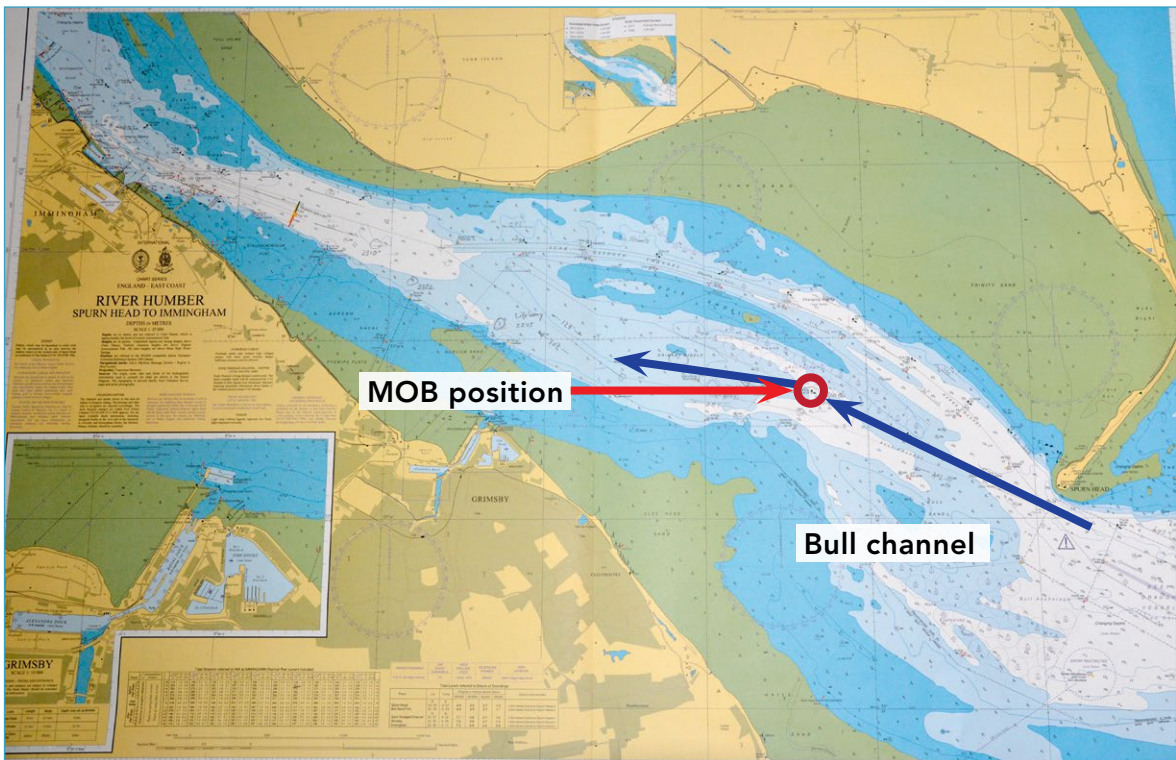
Figure 4: Sea chart of the Humber including the MOB position. (Source: Dutch Safety Board)

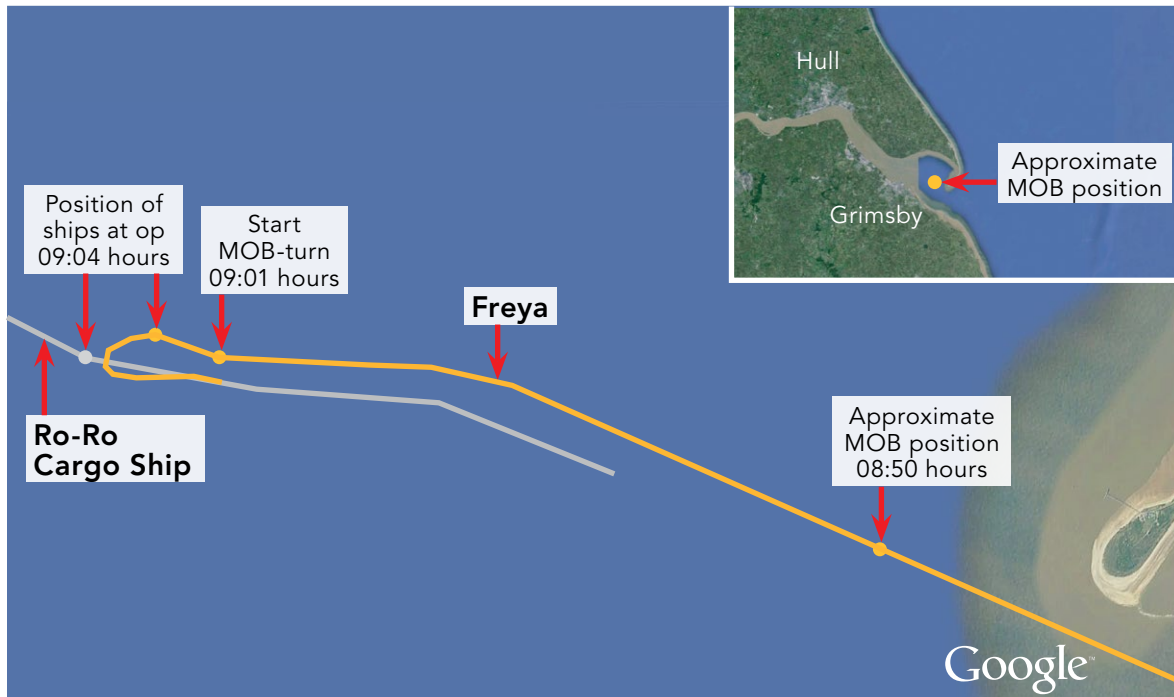
An MOB procedure applies on board Freya. This procedure is practised on board on a monthly basis to ensure that the crew are able to operate routinely and effectively in such a situation. The MOB boat is physically launched during an exercise every three months. The procedure states that, should anyone on board see someone fall overboard, the officer serving on the bridge must be alerted and a lifebuoy must be thrown into the water as soon as possible. The officer serving on the bridge must then also give a general alarm, the position must be marked using the MOB button on the GPS and, if this can be implemented safely, a Man Over Board manoeuvre must be deployed. As soon as the captain arrives on the bridge he must take command. The captain must then warn shipping in the area immediately using the relevant available communication equipment. In the meantime the first mate should count the crew and determine which person is missing. The first mate is also responsible for operations on deck including preparations for receiving the drowning person on board and the smooth and safe launch of the MOB boat. Each crew member has a predetermined task in this. The MOB procedure was last practised on board on 28 July 2014. From the VDR information and interviews it appears that the crew operated in accordance with the MOB procedure. No connection can be made between not recovering the seaman and the actions on board during the rescue.

Figure 5: Sailed course and MOB manoeuvre. (Source: Dutch Safety Board)

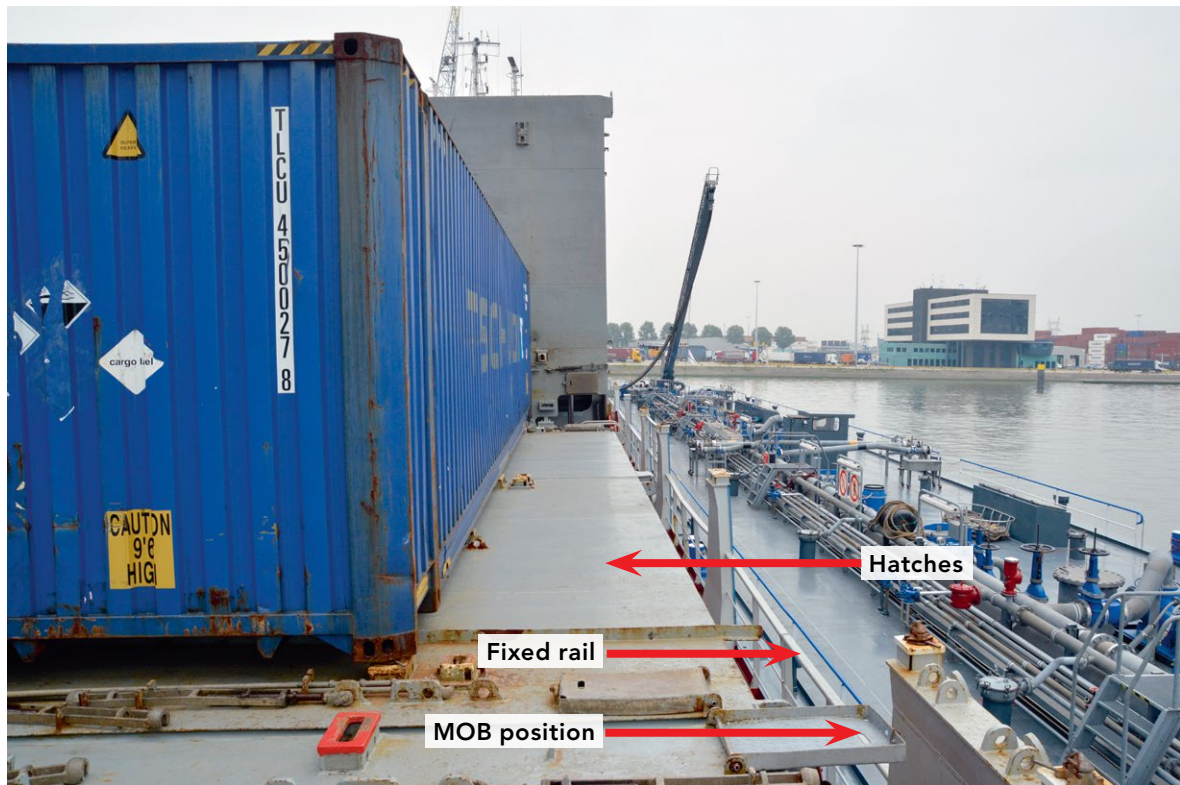
From witness statements it appears that the seaman was last seen balancing with the five-metre long lashing rod in his hand, after which the rod fell overboard. The seaman was then able to retain his balance for a short while before also falling overboard. The witness stated that the victim's eyes turned away just before the lashing rod fell overboard. According to the witness the victim also made no sound when he fell overboard. This could indicate that the victim had become unwell. As the victim has still not been found, this possibility can no longer be verified. We can however state that, irrespective of the cause of death, the seaman falling overboard was a direct consequence of disconnecting the outermost lashing rods. By disconnecting a lashing rod on the outer edge of the deck while sailing the seaman placed himself in a position in which there was a danger of falling.

Figure 5: Accident position. (Source: Dutch Safety Board)
