DUTCH
SAFETY BOARD

Engine failure during initial climb, Boeing 747-412BCF, Meerssen

The Hague, April 2023

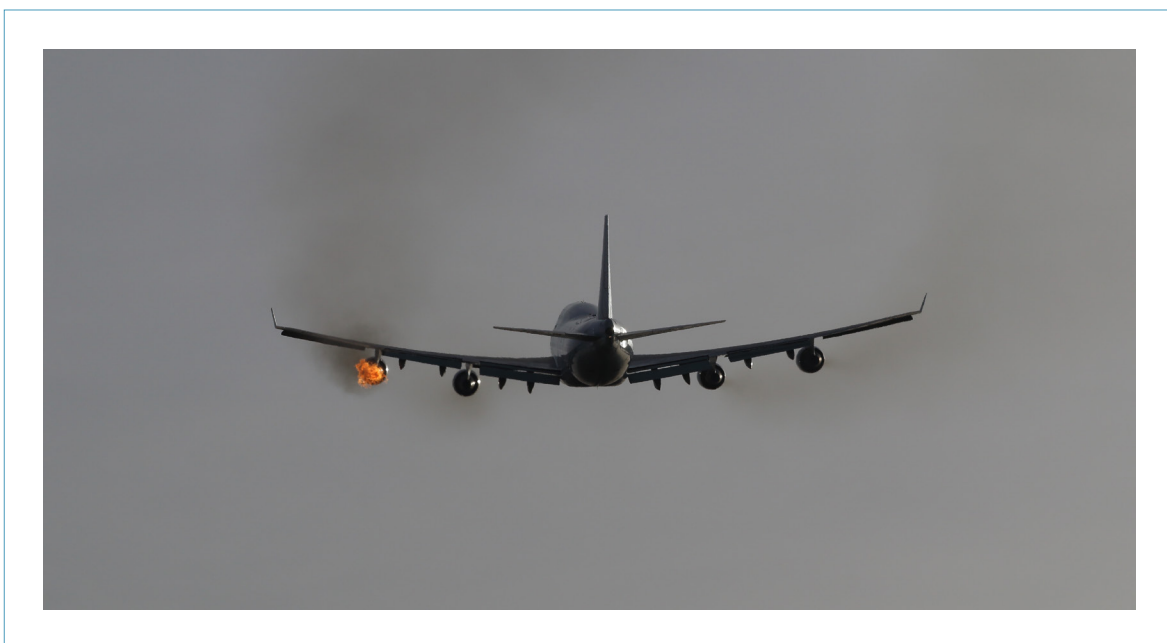
At an altitude of 1,150 feet AMSL (800 feet above ground), the flight crew heard a banging sound and noticed that the aircraft rolled and yawed slightly to the left. The exhaust gas temperature indication for engine 1 showed an exceedance of the maximum temperature. The flight crew identified the situation as an engine surge. Shortly hereafter engine 1 failed and lost thrust.

Figure 1: Observed flames after the engine number 1 failure. (Source: Maastricht Aachen Airport)

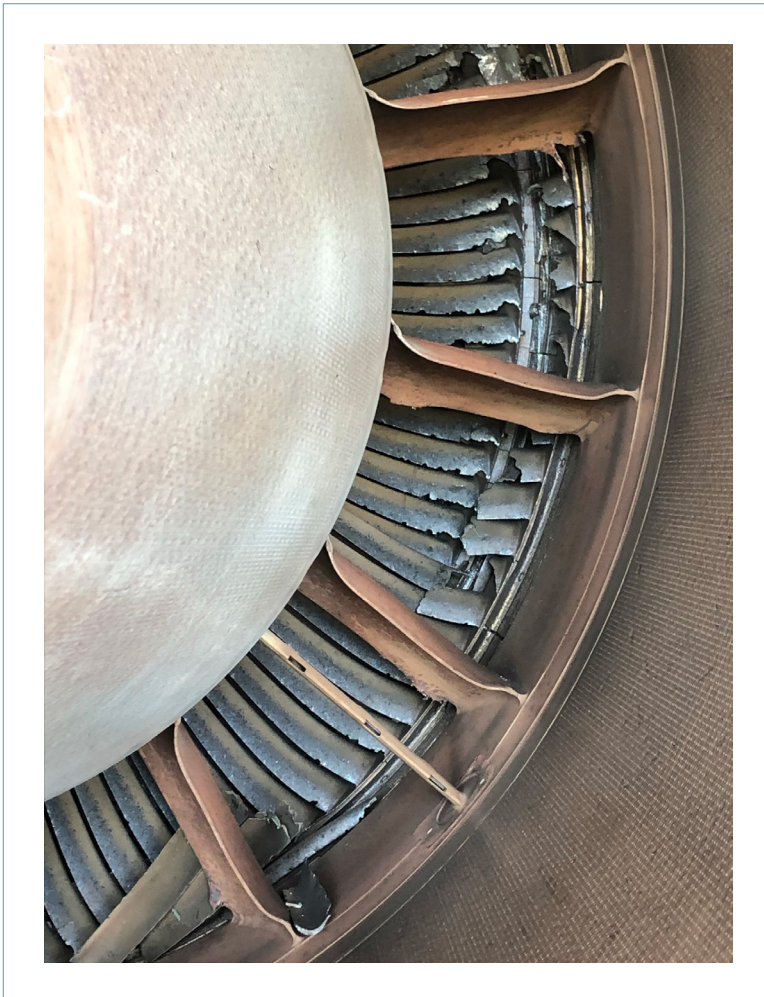
In accordance with air traffic control procedures, the flight was transferred to Liege Approach. A long final approach was flown to allow time to stabilise the aeroplane for landing and to counter possible emerging control difficulties. At 17.09 hours, the aeroplane landed uneventfully on Runway 22L at Liege Airport. After landing, the fire brigade escorted the aeroplane to the parking position. The fire brigade reported to the flight crew that there were no signs of fire from engine number 1, nor that there was external damage visible. The aeroplane was subsequently towed to a parking spot. The landing weight was 292,000 kg, which is below the maximum allowable landing weight. After engine shutdown, significant damage was visible to the aft stages of the low pressure turbine when looking forward into the tail pipe (see Figure 3).

Figure 3: Damage visible to low pressure turbine, looking forward into the tailpipe. (Source: Dutch Safety Board)

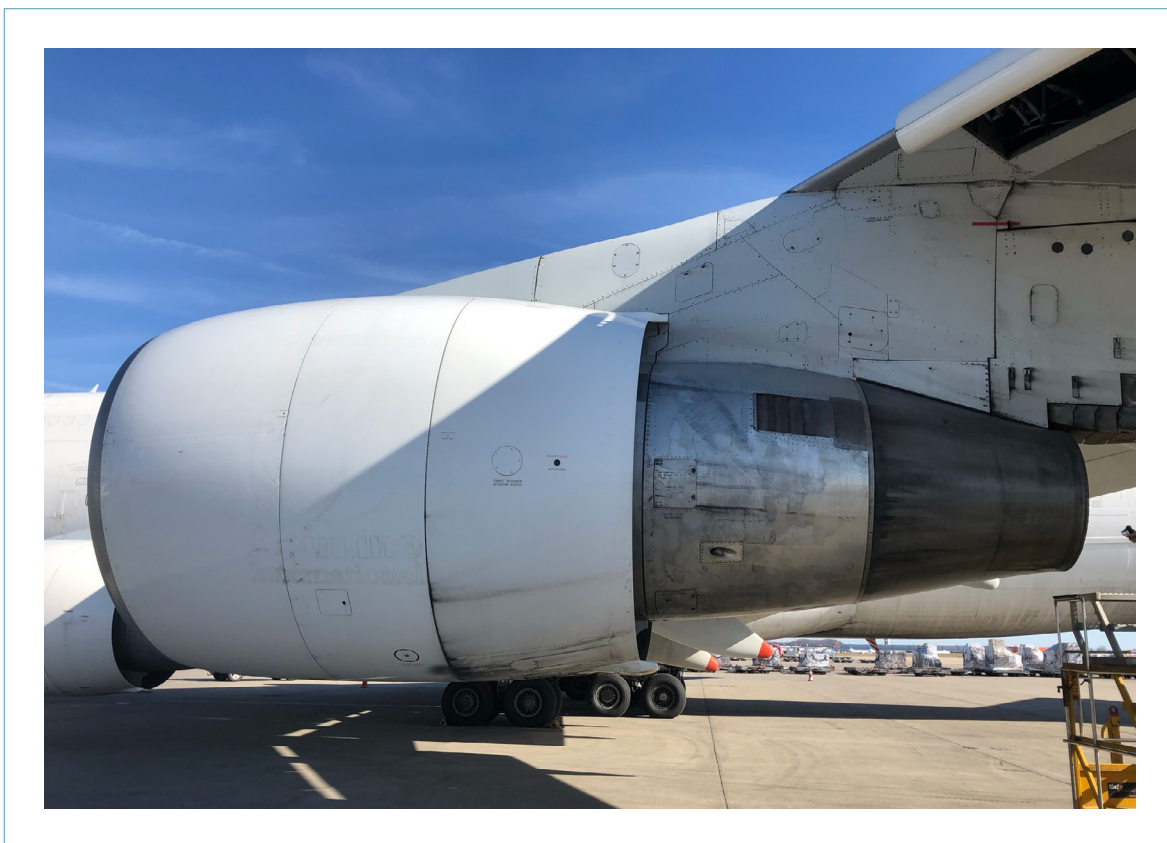
The number 1 engine encountered a contained failure and sustained internal damage of among others the high pressure turbine and low pressure turbine. For a further description of the damage, see Section 2.10.1. There was no damage to other parts of the aeroplane.

Figure 4: Engine number 1 after the diversion to Liege Airport. (Source: Dutch Safety Board)

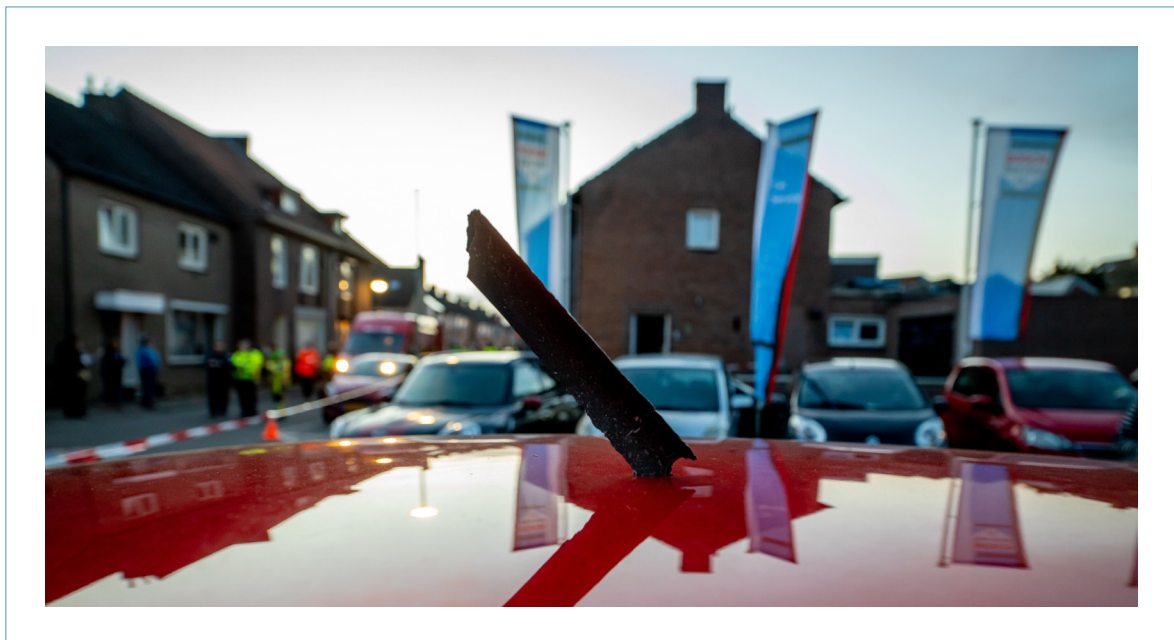
The aeroplane lost metal parts over residential areas of the village of Meerssen (see Figure 5), causing damage to cars (see Figure 6) and houses. Parts were collected and identified as turbine fragments of the number 1 engine (see Figure 7).¹³ Examination of

Figure 6: Turbine fragment in car roof. (Source: Algemeen Nederlands Persbureau)

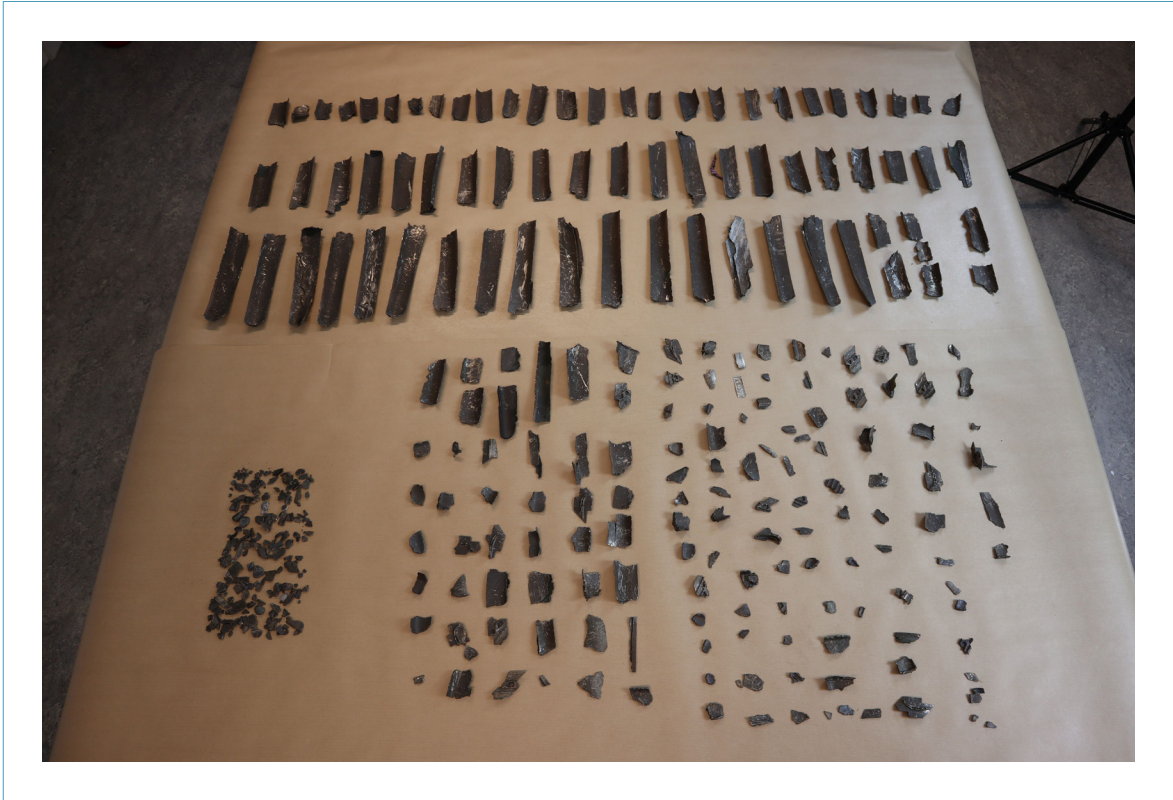
these parts revealed that some were of considerable size¹⁴ and weight and thus posed a hazard to people on the ground and their property.

Figure 7: Collected turbine fragments. (Source: Dutch Safety Board)

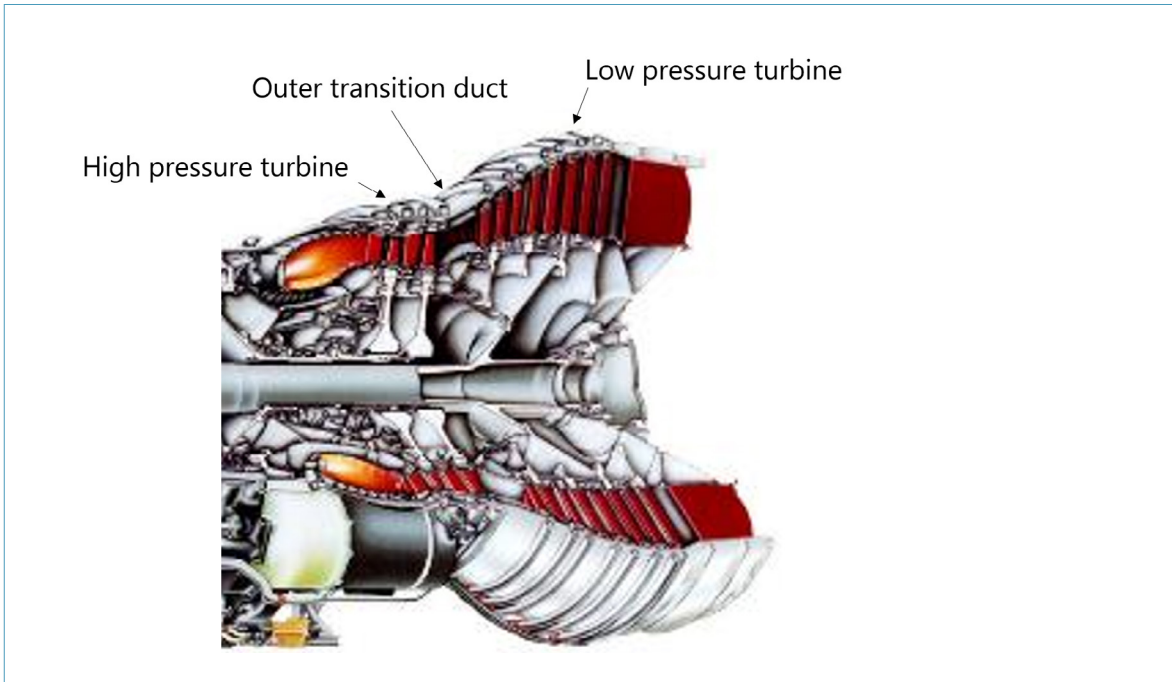
The boroscope inspections revealed various damages within the high pressure turbine (HPT) and low pressure turbine (LPT) (see Figure 9). The HPT showed damage to the trailing edge of second stage blades. Two outer transition ducts (see Figure 10) had come loose and displaced in the flow path of the LPT (see Figure 11). Multiple third stage vanes (first stage of the LPT) were missing and damaged. The last two stages of the LPT were missing turbine blades and vanes. Pratt & Whitney stated that the damage was consistent with other outer transition ducts that had separated in the past (see Section 2.12.2).

Figure 9: The aft part of the engine with an outer transition duct indicated. (Source: Pratt & Whitney)

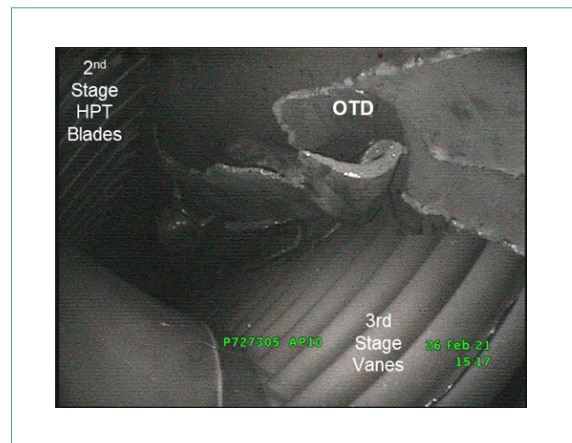
Figure 11: Picture of damaged outer transition duct, taken during borescope inspection. (Source: Pratt & Whitney)

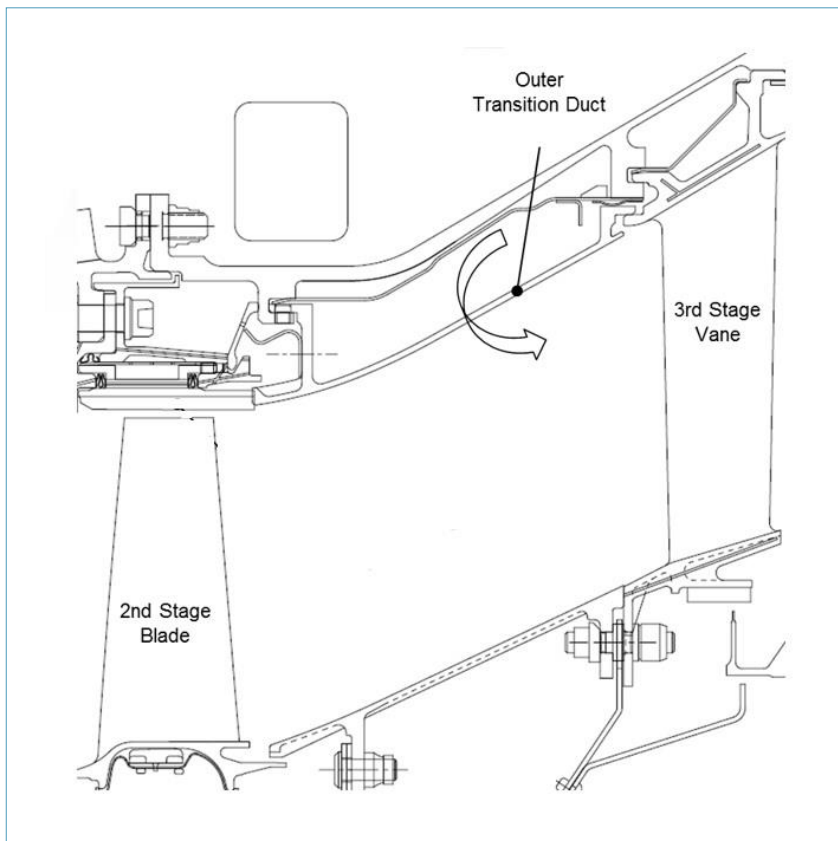
The metallurgic analysis found that the HPT stage 2 blade outer air seals, the outer transition ducts and the LPT case were exposed to high temperatures (see Figure 12). These temperatures resulted in among others, fractures, wear, warping and degradation of coatings. Further details of this analysis are presented in Appendix D.

Figure 12: Cross-section view of HPT/LPT transition area. The arrow indicates the direction of movement of a detached outer transition duct. (Source: Pratt & Whitney)

The investigation revealed that the second stage blade outer air seal of the high pressure turbine (HPT), as well as the HPT itself had deteriorated. This exposed the outer transition ducts to elevated temperatures. These two factors contributed to the slow deformation of the outer transition ducts. The outer transition duct panels distorted, the attachment hooks deformed and backed away from the case, which led to liberation of one panel and one being fractured. These panels then damaged the turbine blades, resulting in fragments of the turbine leaving the engine via the exhaust pipe. The investigation ruled out that runway foreign object debris or a bird strike or drone strike had led to the engine failure. The meteorological conditions played no part in this failure either.

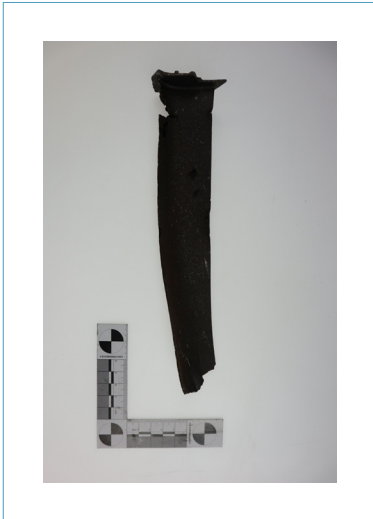
Figure 14: Turbine part. (Source: Dutch Safety Board)

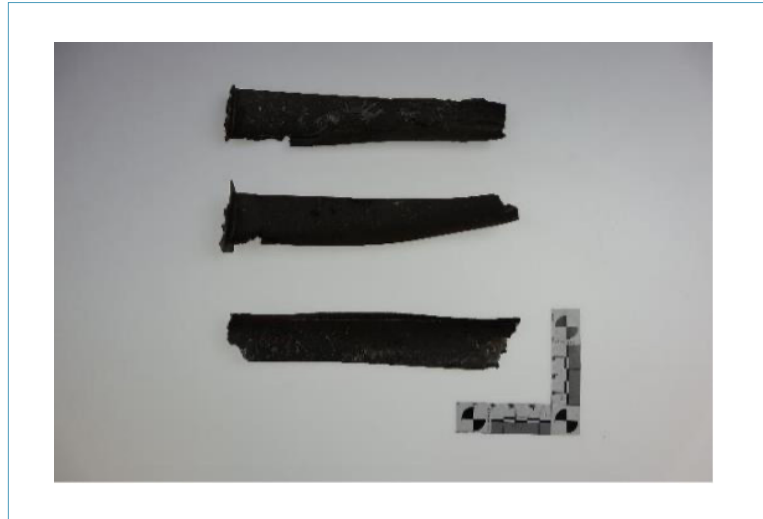
Figure 15: Turbine parts. (Source: Dutch Safety Board)

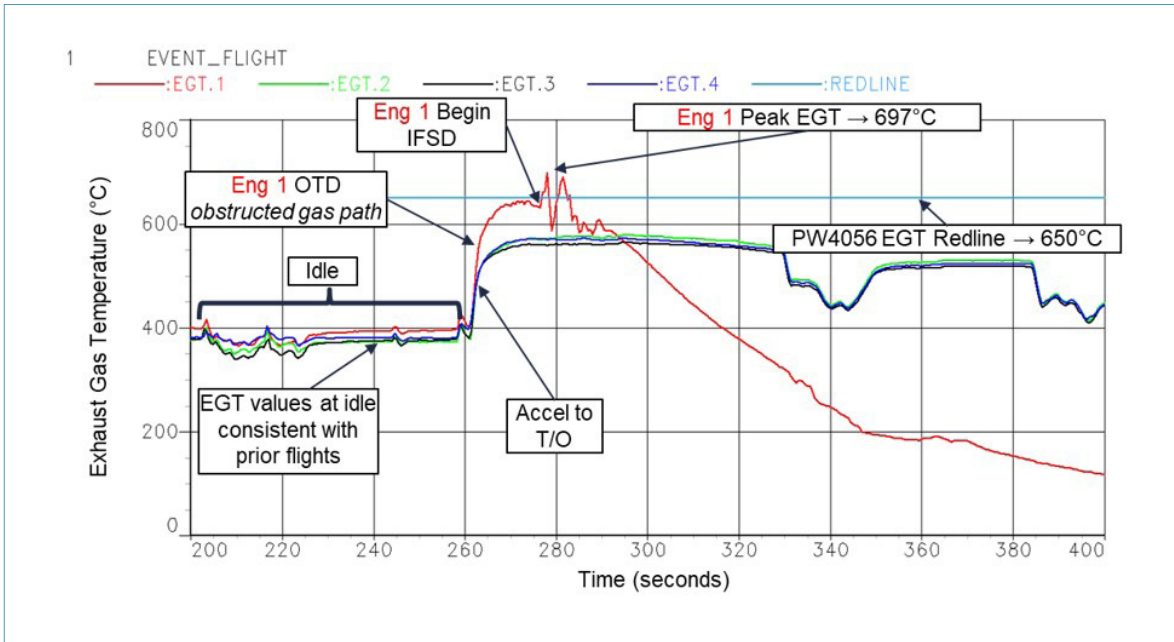
Figure 17: Exhaust gas temperature. (Source: Pratt & Whitney)

The graph is based on data recorded by the flight data recorder. As can be seen, during the period that the engines were set to idle before takeoff, all exhaust gas temperatures (EGT) were around 400 °C. After adding more power to the engines for takeoff, the EGT of engine 1 began to differ by rising to a temperature around 650 °C. The in-flight shut down started with two peaks of almost 700 °C, before the EGT temperature consistently decreased.
