Entrapment by hatch cranes

Extended investigation after
fatal entrapment on cargo ship

The Hague, July 2022

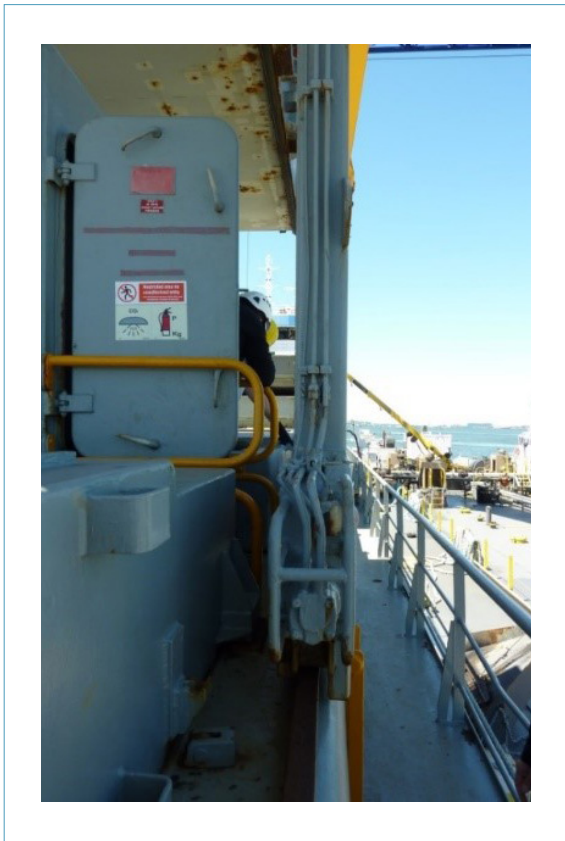
When the unloading of the cargo from hold no. 1 was almost completed, three crew members received the order to close the hatches of the hold. The crew member charged with operating the hatch crane walked to the hatch crane and clambered up to the location of the controls. The other two crew members would assist the operator from the gangway. After switching on the hatch crane, the operator asked via transceiver if the operating range of the crane was free from obstacles. This was confirmed by the other two crew members, one of which the later victim. Subsequently, the operator moved the crane in the direction of the bow and during this movement the victim got entrapped amidships. Immediately after the accident the operator was made aware of the mishap by local stevedores and a fisherman. The victim was on the port side, completely hidden from view to the operator on the starboard side.

Figure 3: Hatch crane near the hold entrance on port side.

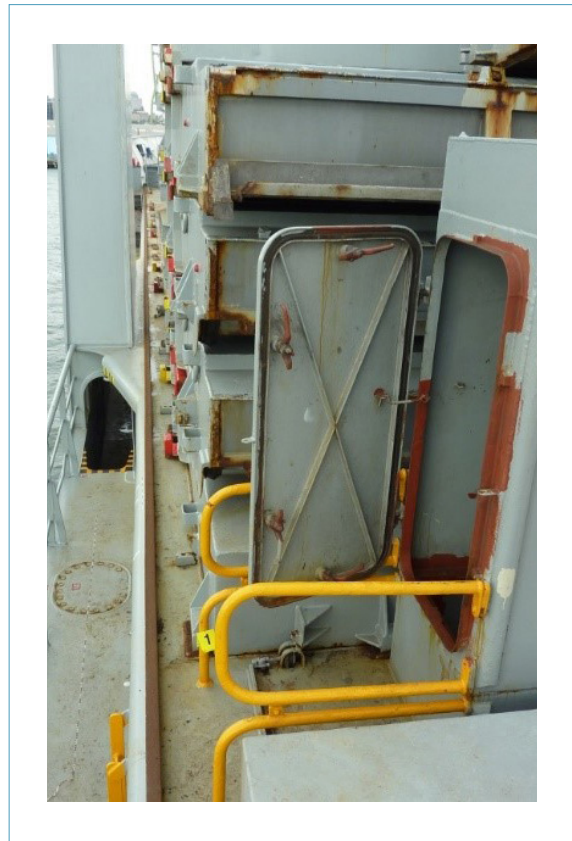
Figure 4: Hold entrance on port side, showing the watertight door and the stacked hatches.

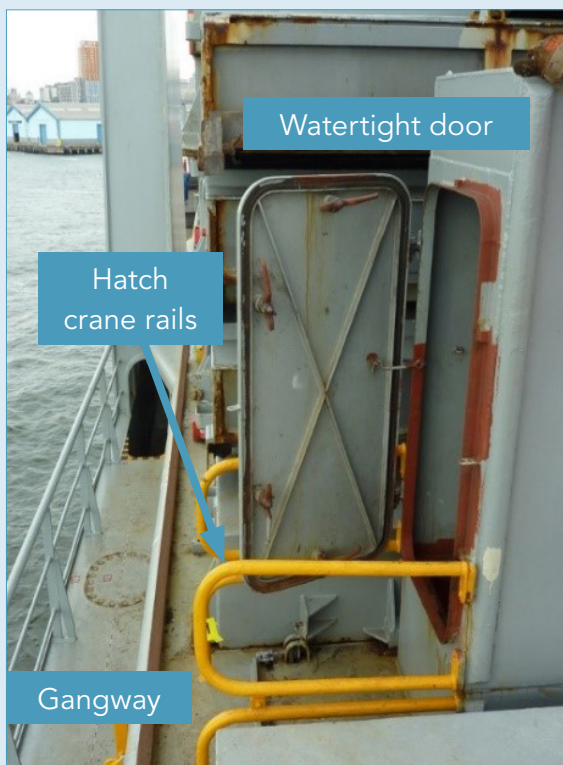
Figure 6: Access to hold number 1 on port side; location of occurrence 2018.

The fatal occurrences on the Beauforce happened in almost identical locations, namely the hold entrance amidships, the only difference being that in 2015 the occurrence was on the starboard side and in 2018 on the port side. On the Beauforce the hold entrance is amidships with a small portal at the top and a threshold (see figure 6). The threshold is 60 cm high and is intended to keep a safe freeboard. Within the portal there is a small landing at the top of a ladder giving access to a shaft of some 8 metres deep. This shaft provides access to the hold.

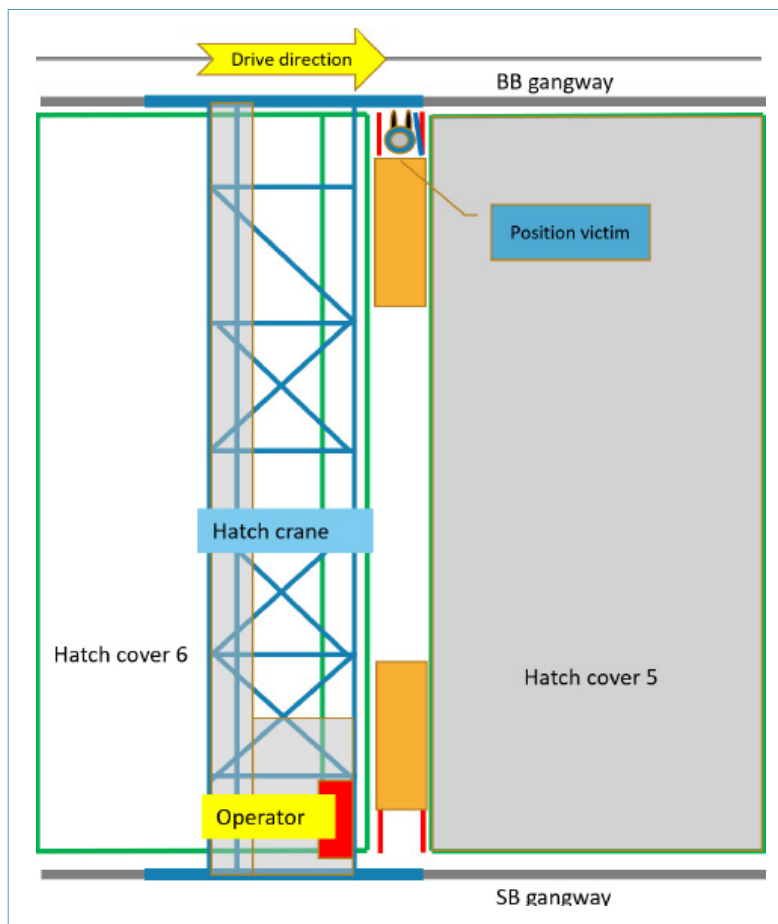
The investigation into the first fatal entrapment on board the Beauforce in 2015 showed that the view of the operator of the hatch crane was severely restricted. The position of the operator and the restricted view were the same in 2018 and therefore the operator could not see whether or not the victim had accessed the gangway. Considering the accident of 2018, the situation described above rendered the first control measure of the procedure infeasible. From his position the operator of the hatch crane could not see if there was anyone present in the port side gangway. People emerging from the hold entrance amidships were not visible to him. This is because the crane controls are on the starboard side. Furthermore, the construction of the hatch crane itself obstructs the view of the area immediately below the hatch crane.

This makes that the operator himself cannot see if the path of the hatch crane is clear. For this he largely depends on the input of others. The restricted view for the operator of a hatch crane is also mentioned in the ILT interim report on hatch crane⁵.

Figure 7: Top view with position of victim in 2018.

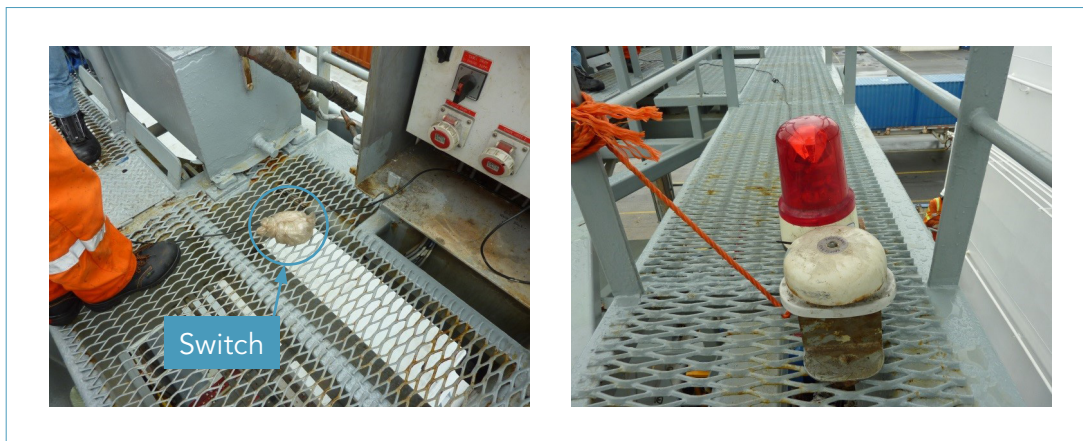
At the time of the occurrence in 2018 the original alarm bell was defective. Since there were no spare parts on board, the bell could not be repaired immediately. For this reason an alternative alarm system was in operation. This alternative alarm system required manual operation. The operating switch of the alternative alarm system was located next to the controls of the hatch crane. This system also caused the alarm to sound louder near the operator, causing other sounds to be drowned out and less audible for the operator. In addition, the bell was further away from the locations where the risk of collision with the hatch crane was present, such as the gangway and the hold entrance amidships. In some instances the alarm was not switched on. The statements made by the witnesses as to whether or not the alarm was sounding at the moment of the occurrence are ambiguous.

Alternative alarm system with on the left (figure 8) the switch and on the right (figure 9) the alarm bell and the strobe light.

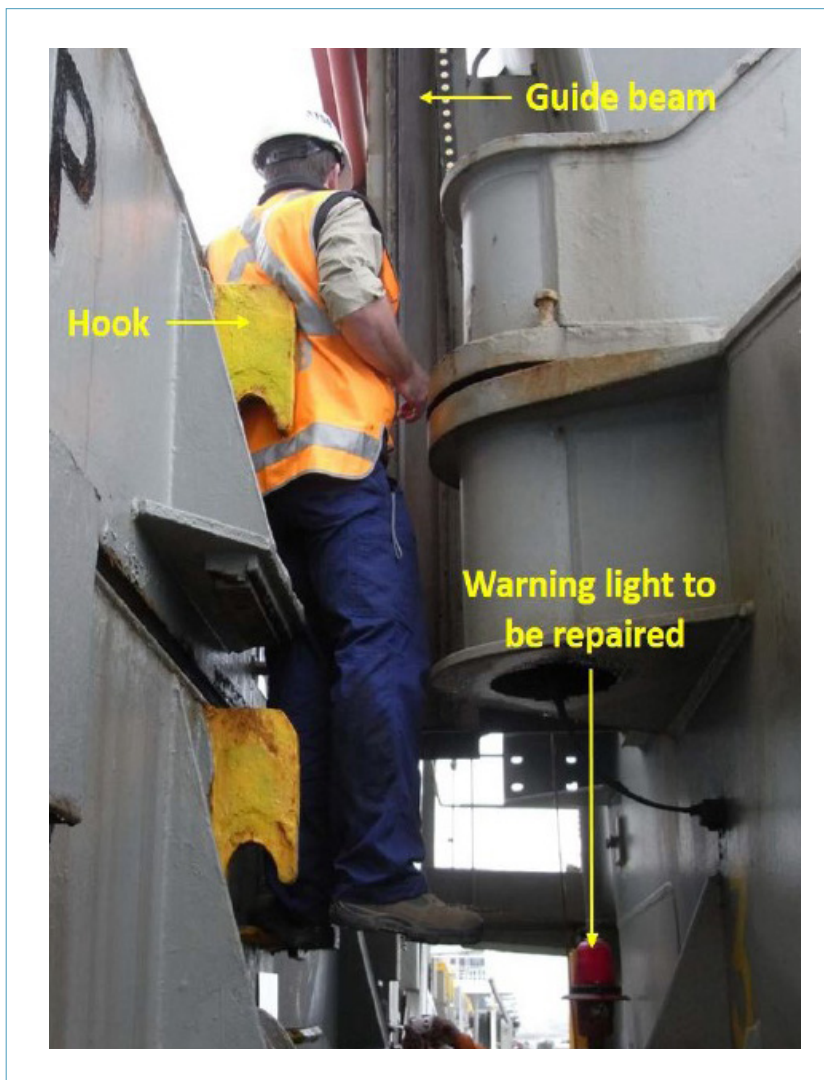
Nobody saw what happened, and therefore investigation by the Australian Transport Safety Bureau (ATSB) was not conclusive as to the actions of the crew member at the time of the occurrence. Tools and a new warning light were found close to the accident location. Partly on the basis of this finding, the ATSB concluded that the victim probably had the intention of replacing the defective warning light of the hatch crane and that he had climbed up two hatches in order to do so. On the basis of forensic evidence it is assumed that he became entrapped between the stacked hatches and the moving hatch crane.

Figure 12: Reconstruction of the occurrence; the victim was probably standing on a ladder of the stacked hatches. (Source: ATSB)
