DUTCH  
SAFETY BOARD

# Erroneous takeoff performance calculation, Boeing 777

Reference number:	2017038
Classification:	Serious incident
Date, time of occurrence:	21 April 2017, 12.06 hrs <sup>2</sup>
Location of occurrence:	Amsterdam Airport Schiphol
Aircraft registration:	VT-JEW
Aircraft type:	Boeing 777-300ER
Aircraft category:	Commercial airliner
Type of flight:	Scheduled passenger flight
Phase of flight:	Takeoff
Damage to aircraft:	None
Number of flight crew:	2
Number of cabin crew:	13
Number of passengers:	343
Injuries:	None
Other damage:	None
Light conditions:	Daylight

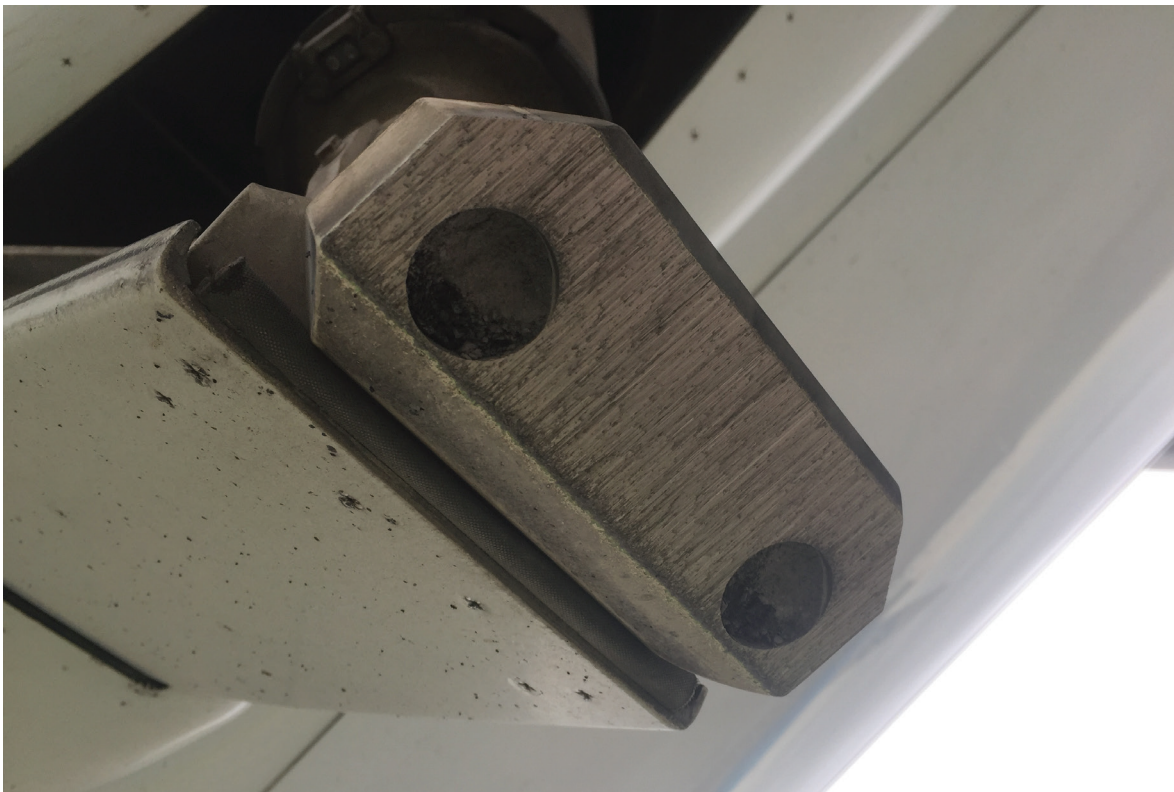
There was no damage to the aeroplane. The tail skid shoe was slightly scraped as a result of the tail strike (see Figure 3), but within limits as stated in the Aircraft Maintenance Manual to allow continued operation of the aeroplane. The fin of the tail strike detection system was still intact, which explains that no 'TAIL STRIKE' warning was generated in the cockpit.

*Figure 3: Tail skid shoe with scrape marks.*

The tailstrike was caused by an overrotation during takeoff, which was the result of a lower than required rotation speed. The reason for this was that the actual takeoff weight was higher than the takeoff weight that had been used for the takeoff performance calculation.
