DUTCH
SAFETY BOARD

Shipping Occurrences Report

November 2014 - April 2015

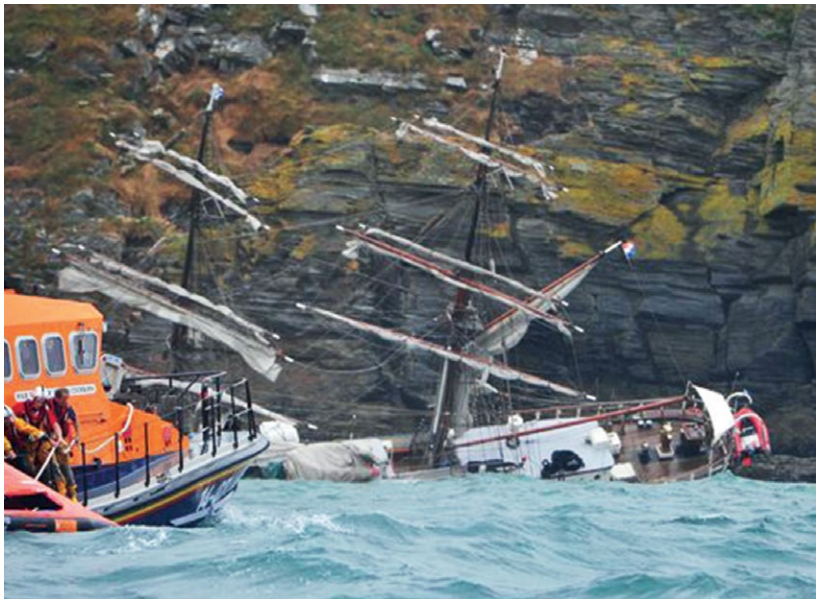
On 24 July 2013, the ship was scheduled to be one of a flotilla of boats taking part in a sailing festival between Oysterhaven and Kinsale. The ship hauled anchor at 11:00 hours¹ and proceeded out of Oysterhaven, using engine power. At approximately 11:35 hours, sails were being hauled and the course was altered. Whilst hauling the sails the engine was still being used and the ship proceeded in a SW direction at a speed of approximately 3 knots.² At approximately 11:40 hours the engine failed and the Astrid ran aground on the coast, 0.7 NM³ North West of the Big Sovereign. The Big Sovereign is a small island just outside of Oysterhaven. Rescue services were alerted and all trainees and ship crew were safely evacuated. They landed onto Kinsale, without injuries. The ship sank, but was subsequently salvaged and deemed an economic write-off. The Irish Marine Casualty Investigation Board (MCIB) conducted a safety investigation and gave the following recommendations:

STV Astrid. (Source: Maritime Casualty Investigation Board)

1. Operators of sail training vessels should ensure that ships engaged in international sail training voyages and carry passengers, comply with the requirements of a passenger vessel, as indicated in the International Conventions and European Union Law. The Minister for Transport, Tourism and Sport should explore mechanisms to ensure that sail training ships entering Irish waters and ports comply with the requirements of the International Conventions and European Union Law.
2. National sail training organisations or other organisations that arrange sail training activities should ensure that the ships act according to the necessary International Conventions, European Union Law and national requirements.
3. Ships engaged in any promotional activities must ensure that the Master has over-riding authority and that the Master should not compromise good passage

planning or the safety of the ship and persons on board when engaged in such activities.

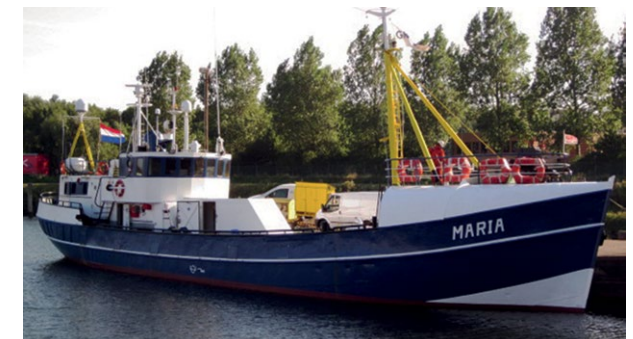
On Monday morning the 7th October 2013 at 01:14 hours, the fishing vessel Vertrouwen (TX 68) collided with guard ship Maria about 21 NM south-west of Den Helder. The Maria was heading north in its 'guard zone' at low speed (about 1 knot). The Vertrouwen (TX 68) was sailing from Den Helder to its fishing area. She was heading west at a speed of 11 knots. Both vessels sailed under the Dutch flag. The Maria was seriously damaged by the collision, and water flooded into the vessel through an opening in its hull on the starboard side. This caused the Maria to sink. Two of the 5-men crew were rescued by the Vertrouwen (TX 68). The other three crewmembers who were onboard the vessel died. Their bodies were recovered later.

Guard vessel the Maria. (Source: Rederij Groen BV, Scheveningen)

The Vertrouwen (TX 68) suffered light damage to her bow, but was able to sail back to her home port without further problems. Due to the fact that the Maria sank with three of her crewmembers, much information was lost. Based on the available data, it is not clear why the collision between the Maria and the Vertrouwen (TX 68) took place. Neither the watchman on the Vertrouwen (TX 68), nor the helmsman on the Maria took any initiatives to avoid the collision. The reconstruction displayed no course alterations before the collision.

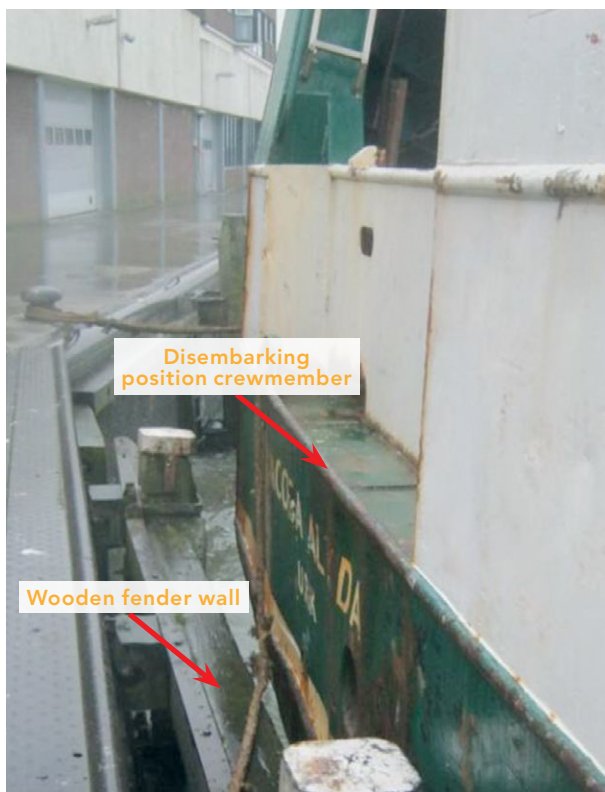
Stern Uk268 and wooden fenderwall.

On the 4th December 2013, a fatal accident occurred on board the fishing vessel UK 268, the Jacoba Alyda. While mooring the vessel into the Dutch port of Lauwersoog, one of the crew members tried to step onto the quay in order to grab hold of the mooring line and fell between the quay and the vessel where he was crushed. The Dutch Safety Board conducted a safety investigation and published a report. The accident could take place because the vessel was not yet flush against the wharf when the crewmember made his presumed attempt to disembark. As there was no quayside assistance to help with mooring, the crew member had to jump on the quay himself. Due to the unawareness of the captain of the fall of the crewmember, the vessel was not kept clear from the wharf and therefore the crew member could become trapped between the vessel and the wharf. Due to the short space of time between the fall overboard and entrapment, the crew was unable to pull the crewmember back on board. Lessons learned from this accident:

1. Communication between disembarking crew and the captain during mooring is crucial, especially in situations where the captain does not have an unobstructed view of the disembarking crewmembers. Clear agreements regarding procedures of disembarkment and the use of walkie-talkies could be useful in this respect, as would be discussing in advance which manoeuvres are to be undertaken.
2. Where possible, quayside assistance should be called in to take the mooring lines, especially during night-time hours. If this is not possible, a full risk evaluation should be conducted and the crew should be made aware of the dangers. In cases without quayside assistance, it is important to provide such a risk evaluation regarding disembarkation during mooring and unmooring procedures of the vessel. This would also prevent unnecessary movements on and off the vessel.

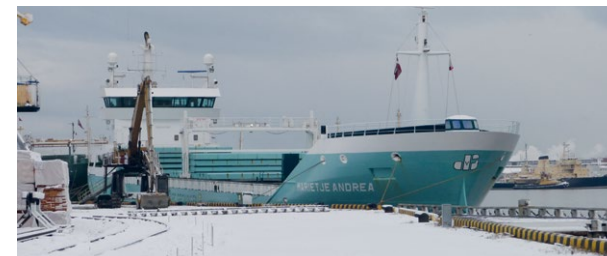
On Thursday the 5th December 2013, two sailors from the Dutch motor vessel Marietje Andrea were lost after they fell overboard in the Baltic Sea in the territorial waters of Sweden. None of the crewmembers saw it happen. At the moment of the incident, it is likely that the sailors were making their way across the deck hatches to the foredeck. The bridge crew heard the sailors calling for help after their fall into the water. They responded by dropping a lifebelt and a smoke marker from the bridge into the water. The ship turned about. When the Marietje Andrea returned to the Man Overboard (MOB) location, indicated by the smoke marker, they could not find the sailors there. The sailors were not found in the following months after the incident. Based on the investigation by the Dutch Safety Board, the board deems it plausible to assume that the crew members were in a location with a heightened risk of falling as there was no effective provision against a fall overboard at the location of the incident. The risk of passing over the deck hatches or the risk of falling overboard, were not identified as possible risks on board of the ship. As a result, control measures were lacking. After the sailors fell into the water, the crew quickly carried out a large number of tasks which could have contributed to a successful rescue. However, they omitted to immediately apply a hard turn to the ship and carry out a MOB manoeuvre. As a result, it took longer than necessary to return to the MOB position.

MV Marietje Andrea.

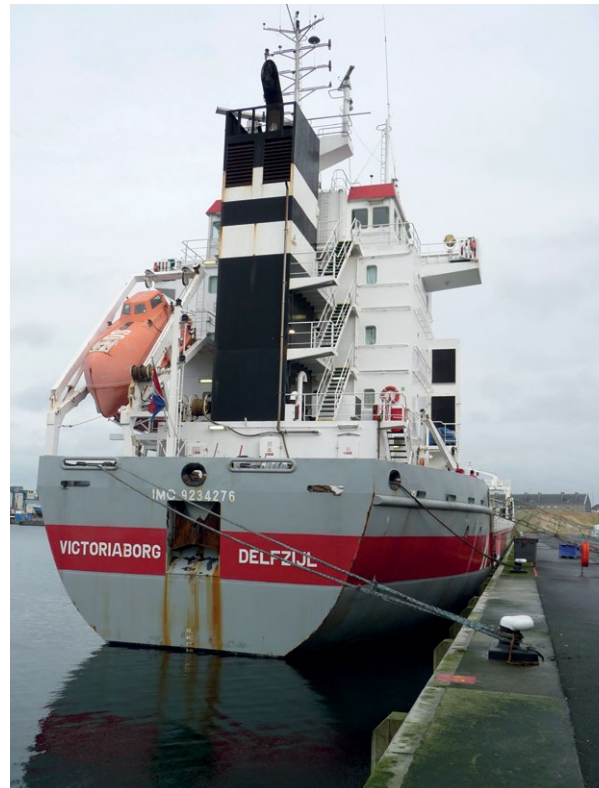
On the 23rd December 2013, the under the Netherlands flag sailing general cargo vessel Victoriaborg, sailed in the Atlantic Ocean from Rotterdam, the Netherlands to Wilmington, United States of America. The ship encountered severe weather during her voyage to her port of destination (wind force 8/9 Bf,⁴ significant wave height 7.5m). Due to a small amount of water inflow which was found in the pantry, the first mate and the cook searched for a possible leak of the vessel. However, they did not find the leakage, and the cook saw the first mate leaving the accommodation.

Soon after, several alarms were sounded, including the fire alarm. In response, the crew reported to the bridge, however the first mate was missing and a search was initiated through the ship. Meanwhile, the chief engineer investigated the cause of the alarms. On his search, he found the entrance door to the emergency generator room open and unlocked; the engine room contained 40 centimetres of water. It is likely that the first mate washed overboard when he opened the door to the emergency generator room, to look for the source of the leakage in the pantry. The body of the chief mate washed ashore several weeks later.

MV Victoriaborg.

Conclusion:
This accident underlines the importance of carrying out a careful assessment in consultation with the crew before going on deck in bad weather. Subsequently, if in this assessment the decision is made to go on deck, the correct safety measures should be taken.

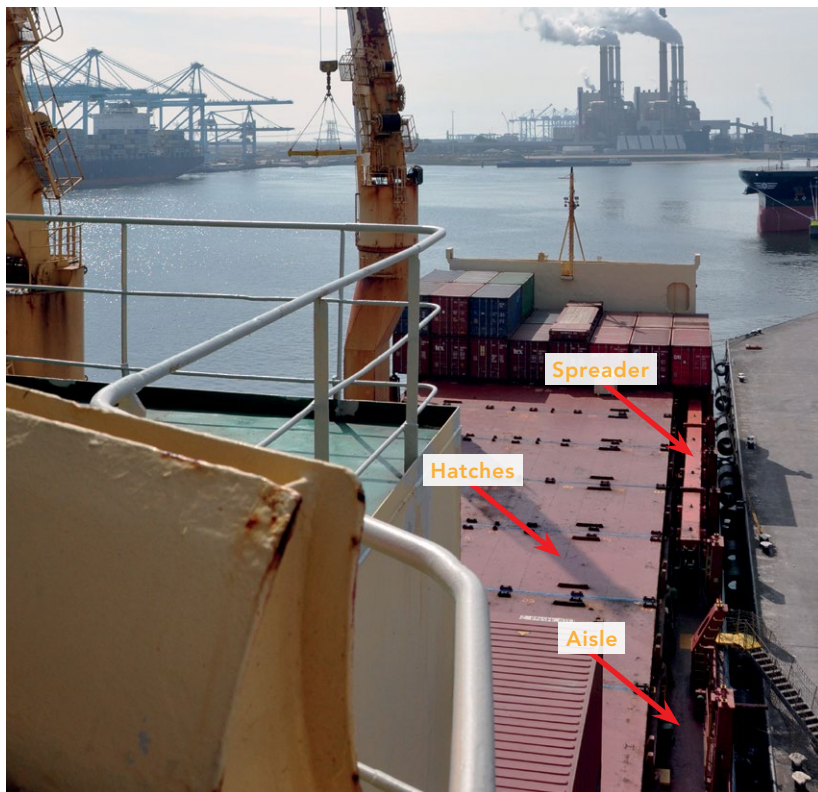
The Dutch Safety Board conducted a safety investigation and published a report. The victim was guiding the hatch during the accident. In order to be able to guide the hatch, he connected a rope to the hatch and walked with it to the fore ship. He passed the starboard aisle during shifting. On the last part of the aisle, a 42 tons spreader was positioned.

This spreader was used to load or unload heavy cargo with the two ship cranes and was blocking the last part of the starboard aisle. The spreader was not part of the standard ship equipment and was placed on board to enhance the commercial value of the vessel. To guide the

MV Clipper Champion.

hatch further, the crewmember saw no other option than to climb on the spreader.

The spreader was above the railing and was not equipped with falling safeguards. The Closed Circuit television (CCTV) footage from a nearby positioned camera showed that the sailor fell off the spreader while the hatch was being moved by the crane. However, the exact reason why the sailor fell off the spreader was not visible. Lessons which can be learned from this accident are:

1. Shipping companies should play a leading role in preventing potential risks when changing equipment. A good way to achieve this is to consult the crew and assess the risks that may be applicable and whether they are acceptable. It is important that all crew members are involved, including the captain and chief engineer, but also the sailor and the cook.
2. The companies should ensure that there is sufficient attention to individual and each other's personal safety. It is important that a culture is developed aboard ships where colleagues dare to point out hazards to each other and find personal safety of paramount importance. Company employees visiting the vessels must show exemplary behaviour by for example, wearing the appropriate protective equipment and speaking to the crew about misuse of personal protective equipment and the possible dangers.

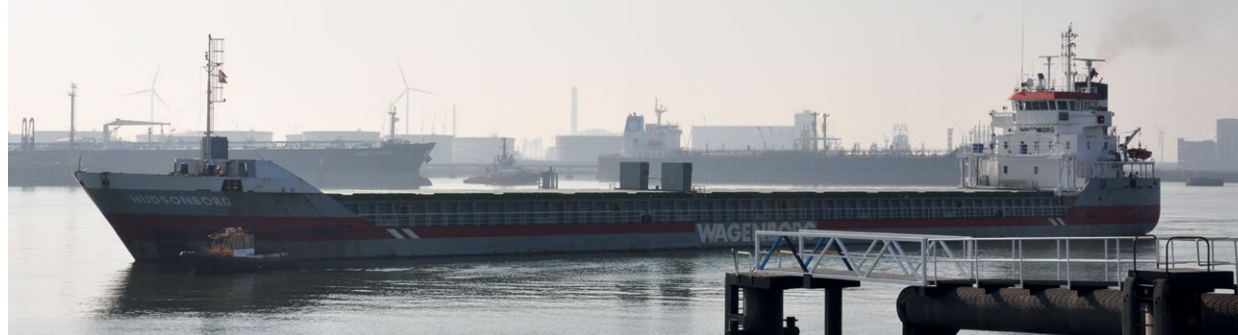
On the 12th March 2014 the first mate of the Hudsonborg died after entering a stairwell leading to a cargo hold containing zinc concentrate. The ship was sailing with a bulk cargo when the first mate was going to perform a cargo inspection. The cargo oxygen-depletion hazard had been underestimated while performing this job. No sufficient safety precautions have been taken. The investigation performed by the Dutch Safety Board showed that the cargo inspection procedure is inconsistent with the execution of the task in practice: Firstly, there is a contradiction, because in accordance with legislation and procedures the hold must be ventilated before entry is permitted. However, the same legislation and procedures prohibit ventilation of the hold during the voyage. Secondly, in order to inspect cargo three different safety sheets and a permit-to-work must be read side by side so as to deduce the appropriate procedure to be followed. Thirdly, according to the procedure five individuals are required to take part in the activities that apply to entering an enclosed space, the ship had an eight-man crew. The cargo documents were in this case not coherent and clear. The documentation emphasized the chemical hazards more than it emphasized the hazard of oxygen depletion.

MV Hudsonborg.

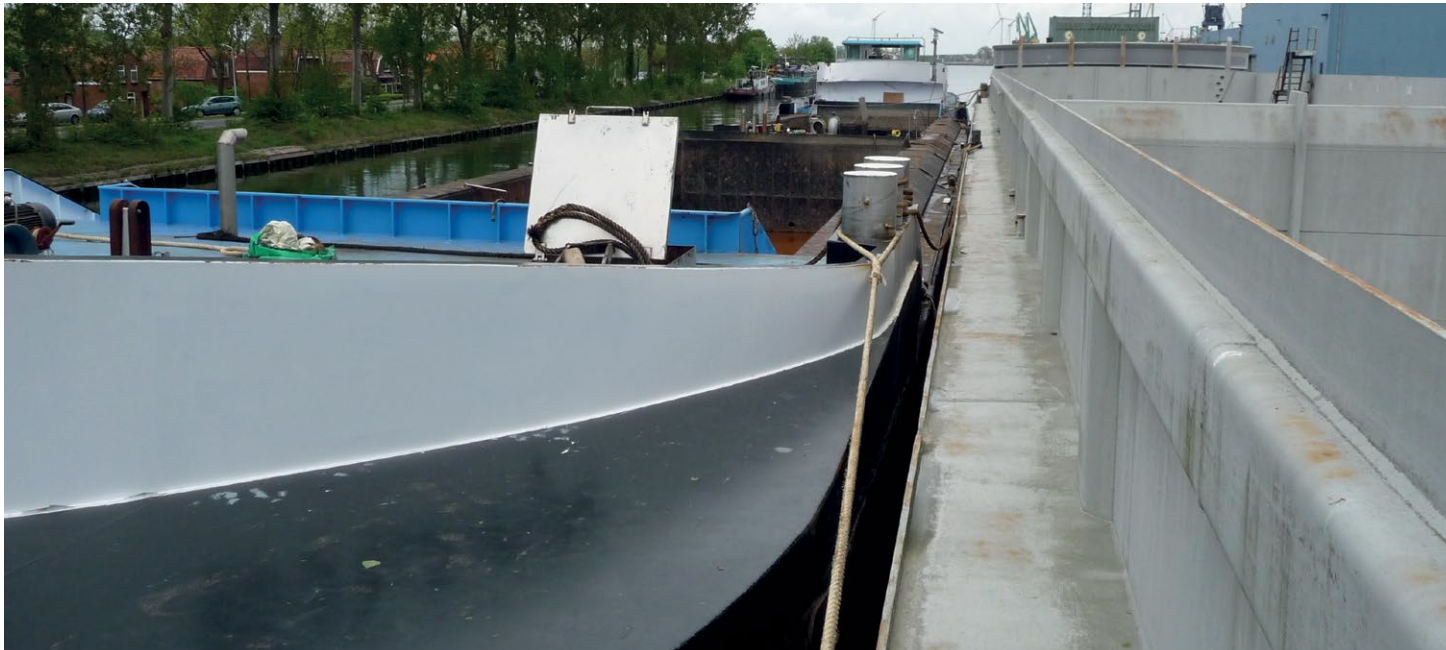
On Thursday evening the 5th February 2015, just before midnight, an inland dry cargo vessel capsized on the Westerschelde at the height of the village Hoofdplaat, between Breskens and Terneuzen. This incident occurred at the moment that the vessel was taken sand from a suction dredger.

When the vessel capsized, the vessel had 3 men onboard. A deckhand who was still on deck, jumped overboard. He was rescued by crewmen of the suction dredger, subsequently. The two other crewmembers went down with the ship. One of them was found alive on the Friday morning. The body of the third person washed ashore a couple of weeks later.

On the 30th March 2015, again the suction dredger had loaded a different dry cargo vessel with sand near Hoofdplaat at the Westerschelde. At 19.30 hours, this vessel capsized also due to a leakage on board of the ship. The two crewmembers were able to climb on board the suction dredger in time.

Dry cargo vessel.

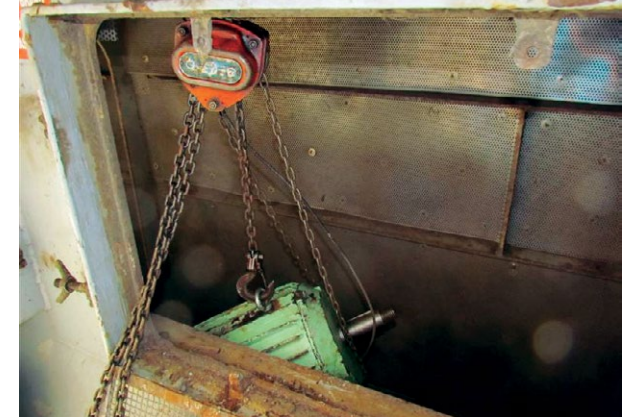
On the 23rd December 2014, during the installation of an electromotor on the Dutch flagged container vessel Maersk Kalmar, one of the fingers of the electrician got stuck between the motor and the fan duct. The electromotor was being hoisted down a fan duct, but got stuck during the hoisting maneuvers. The electrician and a cadet tried to push and pull the motor through the fan

Fan duct and electromotor. (Source: Maersk)

duct. When it came loose, the electrician's finger was hit by the motor and consequently broke despite the leather gloves the electrician was wearing at the time.

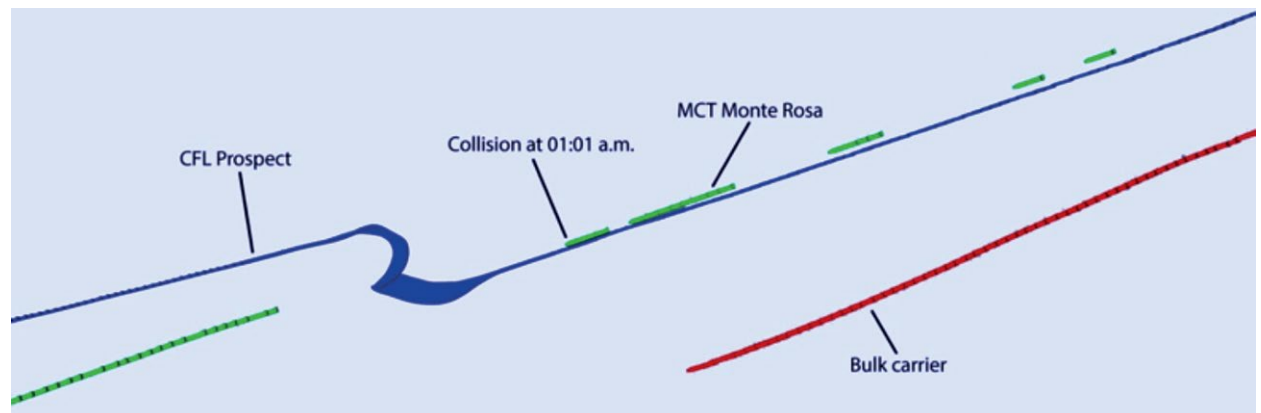
The MCT Monte Rosa and a bulk carrier were overtaking the CFL Prospect. While the other vessel was overtaking the CFL Prospect on port side, the MCT Monte Rosa collided with the vessel on the starboard aft side. The collision did not result in any casualties but minor damage was taken. Both vessels were able to continue their voyage.

Figure: Data points from collision between CFL Prospect and MCT Monte Rosa.
