INVESTIGATION OF A BROKEN HYDRAULIC SWIVEL

Customer : Dutch Safety Board
Anna van Saksenlaan 50
2593 HT Den Haag

Project Element : EAM017776P
Report : EAM017776-1 Rev. 2
Author : A. Bank
Date Report : March 2, 2016
Number of Pages : 20

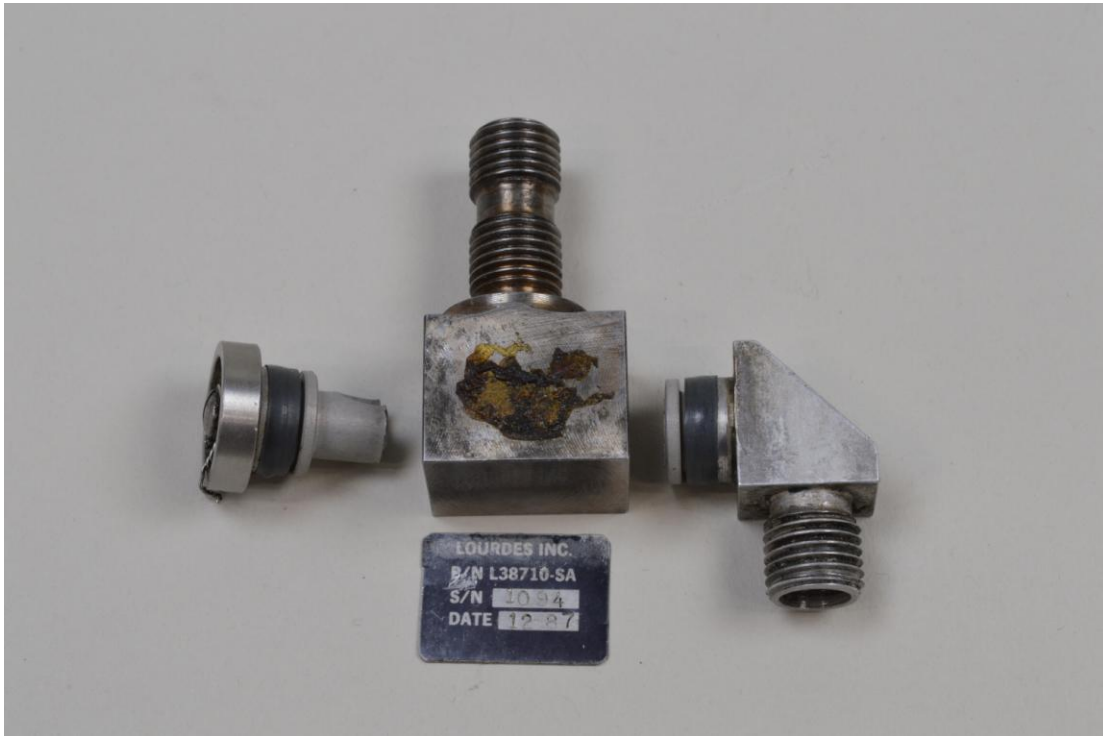
Figure 1. The broken swivel in the as received condition.

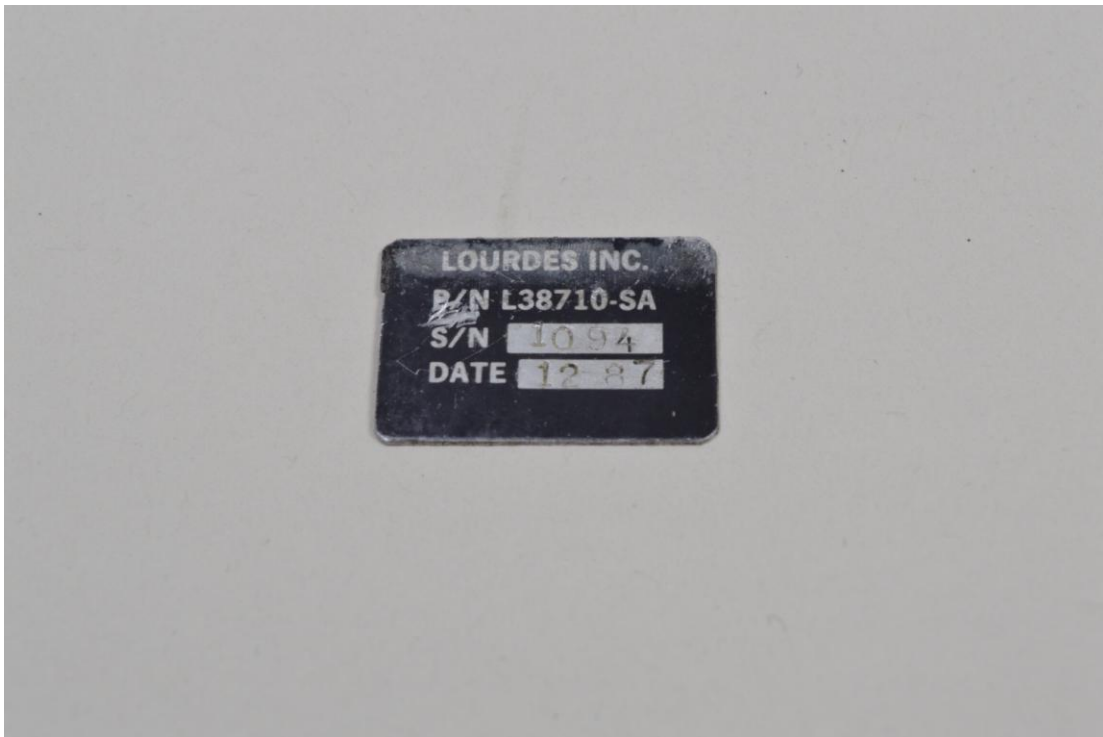
p/n : L387-10 SA
s/n : 1094
Date : 12-87

Figure 2. The identification plate of the swivel.

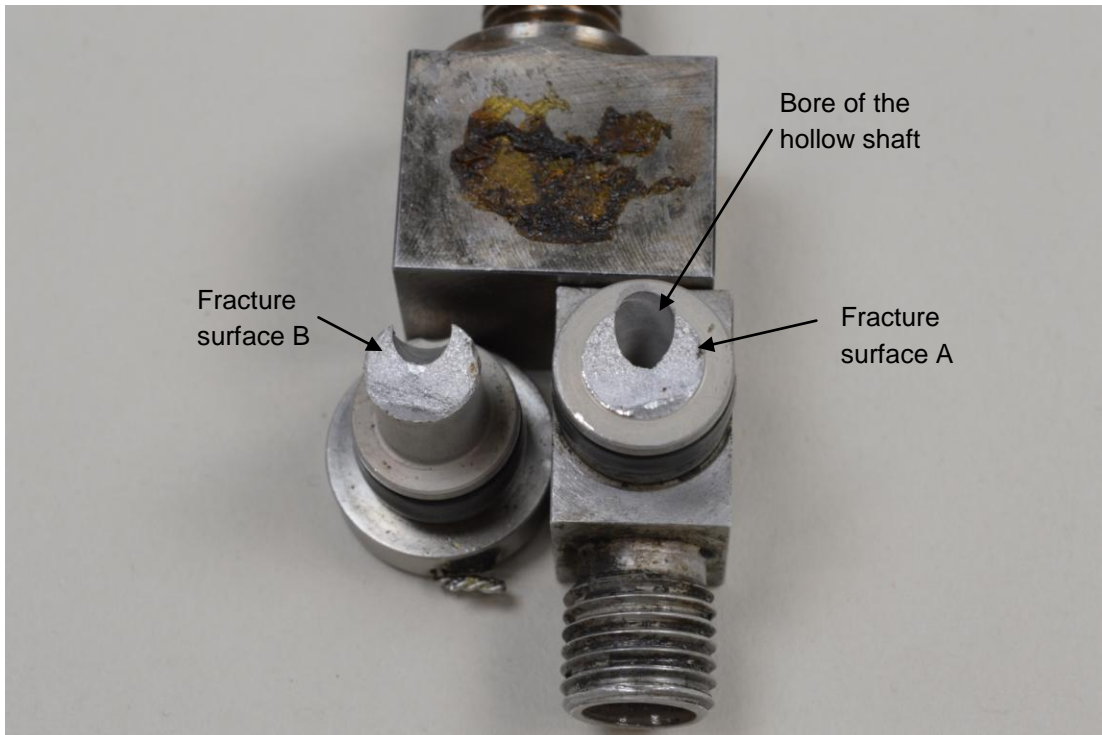
Through the block and the hollow shaft, the hydraulic oil flowed. The hollow shaft turned in the steel block of the swivel. The hollow shaft is broken at the radius from shaft to collar. At this position the bore of the shaft comes through the outer shaft diameter.

Figure 3. The two fracture surfaces (A and B). Bore of the hollow shaft.

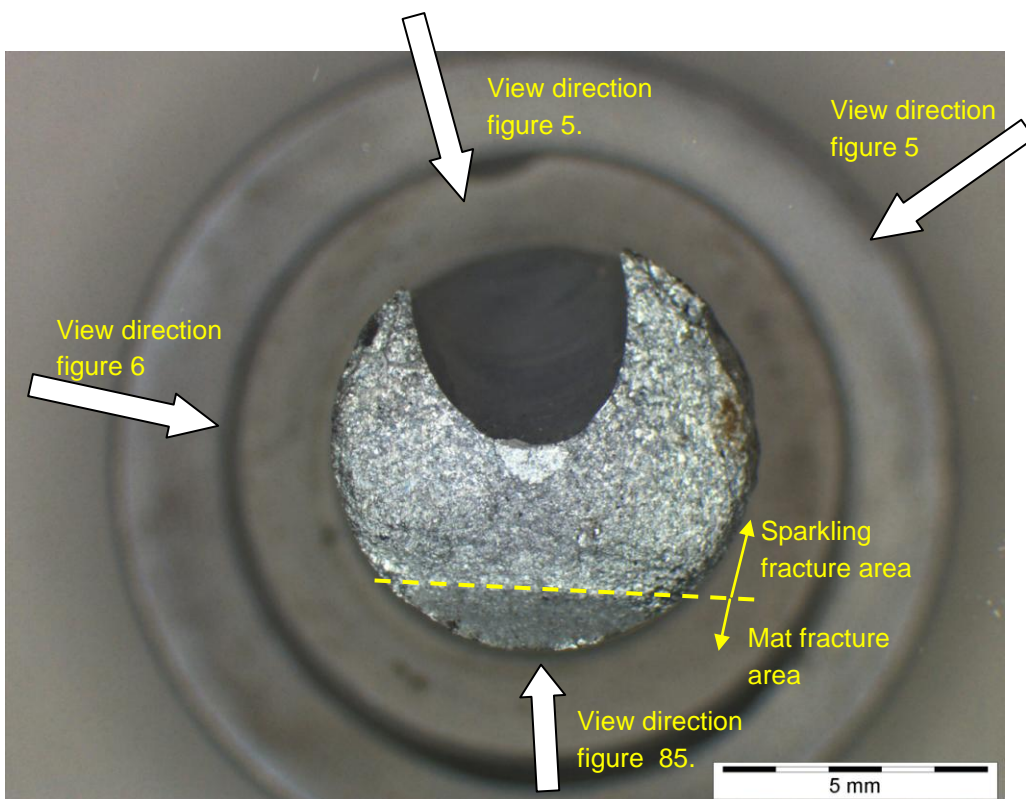
Figure 4. Fracture surface B.

The major part of the fracture surface exhibits a sparkling appearance. Opposite the hole of the bore the fracture surface shows a visually small area with a dull appearance. The figures **4** up to and including **11** show the fracture surface.

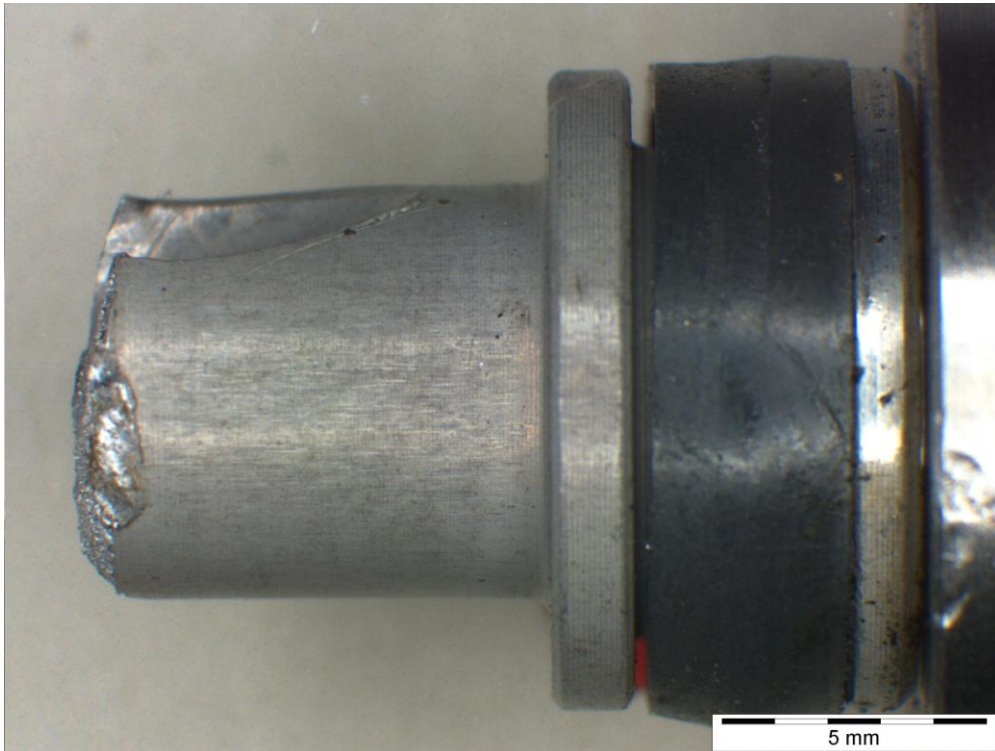
The fracture surface shows one position, which is mechanically damaged. The damage is only present on the fracture surface of the shaft part. At the fracture surface of the collar part the mechanical damage is not present.

Figure 5. Fracture part B; Side view. At the edge the fracture surface is mechanical damaged.

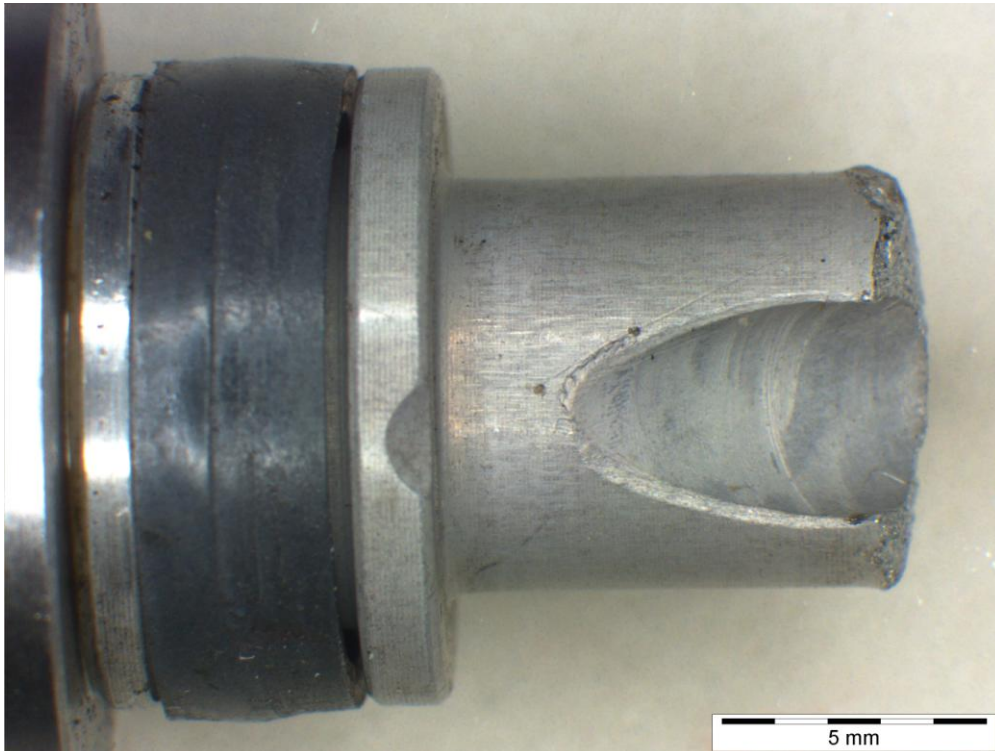
Figure 7. Fracture part B; Top view. The end of the bore is present in this shaft side.

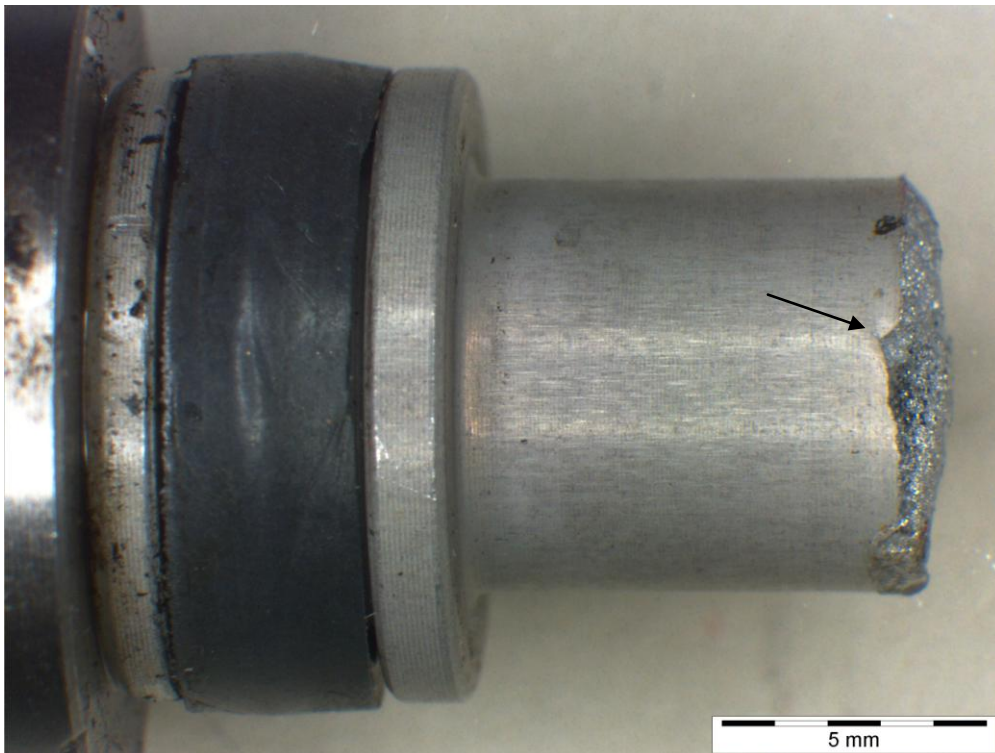
such as dimples and plastic deformed aluminum. These characteristics indicate that this area is the final fracture.

Figure 8. Fracture part B; Bottom view. The deformation from the final fracture is visible at the edge of the fracture surface (arrow).

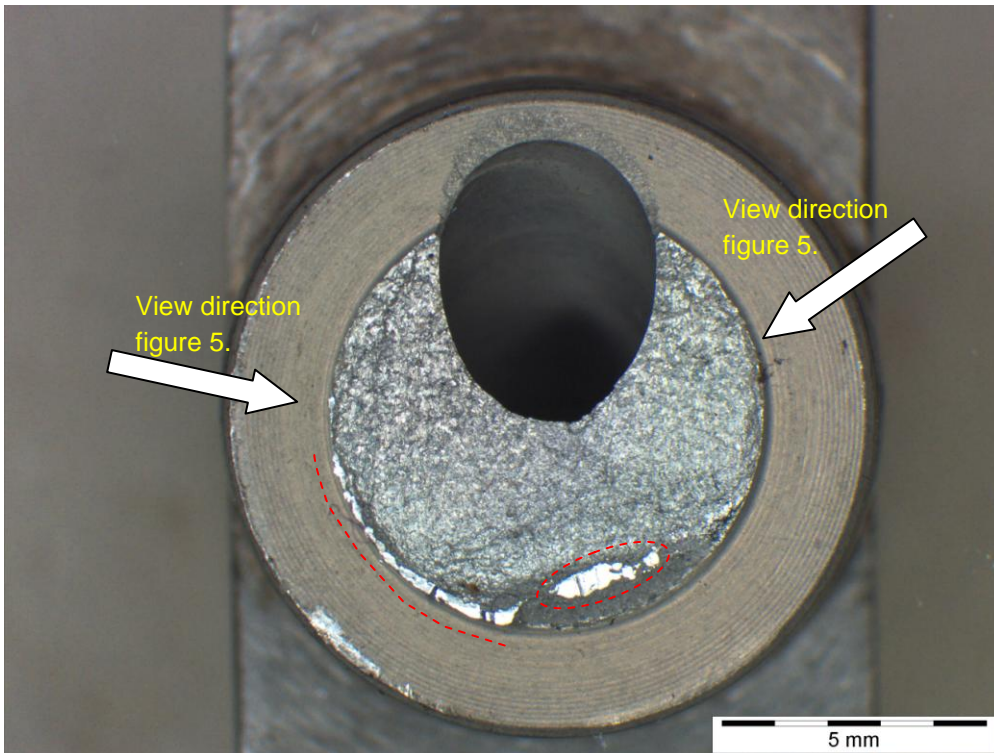
Figure 9. Fracture part A; The shaft is fractured in the radius from collar to shaft. The blinking areas (red markings) represents mechanical damaged fracture surface.

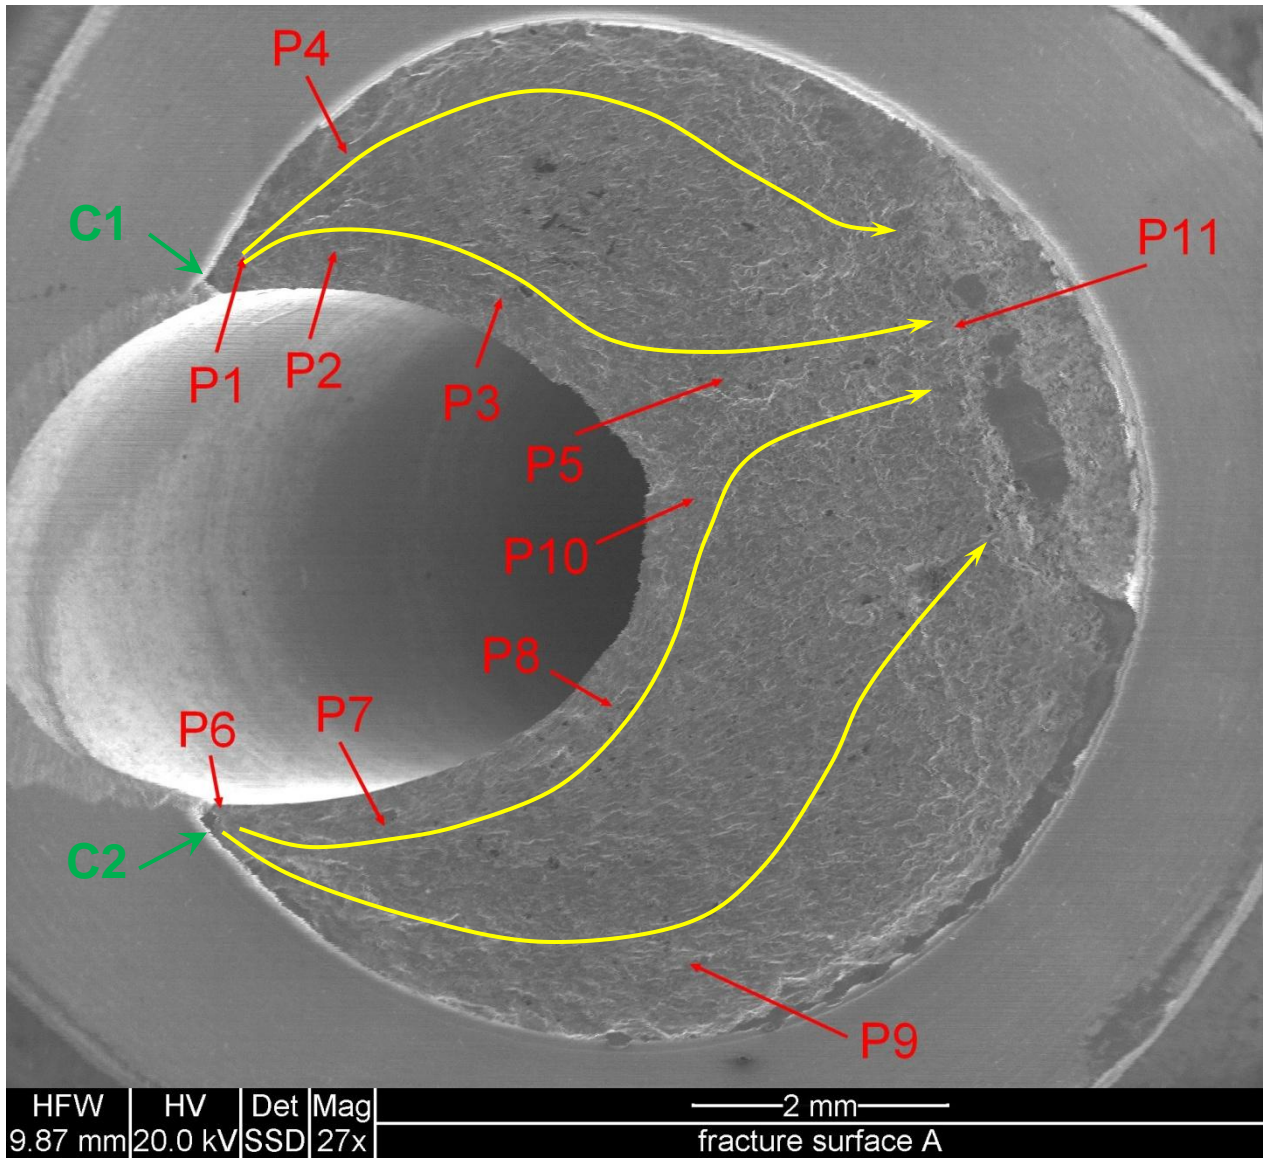
At the outer diameter (radius) where the bore comes through the shaft surface the striations are very difficult to reveal due to chemical attack of the aluminum. These two positions are pointed as C1 and C2 in figure 12. In the direction to the final fracture, more striations are clearly visible and the striation distance increase. In figure 12 the positions of the detailed investigated fracture surface are noted in red. The yellow lines in this figure indicate the crack grow direction from the corners C1 and C2 to the final fracture. The figures 13 up to and including 27 show the detailed investigated positions.

Element Amsterdam had investigated a broken swivel to determine the failure mechanism of a broken shaft from a hydraulic swivel. This swivel shaft is manufactured from aluminum. During the investigation, it was found that the shaft was broken due to fatigue. The fatigue is initiated in the radius between the shaft and collar where the bore of the shaft was come through the shaft surface. At the initiation positions, the striations were very slightly visible due to chemical attack of the aluminum. The outer shaft surface is not chemical attacked. This surface is protected by an anodizing layer. The fracture surface is completely unprotected after fracturing. Due to the absence of oxygen in the hydraulic oil, the aluminum at the fracture surface cannot passivate. This resulted in a high sensitivity for chemical attack of the aluminum.

The direction of the crack grow indicate that the fatigue is caused due to alternated tensile loads in the shaft. Indications of alternated torsion loads are not found.

Figure 12. Fracture surface B. The red markings represent detailed investigated positions. The yellow lines indicate the grow direction of the fracture. The fracture is initiated in at the two positions C1 and C2.

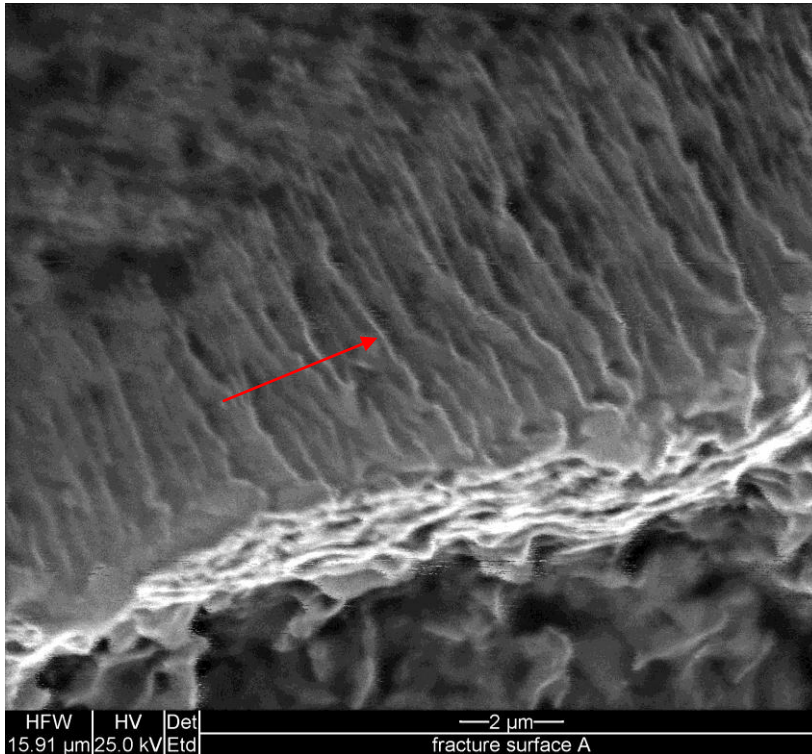
Figure 17. Position P1. Fatigue striations are present. The red arrow shows the crack growth direction.

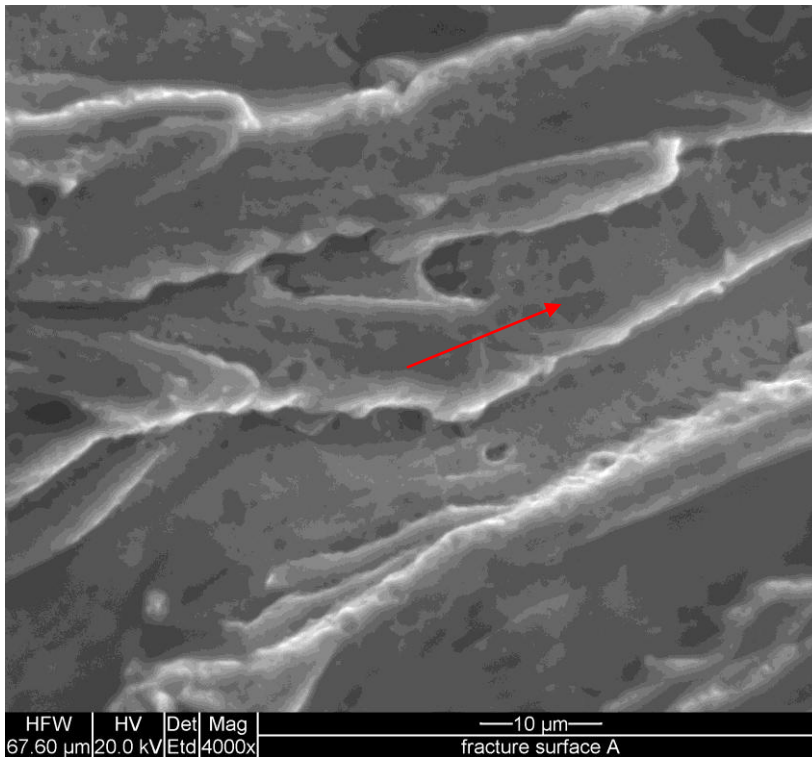
Figure 18. Position P2. Striations are not longer visible due chemical attack. The red arrow shows the crack growth direction.

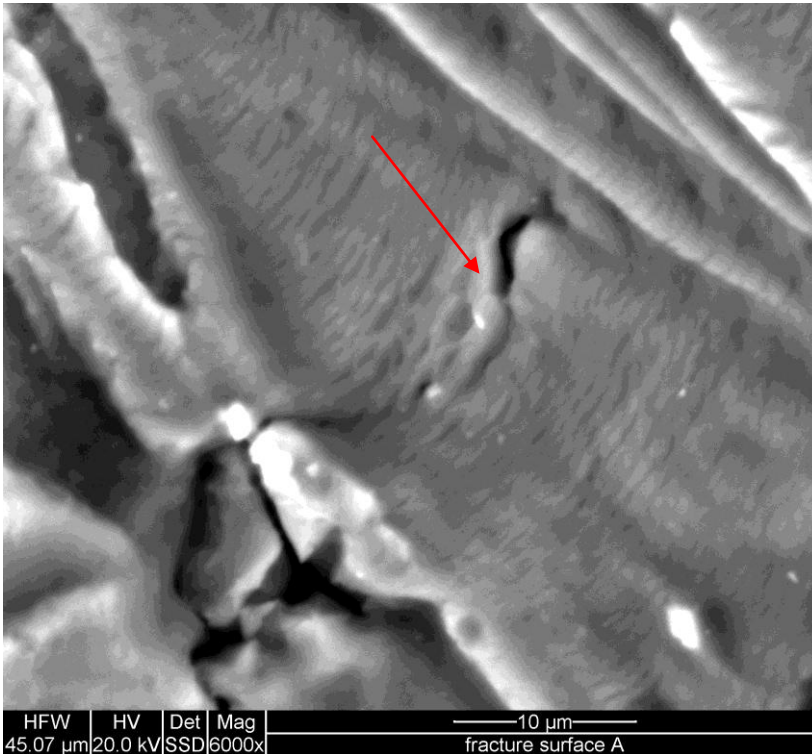
Figure 19. Position P3. Fatigue striations are present. The red arrow shows the crack growth direction.

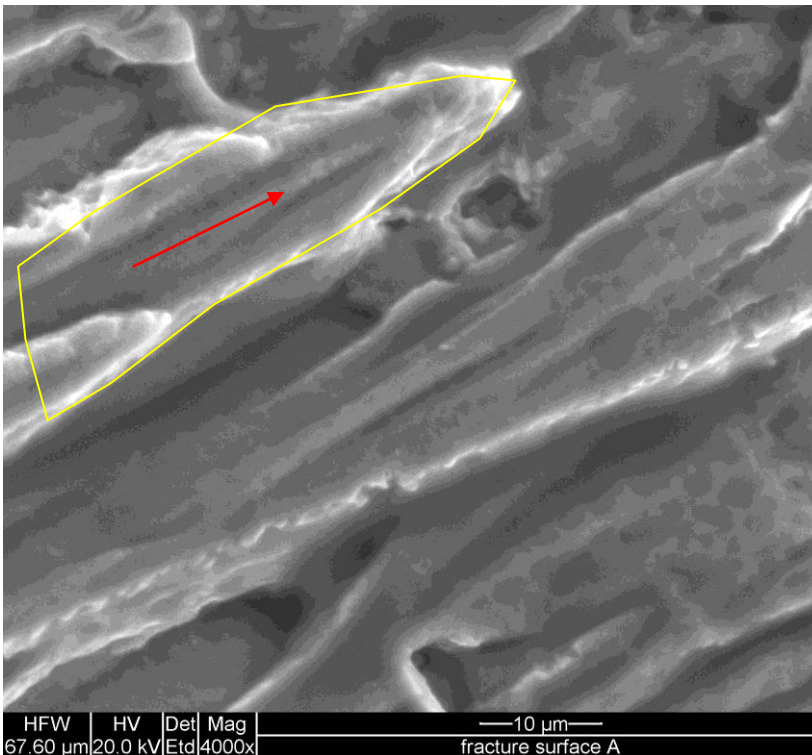
Figure 20. Position P4. Fatigue striations are hardly visible (yellow marking) due to chemical attack of the fracture surface.

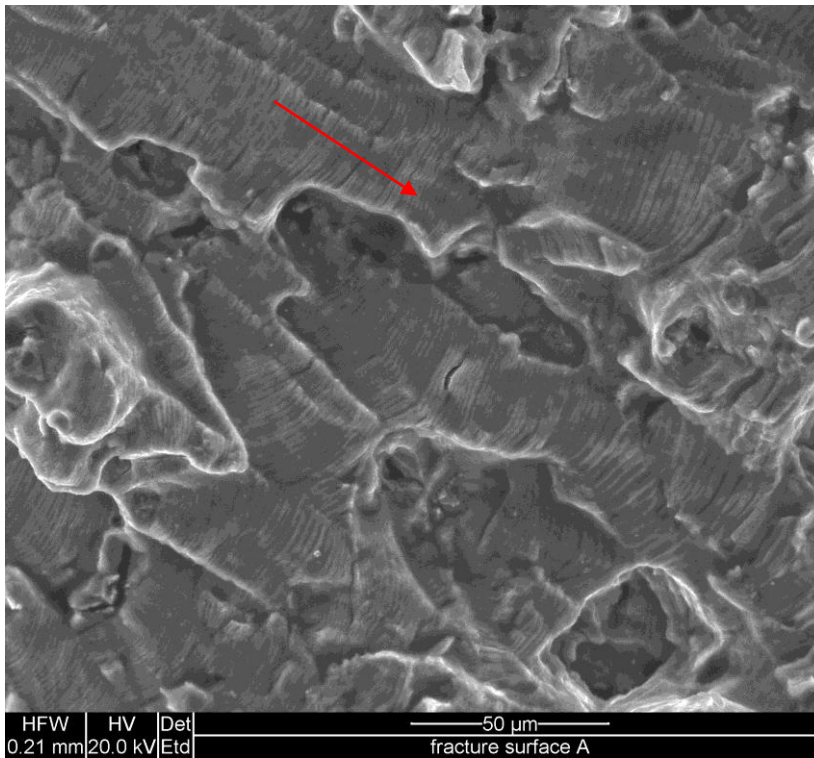
Figure 21. Position P5. Striations are clearly visible. The red arrow shows the crack growth direction.

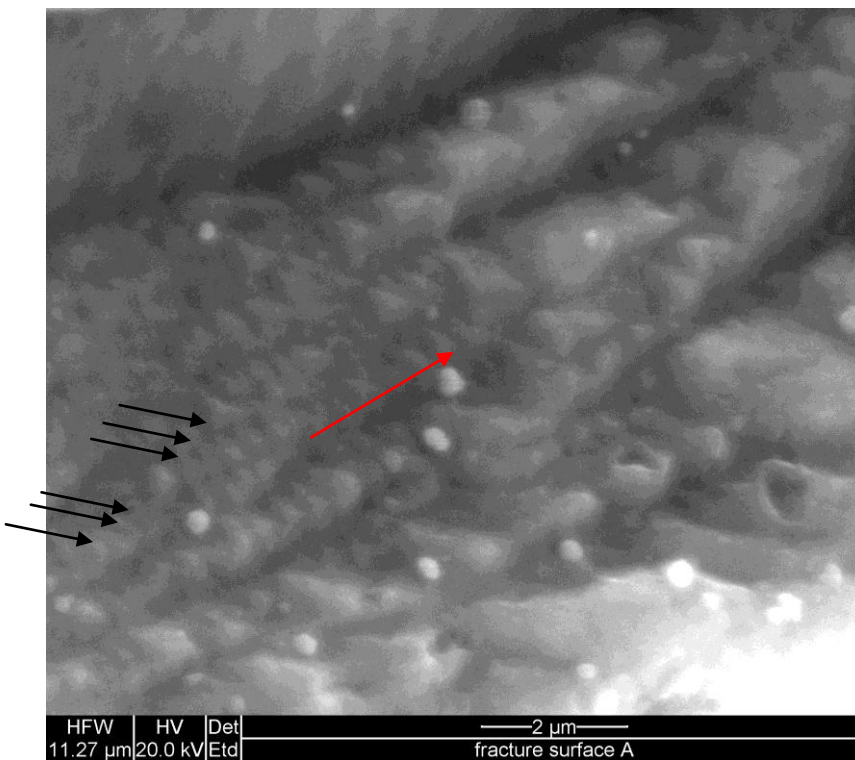
Figure 22. Position P6. Remnants of striations are present (black arrows pointed as example some striations). The red arrow shows the crack growth direction.

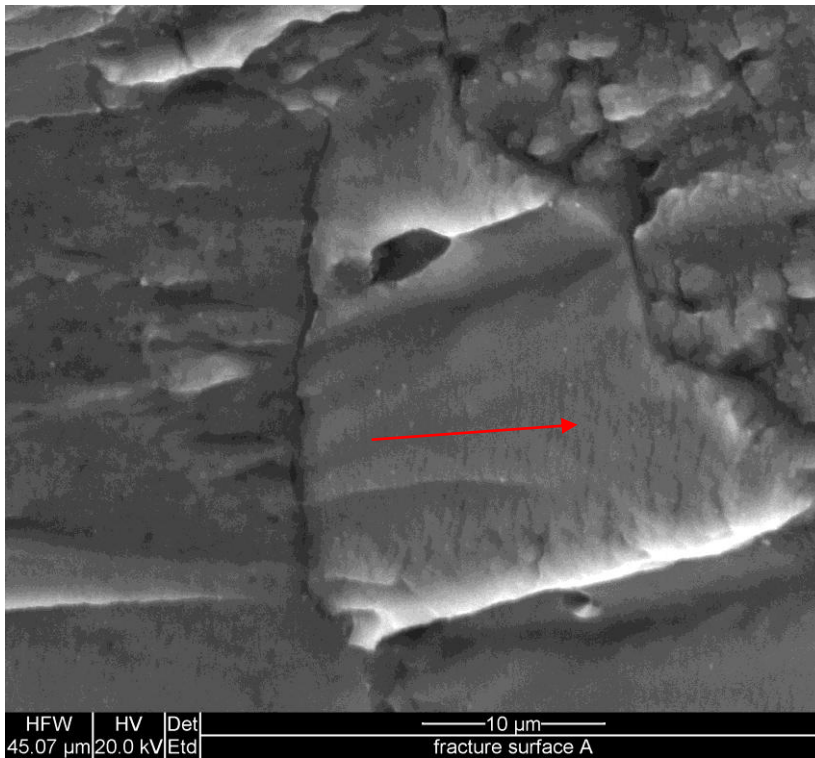
Figure 23. Position P7. Striations are present. The red arrow shows the crack growth direction.

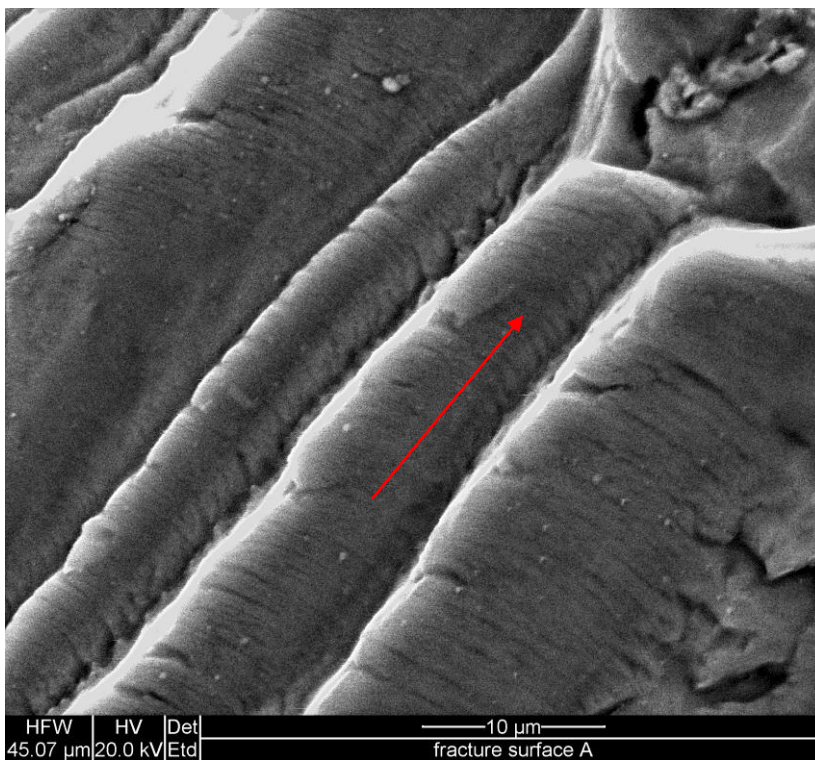
Figure 24. Position P8. Striations are present. The red arrow shows the crack growth direction.

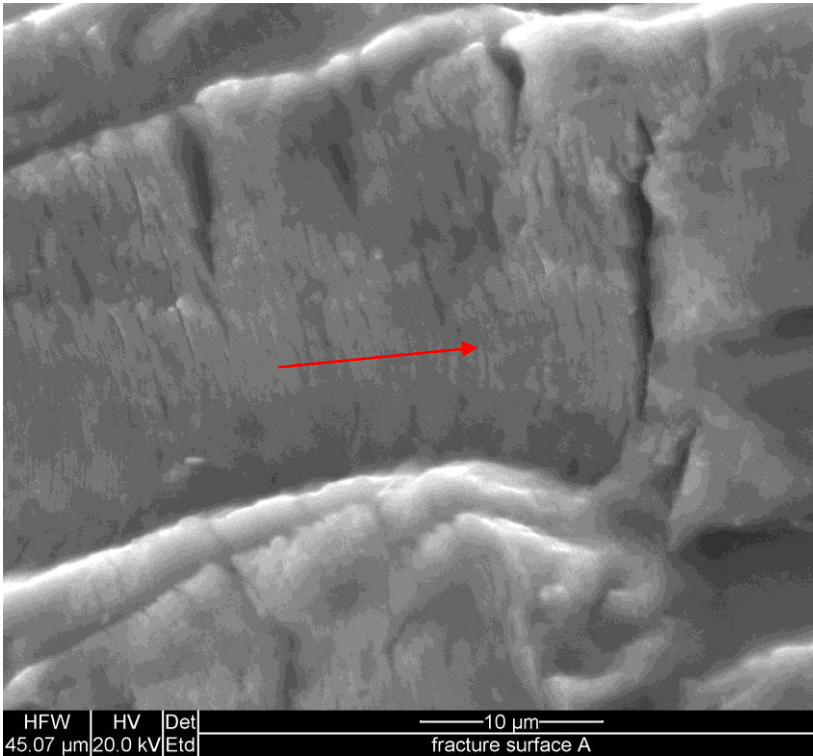
Figure 25. Position P9. Striations are present. The red arrow shows the crack growth direction.

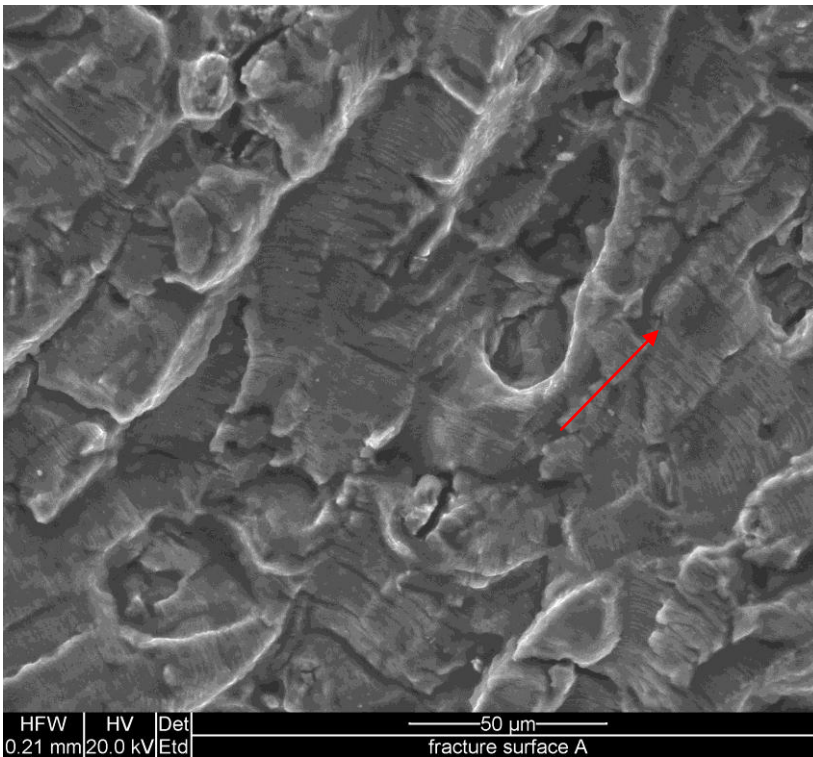
Figure 26. Position P10. Striations are present. The red arrow shows the crack growth direction.

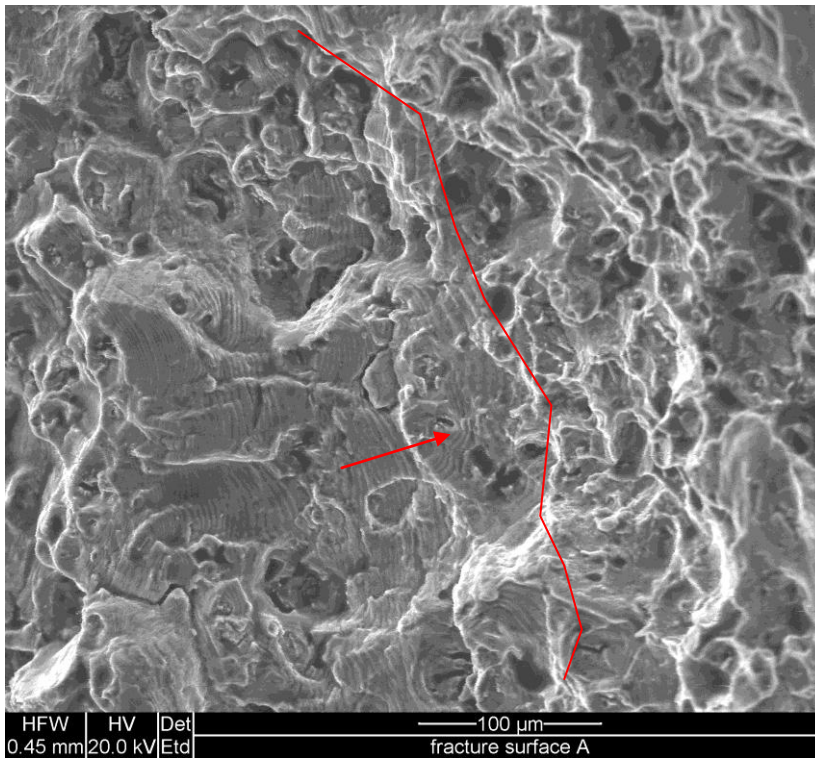
More close to the final fracture the striation distance has increased and more clearly visible due a decrease of the chemical attack. This proves that the fracture is time depended and is caused over a longer time.

Figure 27. Position P11. Striations are present (to the left of the red line). The red arrow shows the crack growth direction. To the right of the red line the final fracture is present.
