DUTCH  
SAFETY BOARD

# Fall from height

Fatal accident on board Fortunagracht -  
16 February 2018

*The Hague, July 2020*

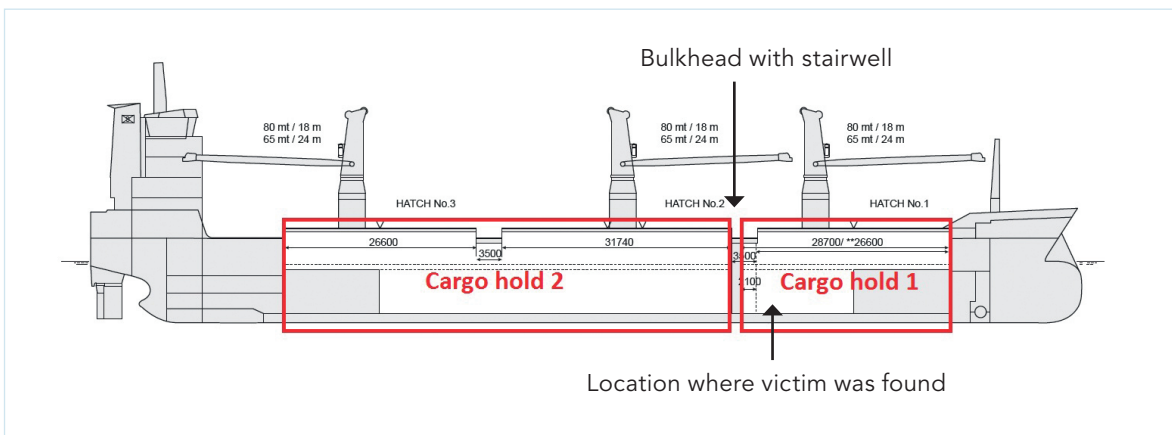
Figure 2: Hold layout on the Fortunagracht, showing the location where the victim was found (Source: Spliethoff)

Based on the location where the victim was found in the hold, it was determined that the deckhand had stepped through a doorway, or fallen through the door opening, at a position where the tweendecks were no longer present.

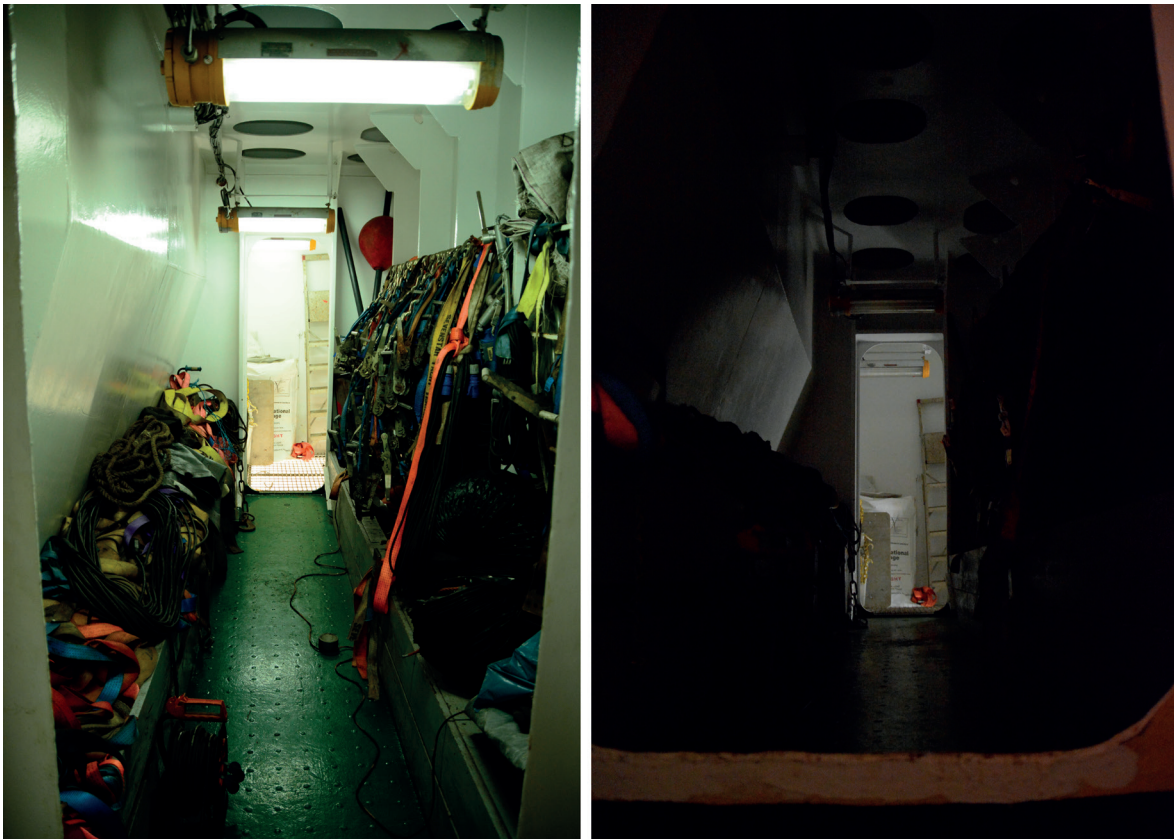
*Figure 6: Stairwell where the welding cables were located, with the lighting on/off. These photographs were taken during the visit to the Fortunagracht, two weeks following the accident. On that occasion, the conditions were different from the conditions on the day of the accident. These photographs therefore provide only an indication of the difference between the situation with the lighting switched on and off.*

Based on the interviews with the third engineer and the trainee engineer, it is for this reason that the deckhand (the subsequent victim) decided to make use of a (borrowed) torch. According to the third engineer and the trainee engineer, the light entering from outside in combination with the torch was sufficient to find the welding cables, but for work further down the stairs and in the hold, in their opinion, this was not sufficient (see also figure 6).

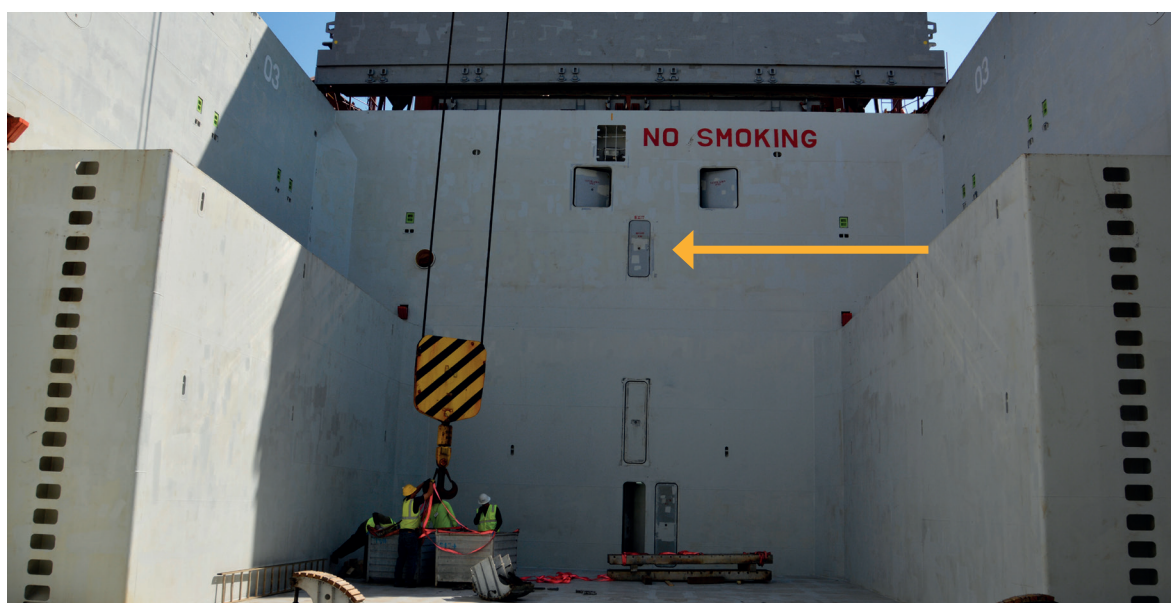
Figure 7: Comparable situation of the doors on the other side of the hold. The deckhand fell into the hold from a door opening at the height marked with the arrow.

The direct cause of the death of the deckhand was the fall from height into the hold, resulting in internal injuries. It is certain that the deckhand fell into the hold through one of the door openings behind which no tweendeck was present at the time. It is not possible to determine with certainty which door exactly and how he came to fall through one of these door openings. The statements and interviews were unable to clarify whether the doors in question were closed and locked<sup>9</sup>. It is certain that no warning or barrier had been applied to the door, clearly indicating that there was no tweendeck behind the door, with the resultant risk of falling.

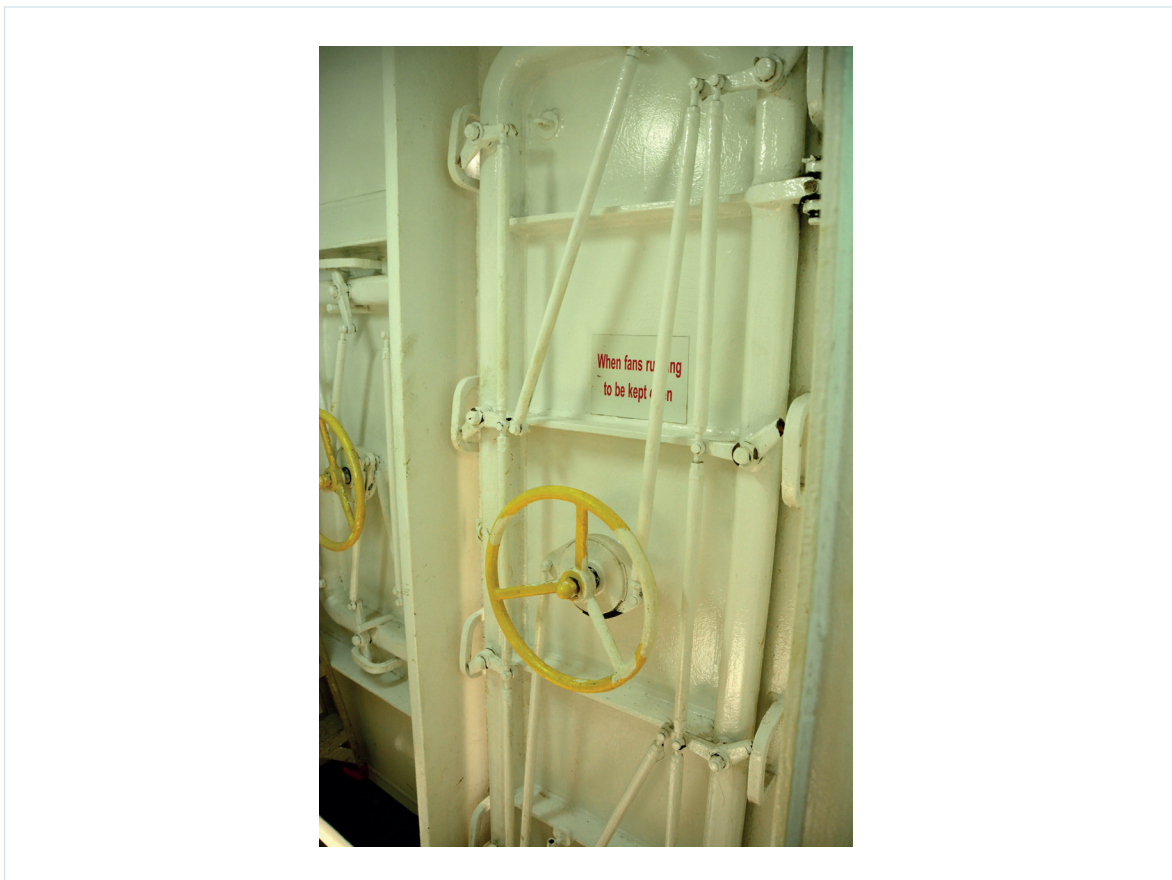
Figure 8: Door locking mechanism.

The Dutch Safety Board has been unable to determine whether the doors in the stairwell that give access to hold 1 were closed and locked after the tweendecks had been removed that morning. During the interviews held on board, contradictory information on these questions was provided by the interviewed crew members. It is however certain that no additional measures were taken to prevent entering a hold without tweendeck.
