DUTCH
SAFETY BOARD

Fall from height

Fatal accident on board the Zealand
Rotterdam - 23 November 2019

The Hague, March 2022

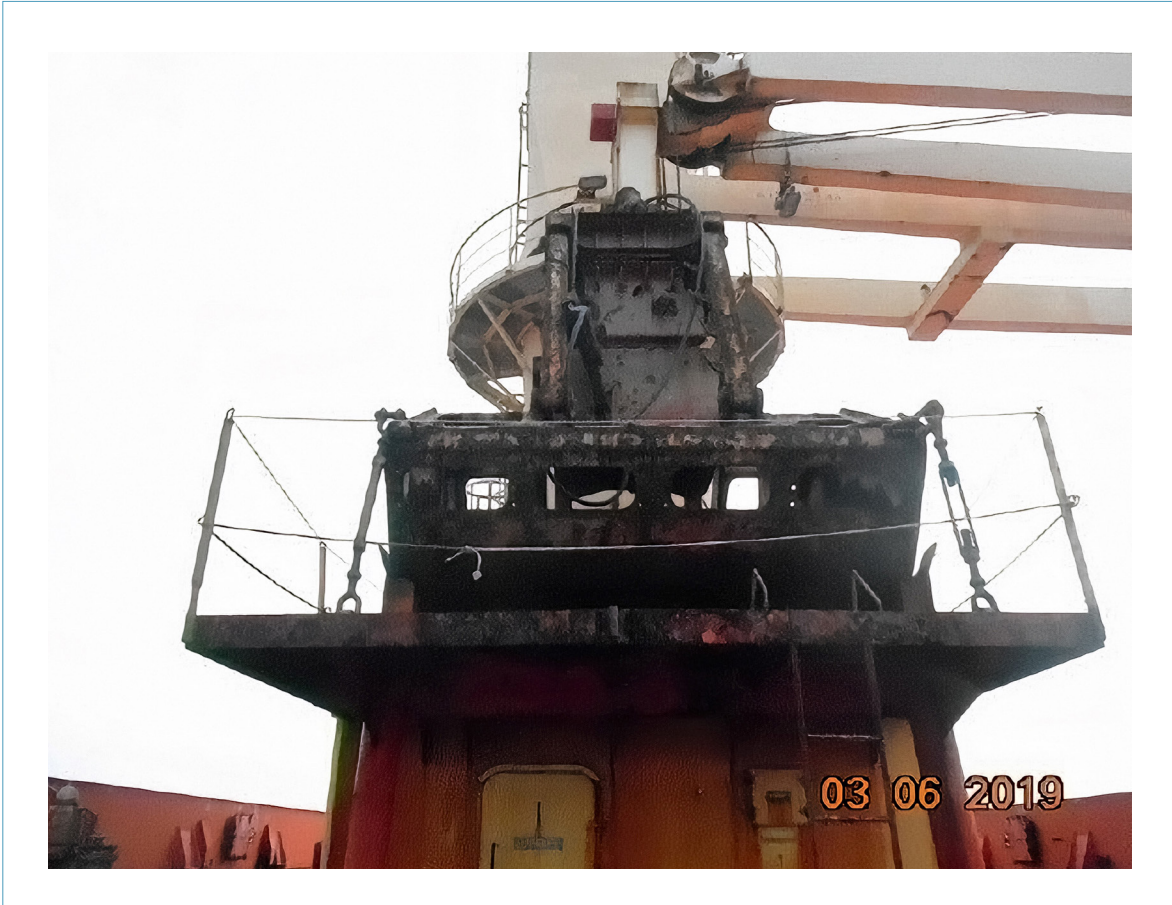
Figure 2: Grab on platform on board the Zeeland Rotterdam. (Source: Q-Shipping)

Part of the preparation for unloading was the fitting of the grabs on the four ship's cranes. The grab involved in the occurrence was placed on a platform that protruded two and a half metres above the deck. The top of the grab to which the crane hook had to be attached protruded over six and a half metres above the deck.

At that moment, the lifting block on the crane made a sudden swinging motion, colliding with the AB. The crew member then fell over backwards and landed on the deck below, on his head. During the investigation, it was not possible to determine with certainty the cause of the sudden swinging of the lifting block.

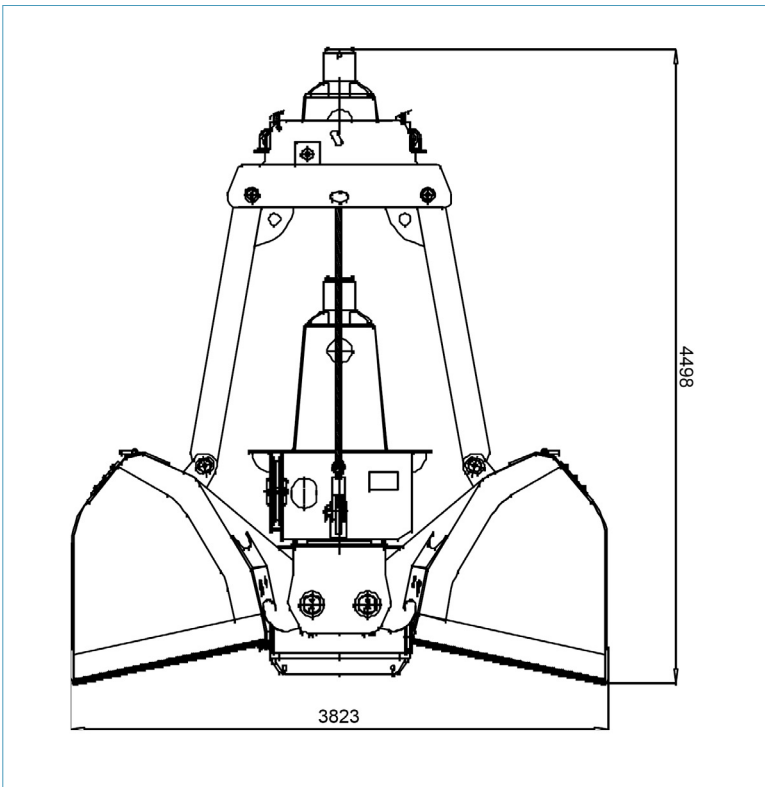
Figure 3: Diagrammatic representation of the grab with dimensions in millimetres. (Source: User manual radio remote control - Q-Shipping)

The ring from which the grab is suspended from the crane could be lowered sufficiently that it could be reached from the platform. This would have removed the risk of the crew member falling from the grab, at the source. The Safety Board was unable to determine clearly why the procedure on board was such that it became necessary to climb onto the grab.
