ONDERZOEKRAAD
VOOR VEILIGHEID

Fatal accident due to breaking of stern line

Lessons to be learned about
safe working and supervision

Damsterdijk, 2 October 2019

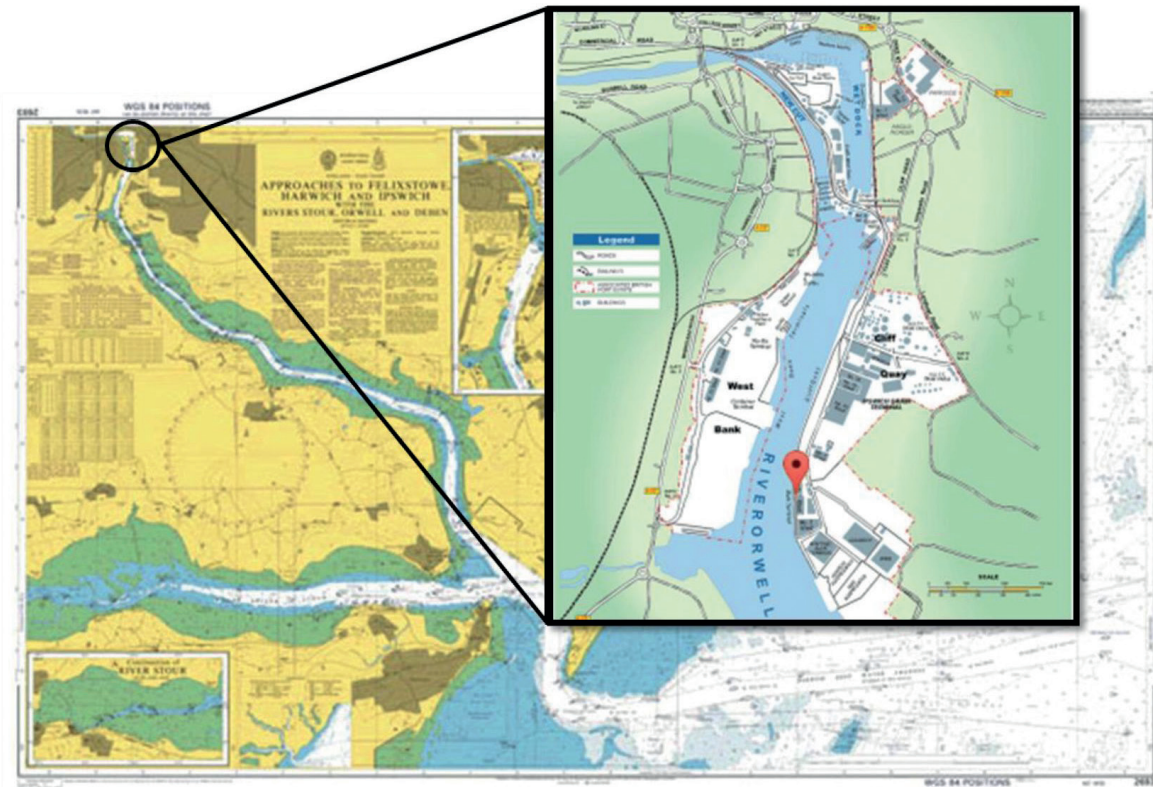
Figure 1: Berth of the Damsterdijk in the port of Ipswich, where the incident took place.
(Source: Associated British Ports)

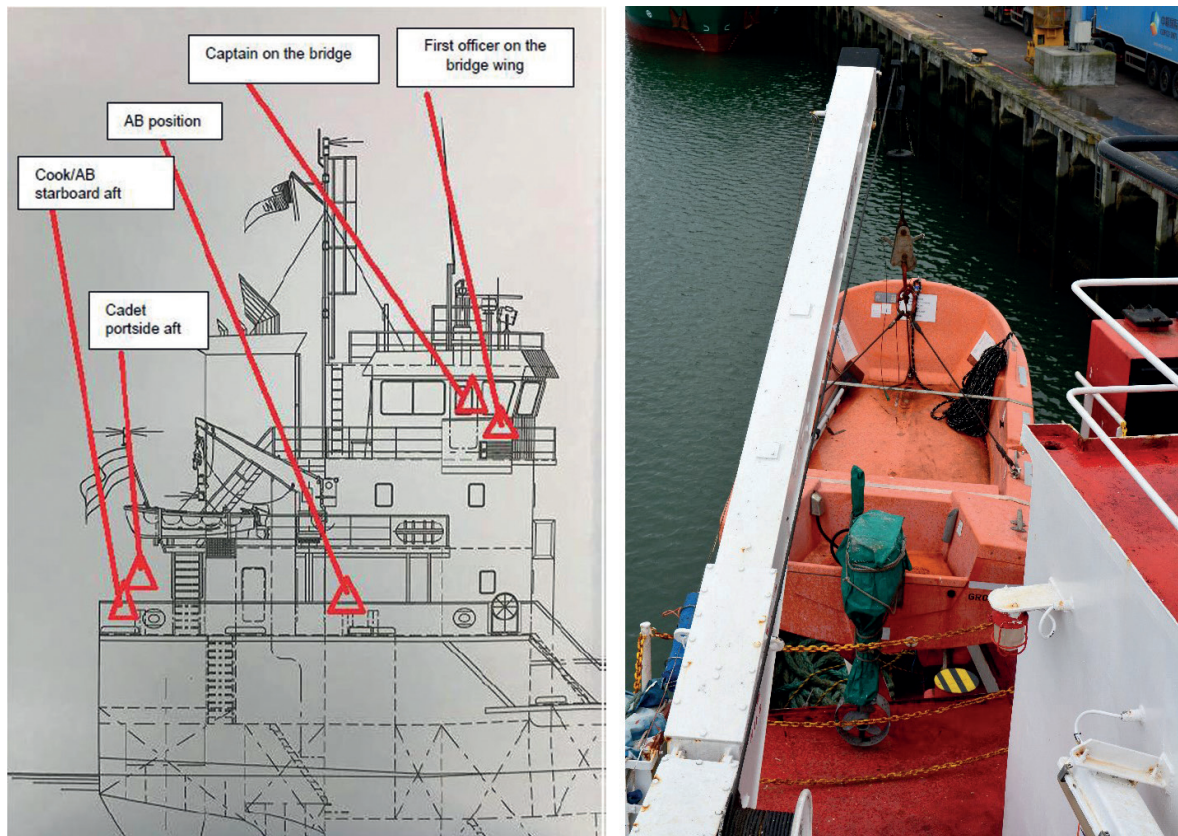
Figure 2 & 3: On the left the position of the crew on the bridge and on the aft deck and on the right the view of the first officer over the aft deck. This view was blocked by the superstructure and the ship's boat. (Source: Shipping Company Groningen)

The cook/AB was not issued with a walkie-talkie and as a result was unable to hear the new instruction from the captain. Because the AB was carrying out his task near the aft spring, at that moment there was no overview of the aft deck and no supervision of the work.

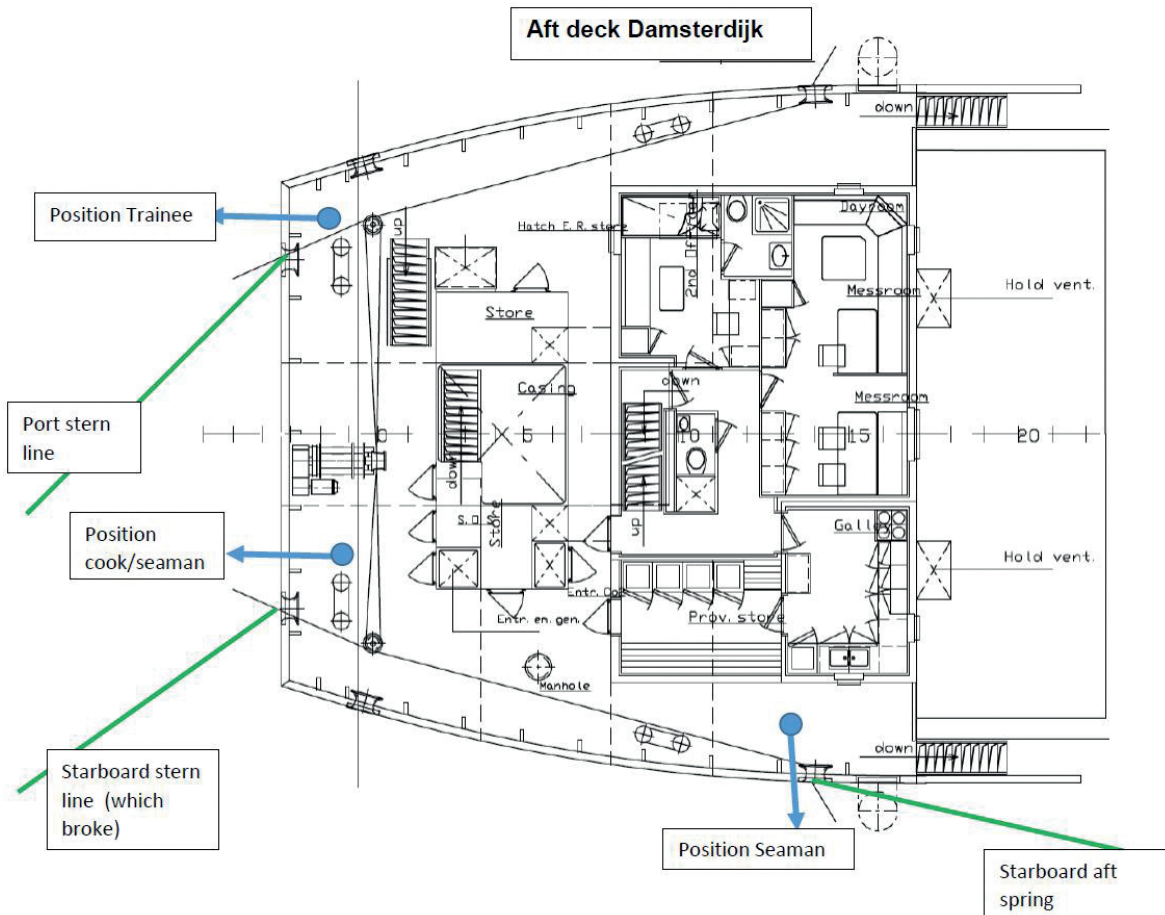
The three crew members on the aft deck stood relatively close together, but were not in each other's field of vision. Due to the background noise caused by the engines, they were also not within hearing distance of each other. Each of them was responsible for releasing and re-securing a mooring line; the cook/AB was responsible for the stern line on the starboard side; the cadet for the stern line on the port side; and the AB for the aft spring on the starboard side. The mooring lines were not coiled around the storage drums during the manoeuvre but were placed loose on deck, because of the short distance to be covered during the berth change.

Figure 5: Positions of crew members and mooring lines on the aft deck. (Source: Shipping Company Groningen)

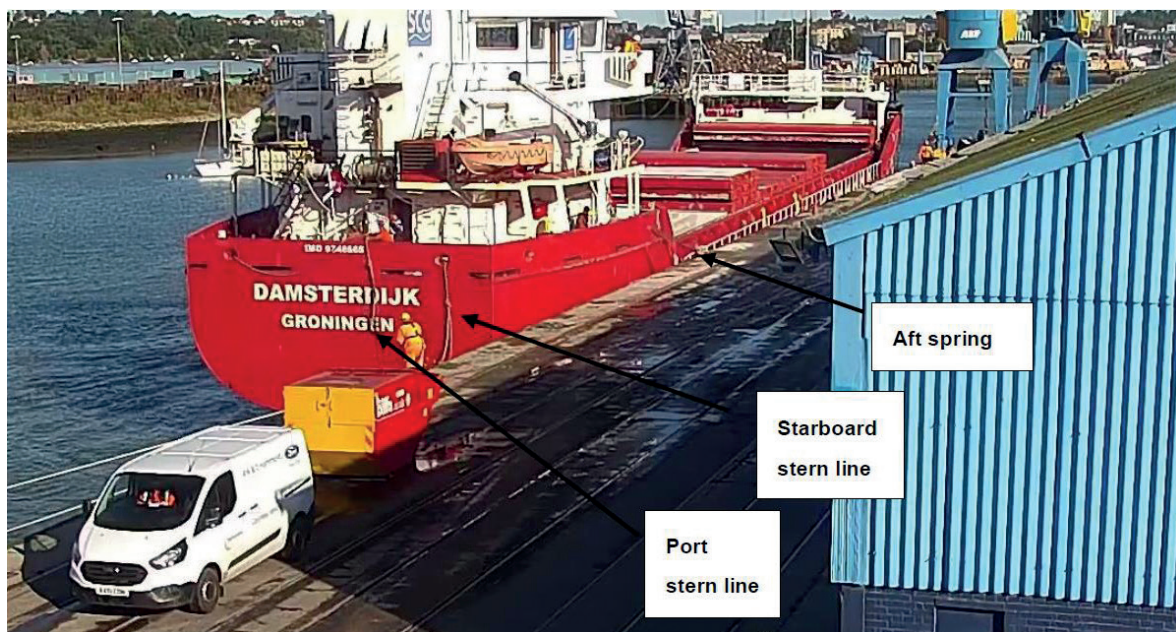
The CCTV images show that the cook/AB was concentrating on the port stern line and on the cadet, which meant that he had his back turned to his own workstation. At that same moment, behind him, the starboard stern line entered the water, at high speed.

Figure 6: CCTV image at 09.42 hours showing the aft deck of the Damsterdijk from which at that moment two stern lines were being paid out, with on the starboard side the aft spring being slackened. (Source: Associated British Ports)

The fact that both stern lines went overboard simultaneously, and immediately thereafter ended up in the water at high speed, is an unusual situation that must not be allowed to occur in connection with the risk of the mooring lines becoming entangled in the propeller. The images show clearly that in both cases, too long a length of mooring line had been released too quickly. Because the mooring lines were lying loose on deck, they were able to run out unhindered.

The direct cause of the accident was the entanglement of the stern line in the propeller, which caused the line to come under tension and subsequently break. This was caused by a lack of clear communication. The cook/AB was not aware that the ship was not yet in position. The two stern lines were paid out without the captain's command and at the same moment that the vessel once again started moving backwards.
