# Fatal accident in cargo tank of chemical tanker

Lessons learned from the occurrence on  
board the NCC SAFA

*The Hague, July 2023*

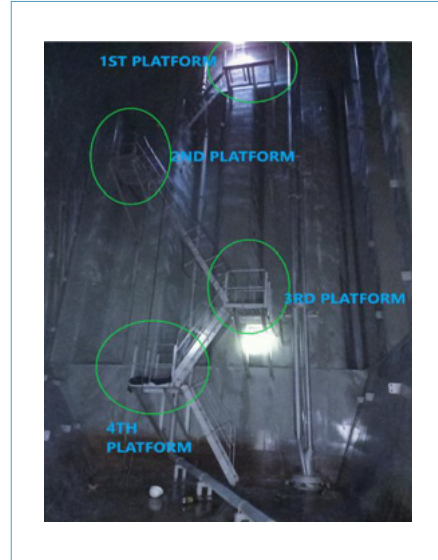
Figure 3: Inside of tank 1S.  
(Source: Mideast Ship Management)

The captain reached the tank opening and looked in from above. He saw the AB lying on the second platform in the tank and immediately sounded the alarm. The rescue team, made up of crew members from the vessel, immediately entered the tank equipped with the appropriate rescue gear. The AB was carried onto the deck by the rescue team, where oxygen was administered. He was subsequently transported to hospital in Alkmaar (NL) by SAR helicopter. On arrival, he was admitted to intensive care with serious injuries.

The first officer was discovered at the bottom of the tank on the fourth and final platform, from where he was carried to the ship's deck by the rescue team. Investigation revealed that the first officer had probably entered the tank after the AB and, just like the AB, had become unwell due to a lack of oxygen. As a result, he fell into the 18-metre-deep tank. As a result of the fall, he suffered such severe injuries that the attempts to resuscitate him, on location, proved unsuccessful.

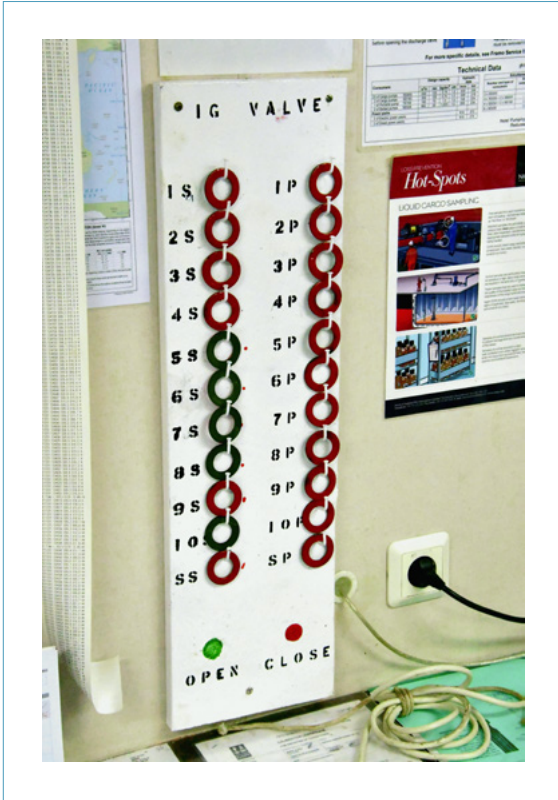
The inert gas (the nitrogen) on board the tanker is produced in the engine room, and production is supervised and operated from the cargo control room. Using two pumps, the inert gas is pumped through a central pipeline that runs from the rear of the vessel to the front, with a branch to each individual cargo tank. After each branch, a butterfly valve is fitted, which can be manually opened and closed by the crew members. When a valve is opened or closed, the cargo control room is duly notified by the crew member, via the walkie-talkie. On a marker board in the control room, the colour of the indicator is then manually changed, making it possible to see which valves are open and which are closed. Figure 5 shows the position of the valves on the marker board on the day following the accident. The red ring indicates that the inert gas valve to tank 1S is closed. This matches the information obtained during the various interviews. There is no other signal or marker that indicates whether the valves in this system are open or closed, or whether there is inert gas in the pipelines.

Figure 5: Marker board inert gas valves.

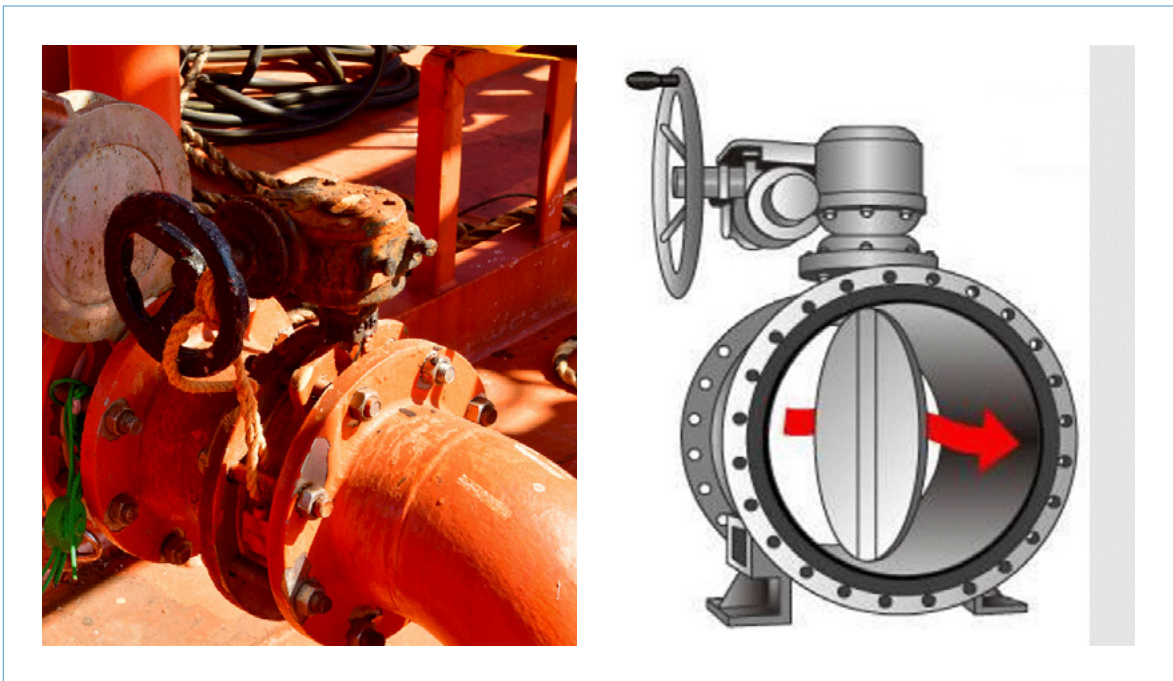
Two days after the incident, the inert gas valve was removed from tank 1S for inspection. The investigation revealed that this valve no longer closed correctly, while it appeared to be fully closed off. Due to damage to the worm gear (see figure 7), the disk remained open after closing, leaving a gap of approximately one centimetre.

Figure 6: Valve in original position on board and illustration of the inner workings of the butterfly valve.

The leaking valve allowed the nitrogen with which the front tank was being filled at the time of the incident to unintentionally also enter tank 1S. The preparation of the tanks for the new cargo by filling them with inert gas, had been started one day prior to the incident. As a result, the concentration of oxygen in tank 1S was also gradually reduced. An oxygen concentration of between 19 vol% and 21 vol% is safe. In an atmosphere with less than 19 vol%, there is a lack of oxygen, and at less than 18 vol% oxygen, the oxygen level is insufficient (see table 2).

1. Provide an inert gas system constructed so that there are multiple safety barriers. This should include a control system for the use of inert gas, whose capabilities and limitations are known to the entire crew.

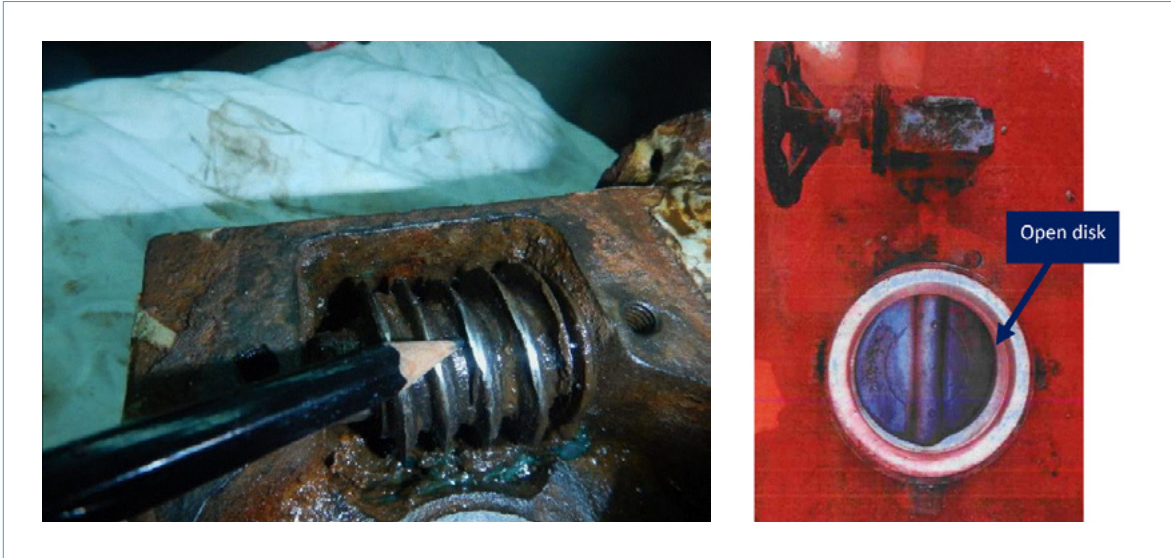
Figure 7: On the left, damaged worm gear, and on the right the disk still open in closed position.

The safety of the crew and protection against hazardous gas mixtures caused by an inert gas system are dependent on the correct functioning and maintenance of the entire system. It is above all important to ensure that valves are functioning correctly. The maintenance protocol followed on board was limited to a visual inspection of part of the valve, as a result of which the damage to the worm gear went unnoticed.

- The limited maintenance protocol consisted of lubrication and a visual inspection of the free movement of the hand wheel, which meant that the damaged internal part of the valve went unnoticed.
- Safety-critical components such as valves were not subject to a structural overhaul cycle.

1. During inspection and maintenance, the crew must be mindful of possible failure of the inert gas system due to damage. Ensure that all safety-critical components are identified and adjust the maintenance protocol accordingly. A maintenance protocol limited to only lubrication and visual inspection of part of a valve gives an unwarranted sense of being safe.
2. Crew should be able to speak up and stop work if another crew member (including the captain) does not follow a procedure. Provide a working environment where crew feel safe to do so.
3. Targeted training and education ensure that procedures can be followed and impulsive actions, where people put themselves in mortal danger, are prevented.
