DUTCH  
SAFETY BOARD

# Fatal fire in a block of flats in Arnhem

Lessons for fire safety

*The Hague, September 2021*

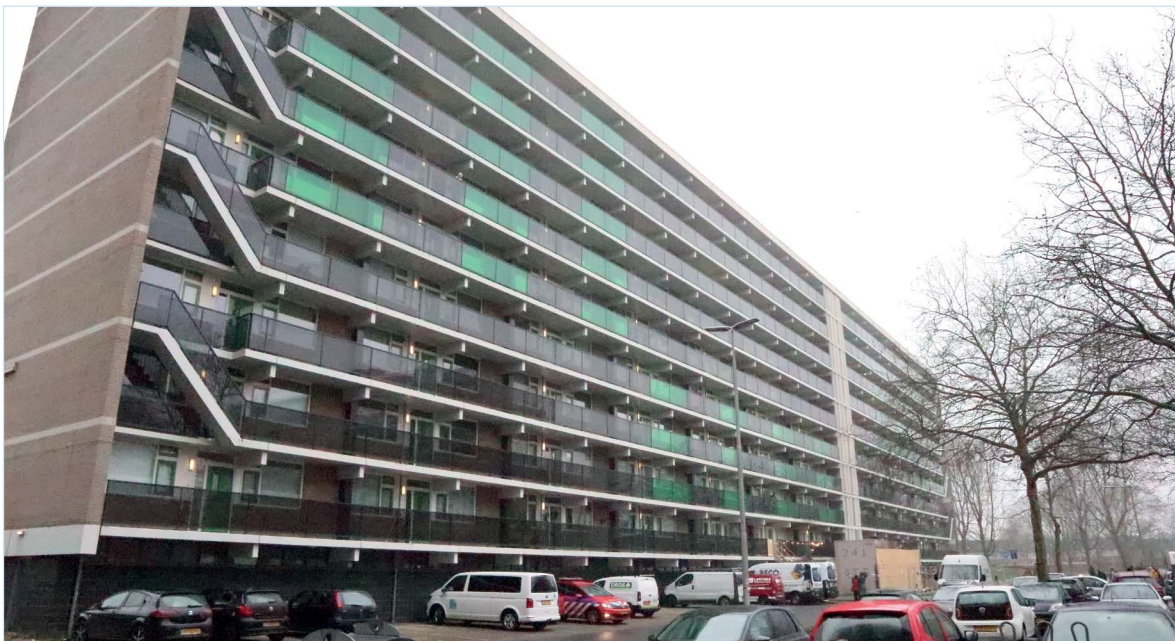
Figure 1: Block of flats where the fire raged on New Year's Day 2020. (Source: Dutch Safety Board)

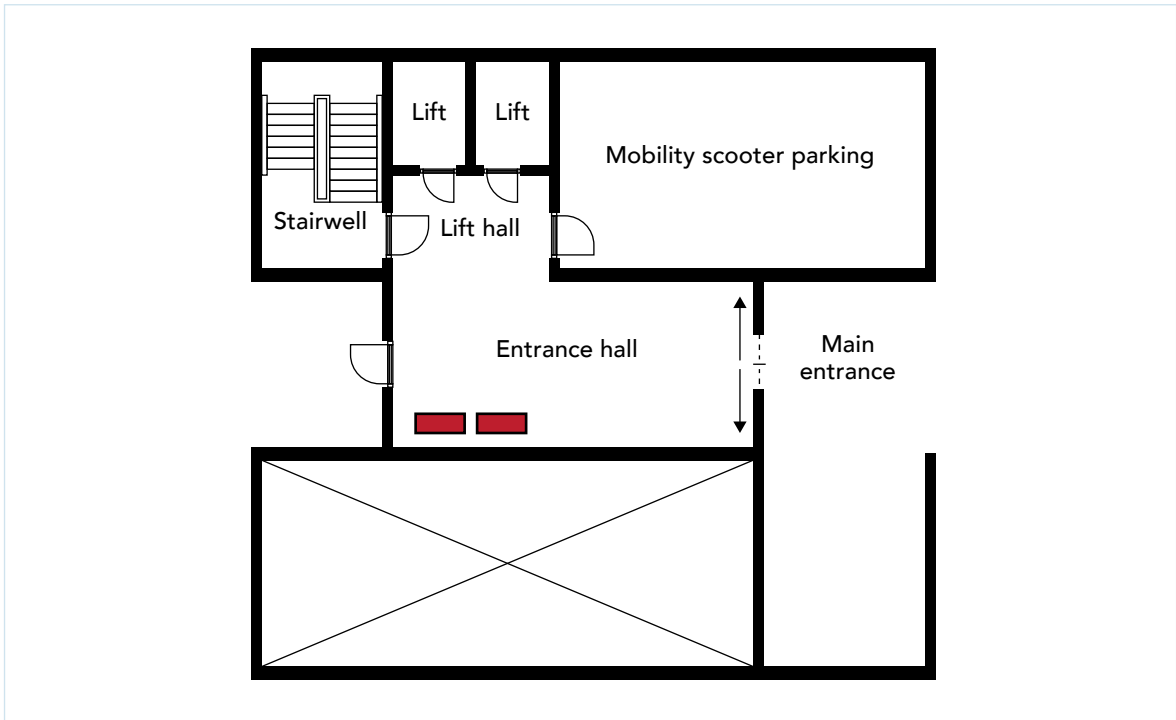
Figure 5: Schematic floor plan of the entrance hall to the flat showing the sofa marked in red.

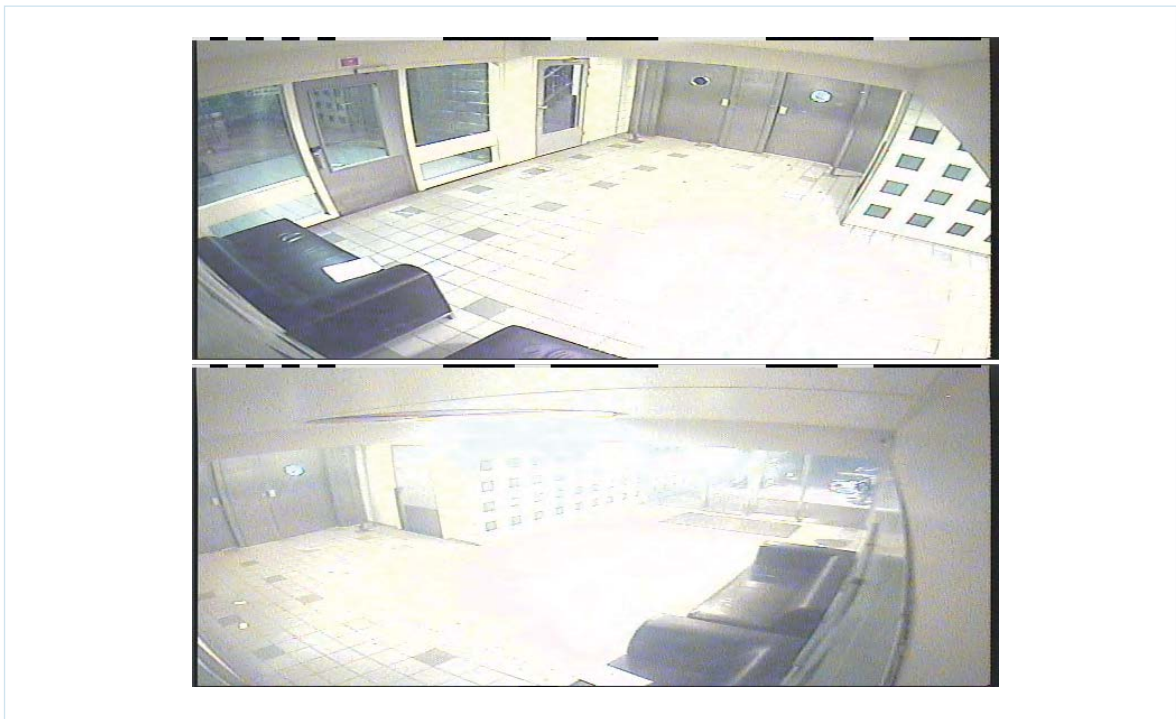
Figure 6 below shows that the sofa had a black, imitation leather covering. This type of sofa is generally filled with plastic foam.

Figure 6: Stills of camera images showing both sofa sections opposite the lift doors. The sheet of paper is placed on the left-hand sofa.

With regard to all these three aspects, the composition of the sofa placed by a resident in the escape route plays an important role. The sofa contained plastic foam, which is known to be highly inflammable, to burn fiercely and to produce much toxic smoke. Chapter 4 of the report deals with this in greater detail.

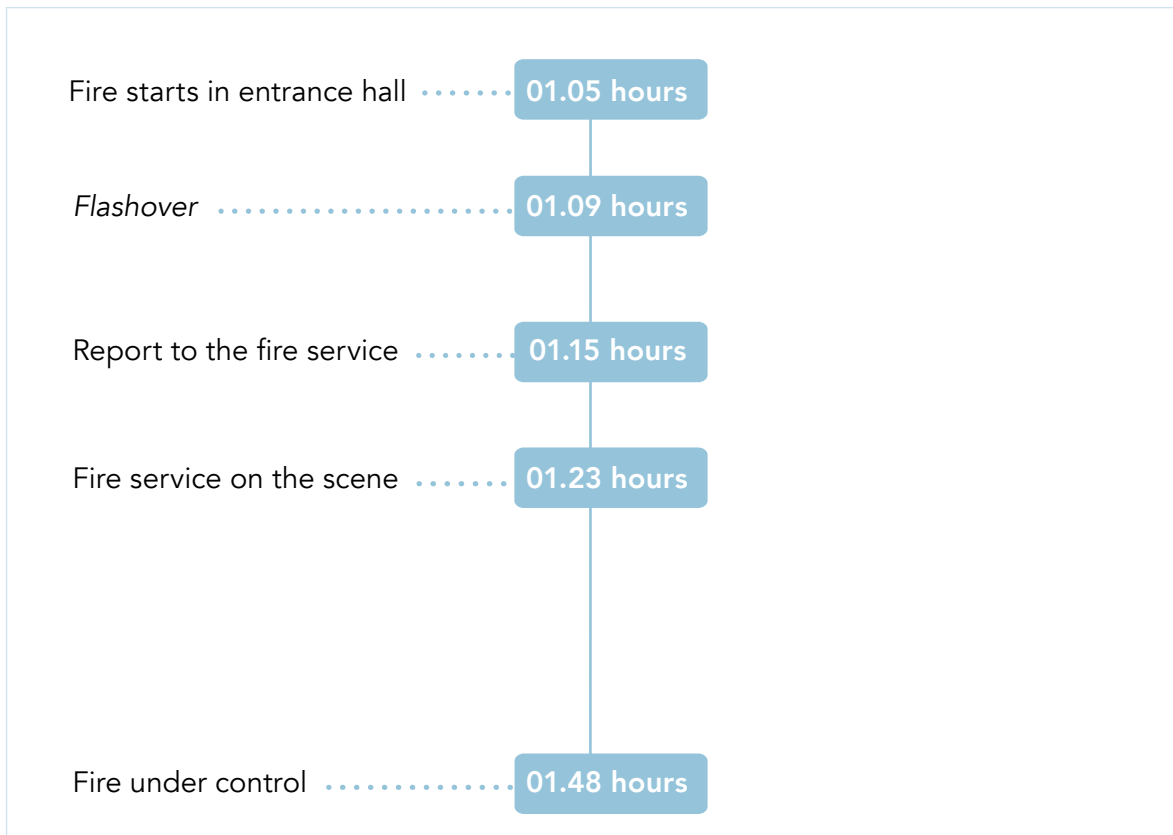
Figure 7: Timeline of the fire development.

- The fire was started by a low-energy ignition source. The description of the fire development shows that the fire was caused by a so-called ground bloom flower. A ground bloom flower is a firework classified in the lowest European category of consumer fireworks (F1) and is a low-energy ignition source. This type of ignition source will only cause a highly inflammable object to catch fire.
- The fire developed rapidly and fiercely. The description of the fire development shows that 5 minutes after the start of the fire, the flashover occurred, resulting in a fully developed fire. In fire safety theory, for the period between the start of a fire and the flashover, on average 15 minutes are assumed.<sup>18</sup> In practice in this fire, the time to flashover was one third of the average time assumed in fire safety theory.

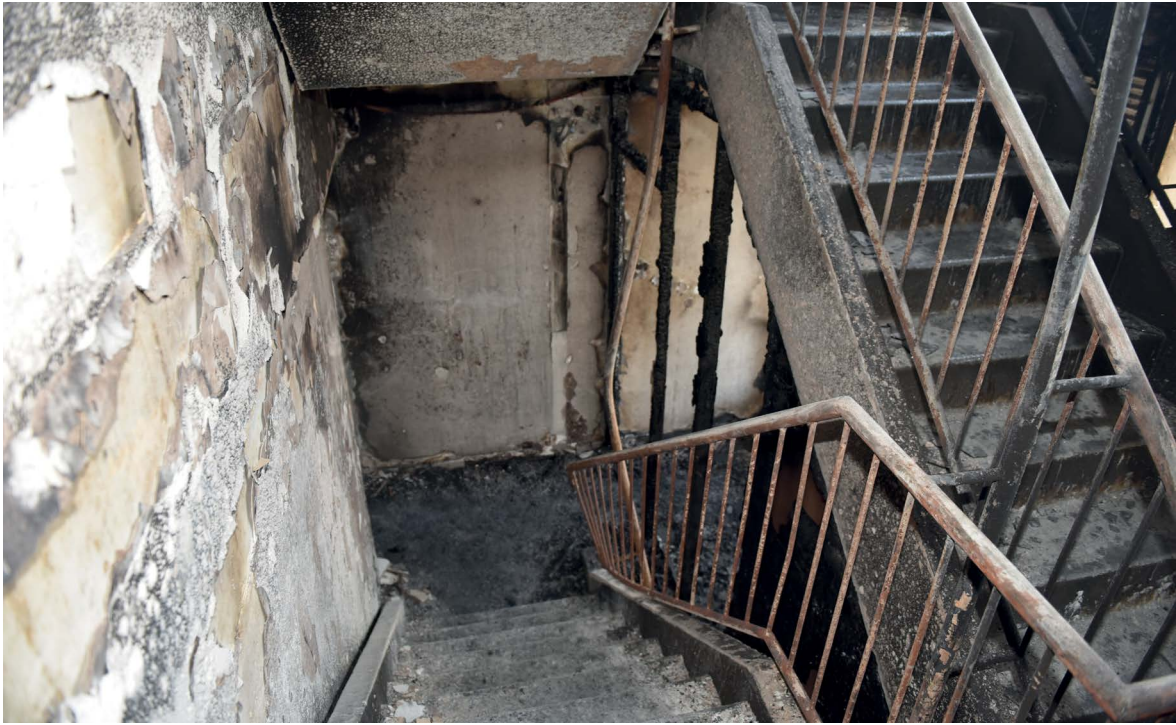
- The Lexan panel in the door between the entrance hall and the stairwell. The Central Gelderland Fire Service concluded in its investigation into the fire that the Lexan panel in the door between the entrance hall and the stairwell slipped down and was burned during the fire, as a consequence of the high temperature.<sup>20</sup> As a result, on the one hand oxygen from the stairwell was able to flow into the entrance hall, thereby feeding the fire. On the other hand, the fire and the smoke were able to spread to the stairwell. Based on the fire damage in the stairwell on the ground floor and on the landings between the ground floor and the first floor (see figure 8), it could be determined that the fire burned fiercely at the bottom of the stairwell, and that flue gases flowed throughout the stairwell up towards the upper floors.

Figure 8: Picture taken from the landings between the ground floor and the first floor (Source: Veiligheids- en Gezondheidsregio Gelderland-Midden (2020). Brand Gelderseplein Arnhem – 1 januari 2020.)

All of these three elements are known to have not formed part of the entrance hall and the stairwell, when the block of flats was completed. The Lexan panel and the wooden structure below the stairs were added in the early nineteen nineties by or on the instructions of the then building owner; the suspended ceiling was installed well before 2015. Beyond this, little is known about this work by Vivare, the current owner of the building. Vivare has no information as to why this suspended ceiling was installed. The reason for installing the wooden wall structure beneath the stairs, according to Vivare, is that the space below the stairs was used for a whole range of activities that detracted from the quality of life in the building. According to Vivare, the Lexan panel was installed to replace the safety glass<sup>22</sup> that was originally in the door, because the glass was regularly broken by vandals. The lack of documentation about this work makes it unclear to what extent consideration was given to fire safety. This is dealt with in more detail in chapter 3.
