DUTCH
SAFETY BOARD

Fishing vessel sinks due to failure of bilge pumping system

Lessons learned from the occurrence
involving the UK-160 Riemda,
23 December 2020

The Hague, May 2022

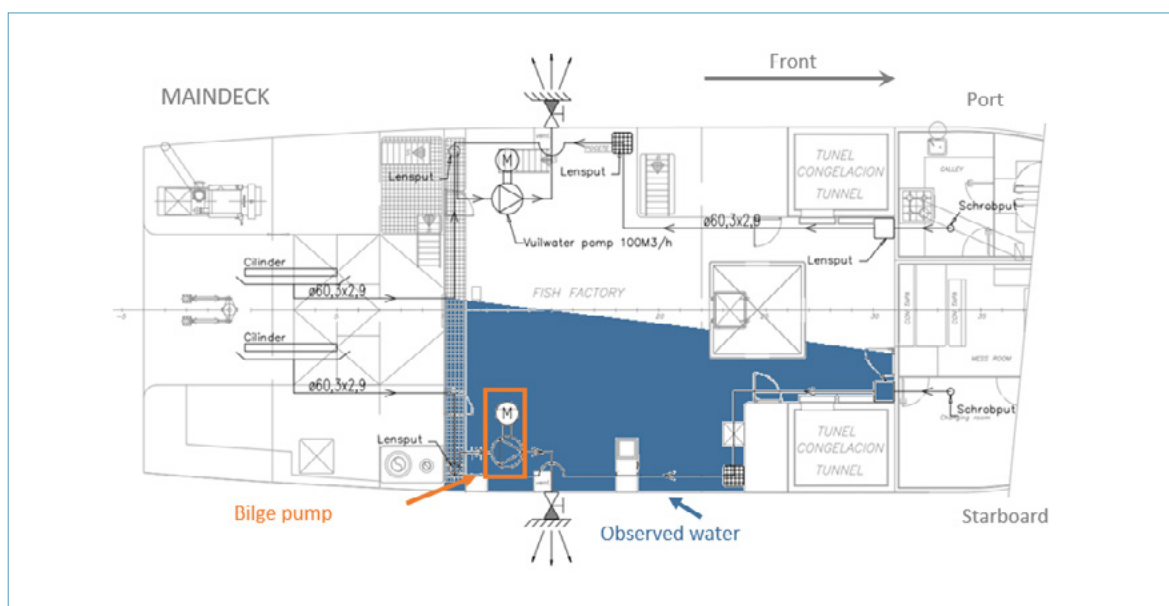
Figure 1: Bilge diagram - Fish processing deck – Top view fish processing deck with indication of observed water (blue). (Source: Maaskant Shipyards Stellendam / ILT)

When the deckhand arrived at the fish processing deck, he saw a large volume of water on the starboard side (see figure 1). He warned the master and the ship's engineer. The ship's engineer went to the fish processing deck to identify the source of the problem. He concluded that the starboard bilge pump must have failed and instructed the deckhand to switch the pump to 'manual'. In the meantime, he himself went to the engine room to check whether a fuse had blown. The bilge pump was thermally still operational, but after switching to manual mode, it still failed to start pumping. The ship's engineer concluded thereupon that the pump must have become jammed. He warned the master and went back outside to check the output of the starboard bilge valve, at which point he saw cordage protruding from the overboard pipe.

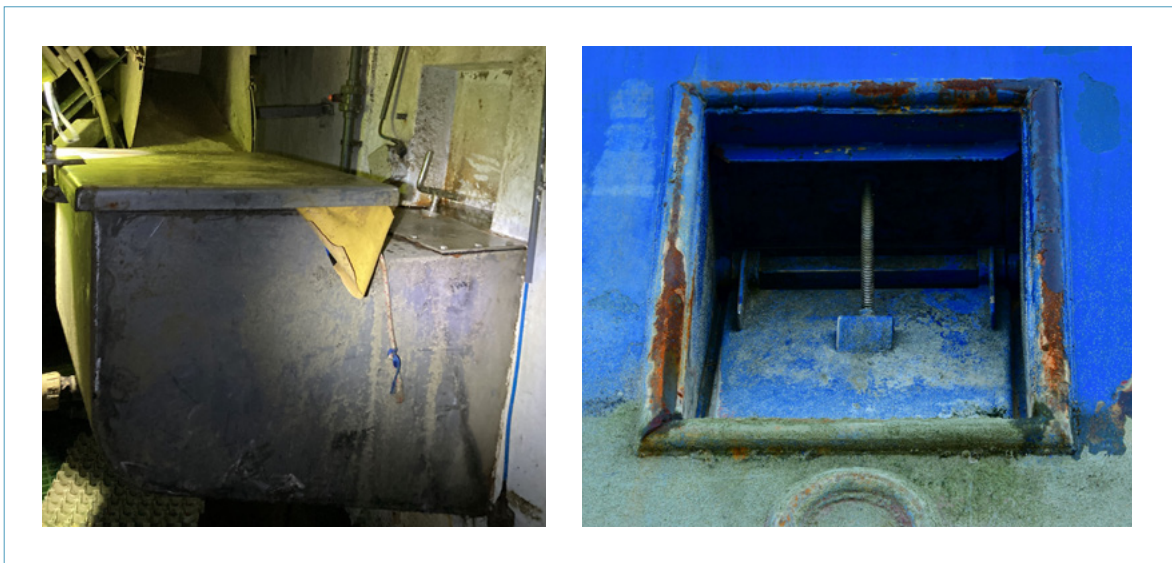
Because the angle of list continued to increase, the water started to advance steadily higher against the upright wall of the fish waste discharge chute (see figure 4). Occasionally water lapped over the edge of the discharge chute into the fish processing compartment. In an attempt to keep as much water as possible outside the vessel, at around 17.40 hours, one deckhand went below to close the hatch cover of the fish waste discharge chute (see figures 4 and 5). This hatch was still open because it is only ever closed while sailing between port and the fishing grounds. As he closed the chute, the deckhand was already up to his waist in water.

Figure 4: Fish waste discharge chute - side view.

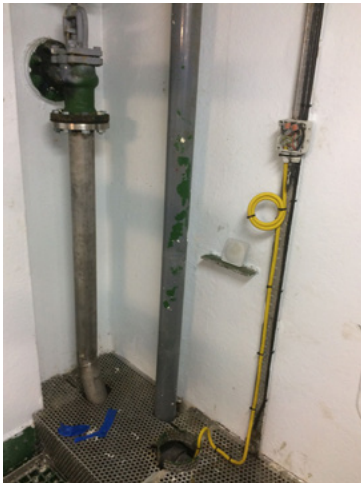
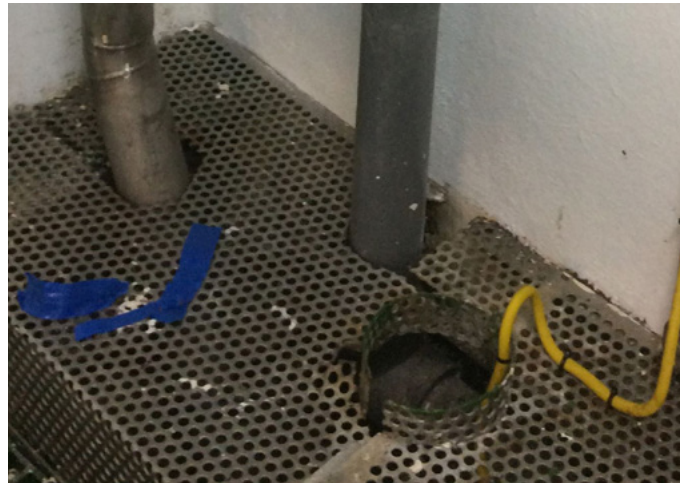
The fish processing deck was located below the working deck, level with the water surface. A bilge system was fitted on both sides of the processing deck (see figure 10). Each of the bilge pumps had a capacity of 100m³/h². The pumps were set in such a way that they automatically started pumping when the floater was activated when the water level in the sump rose to above a certain level. The sump was covered with a grid to prevent the bilge pump drawing in materials, and becoming blocked. Above the pump was an opening for the electricity supply to the pump (see figure 11).

Figure 10: Starboard bilge installation UK-160.
(Source: Maaskant Shipyards Stellendam)

Figure 11: Detail starboard bilge installation UK-160.
(Source: Maaskant Shipyards Stellendam)

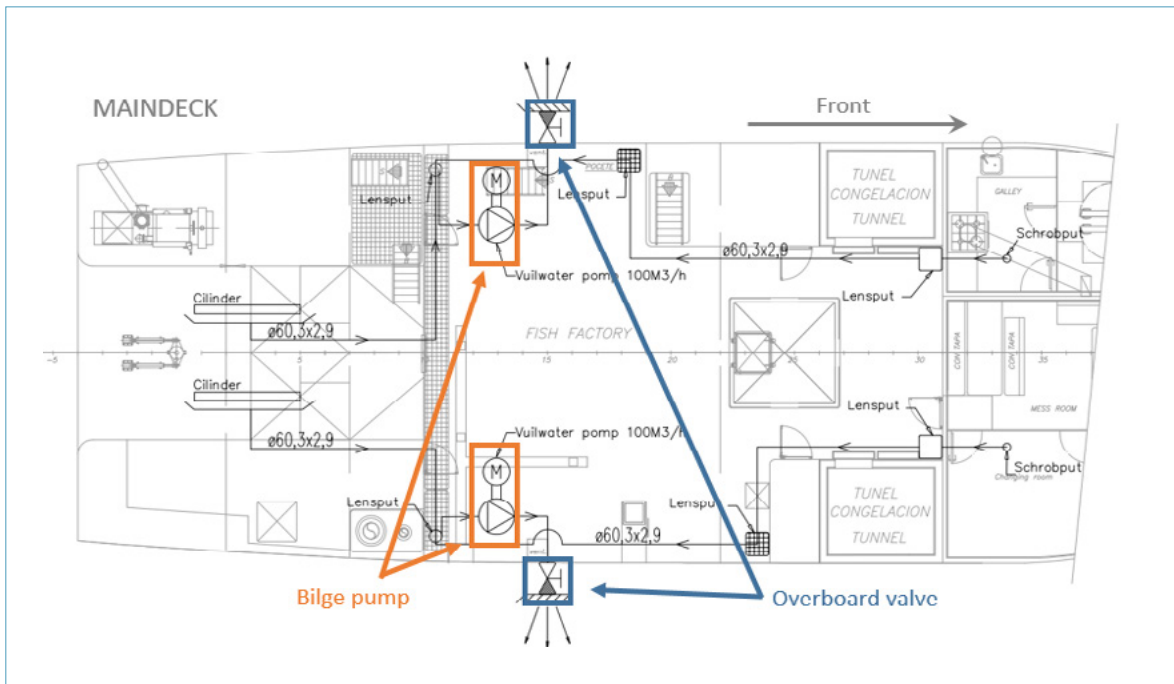
During fish processing, pieces of rope and other materials were regularly hauled on board together with the catch. These materials were carried by the rinsing water and transported to the lowest point. The bilge system consisted of two independently operating circuits; one starboard and one port circuit. Each circuit was fitted with an overboard valve with non-return valve (see location in figure 12). This valve was located 1.5 metres above the floor panels of the fish processing deck. On board, a portable immersion pump with a lower capacity was available, for use as a backup.

Figure 12: Bilge system circuit diagram fish processing deck - top view. (Source: Maaskant Shipyards Stellendam / ILT)

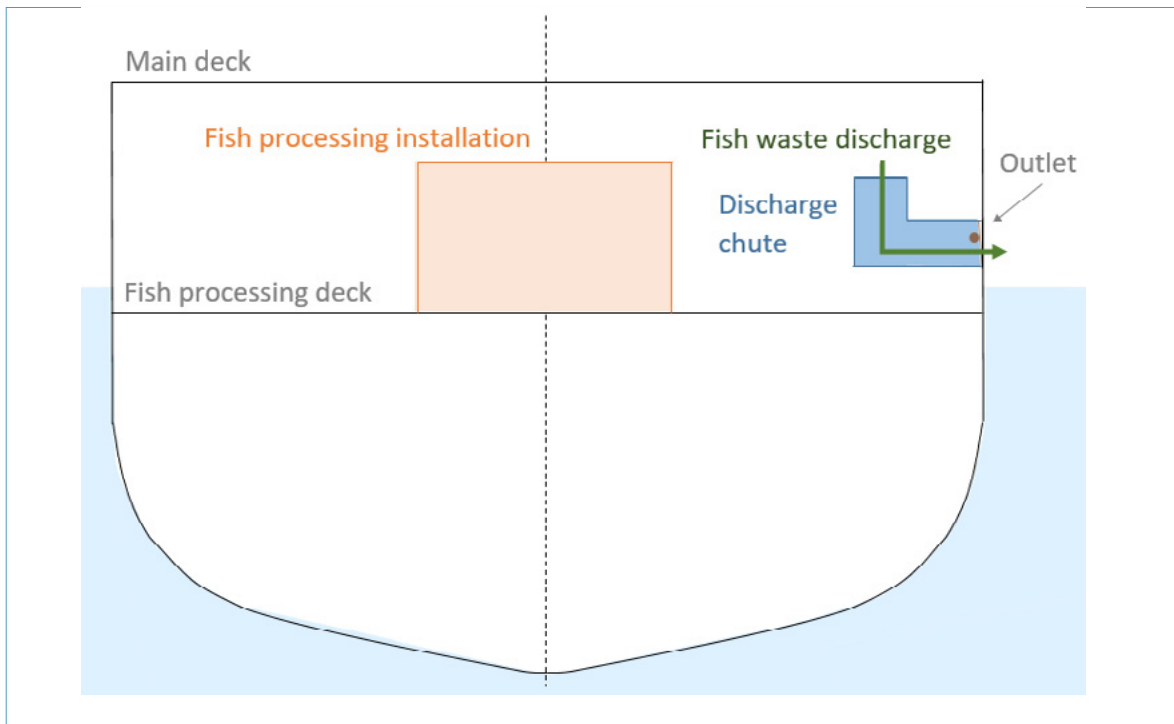
The fish waste discharge chute (see figure 4) was located on the starboard side of the fish processing deck (see figure 16). The outlet of this discharge chute (see figure 5) ended half a metre above the waterline.

The layout was such that seawater could not easily flow in. In poor weather conditions and during the transit between port and fishing grounds, this chute was closed using a manually closable cover.

Figure 16: Cross section of fish processing deck - discharge chute.

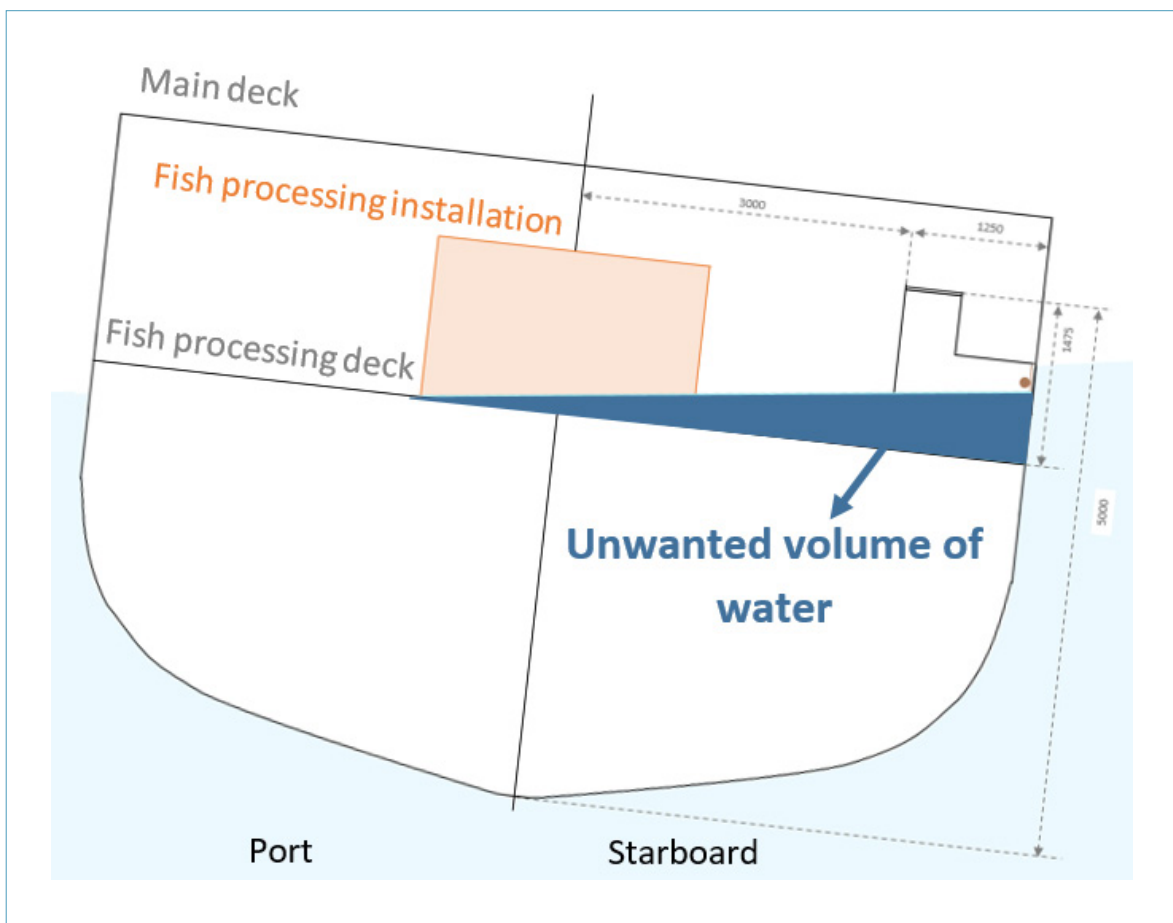
Inspections of the hull revealed no perforations on the outside of the vessel at the level of the fish processing deck which could result in the inflow of seawater. However, the fish waste discharge hatch was at the level of the waterline. This hull configuration negatively influenced the watertight integrity of the fish processing deck at moments when the hatch was not closed. Despite the fact that the water must have flowed onto the fish processing deck in a progressive manner, no internal damage to the pipelines was discovered. However, the capacity of the seawater pumps taking in water to rinse the catch, was more than sufficient to take in the volume of water present, within the time set.

For inexplicable reasons, the vessel suddenly adopted a list to starboard. This list was not the reason for the sinking, but was probably a contributing factor to the failure of the barriers. The hauling in of the nets was sufficient to move the excess volume of water to starboard, causing it to accumulate to such a level that a rope was able to make its way into the sump through an opening in the bilge grid.

Figure 17: Cross section of fish processing deck.

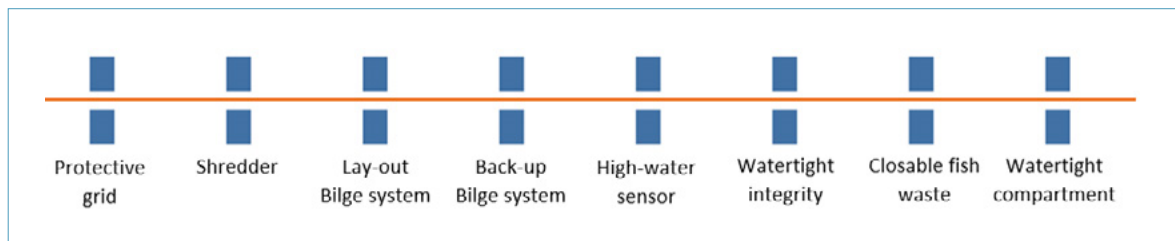
In its analysis of the sinking of the UK-160, the Safety Board identified several failing or missing barriers (see figure 18). This analysis chapter discusses the following barriers in more detail:

Figure 18: Overview of fundamentally failing barriers.

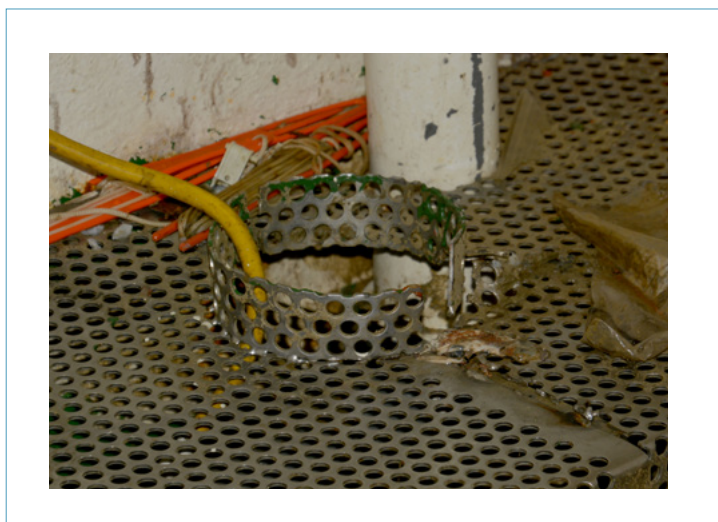
The bilge system on the fish processing deck was designed in such a way that a sump was located on both sides of the vessel, each equipped with a bilge pump connected to a sensor. If the water level in the sump rose to the height of the sensor, it activated the bilge pump so that the sump was pumped dry. The sump was encased in a grid designed to prevent sections of cordage and other waste from ending up in the bilge pump.

Figure 19: Bilge pump grid surrounding the bilge pump (fish processing deck).

The electricity cable that supplied power to the bilge pump on the fish processing deck passed through an opening with a diameter of 10 centimetres, on the top of the protective grid (see figure 19). This opening was originally sealed by a higher bilge pump. During the Dutch flagging process, however, these pumps were replaced with pumps of a more compact format, leaving a free opening in the protective grid.

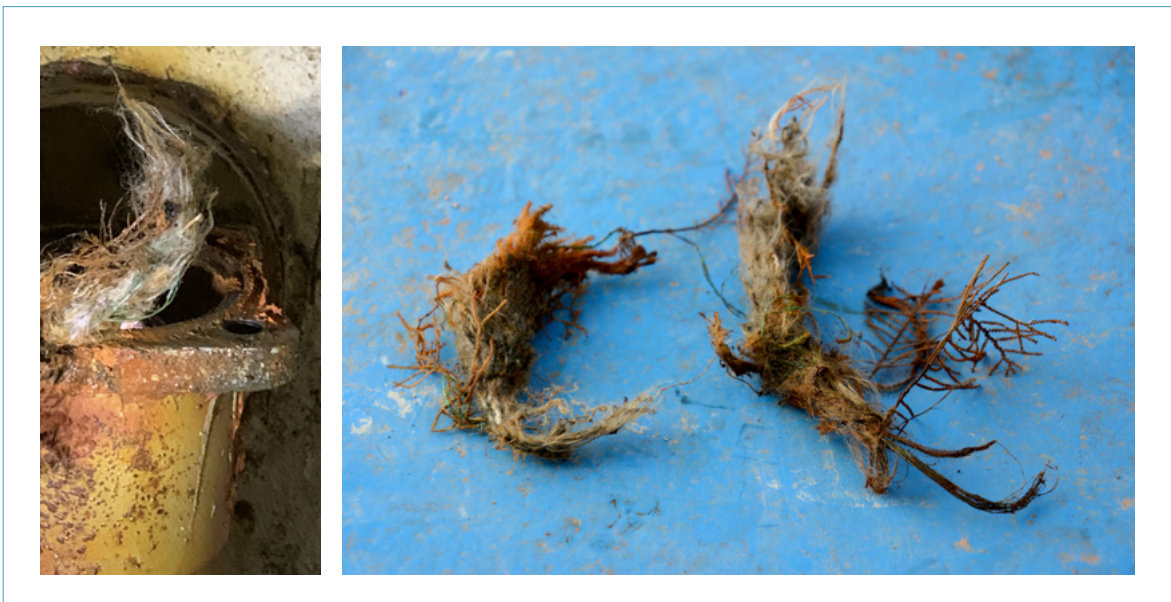
At the time of the investigation, there was no further evidence of factors that reduced the integrity of the grid. This led to the conclusion that the section of cordage (see figure 20 and 21) drawn into the pump must have entered the sump via this opening. The cordage matched material used commonly on board. According to standard procedure, waste found in the catch was regularly emptied into a waste basket intended for this purpose.

Figure 20: Cordage in the starboard bilge pump outlet. (Source: National Police)

Figure 21: Section of cordage from the starboard bilge system.

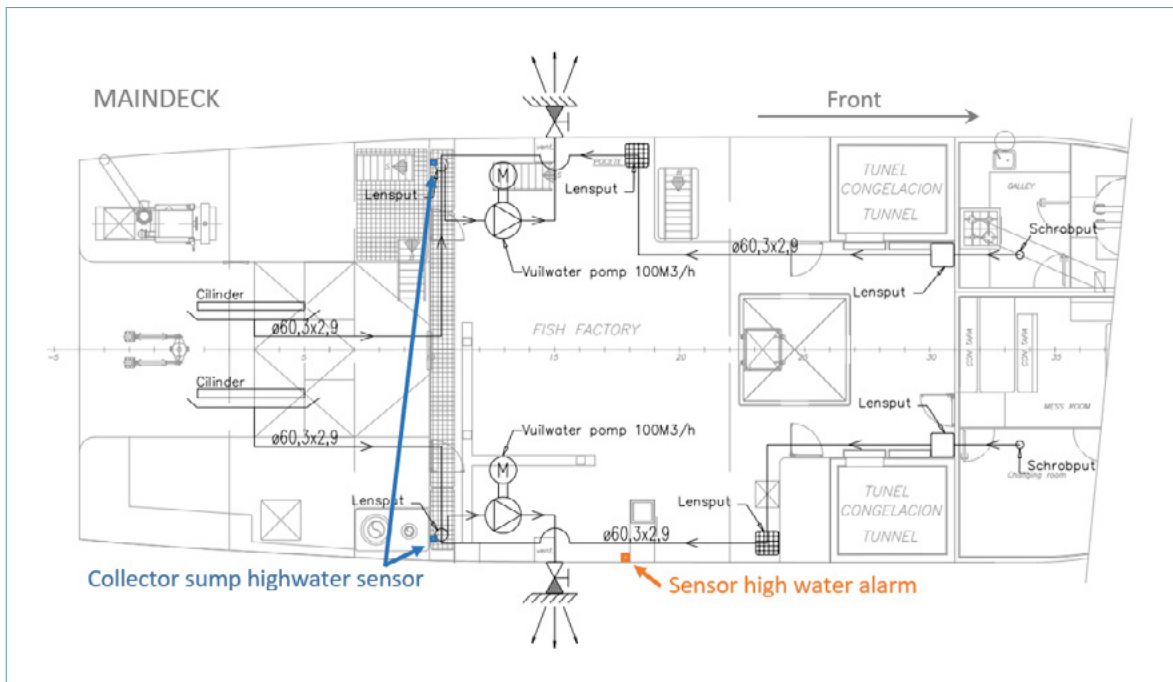
On the fish processing deck, the rinsing water was pumped away using a bilge system that was separated from the engine room. The system consisted of two fully independently longitudinally mounted sections, each with a single bilge pump and a series of sumps (see figure 22). Because due to the vessel's configuration, the vessel was raked back a few degrees as standard, the bilge pumps were located at the back of the fish processing area, against the watertight bulkhead. The high-water sensor that activated the bilge pump was located at the top of the collector sump in which the intake to the bilge pump was positioned.

Figure 22: Bilge system circuit diagram fish processing deck - top view. (Source: Maaskant Shipyards Stellendam / ILT)

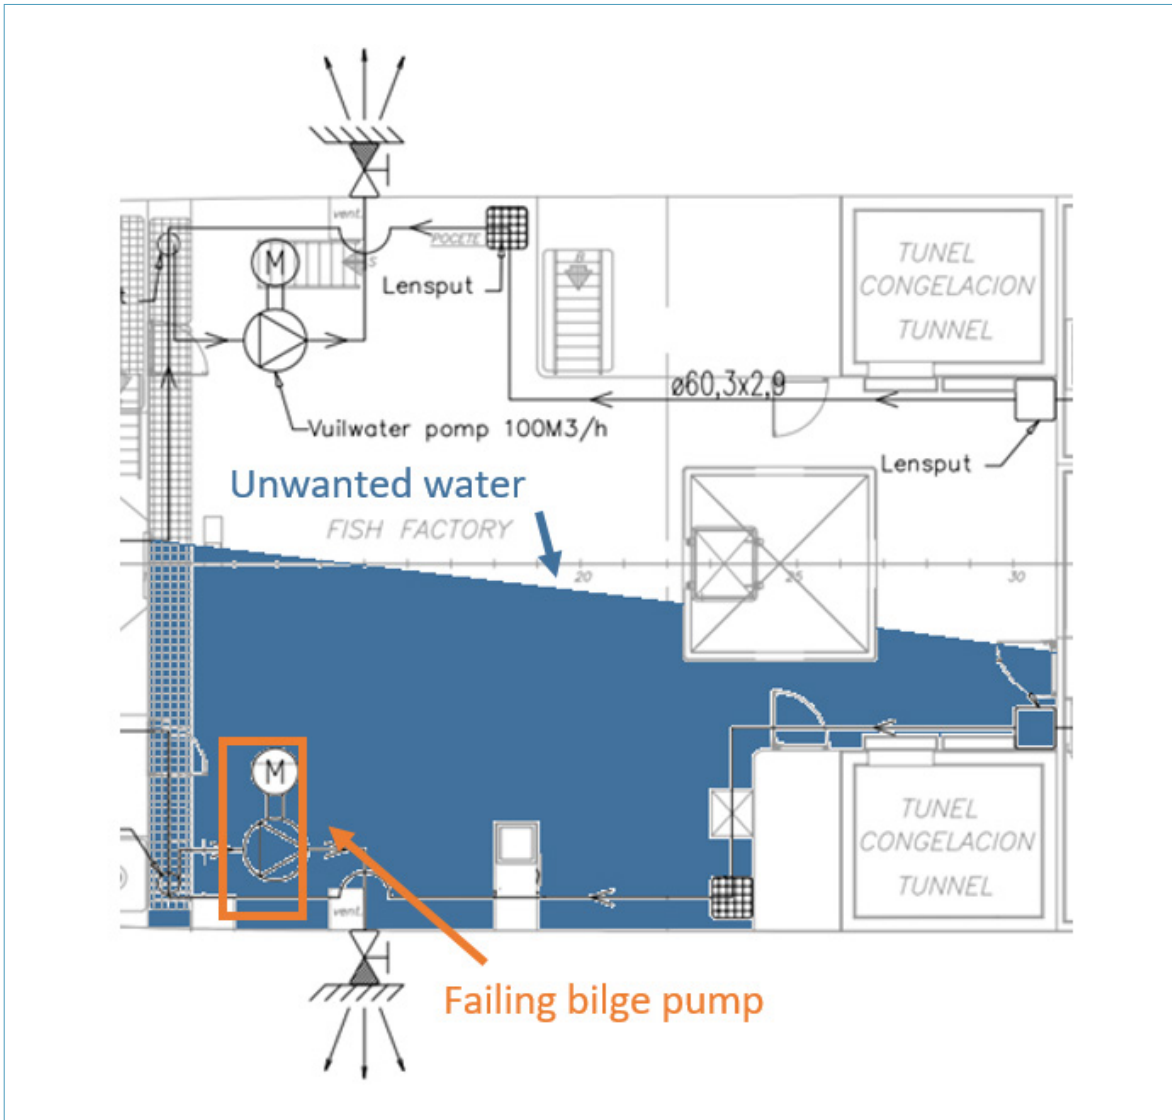
On board, an immersion pump of a smaller format was in storage on starboard side, but due to the water, it was positioned beyond the reach of the crew. In this scenario, both backup measures provided proved insufficient.

Figure 23: Bilge system circuit diagram fish processing deck - top view. (Source: Maaskant Shipyards Stellendam / ILT)

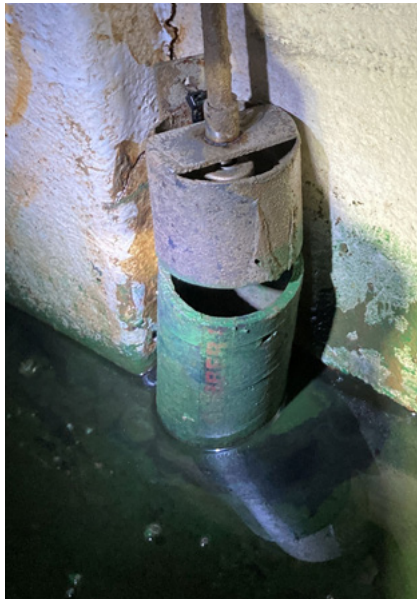
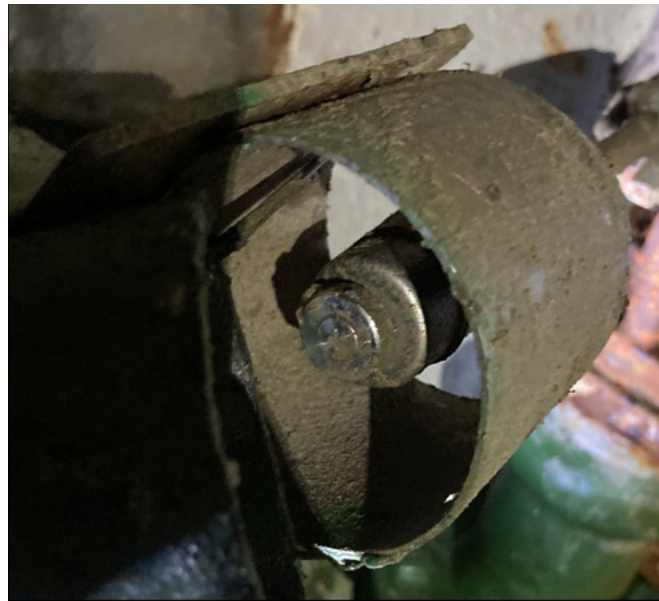
There was a single general high-water sensor on the fish processing deck (see figure 24 and 25) that was connected to an alarm system on the bridge. This sensor was mounted at a height of 40 cm next to the fish waste discharge chute on the starboard side of the fish processing deck. The reports from the periodic ILT inspections revealed that this sensor was tested annually, and that no shortcomings had been identified with regard to the functioning of this sensor.

Figure 24: Bilge system sensor - fish processing deck. Figure 25: Underside of bilge system sensor - fish processing deck.

Several weeks prior to the occurrence, following the replacement of another sensor, all sensors on the fish processing deck were tested by the crew and found to be in good order. Nonetheless, the sensor on the fish processing deck failed to sound an alarm when it became submerged during the occurrence. Because there was only a single sensor on the fish processing deck capable of informing the bridge of a high water level, there was no backup facility available, if this sensor malfunctioned. As a result, the abnormal water level was not observed until later.

On the fish processing deck, there was only a single high-water sensor connected to the bridge alarm. During the build-up of water, this system failed to sound the alarm.

2. Tighten legislation regarding the water tightness of compartments where fish processing takes place, in order to prevent that flooding of such a compartment results into the loss of the watertight integrity of the other compartments.
3. Adjust regulations regarding the obligation to have a continuous back-up in the bilge systems in order to guarantee back-up in the event the vessel lists. In addition, guarantee by means of a Policy Rule / Technical Regulation that there is an adequate bridge alarm if a bilge pump fails.

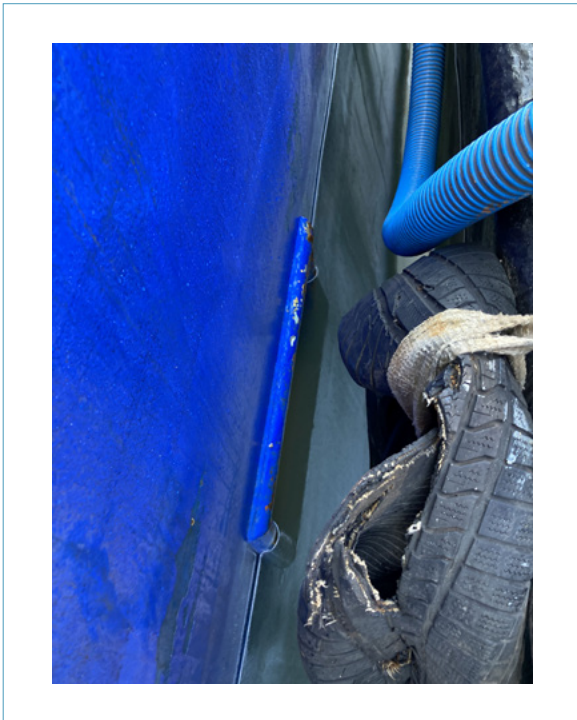
According to the calculations carried out by SARC, the discharge chute was positioned in such a way that the sea outlet (see figure 5) was located less than half a metre above the waterline, under normal loading conditions.

If the vessel rolled, at a certain angle of list to starboard, or if the vessel was more heavily laden, it was possible for the sea outlet of the discharge chute to be positioned at or below the waterline (see figure 26).

Figure 26: Sea outlet of the discharge chute; photograph taken in March 2021 from a bunkering boat moored alongside, with car tyres acting as fenders.

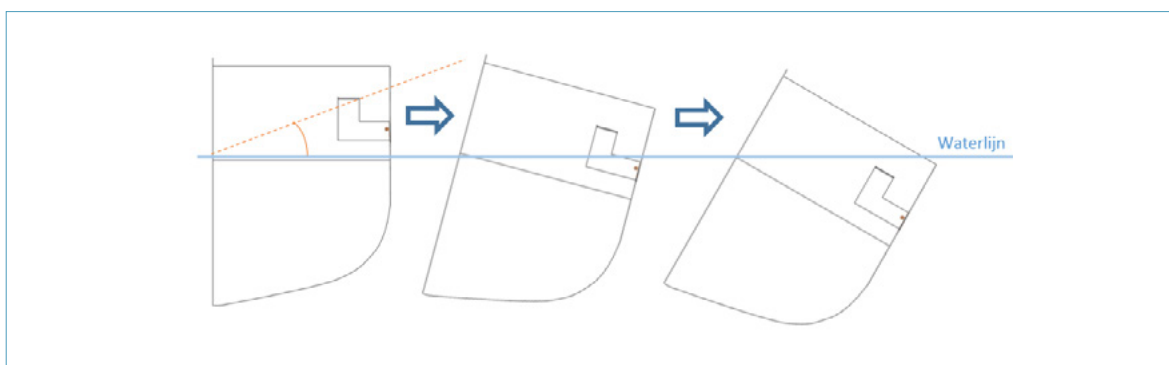
The vessel was still in the process of completing its last track, so this fish waste discharge chute was still open, at the time of the occurrence. When the vessel had adopted a list of more than 30 degrees to starboard, and the crew on the main deck had moved the fishing gear to the port side, one of the deckhands went below to close the fish waste discharge chute. According to the statement of the crew, when the hatch was closed, the water had risen to waist height.

Figure 27: Cross section starboard in neutral starting position (left), at a 15-degree angle of list (centre) and a 30-degree angle of list (right).

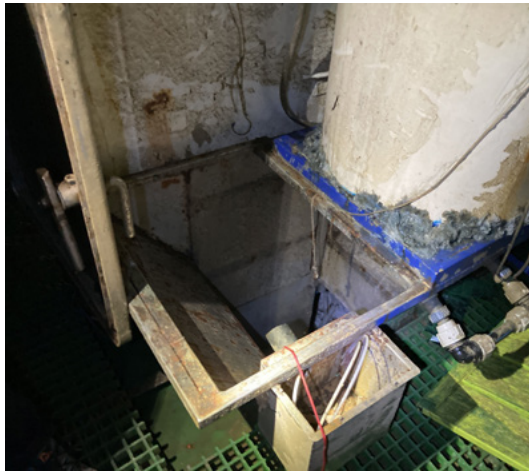
The fish hold, located below the fish processing area, had two openings to the area above (see figure 30). Midships was a large hatch through which the fish could be transported into and out of the hold. On the starboard side was a further smaller opening (see figure 28 and 30) at the site where a freezer installation had previously stood. As shown in figure 29, at the time of the last maintenance period, this installation was still on board. The opening was only made in the year before the occurrence, by removing the freezer installation positioned above the hole and then closing the hole with a water-permeable panel. This change to the ships' structure was not known to the Dutch Shipping Inspectorate.

Figure 28: Small opening on the starboard side of the fish processing area to the fish storage area.

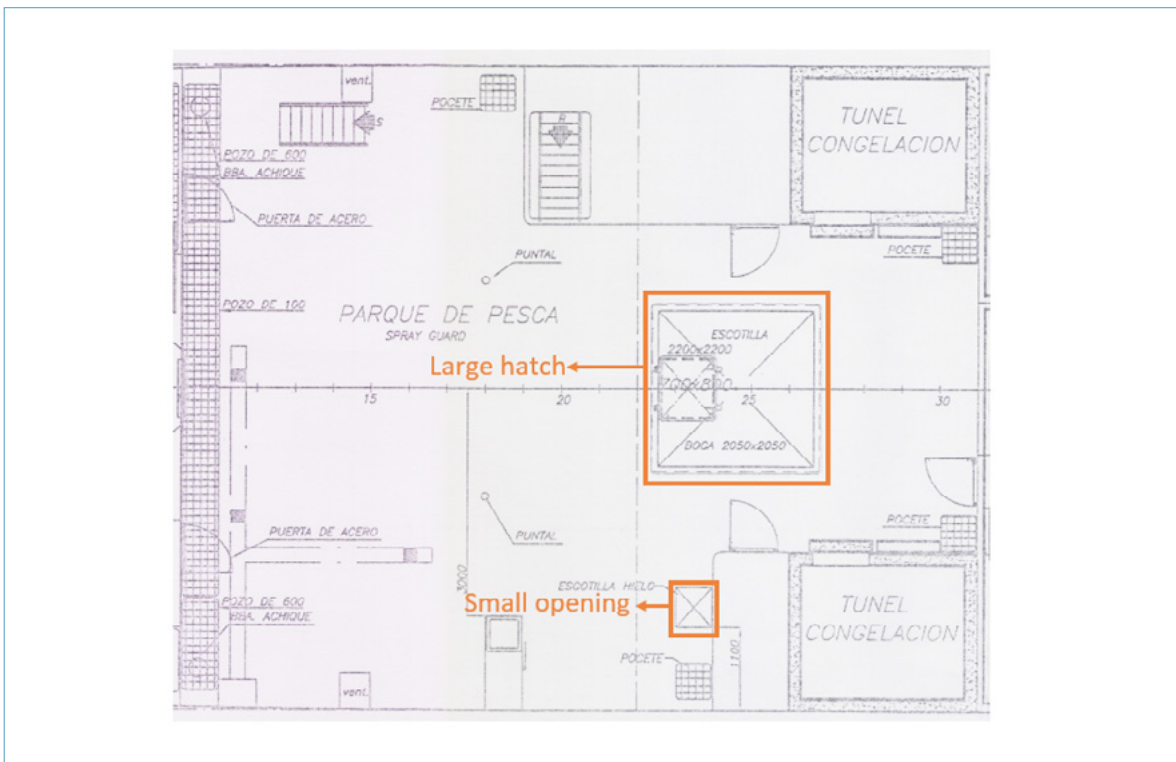
Figure 30: Overview of openings between the fish processing area and the fish storage area. (Source: Stability book UK-160)

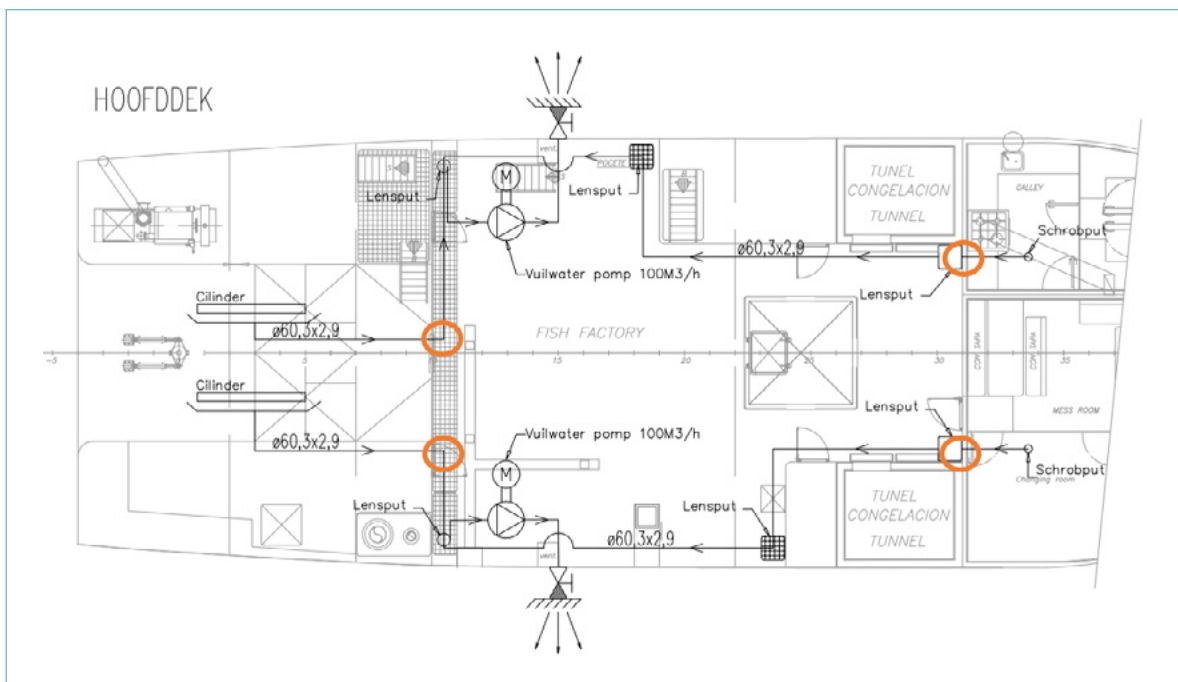
The drain in the accommodation area is connected to the bilge system on the fish processing deck. The investigation on board revealed that there were no non-return valves in the bilge system between the drain (marked as a rinsing drain on the bilge system plan) in the accommodation, and the pump in the fish processing area and also not between the fish processing area and the areas located behind it (see figure 31).

Figure 31: Bilge system tweendeck - marked at the height of the watertight bulkheads. (Source: Maaskant Shipyards Stellendam / ILT)

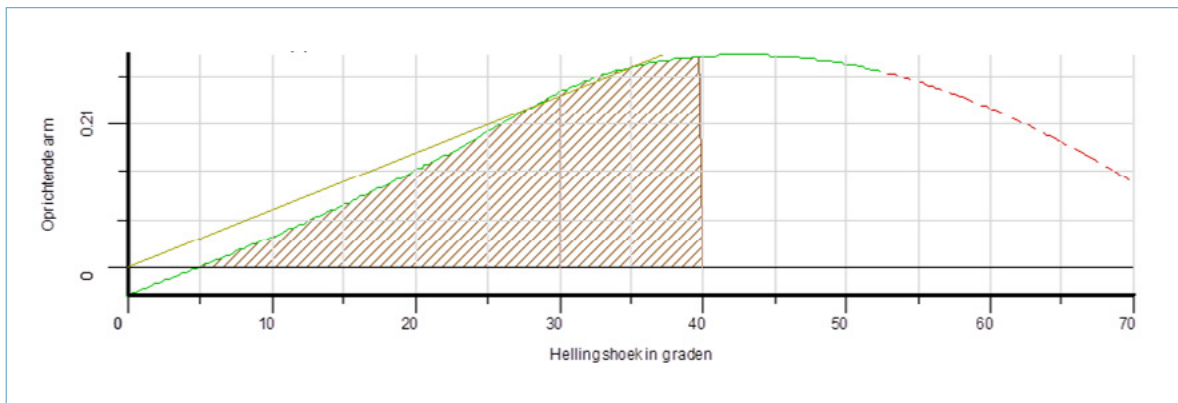
Dutch legislation and regulations contain eight requirements with which fishing vessels must comply at all times. Table 1 shows these minimum requirements compared with the values calculated for the condition of the UK-160 on the day of the occurrence. Figure 32 is a graphic representation of the stability in this condition. On the graph, the area below the GZ curve equates to the self-righting capacity of the vessel. The greater the surface area, the better the ship is able to return itself to its original position. On the day of the occurrence, only the area up to 30 degrees (see table 1, marked in red) failed to comply with the legal minimum requirement.

Figure 32: GZ curve UK-160 on the day of the occurrence. (Source: SARC)

Based on the tank level figures in Annex G, the calculated loading conditions show that on the day of the occurrence, the UK-160 had an angle of heel of slightly less than five degrees to starboard. This matches the statements by the crew. Despite the fact that this condition did not fully comply with the applicable stability criteria, the vessel still had more than sufficient stability to to right itself to the initial angle of heel.

Despite the fact that the operating conditions on the vessel meant that the ship stability did not fully comply with the initial legal requirements, on the day of the occurrence, the vessel still had more than sufficient self-righting moment.

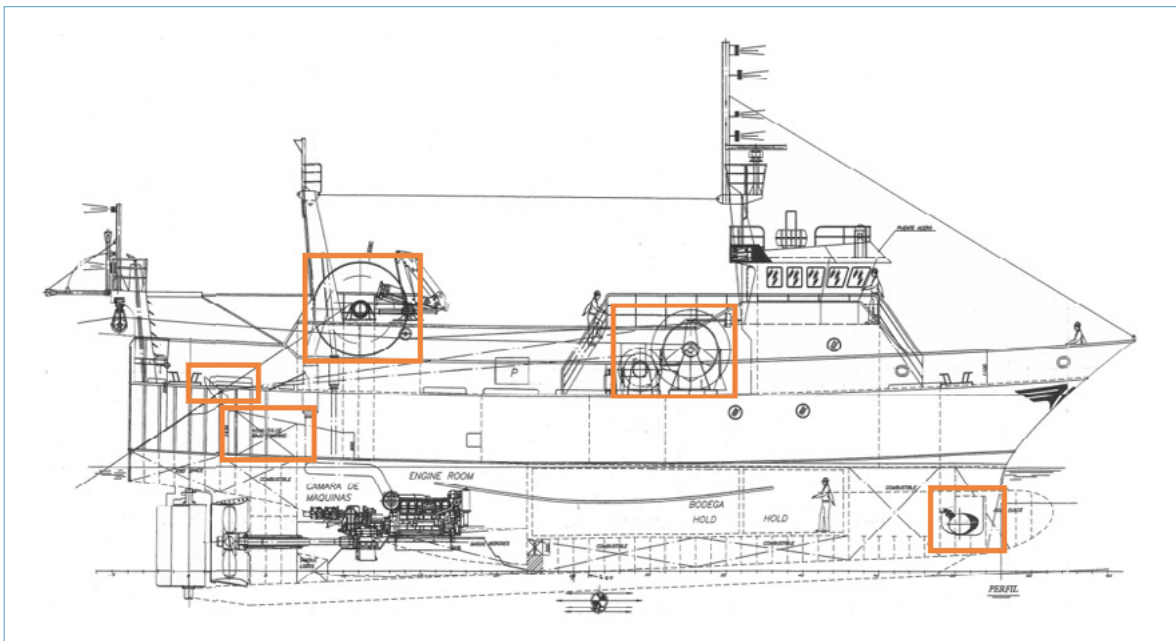
The eventual ship layout under Dutch flag differed considerably from the original design (see Appendix D). Figure 33 shows the main differences, with a further explanation in the text below.

Figure 33: Ship plan under Dutch flag - side elevation (2018). (Source: Stability book UK-160)

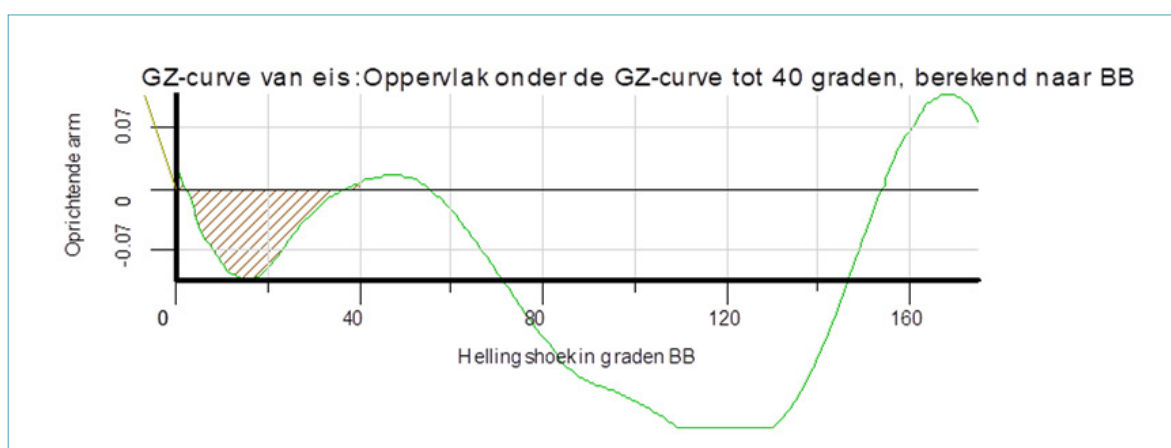
When water started flowing in through the engine room air inlet, the vessel reached a critical point. Figure 34 shows that the area below the GZ curve became minimal or even negative, from an angle of heel of 48 degrees. In this position, the vessel therefore had no further self-righting moment and as a result suddenly rolled, causing it to swing to a list of 150 degrees to starboard (the moment at which the curve returns to positive) therefore leaving the vessel upside down.

Figure 34: Stability condition 18.30 hours. (Source: SARC)
