ONDERZOEKSRaad
VOOR VEILIGHEID

Mortierongeval Mali 2016

Heropening onderzoek 2022

Den Haag, augustus 2022

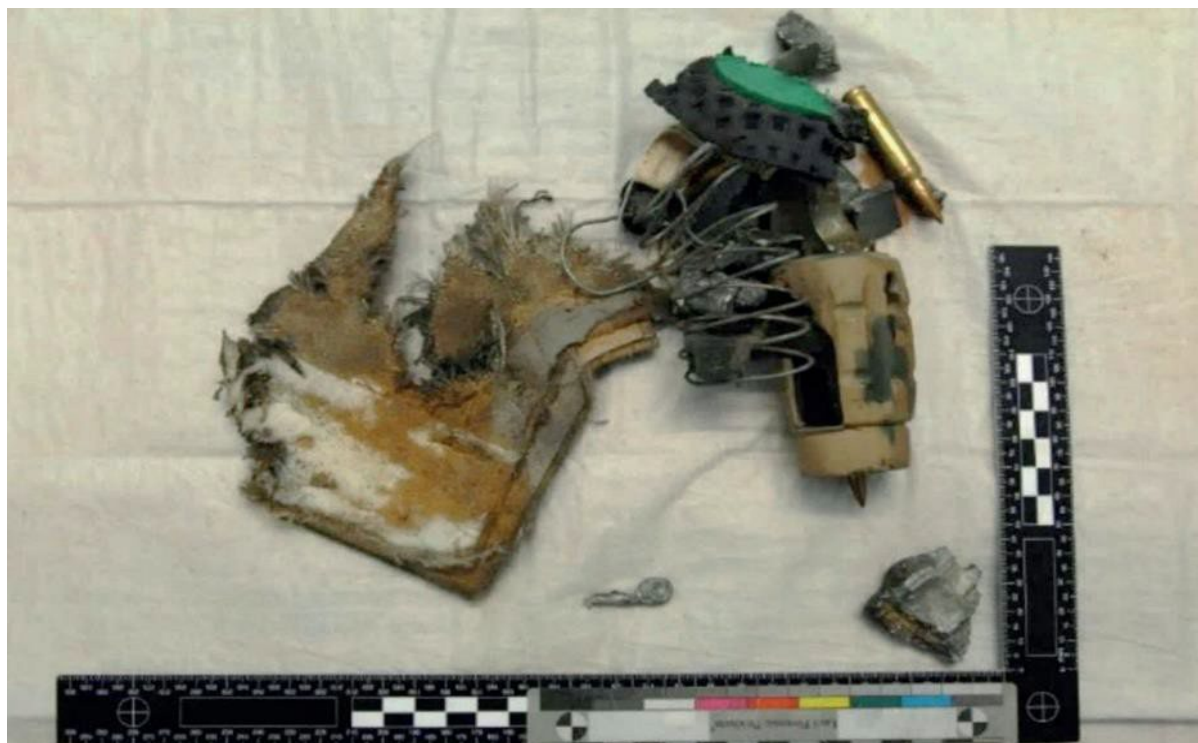
Figure 6: Content of the paper bag: visible are fragments of a shock pylon, a part of a shoe, rounds, a magazine spring, (probably) a cover of the mortar, straps of the transport safety of the grenade and the rubber cover of the sights of a Colt rifle. (Picture: TNO)

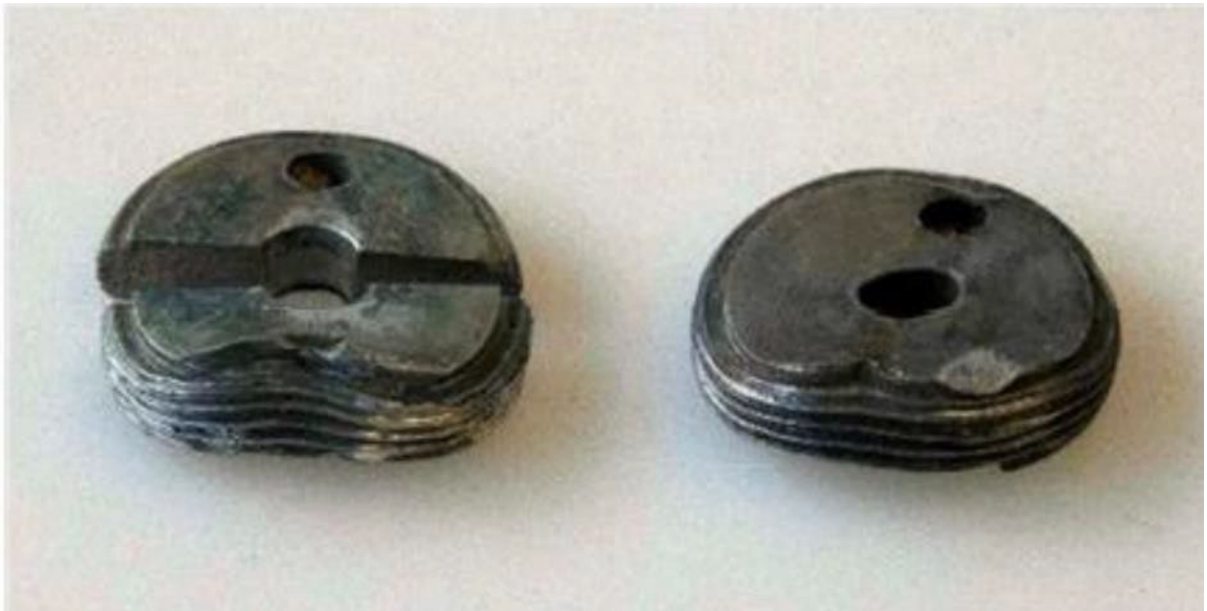
Figure 8: Left explosion train interrupter plate; DSB-report; right explosion train interrupter plate; controlled destruction. (Picture KC W&M)

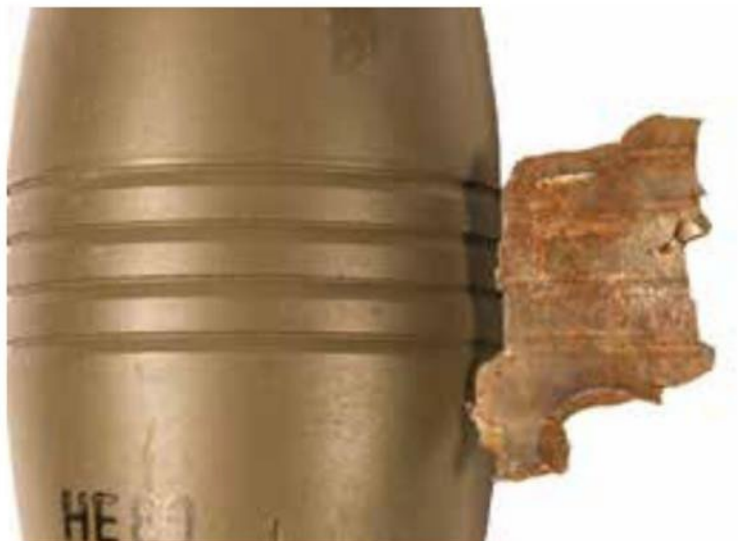
Figure 11: Imprint on the fragment of the launch tube, originating from the grooves on the shell casing when the main charge explodes. Figure illustrates the steel fragments produced during detonation of an HE 80 mortar round. (Picture: TNO)

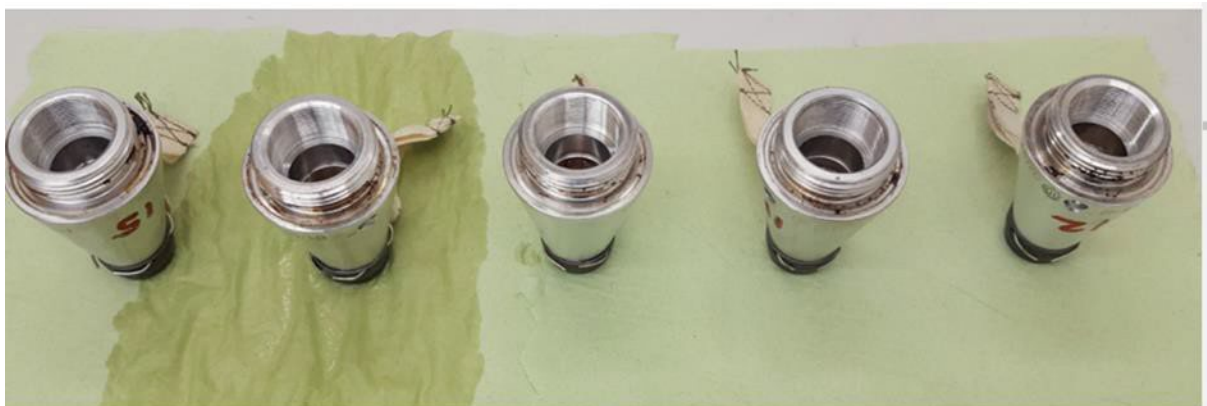
Figure 16: Filling the top of the M6-N fuze with water to show leakage. The adhesive layer of one of the five fuzes tested is leaking after a drop test from about one metre height with random impact orientation. (Picture: TNO)

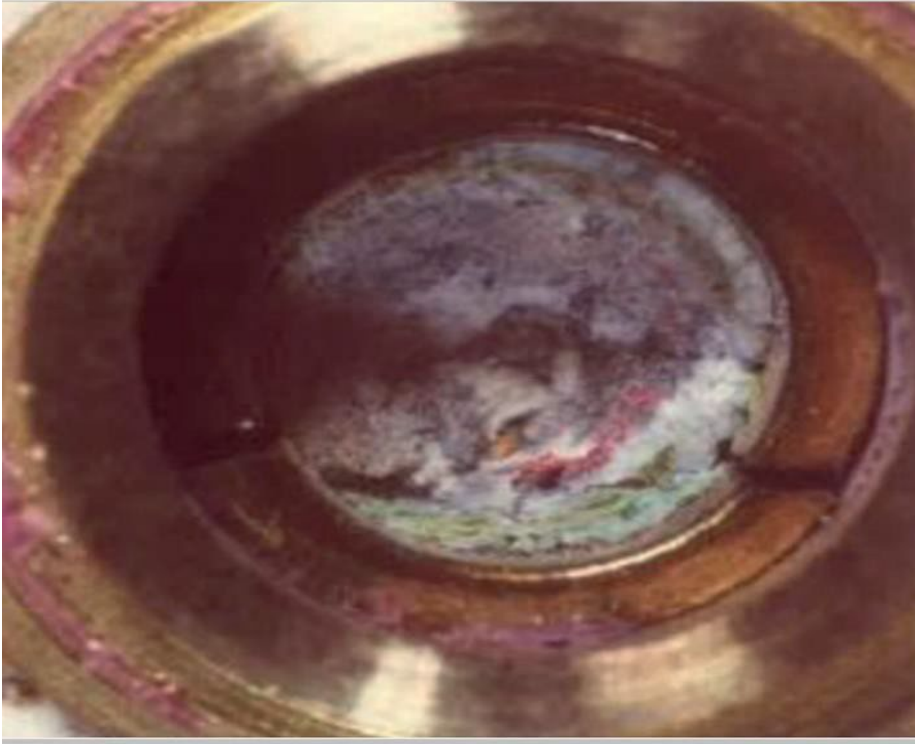
Figure 17: Top view of the aluminium detonator in the brass casing from fuze type V-19. Den Helder (1974) spontaneous reaction of corroded fuzes. (Picture: TNO)

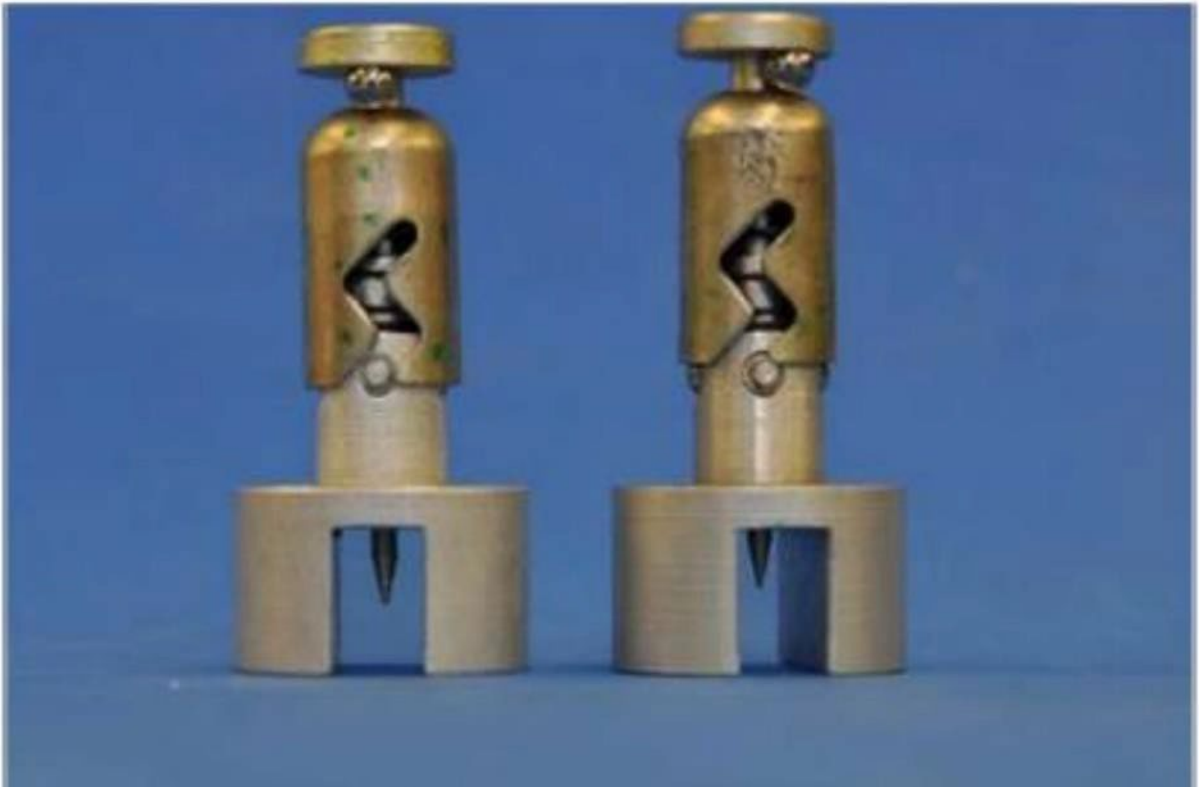
Figure 25: Combination firing pin and non-return valve; left correct; right incorrect (Photo: KC W&M)

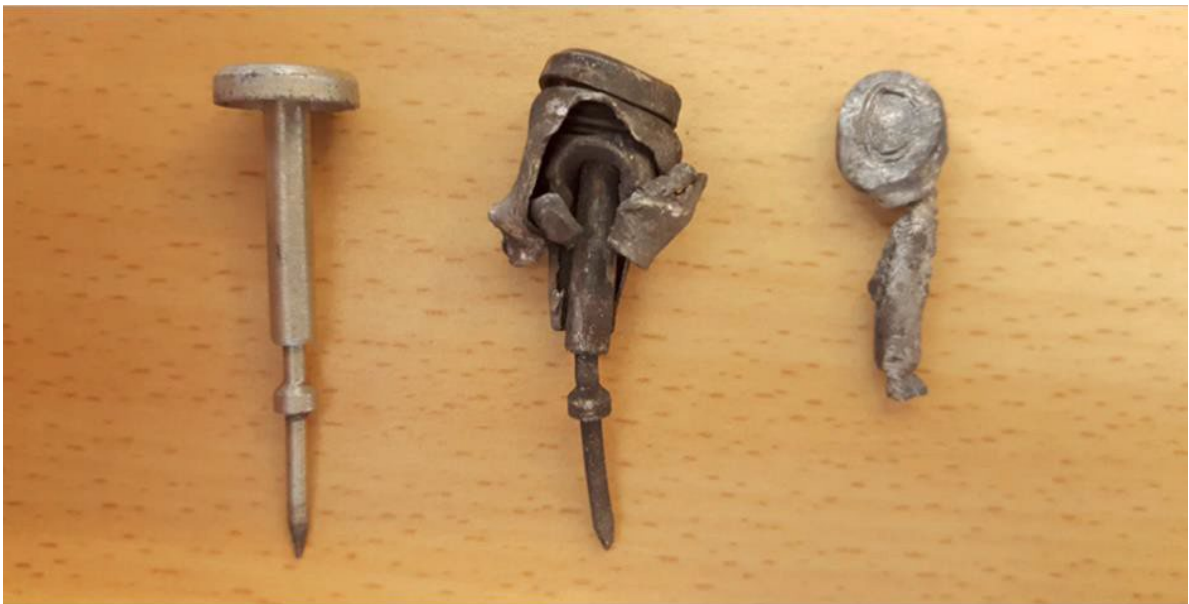
Figure 28: Unused firing pin (left), firing pin from the test in armed position (centre) and from the accident mortar round (right). (Picture TNO)

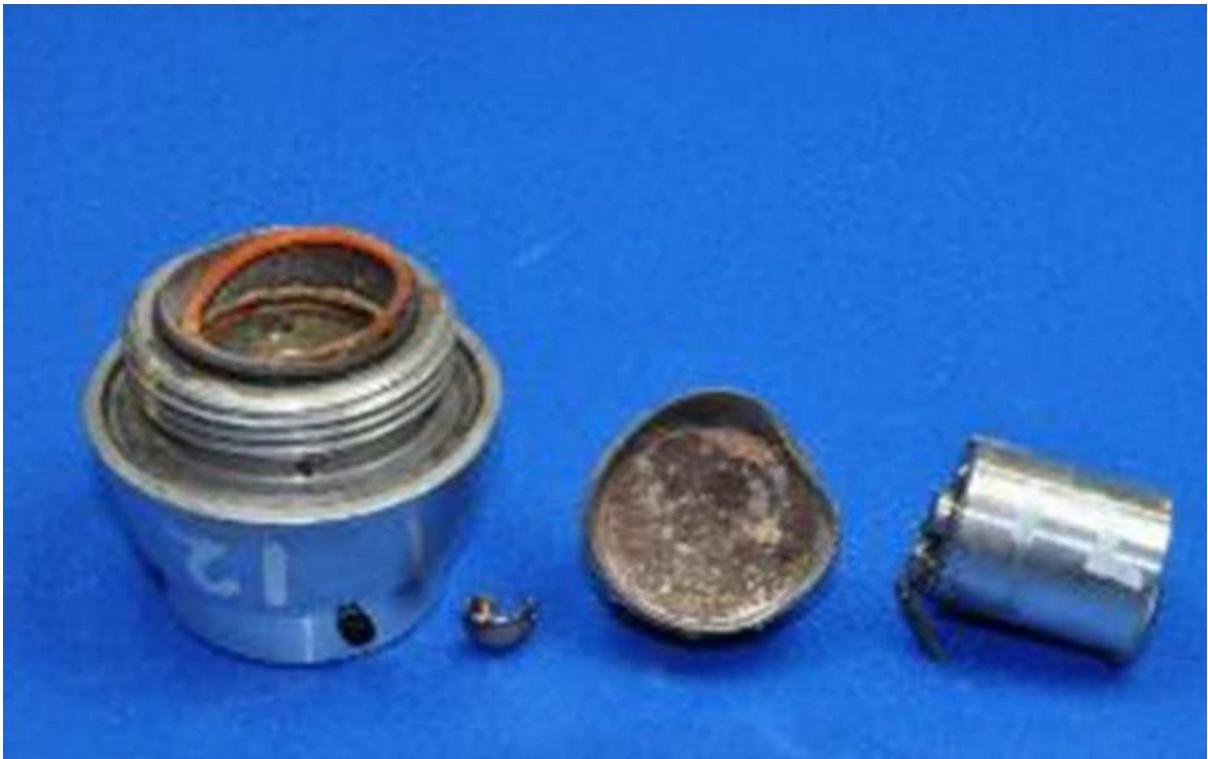
Figure 34: Explosive train interruption test carried out at 63°C by KC W&M. The booster charge has not detonated but it has fully combusted. In a higher confinement condition, as in an HE 80 round, transition to detonation may have occurred. (Picture: KC W&M)
