DUTCH
SAFETY BOARD

Fokker 70 lost all braking pressure during taxi-in

Ground-flight detection failure resulting
in collision

The Hague, December 2019

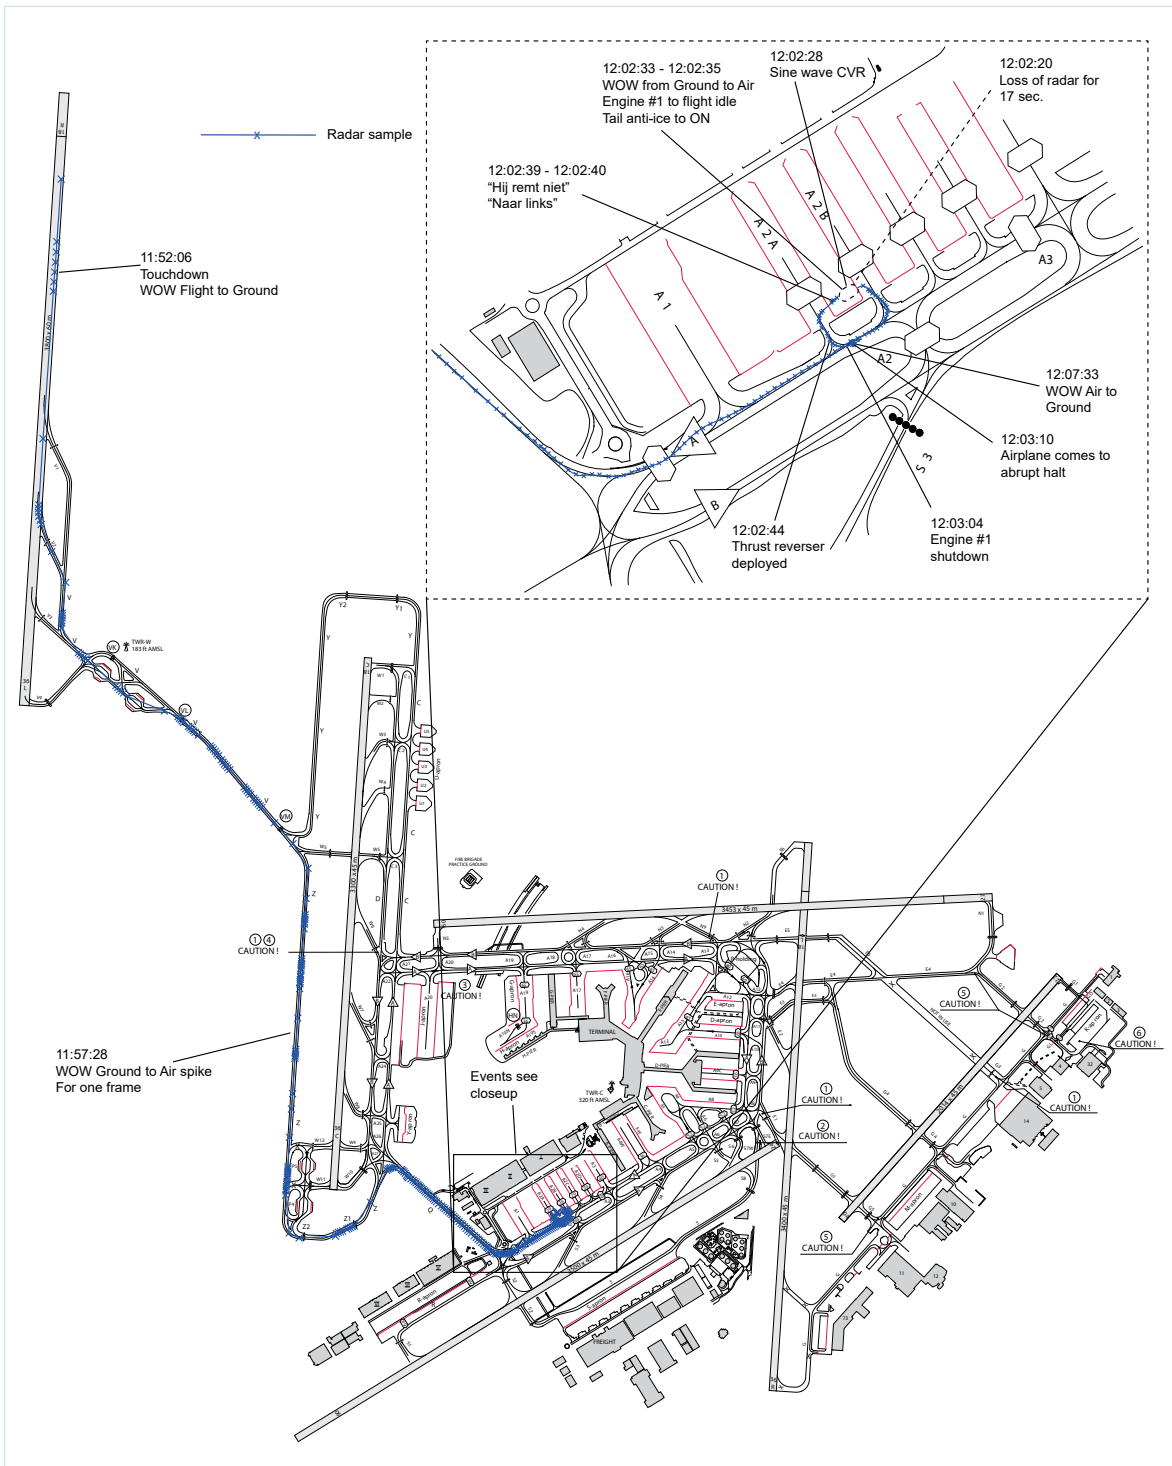
When turning into the parking stand the first officer applied the brakes to slow down a little bit and experienced no response from the braking system. The first officer stated that he exclaimed to the captain "It does not brake!" whilst he had fully pushed down the brake pedals which itself felt normal. Then also the captain had fully applied the brakes without any effect on the aircraft. Only one ground handler looked at the aircraft and when he suddenly noticed it was coming towards them without slowing down, he warned his colleague who was facing the GPU and could not see the aircraft. The two ground handlers then fled into the direction of parking spot B62.

Figure 1: Overview of the taxi tracks with annotated event locations.

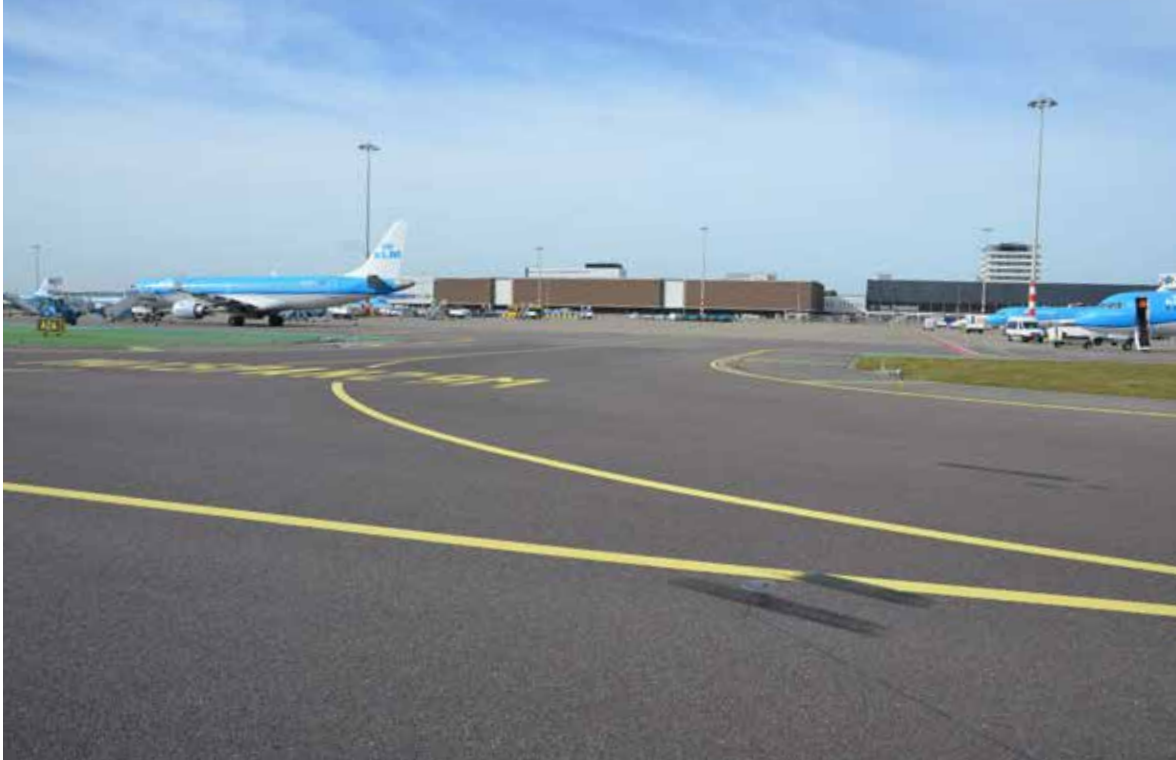
how to solve the problem whereupon the first officer suggested to shut down the remaining engine. When the captain shut down the engine, according to the first officer the brake pedals were still applied and the aircraft bumped and abruptly stopped. This is confirmed by QAR data and skid marks on taxiway Alpha, see Figure 2.

Figure 2: Skid marks. (Source: Aviation police)

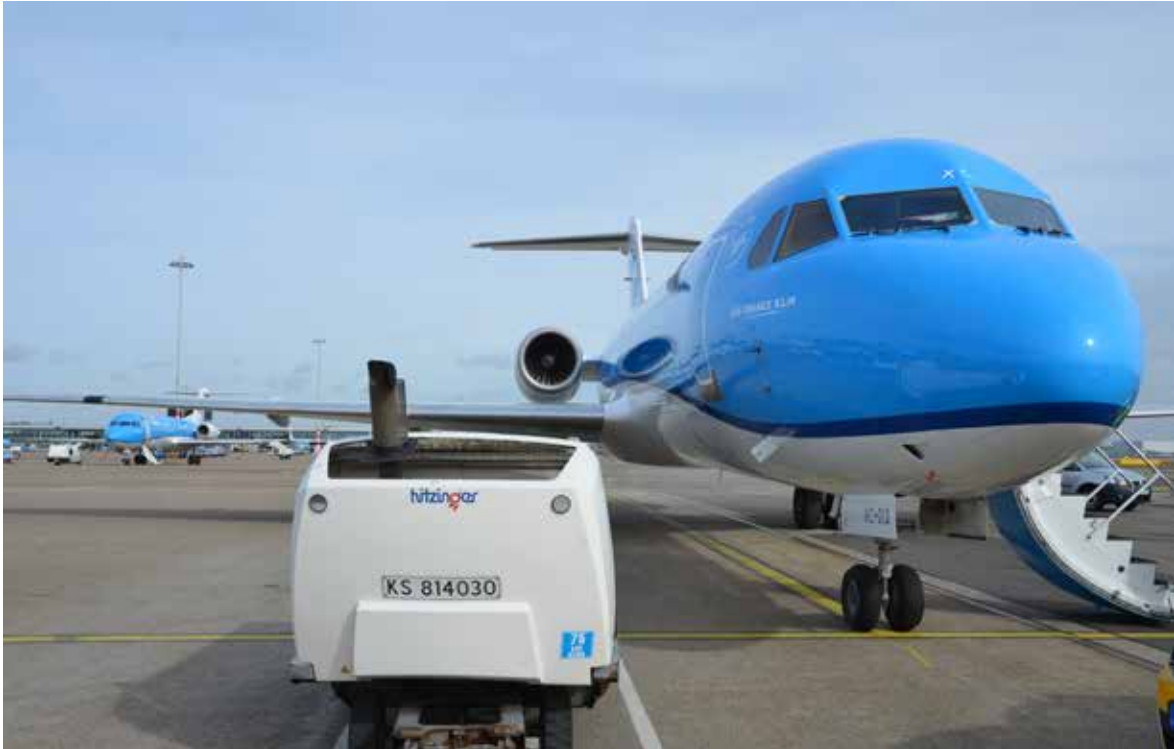
Figure 3: GPU and aircraft after being towed back to its stand after the event. (Source: Aviation police)

The right wing showed damage of the lower skin, leading edge and flap caused by the exhaust pipe of the GPU. A shielded wire¹² of the right hand outboard wheel speed sensor was found broken and a wire¹³ of a landing gear door was found damaged. According to the operator, regarding the damage on the right wing and the damage of both wires, the distance between both locations could not be the result of the collision with the GPU.

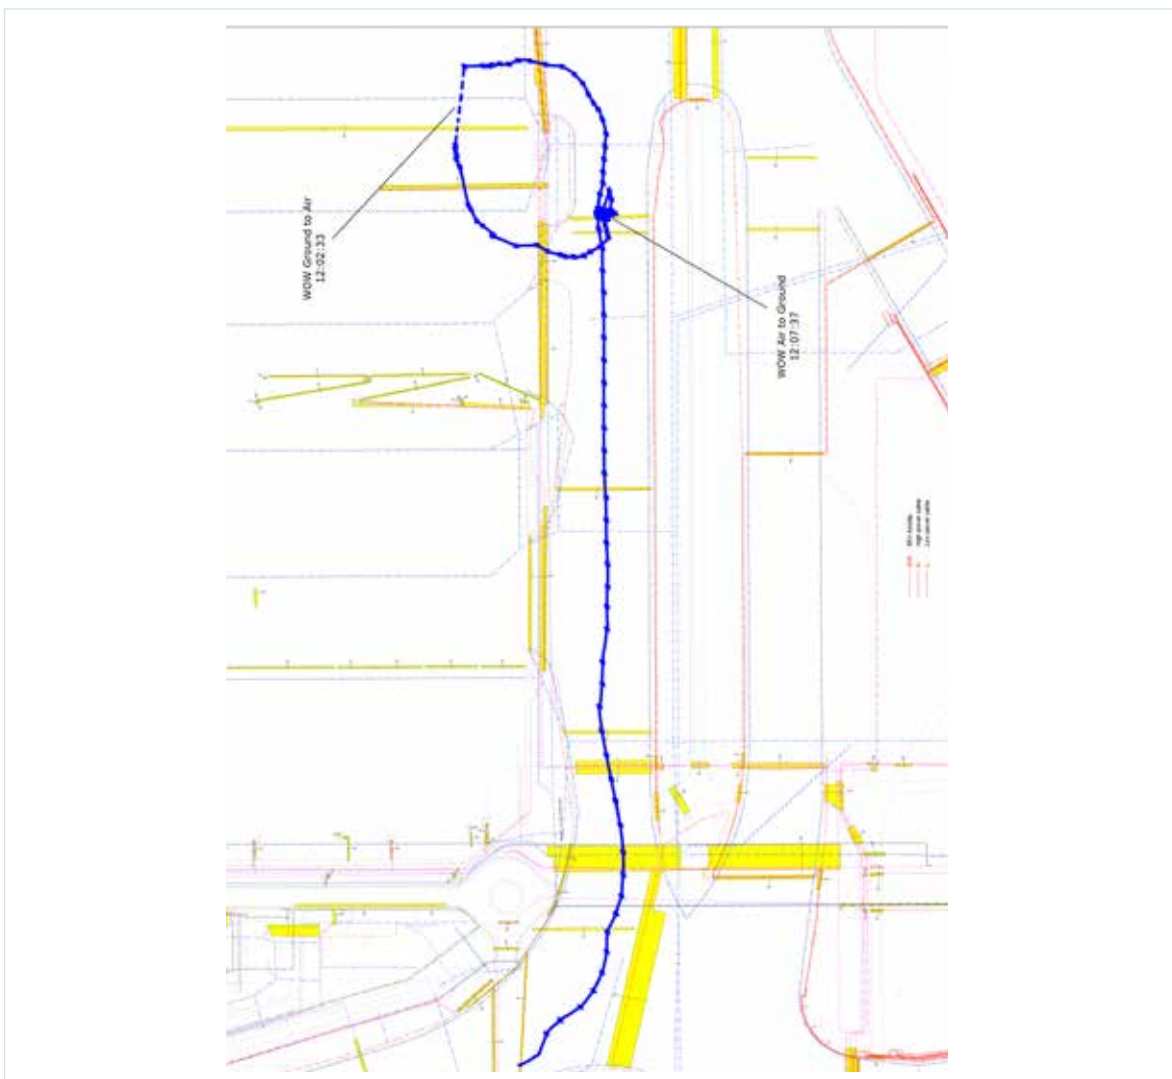
The electrical power supply on airports is usually transported by underground power cables. Since cables produce electrical-magnetic fields, the position of the cables⁴⁰ and the power that was being transported at the moment of the event were reviewed. The taxi track followed by the PH-WXC and the position of the power lines were analysed versus the moment of ground to flight mode switching, see also Figure 4.

Figure 4: Taxi track and position of the power cables.

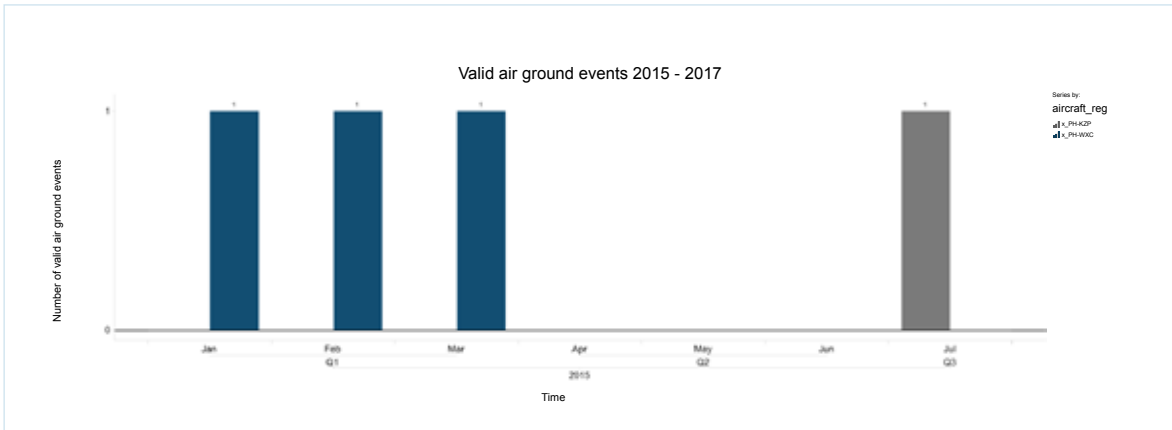
The figure represents three reports (not spikes) of ground flight switching of the PH-WXC (10 January, 18 February, 5 March 2015) and one of the PH-KZP (July 2015). No ground-flight switching events were observed in 2016 and 2017.

Figure 5: Incorrect ground flight switching analysis 2015 through 2017.

The operator also found approximately 170 ground-flight switching spikes in its data analysis following an electrical power switch (following engine shut down). In view of the operator these spikes should be considered as invalid as multiple variables indicate impossible values at the same time. They should be rejected as evidence of ground-flight switching.
