# Loss of control after interrupted winch launch, Gilze-Rijen Air Base

*The Hague, May 2021*

Identification number:	2020047
Classification:	Accident
Date, time of occurrence:	12 July 2020, 12.47 hours <sup>1</sup>
Location of occurrence:	Gilze-Rijen Air Base
Registration:	PH-1150
Aircraft type:	Rolladen-Schneider LS8-18
Aircraft category:	Glider
Type of flight:	Pleasure
Phase of operation:	Winch launch
Damage to aircraft:	Nose destroyed, fuselage and cockpit severely damaged, tail broken
Flight crew:	One
Passengers:	None
Injuries:	Pilot fatally injured
Other damage:	Fence
Light conditions:	Daylight

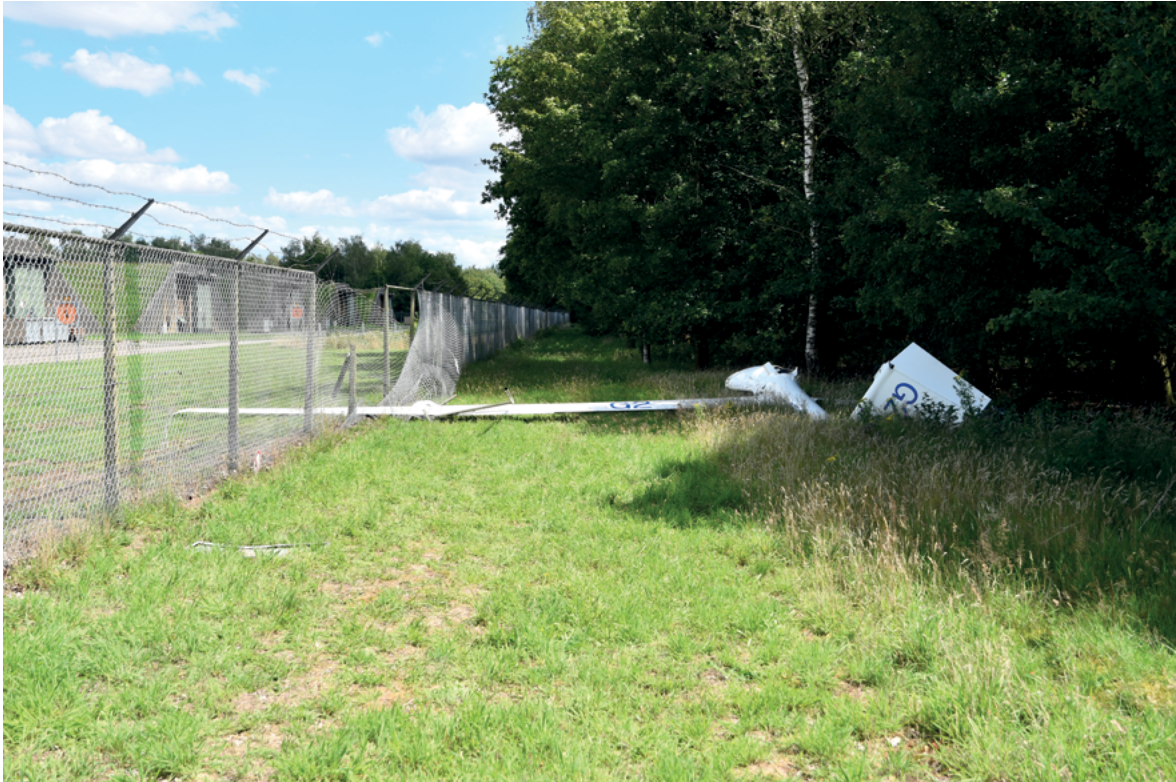
Figure 1: Accident location. (Source: Dutch Aviation Police)

The right wing of the glider ended up on a fence. The fence was damaged as a result (see Figure 1).

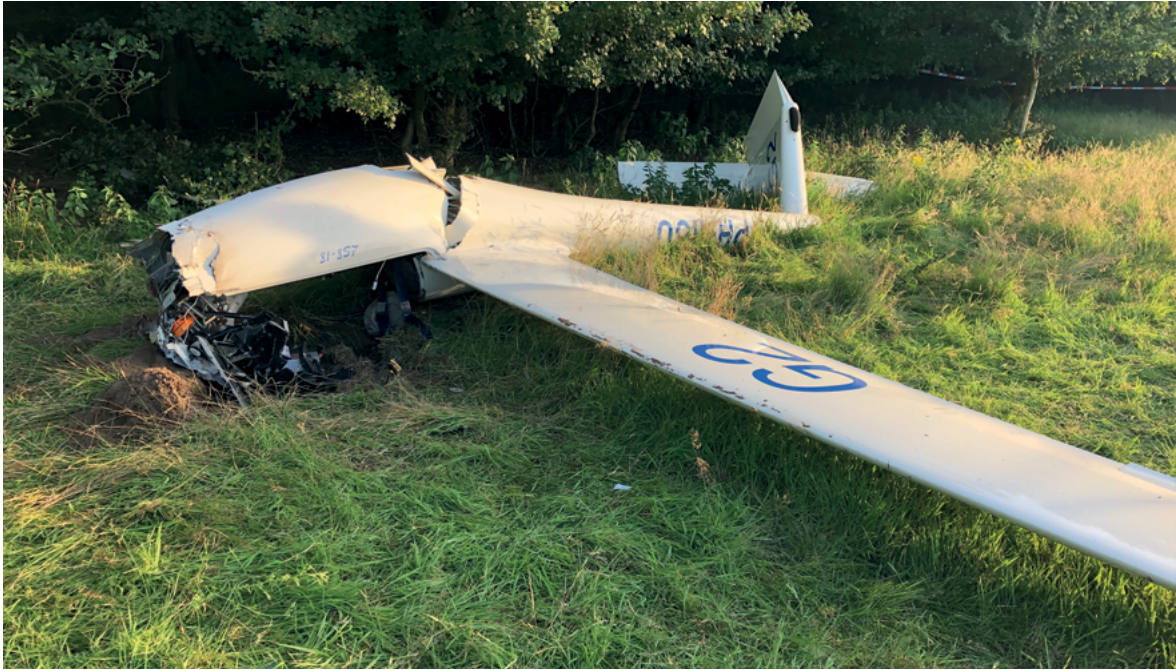
The nose was destroyed and the tail had broken off as a result of the crash. The fuselage was almost broken in half at the level of the wings. The wheel bay and the cockpit were severely damaged (see Figure 2). The right wing was damaged at the point where it hit the fence. The underside of the trailing edge of the left wing was damaged. The glider was beyond repair.

Figure 2: Wreckage of the glider. (Source: Dutch Safety Board)

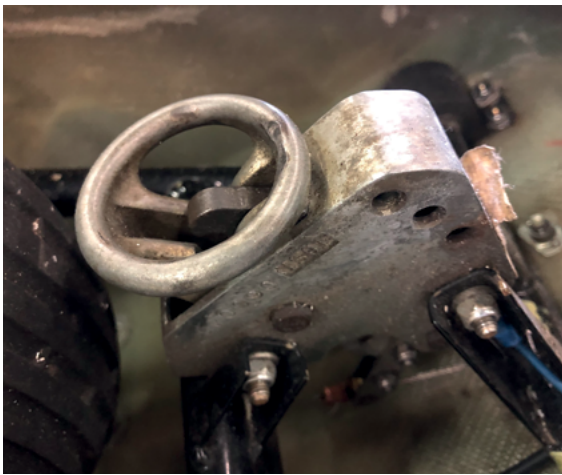
The winch cable is connected to the glider via the centre of gravity release hook (see Figure 3), which is attached to the bottom of the fuselage near the landing gear (see Figure 5). The pilot can release the cable during the winch launch, by pulling the yellow T-shaped handle in the cockpit. The cable release handle in the LS8 is normally guided a little further into the cockpit, via a molded sleeve<sup>17</sup>, to enable the pilot to access it better during flight (see Figure 4).

The hook has automatic safety release features, governed by a special solid-steel ring. It operates on kinematic principles. The solid, high-grade steel ring takes the lateral load of the cable and governs the automatic release. After 2,000 starts, the release hook must be sent to manufacturer for an overhaul. According to the records, PH-1150 had made a total of 1,737 flights with this hook up to and including 11 July 2020.

Figure 3: The centre of gravity release hook of PH-1150. (Source: Dutch Safety Board)

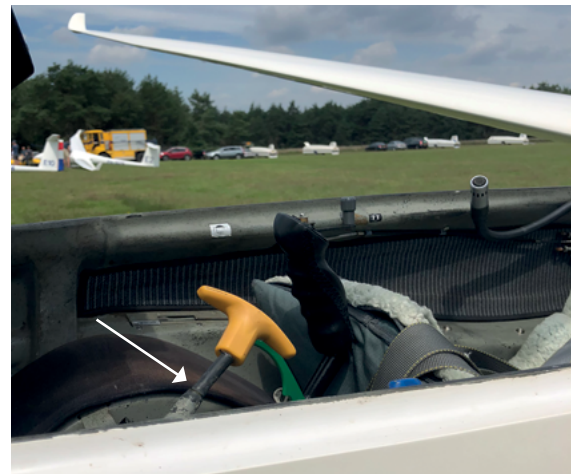
Figure 4: Molded sleeve and yellow release T-shaped handle in another LS8's cockpit. (Source: Dutch Safety Board)

As a result of the broken molded sleeve, the yellow release handle in the cockpit, which is connected to the release cable, hung loosely. Because of this, it was possible that the release handle was hanging outside the cockpit when the canopy was closed. This is undesirable, because then the canopy cannot be closed properly and the handle is also not accessible to the pilot. Hence a repair was carried out. The purpose of the repair was to bring the molded sleeve (and also the yellow handle) more in the pulling direction towards the pilot. In the workshop it was found that the repair of the broken molded

28 The break may have been caused by disproportionate loads, which occurred when the release handle was pulled by someone outside the glider through the sliding window in the canopy

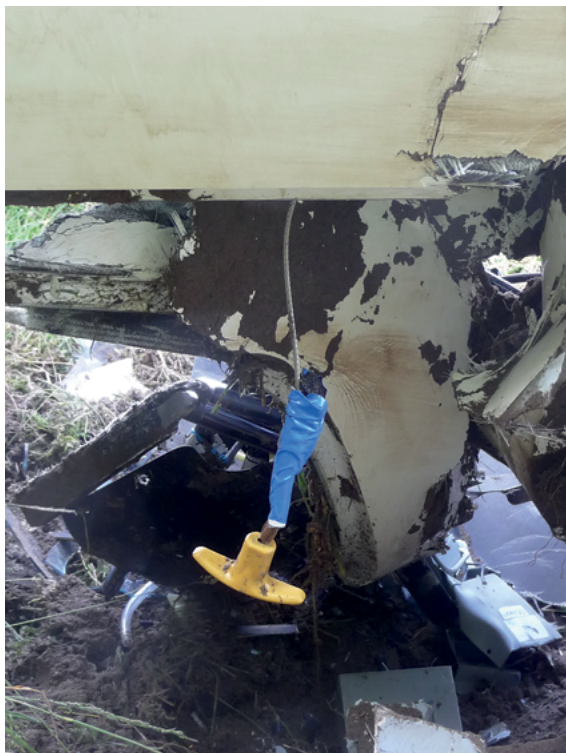
sleeve would take longer than hoped for and it was therefore decided to make a temporary repair.<sup>31,32</sup> See Figure 6.

Figure 6: The temporary repair of the molded sleeve, as found at the accident site.  
(Source: Dutch Safety Board)

The pilot, who experienced the third premature cable release, observed after the next (and last) flight of PH-1150 that day, that the repair to the molded sleeve had broken and detached.

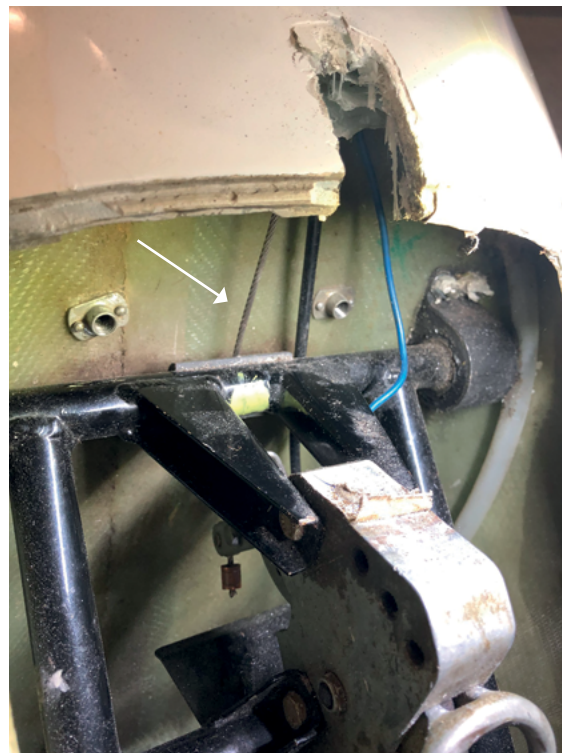
Figure 7 shows the routing of the metal release cable after it had been adjusted on 8 July 2020. As visual, the metal cable runs behind a crossbar of the landing gear. It was found, when the glider was in the workshop, that this routing ran incorrectly along the landing gear on this side of the crossbar, as shown in Figure 7. There was a visible wear spot on the crossbar of the landing gear along which the cable had run.

Figure 7: The metal cable of the release mechanism after the routing adjustment.  
(Source: Dutch Safety Board)

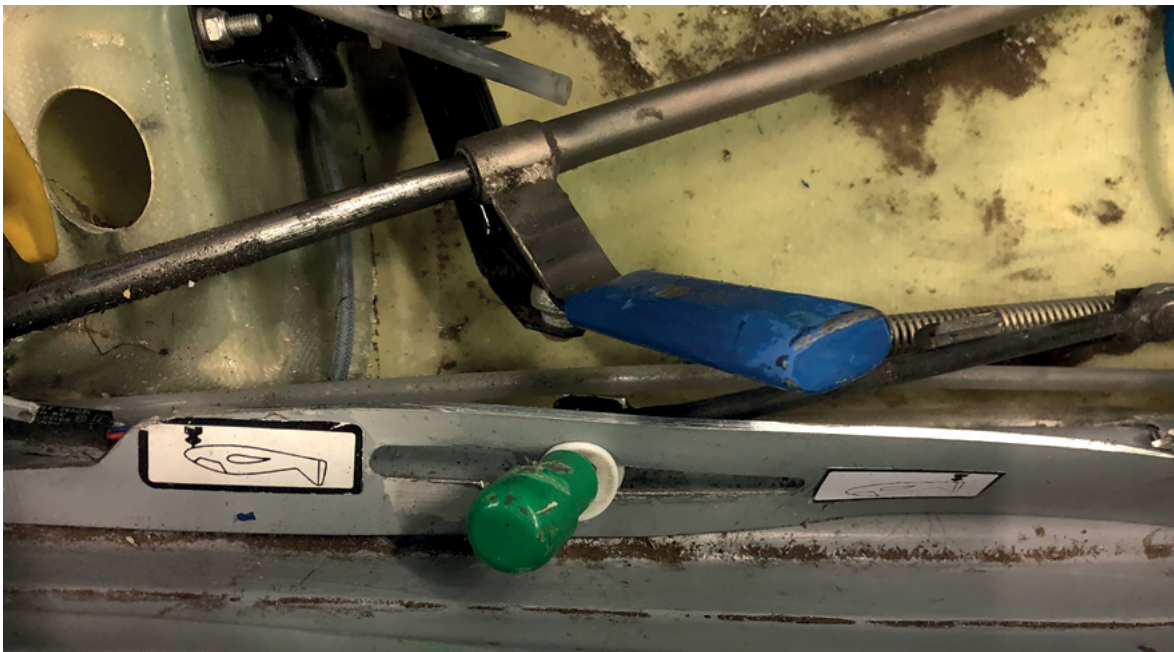
The nose section of the glider was destroyed and the cockpit was severely damaged. The green trim position indicator was found near the neutral position, just a bit forward of it: see Figure 8. The slot in which the indicator moves, was bent. No marking to indicate the neutral position of the indicator was visible along the slot. The lever to operate the retractable landing gear was found in the 'extended' position. Two orange coloured pieces of lead, of which the text 'LS8' was visible on one, were found in the nose of the cockpit.

Figure 8: Green trim position indicator and the blue air brake handle. (Source: Dutch Safety Board)

The green trim position indicator was found near the neutral position, just a bit forward of it. As the slot, in which the indicator moves, was bent, it is possible the indicator had moved as a result of the impact forces. This could not be determined. According to the Flight Manual, the trim should have been set to slightly nose heavy. As the manual is not clear about the exact position the trim should be set to during takeoff, it could not be established if the trim position may have contributed to inadequately lowering of the nose, after the cable disconnected. However, it is unlikely that the trim position had a significant influence on this.

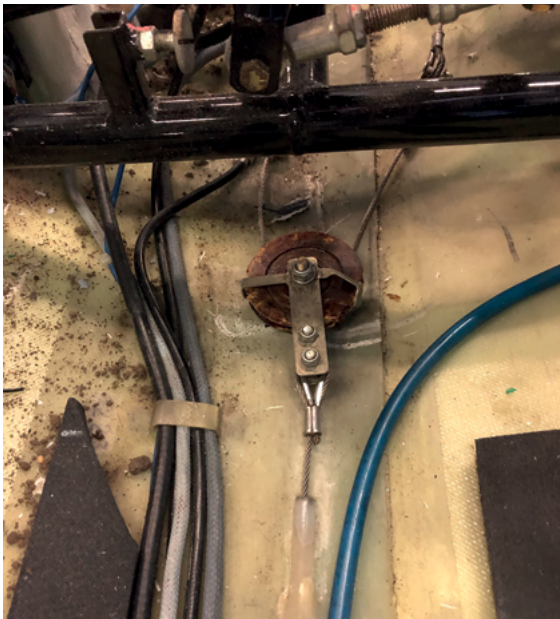
On the inside of the cockpit, under the seat, there is a pulley, made of a synthetic resin<sup>38</sup>, around which a cable runs towards the nose hook.<sup>39</sup> This cable and the pulley are part of the cable release mechanism. The pulley is also connected to a cable that runs backwards and is connected to the centre of gravity hook.<sup>40</sup> See Figure 9. The cable that runs through the pulley to the nose appeared to have come loose from the pulley. See Figure 10. The edge of the pulley was found damaged in some places. A technician stated that no peculiarities of the pulley and cable were found during the last maintenance in the winter.

Figure 9: Pulley and release cable at the bottom of the cockpit. (Source: Dutch Safety Board)

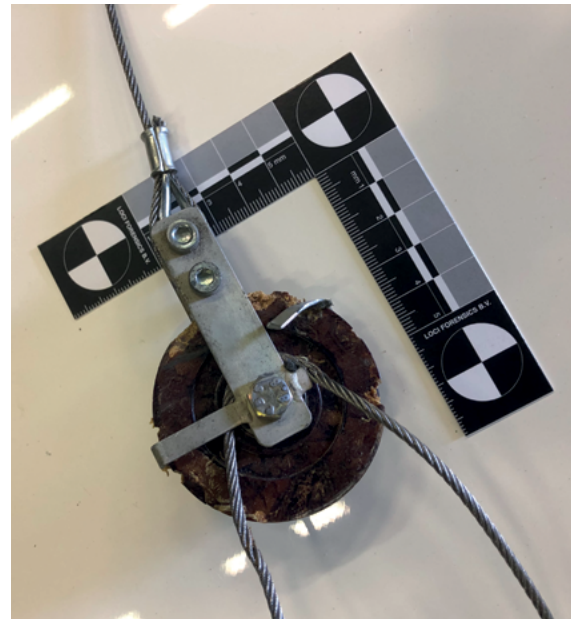
Figure 10: Loose cable around pulley. (Source: Dutch Safety Board)

The cable, which is part of the release mechanism and runs through a pulley to the nose of the glider, appeared to have come loose from the pulley. The edge of the pulley was found damaged in some places. The synthetic resin, from which the pulley is made, becomes brittle over time. This may cause the edges to break. The cause of the damage to the pulley has not been investigated. No peculiarities of the pulley and cable were found during the last maintenance. It is unlikely that the cable came loose while making the repair to the molded sleeve or the adjustment of the routing of the release cable. It is therefore likely that the cable came loose as a result of impact forces during the crash.

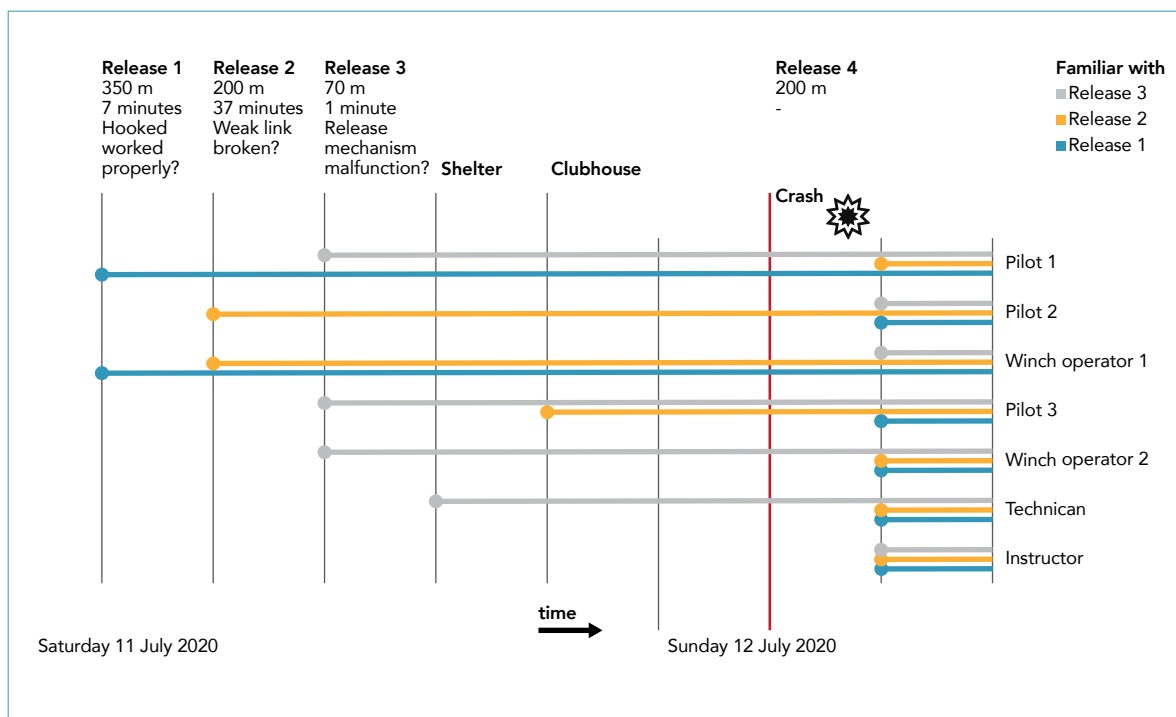
Figure 12: Schematic representation of the times when the main persons involved became aware of the three separate premature cable releases. Pilot 1, 2 and 3 are the pilots involved in respectively the first, second and third premature cable release. Technician is the technician who received the verbal report about one premature cable release. Instructor is the instructor in charge during the accident flight.

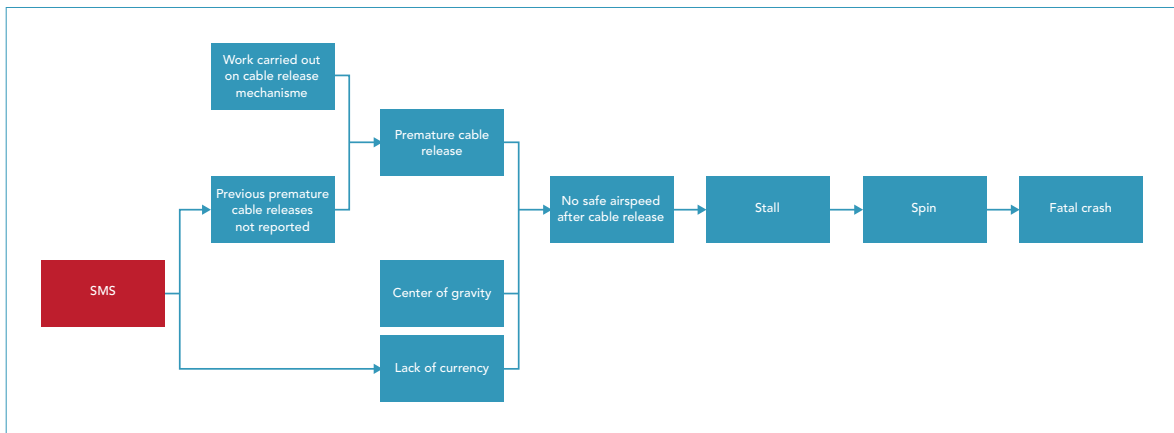
Concluding, a temporary repair had been carried out on PH-1150 and then three times a premature cable release took place. PH-1150 was subsequently not grounded, but made available for flight operations with a malfunction of the cable release mechanism, without

the cause of the cable releases being thoroughly analysed. This in combination with the allocating of PH-1150 to a pilot, with a lack of recent experience on single seater gliders, created a situation in which the accident could occur. The club's safety management system did not ensure that such a situation was prevented from happening.

Figure 14: Schematic representation of the findings. SMS stands for the club's safety management system.
