DUTCH  
SAFETY BOARD

# Loss of control after opening of canopy, near Kornhorn

*The Hague, February 2023*

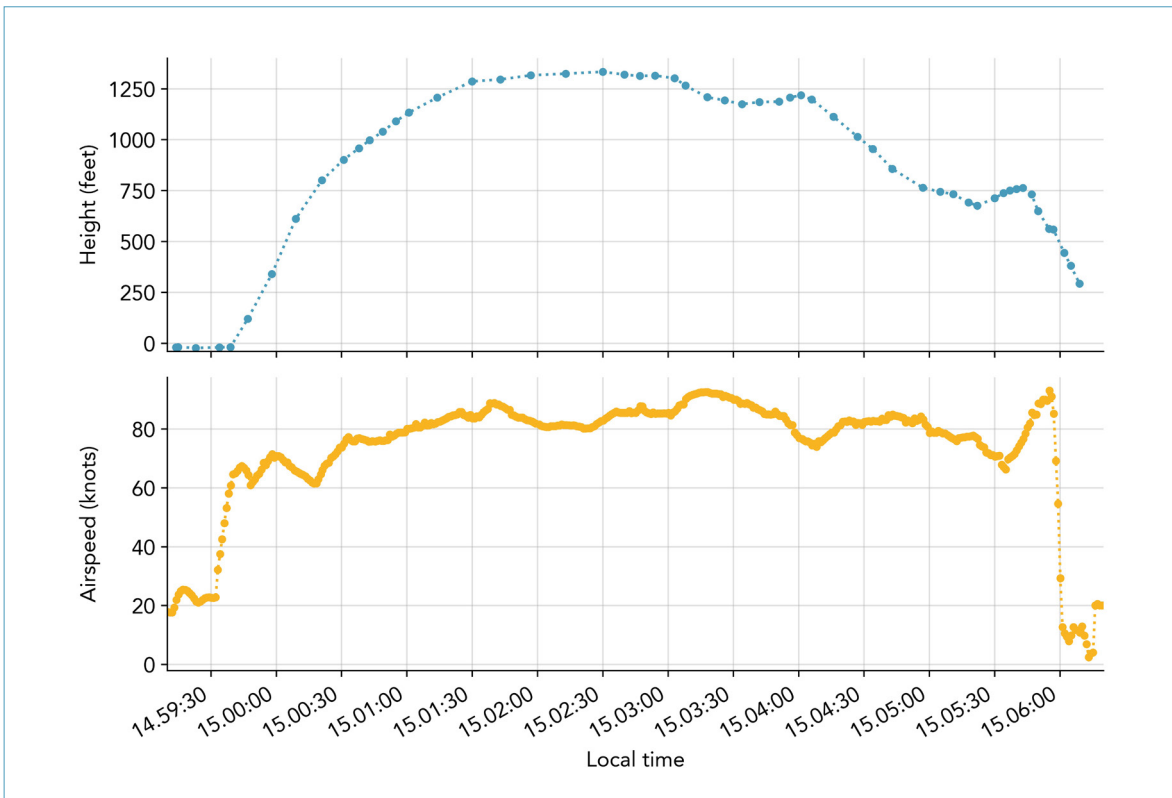
altitude of approximately 760 ft, decreasing the airspeed to 70 kts. From the altitude of 760 ft, the aircraft descended until the end of the recordings. The airspeed during the descent increased to around 90 kts. The last recordings of the speed are not considered reliable (see Figure 2).

Figure 2: Graph with height in feet and airspeed in knots (kts) during the flight. (Source: Dutch Safety Board)

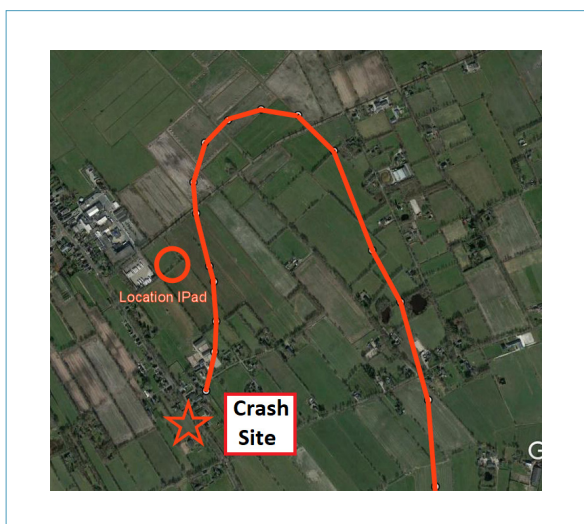
Eye-witnesses observed the aircraft flying near Kornhorn, about 11 kilometres northeast of Drachten Airport. Several witnesses stated the aircraft pitched down and up, followed by a dive towards the ground. Witnesses saw objects flying out of the cockpit and one witness stated the canopy of the aircraft appeared to be open. Light items, like papers, were found in the wide surroundings along the last part of the flight path. Heavier items, like the iPad, keys and aircraft logbook, were found close to the flight path, around 600 metres before the crash site (see Figure 3).

Figure 3: Last part of the flightpath. (Source: Google and Dutch Safety Board)

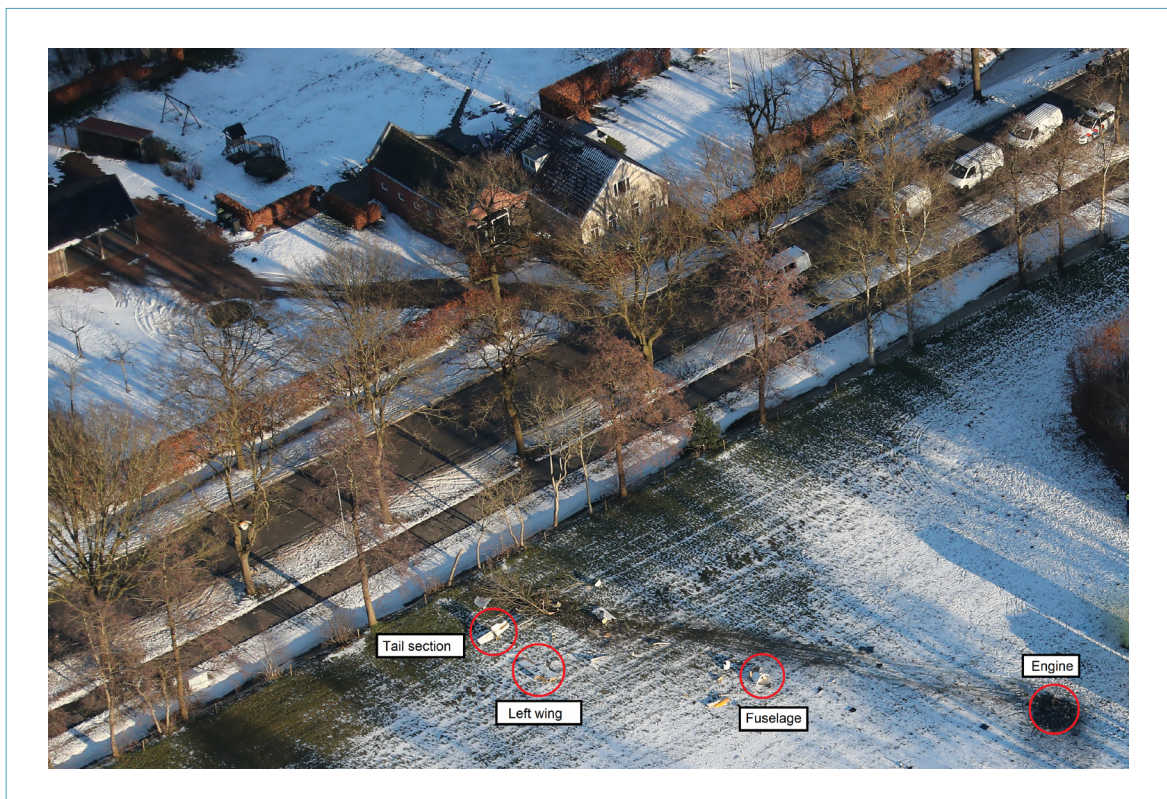
The aircraft was destroyed as a result of the crash and the post-impact fire. Part of the wing was found in a ditch near where the aircraft struck the trees. A large part of the tail-section was found together with the branches that were broken as a result of the impact. A large part of the canopy frame was found near the tail section. Several other aircraft

parts were scattered across the meadow. The engine was found several meters beyond the main aircraft wreckage (see Figure 4).

Figure 4: Crash-site. (Source: Aviation Police)

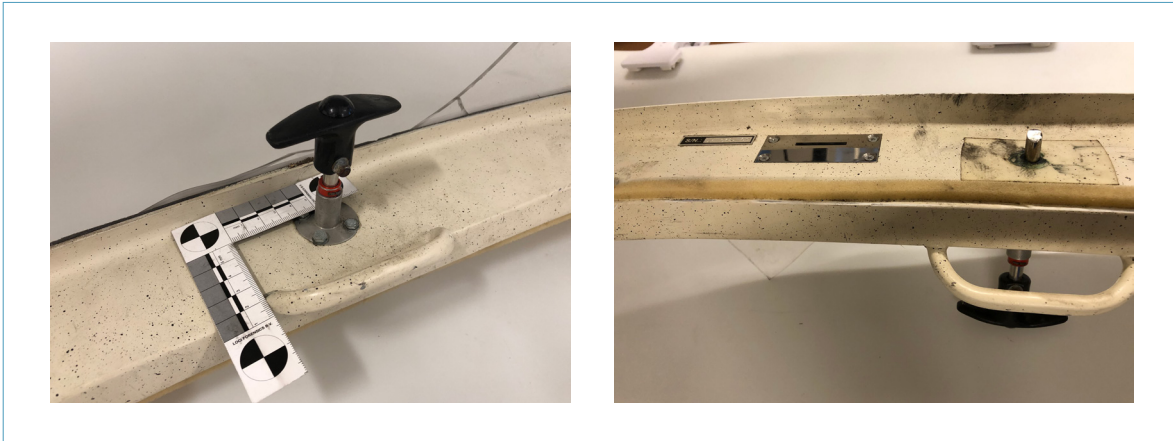
Figures 7a and 7b: Open/closing handle with red ring and locking pin of PH-4E7. (Source: Dutch Safety Board)

The canopy frame and the relevant part of the fuselage were found damaged. Investigation revealed that the latching and locking system was undamaged and functioned without problems.

The latching and locking system of the canopy was found undamaged and functioned without problems. Due to the construction of the latching and locking system, the canopy cannot unlock and open on its own when properly closed and locked. It is highly unlikely

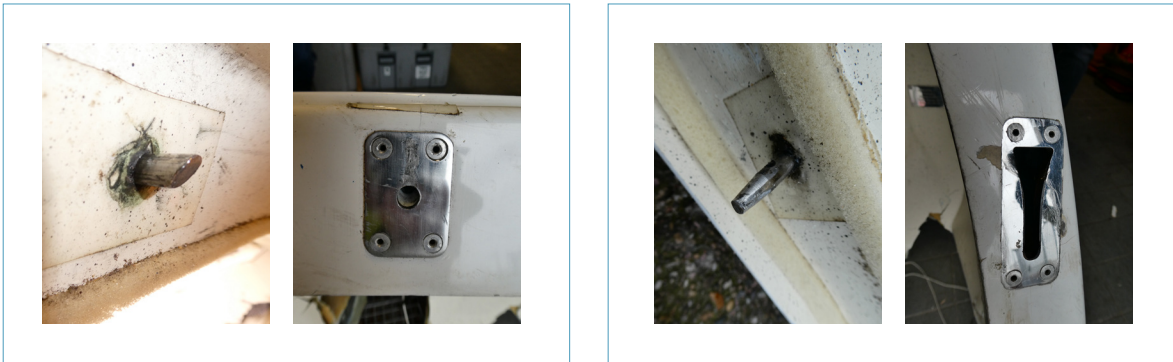
Figure 8a: Locking pin and Figure 8b: Locking socket. (Source: Dutch Safety Board)

Figure 9a: Guiding pin and Figure 9b: Guiding slot. (Source: Dutch Safety Board)

A repair was found around one of the guiding pins in the canopy frame. A plastic card was used for this repair as a mold for the resin and the card was still in place. It turned out that the repair was carried out, after the pin had been found loose after the incident on 5 December 2020 (see Section 2.11.1), by a member of the flying club on his own initiative and without consultation of the responsible persons. This repair was not included in the technical administration of PH-4E7.

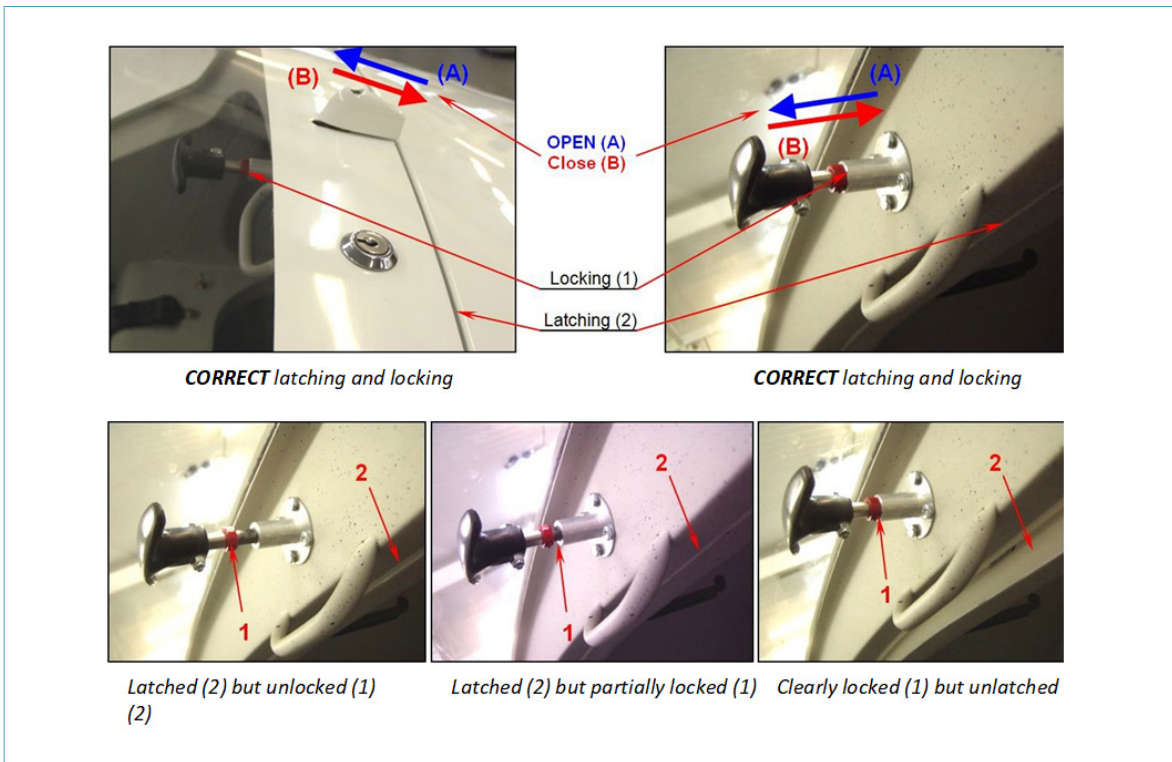
Figure 10: Examples of correctly and incorrectly closed canopies. (Source: POH Aerospool WT9, issued 20 January 2015)

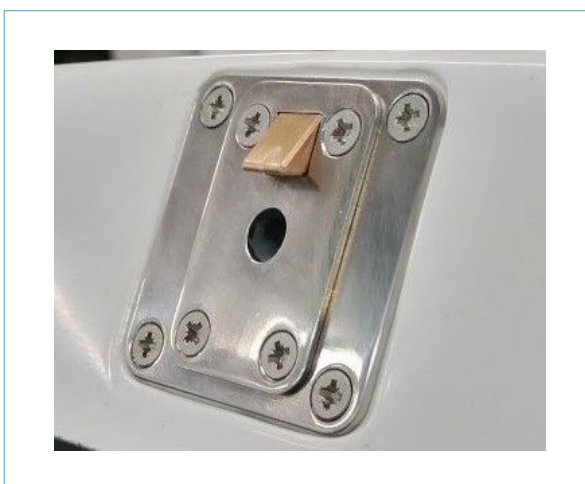
Figure 12: New lock with an additional safety latch. (Source: Aerospool)

The installation of the canopy lock with safety latch and sensor as recommended by the manufacturer had not been installed on the aircraft at the time of the accident. The board of the flying club was of the opinion that implementation of this recommendation was not necessary. Why and when this decision was made could not be determined.

Manufacturer Recommendation DV WT9 10B/2019 was issued on 4 April 2019. This recommendation applies to all WT9 Dynamic MLA.<sup>7</sup> It recommends to install a new canopy lock with an additional safety latch and sensor, which holds the main latch after plug-out from the canopy lock socket and a check lamp on the instrument panel as an indication of insufficient plug-in of the main latch (see Figure 12).

After two more occurrences, the manufacturer issued a non-mandatory recommendation on 4 April 2019, to further minimize the risk of inadvertent opening of the canopy during flight. It recommends installation of a canopy lock with safety latch and sensor. Therefore, a more adequate solution was available to prevent a pilot from taking off while the canopy is not properly closed or keeping the canopy closed in case of an inadvertent opening. However, it is not mandatory to install this provision as it is a recommendation. It is up to aircraft holders to decide on implementation of this recommendation.
