DUTCH  
SAFETY BOARD

# Loss of control during touch-and-go

Piper PA-28-181

*The Hague, February 2022*

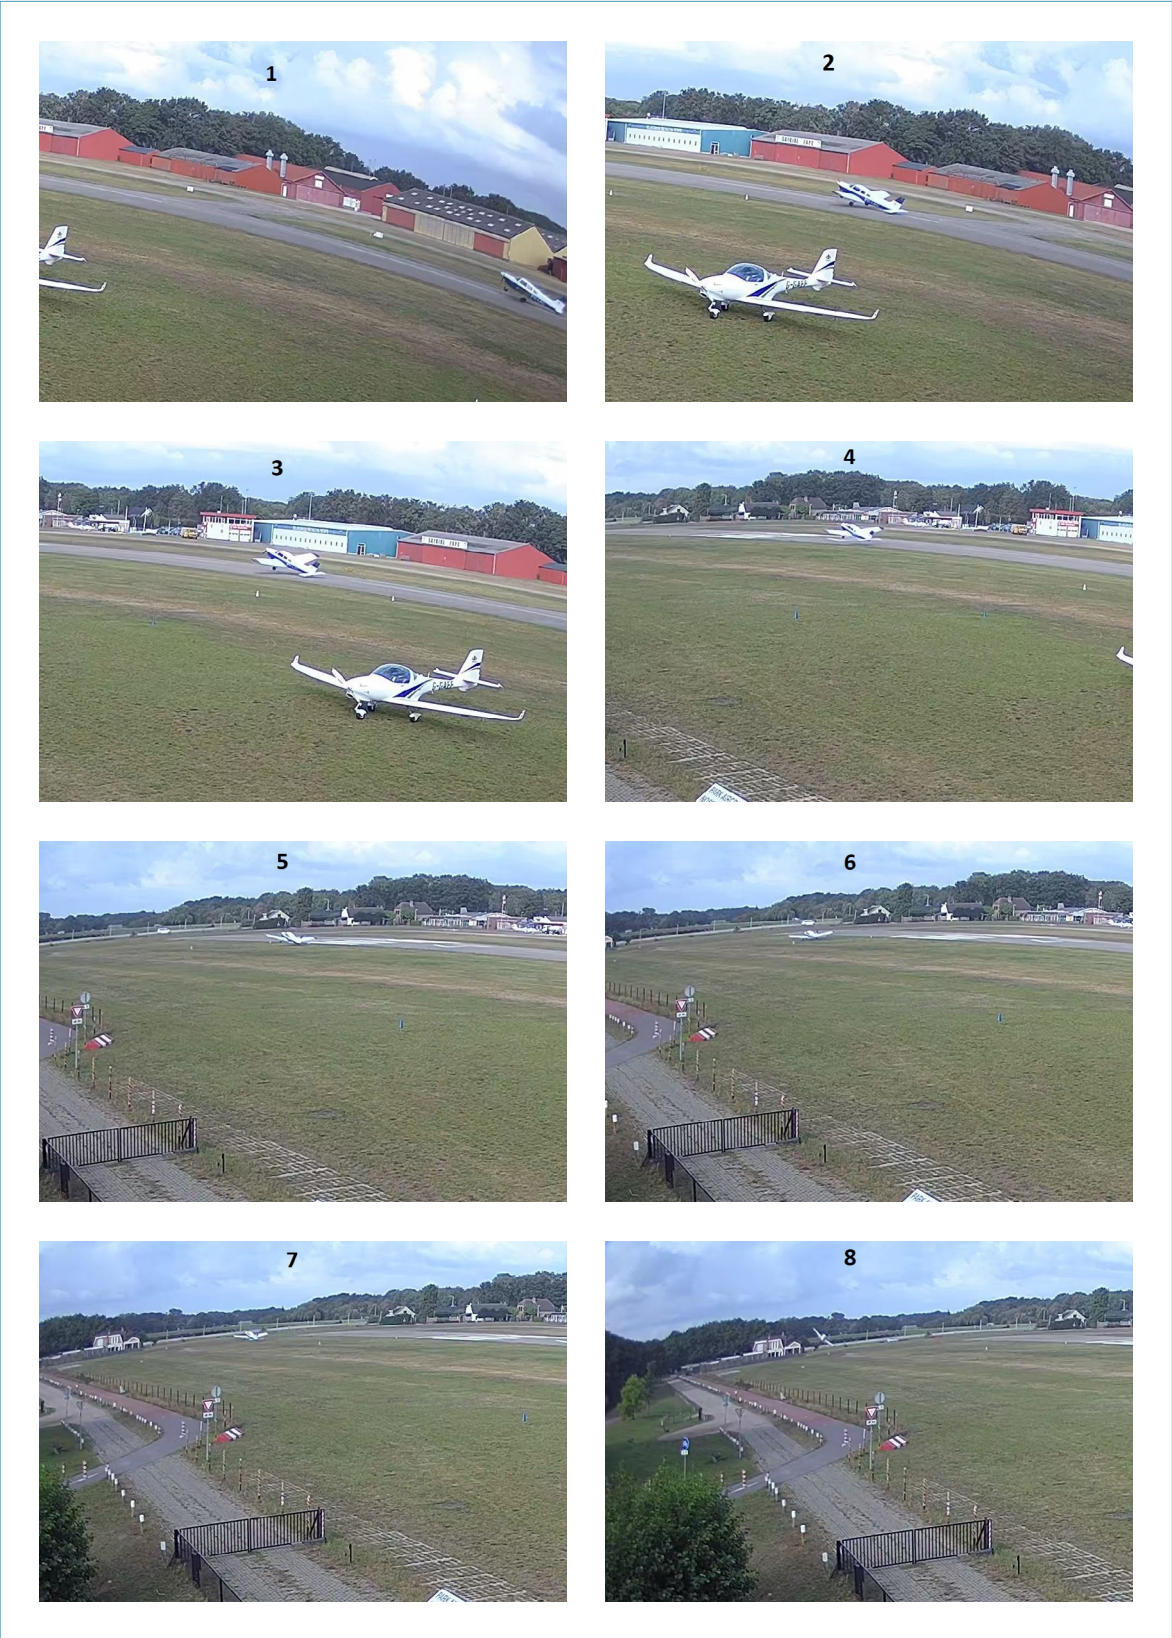
Figure 1: Images of the recorded camera footage of the crash. (Source: Breda International Airport)

The airport is equipped with cameras. One of these cameras is aimed at the last part of runway 25 and had recorded most of the accident. The events are portrayed in Figure 1 (pictures 1-8) and represent a time frame of roughly 13 seconds. The eight pictures in Figure 1 portray the following events in the recordings:

- The recordings show around the last 300 metres of the runway and the area outside the airport where the aircraft crashed. From the moment the aircraft is visible on the recordings, it rolled over the runway in a nose-up position, with the nose wheel lifted from the surface (see Figure 1, pictures 1-2).

- Around 200 metres before the end of the runway, the aircraft's nose lifted a little more, where after the aircraft became airborne a little above the surface, still with a nose-up attitude (pictures 3-4).

- The aircraft banked a little to the left, consequently drifting to the left. Abeam the threshold of runway 07, it drifted left of the runway, touched the grass and rolled several metres on the grass (pictures 5-6).

- Abeam the end of the concrete, the aircraft became airborne again and after some metres of flying, the aircraft banked to the right and lost height. The right wingtip hit the ground, where after the aircraft crashed (pictures 7-8).

The footage (Figure 1) shows that during the takeoff roll, the nose wheel of the aircraft was permanently detached from the ground and that the aircraft had a high nose attitude during the takeoff roll. This is an indication that, although the instructor stated that he pushed the yoke after the landing, the yoke was still pulled or pulled again.

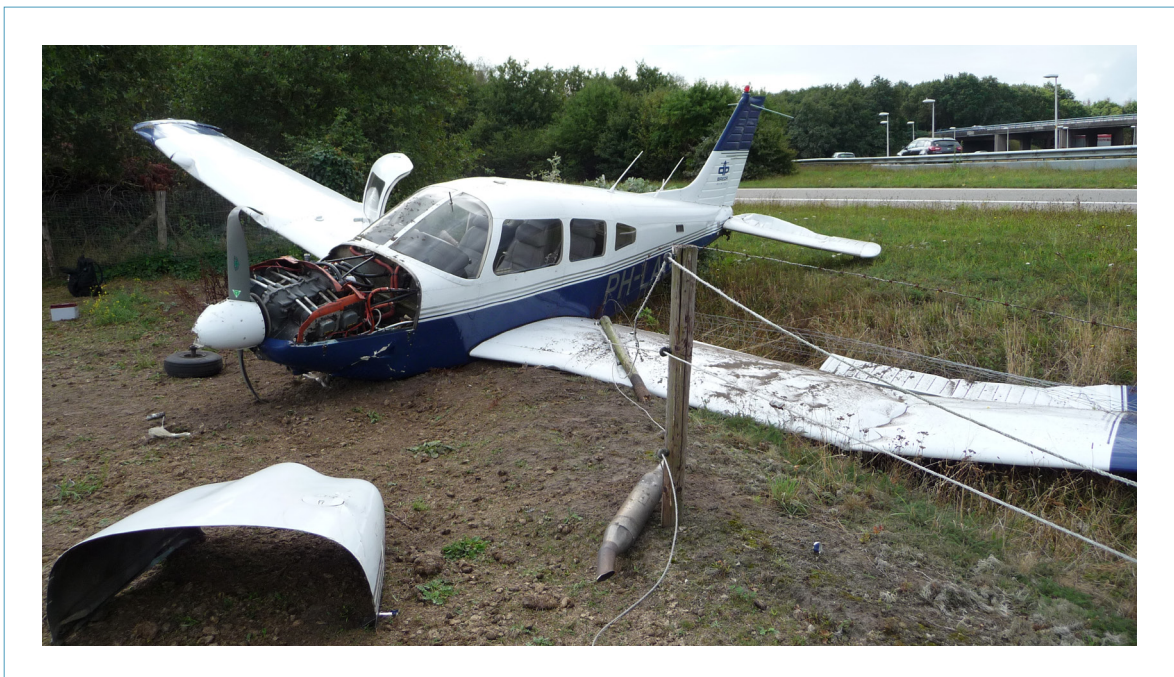
Figure 2: The Piper after the crash. (Source: Dutch Safety Board)

Both wings, the under carriage, the front including the propeller and the horizontal stabilizer of the aircraft were heavily damaged.

The primary control surfaces and controls of PH-LAG were examined and found working as normal, although their functioning was limited due to the damage. The elevator trim tab was found down, meaning 'nose up', but the elevator trim control in the cockpit was found in slightly 'nose down' position. The flap control handle was found in the first detent, indicating 10° flaps, which matched with the found position of the wing flaps.

The aircraft ended up in a fence, which was partly destroyed as a result (see Figure 2).

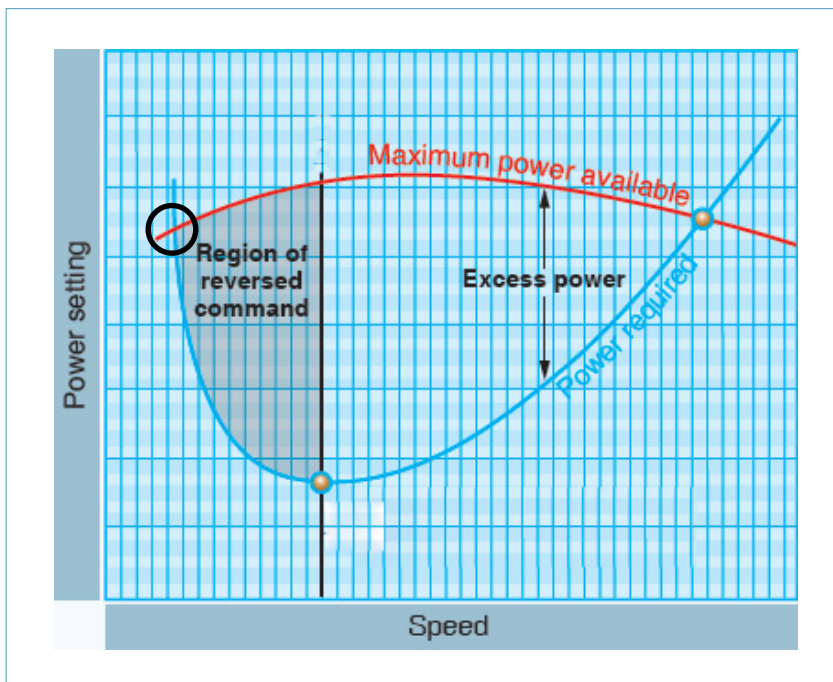
Figure 4: Power curve. (Source FAA, modified)

Despite the fact that the instructor had selected full power, the aircraft did not accelerate during the touch-and-go. This can be explained by the aerodynamic properties. A moving aircraft has to overcome drag to be able to fly. The total drag consists of parasite drag and induced drag. Parasite drag is highest at high airspeeds, induced drag is highest at slow airspeeds and high angles of attack. To overcome the total drag of the aircraft to be able to fly, the power available must be higher than the total drag. The difference between the available power and the power required to fly, determines the climb or acceleration capability. At a certain point at low speed, the maximum available engine power is not enough to compensate the drag. If this happens during flight, an increase in power can easily lead to an increase in drag. This is called the 'back-side-of-the-power curve' or 'the region of reversed command'. This was the case during the takeoff roll: the drag as a result of the high angle of attack and the relative low airspeed could not or hardly be compensated by the engine power (see the black circle in Figure 4).

When full power is already selected, lowering the nose of the aircraft to decrease the angle of attack is the only way to increase speed.

The drag as a result of the high angle of attack and the relative low airspeed could not or hardly be compensated by the engine power.
