DUTCH  
SAFETY BOARD

# Loss of directional control during water landing, Consolidated PBY-5A Catalina

*The Hague, December 2018*

Identification number:	2017086
Classification:	Serious incident
Date, time <sup>1</sup> of occurrence:	15 August 2017, approximately 14.15 hours
Location of occurrence:	IJsselmeer, near Lelystad, the Netherlands
Aircraft registration:	PH-PBY
Aircraft model:	Consolidated PBY-5A Catalina
Type of aircraft:	Twin engine amphibious
Type of flight:	Memorial flight followed by touch-and-go on water
Phase of operation:	Landing
Damage to aircraft:	Minor
Cockpit crew:	Two
Cabin crew:	One
Passengers:	Fifteen
Injuries:	None
Other damage:	None
Lighting conditions:	Daylight

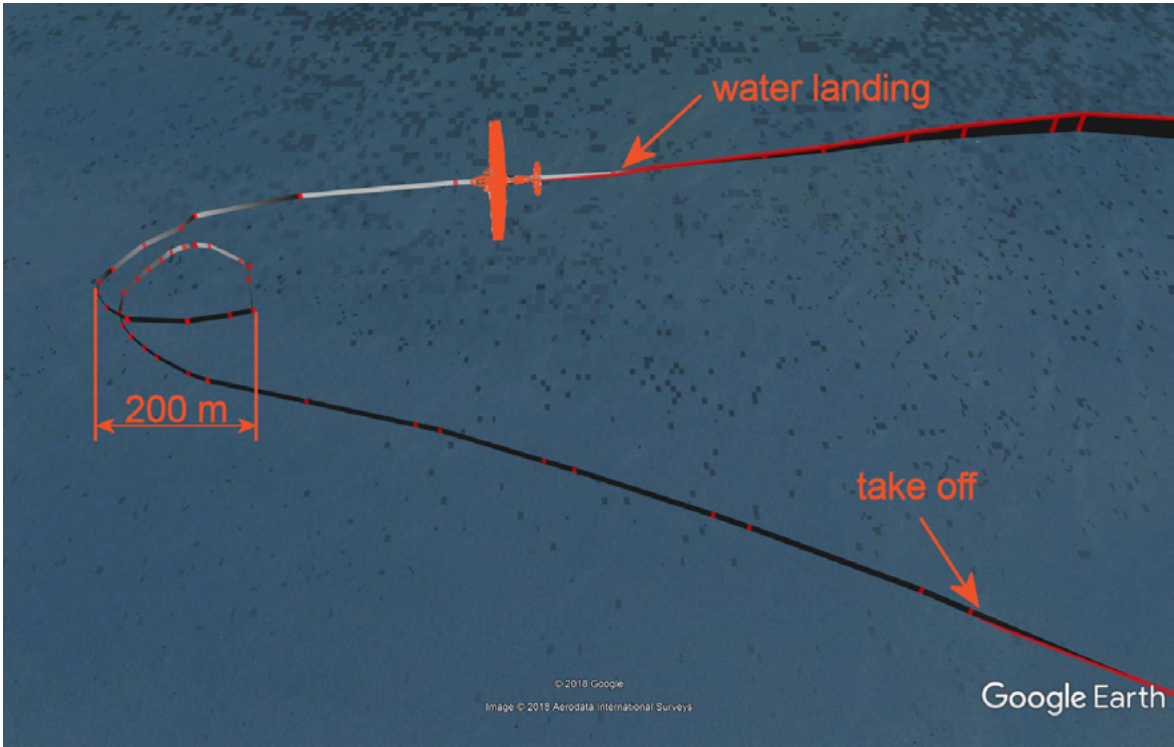
Before the water landing, wind direction and wind speed were checked and an inspection run was performed to look out for ships, buoys and other possible obstacles that might jeopardise the landing. No abnormalities were seen and the crew performed the briefing and the approach checklist. The approach started at 300 feet with an airspeed of 85 knots. Shortly before the water landing the airspeed was reduced to 72 knots. Vertical speed was between 100 and 200 feet/minute. Immediately after hitting the water the aircraft started to turn severely around the vertical axis to the left. The captain, who was pilot flying (PF), ordered full power from the pilot monitoring (PM). Despite full right rudder and aid of the ailerons, the aircraft persisted the left-hand turn. The PM selected asymmetric power to counteract the movement around the vertical axis. After a full 360-degree turn, directional control was suddenly regained after which the PF ordered full power.

Figure 1: Track of PH-PBY on the water, based on GPS recording. (Source: PBY Catalina Foundation)

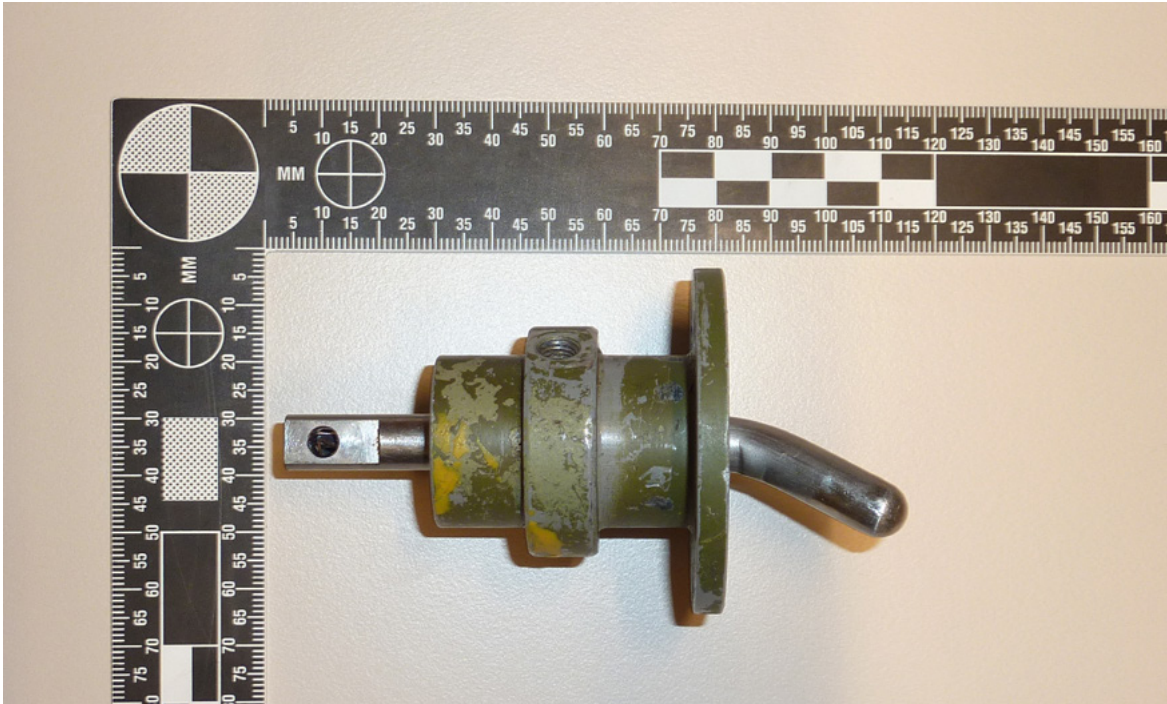
When pressure is applied to the hydraulic cylinder the torque tubes start to rotate and open or close the corresponding wheel doors. Before the doors can be opened, a lock pin on each door must be retracted. When the lock pins are not retracted, the doors remain closed and the nose wheel cannot be lowered. During inspection of the nose gear mechanism of PH-PBY, the flight crew's initial findings were confirmed: the left-hand door was missing completely. Besides the missing door it was discovered that the left-hand lock pin was bent in the extended (locked) position (see Figures 6 and 7).

Figure 6: Bent left hand lock pin. (Source: Dutch Safety Board)

When the flight crew attempted to lower the nose gear, the bend prevented the pin from retracting. Because both lock pins are mechanically connected, also the right hand lock pin remained in the extended (locked) position and prevented the right-hand wheel door from opening. With a closed wheel door the nose gear could not be lowered. This forced the flight crew to make a nose wheel up landing.

After a more than 360-degree turn on the water, the left-hand wheel door was most likely ripped off. This caused the movement to the left to stop. The flight crew then managed to regain control of the aircraft, increased speed and took off. The bending of the left-hand lock pin most likely occurred when the door broke off.

- The operator is intending to mount sensors near both lock pins and an indicator in the cockpit to enable the flight crew to check the status of the pins (locked or unlocked).
- Two small bluetooth cameras will be installed in the nose wheel bay and linked to an iPad in the cockpit to check if the nose wheel doors are closed completely.
- Deflector spoilers will be fitted to the fuselage to deflect the full water force from the front of the nose wheel doors.

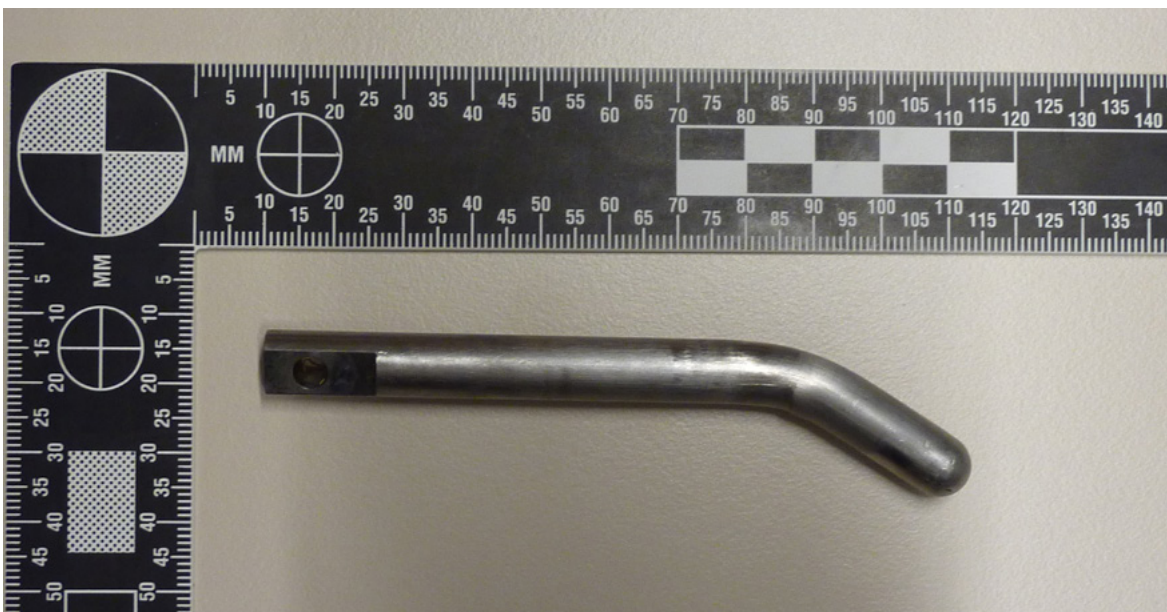
Figure 7: Disassembled left-hand lock pin. (Source: Dutch Safety Board)

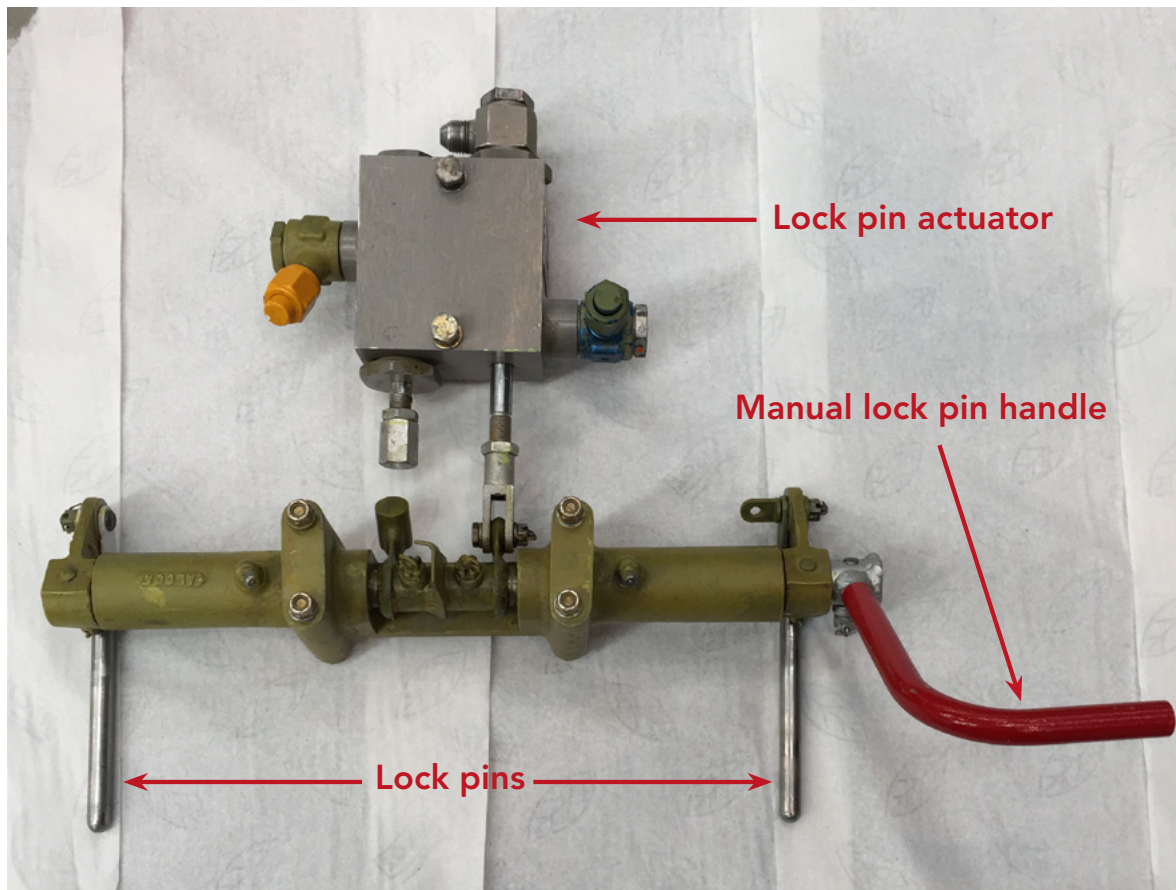
Figure 8: Lock pin mechanism (note that the bent left-hand pin has been replaced). (Source: Dutch Safety Board)
