DUTCH
SAFETY BOARD

Man missing after falling overboard

Learning points from an accident
in the Baltic

The Hague, November 2019

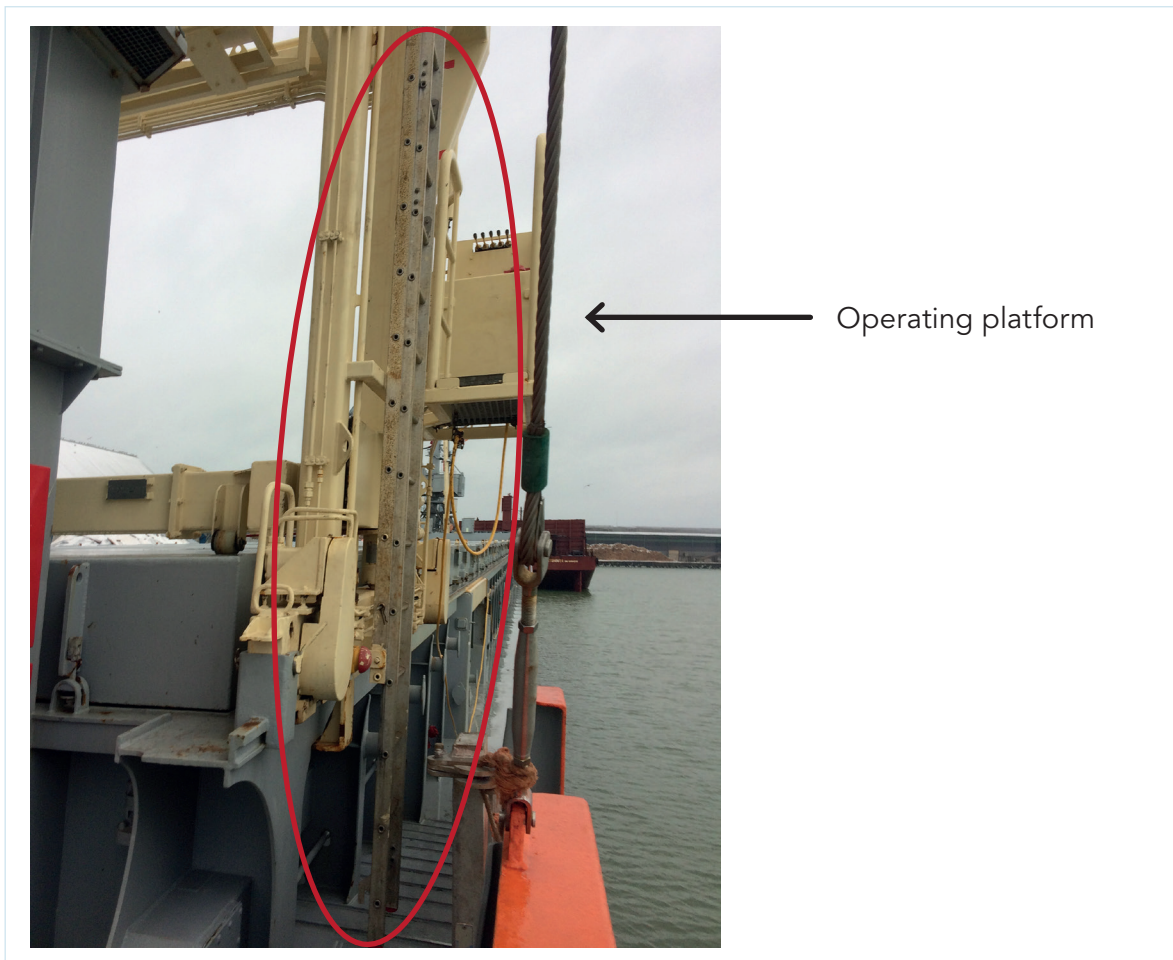
No one saw the victim fall, as a result of which it is not possible to determine with any certainty the precise cause of the fall overboard. The adjustable ladder on the hatch cover crane was discovered hanging loose by the motorman, after he had heard the victim's scream, but it is unknown whether the victim was on the ladder at the time of the fall. It is probable that the ladder hanging loose is related to the fall overboard. No other plausible explanation could be identified for the fall overboard, and the call for help also suggests a fall. Moreover, no other explanation was found for the loose-hanging part.

Figure 4: The ladder on the hatch cover crane with the adjustable section (circled). (Source: Dutch Safety Board)

The hatch cover crane and the ladder are built and certified by the company Coops & Nieborg. The ladder consists of two sections: a fixed section and an adjustable section. The adjustable section is necessary in order to adjust the height of the step-up. The reason for this is that as the hatch cover crane is moved, the height from the deck in respect of the ladder varies. The adjustable ladder section is hooked onto the fixed ladder section at the top and at the bottom, by means of a hook with a locking pin secured to the fixed section (see Figure 5). Because of the removable section of the ladder, there was no fall protection fitted in the form of a handrail or cage.

The cause of the deckhand falling overboard from the Lady Ami and his subsequent missing cannot be determined with any certainty. The victim possibly fell from the ladder on the hatch cover crane, when the ladder broke free. Because the ladder on the hatch cover crane was not equipped with fall protection such as a guiderail or a cage, there was no barrier to prevent a fall overboard of the deckhand. Despite the peculiar position in which the ladder was found, it has not been proven the victim has stood on the ladder.

Together with the supplier of the hatch cover crane, the shipping company has looked into a better solution for the ladder, but has not yet identified a proper solution.

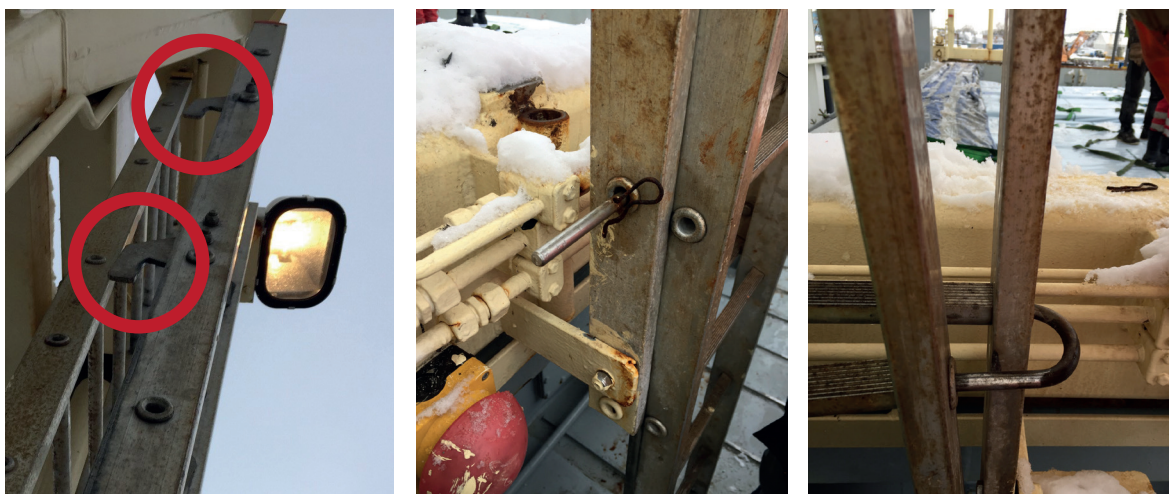
Figure 5: Hooks and securing mechanism for the adjustable ladder. (Source: Dutch Safety Board)

To remove the adjustable section of the ladder, the bottom pin must be removed and the ladder section lifted from the hooks. If the ladder is correctly fixed in place, it cannot hang loose of its own accord. According to the crew members, this section of the ladder is rarely removed and is only used to climb onto the hatch cover crane. The victim had not received instructions which made climbing onto the hatch cover crane necessary. The standard route from the deck to the hold was not via this ladder.
