# Mid-air collision between two Piper Super Cubs near Oudemolen, 21 June 2019

*The Hague, October 2021*

Identification number	2019052
Classification	Accident
Date, time of occurrence	21 June 2019, 12.20 hours
Location of occurrence	1 nautical mile northeast of the village of Oudemolen

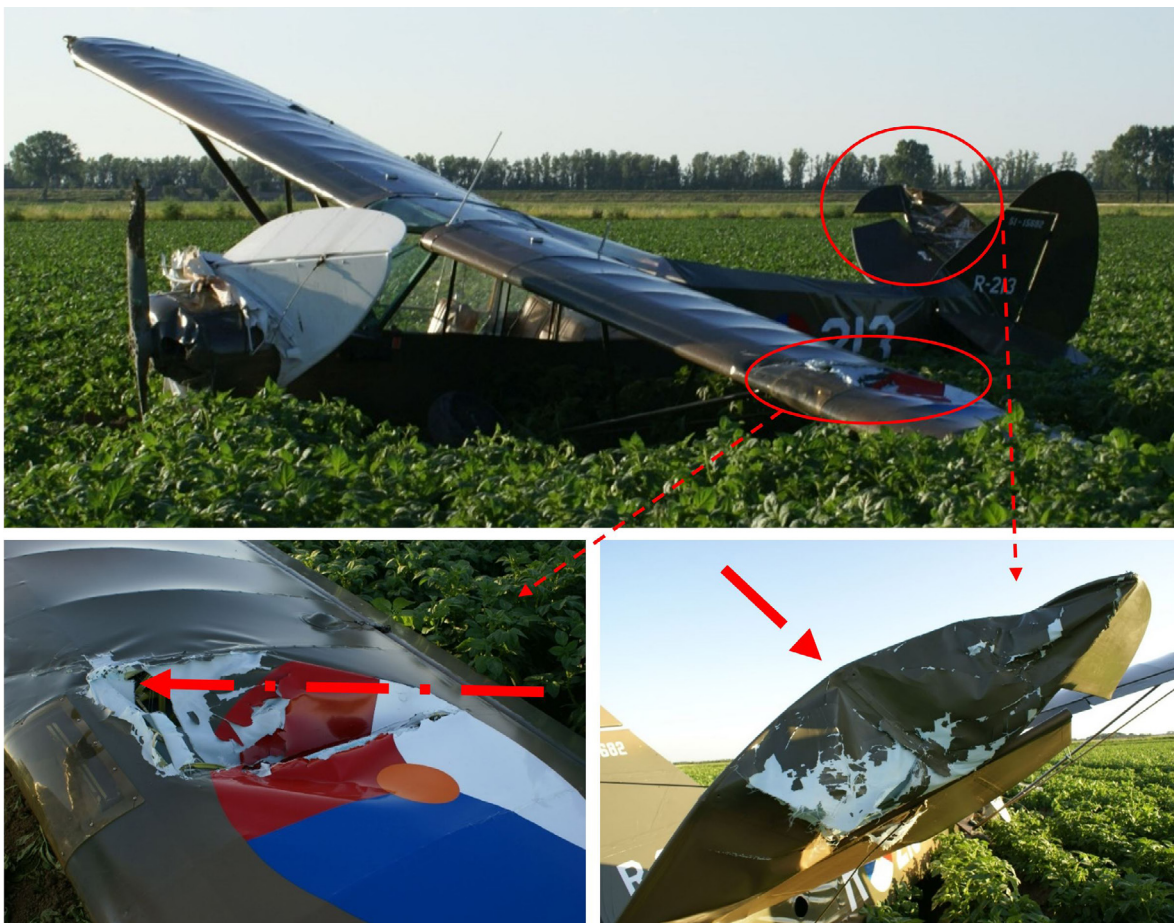
The examination showed that RED's right hand elevator had a distinct dent and was deformed. The horizontal tail section and the aft fuselage were twisted to the left as a result of the collision. Furthermore, RED's left wing tip had a large indent just behind the left wing light. The construction inside of the wing tip was damaged and the wing's bottom skin cover was punctured. RED's left wing tip damage area had scrapes indicating that the movement off collision was from behind, moving forward and to the right (see Figure 2).

Figure 2: PH-RED's damage pattern right elevator and left wing tip. (Source: Dutch Safety Board)

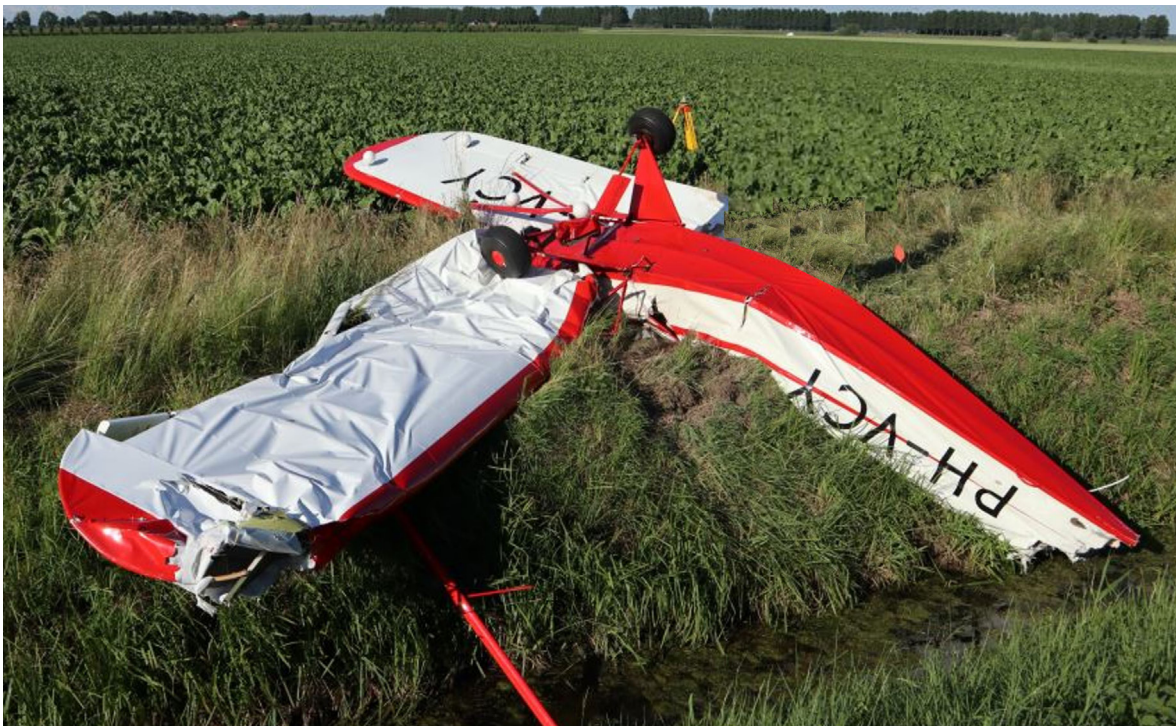
The examination of VCY showed that the right wing was structurally damaged and partly disconnected from the fuselage. The right wing tip was substantially damaged and deformed. Furthermore, the tail section was cut off from the aft fuselage on approximately a 45° angle (see Figure 4). The other damages to VCY were caused by the crash.

Figure 4: Wreckage of PH-VCY, damaged right wing (lower left corner) and the cut-off angle rear fuselage. (Source: Dutch Safety Board)

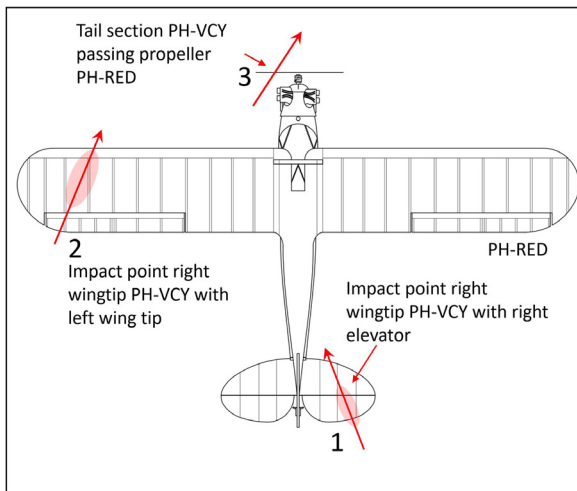
The mid-air collision consisted of three distinct events (Figure 5). The sequence of the parts is based on the statement of the passenger in the leader's aircraft, and the described damage pattern as a result of the mid-air collision.

The first event of the mid-air collision was that the wingman with its right wing tip struck the leader's right side of the horizontal tail first. Then, the wingman moved forward and to the left. The second event was the wingman with its right wing tip striking the leader's upper side of the left wing tip. The third event was the wingman crossing the nose and propeller of the leader within close proximity with a right angle of bank between 90° and 180°. This crossing caused the tail section of wingman's aircraft to be cut off (see Figure 6).

Figure 5: PH-RED's (leader) damage pattern and PH-VCY's (wingman) direction of movement. (Source: Kaboldy, Wikipedia Commons, modified by the Dutch Safety Board)

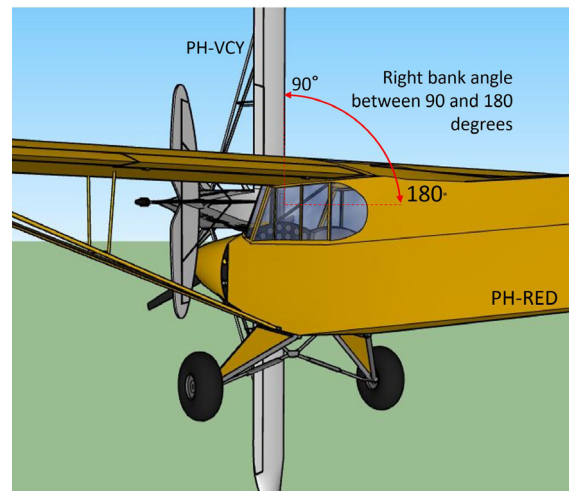
Furthermore, the assessment of the mid-air collision damage revealed that the propeller of RED had marked indents on the leading edge of the propeller blade. Further, it was found that the steel tubes of VCY's aft fuselage frame showed distinct cut and shear marks. And, that the entire aft tail section of VCY was cut at approximately 45 degree angle (see Figure 5). This implies that VCY had crossed in close proximity in front of RED, whereby the propeller of RED had cut off the aft tail section of VCY.

Figure 6: Propeller PH-RED (leader) cuts of tail section of PH-VCY (wingman). (Source: Dutch Safety Board)

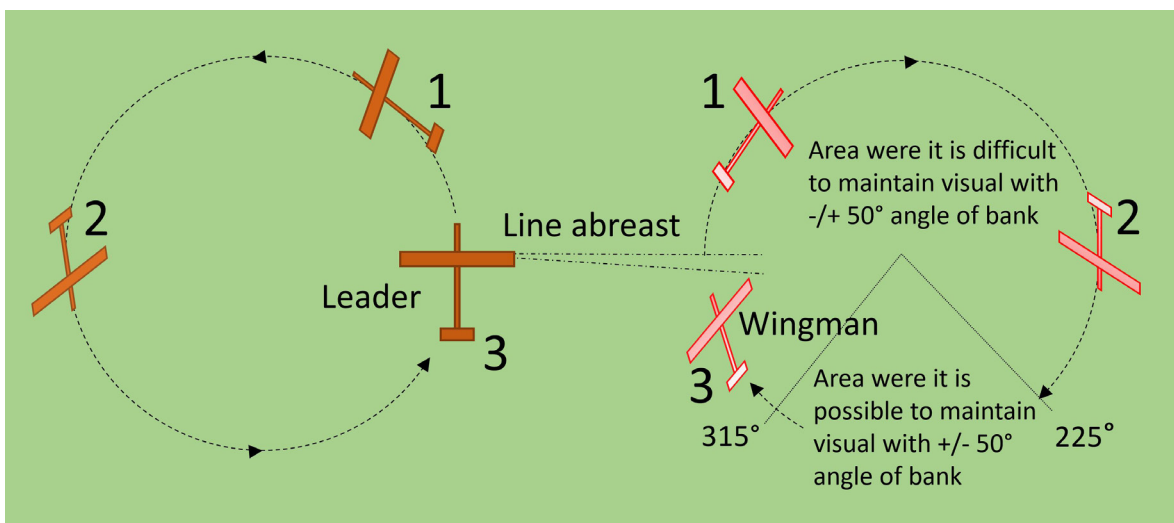
The new manoeuvre starts with a formation split up from a line abreast position, followed by two opposite 360° level turns, finishing with a rejoin in a line abreast formation. The objective of the exercise is to fly the manoeuvre symmetrically. However, during the end phase of the rejoin the wingman is to be slightly aft and closing in from behind in a controlled manner (see Figure 7). The intended separation between the leader and the wingman in the line abreast formation is the width of one wingspan, which is approximately 11 meters. The 360° turn is flown with approximately 50° angle of bank. The manoeuvre progresses fairly quickly: it takes approximately 25 seconds to complete the 360° turn. The fact that both aircraft had different types of engines and thus a different performance, did not hamper the ability of the aircraft to perform the manoeuvres symmetrically.

Figure 7: Geometry of the 360 degree opposite turn and rejoin manoeuvre. (Source: Dutch Safety Board)

Flying the two opposite 360° turns, poses a difficulty for the pilots to keep each other in sight. After the split-up, pilots will quickly lose sight of each other, because they are turning away from each other (see Figure 7). In this stage of the manoeuvre this is not a concern, because the distance between the aircraft is increasing. Further into the turn, the difficulty of maintaining visual is caused by the high wing of the aircraft; blocking the view to the inside of the turn.

It is reasonable to assume from a theoretical standpoint that while continuing the turn, pilots are able to regain visual contact once they have turned approximately 225° and maintain visual contact until approximately 315° into the turn. After this point, which is during the last 45° of the turn, it will become increasingly difficult to keep each other in sight because of the 50° angle of bank. In other words, during the end phase of the manoeuvre, both aircraft were turning with their bellies towards each other, which made it almost impossible for both pilots to keep each other in sight. And, because of the steep bank angle, it was for the wingman increasingly more difficult to judge the closure during the rejoin.
