DUTCH  
SAFETY BOARD

# Damage to left wing spar

*The Hague, August 2018*

Identification number:	2016072
Classification:	Accident
Date, time of occurrence:	15 July 2016, 14.20 hours
Location of occurrence:	Larserveld
Registration:	PH-1006
Aircraft type:	SZD-51-1 "Junior"
Aircraft category:	Glider
Type of flight:	Local
Phase of operation:	En route
Damage to aircraft:	Substantial to left wing spar
Flight crew:	One
Passengers:	None
Injuries:	None
Other damage:	None
Light conditions:	Daylight

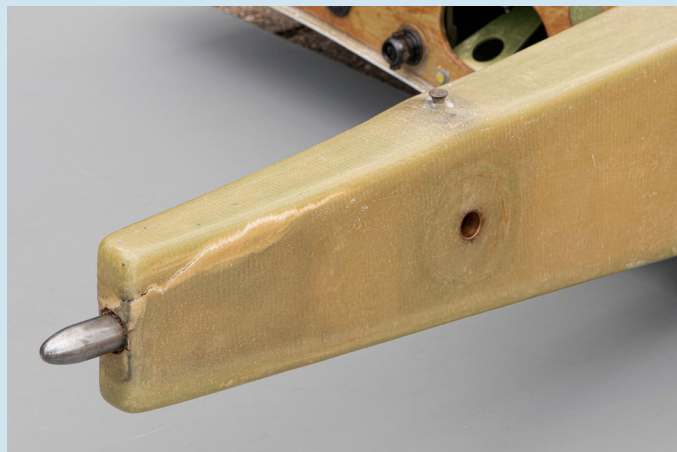
The glider sustained substantial damage as a result of the occurrence. A crack was present at the top of the end of the spar of the left wing.

Figure 1: Failed spar of the left wing observed from the leading edge side. (Photo: NLR)

The number of layers in the TE C-frame and the wrapping were according to specification. During removal of the aluminium insert it was noticed that the aluminium insert had some freedom of movement and was not fixed to the C-frames anymore. With loss of adhesion between the GFRP spar and the aluminium insert the load is transferred to a small line of contact at the end of the spar and the top of the aluminium insert and a small line of contact at the bottom of the aluminium insert towards the middle of the spar. This would result in high local stresses in the C-frames and in the wrapping at the end of the spar. At the end of the loops the loads on the steel pin are highest and in an upward direction. The crack location at the top of the aluminium insert corresponds with a high load on the steel pin at the end of the loop and the moment when the pilot heard a cracking sound. Therefore, it is likely that the spar failed by a high load at the end of the loop. The irregularly shaped particles and the discoloration on the fracture surface close to the origin of the crack indicate that the crack grew to a certain length prior to the overload. The presence of a crack prior to the occurrence indicates that the end of the spar was highly loaded and could indicate that the aluminium insert was already detached from the GFRP material for some time prior to the occurrence. The reason for the poor adhesion was outside the scope of the investigation performed by the NLR.

- The crack location at the top of the aluminium insert corresponds to a high load on the steel pin at the end of the loop and the moment when the pilot heard a cracking sound. Therefore, it is likely that the spar failed by a high load at the end of the loop.

- The irregularly shaped particles and the discoloration on the fracture surface close to the origin of the crack indicate that the crack grew to a certain length prior to the overload at the end of the loop. This implies that the crack already existed before the pilot initiated the second loop.

- The presence of a crack prior to the occurrence indicates that the end of the spar was highly loaded and could indicate that the aluminium insert was already detached from the GFRP material for some time prior to the occurrence.

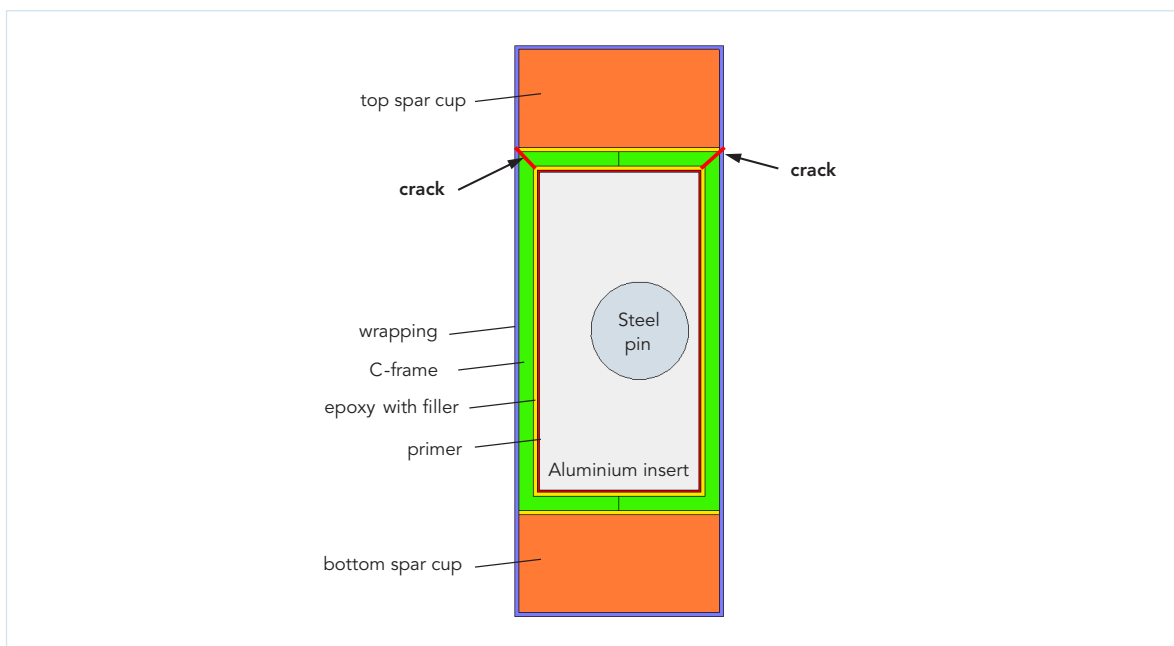
The wing spar consists of two unidirectional glass-fibre reinforced plastic (GFRP) spar cups that extend from the wing; see Figure 2. Between the spar cups two C-frames, that consist of ten layers of GFRP, are put together to make a tubular shape. An aluminium insert is enclosed at the end of the tubular shape consisting of the two C-frames. This structure is wrapped in three layers of GFRP. The aluminium insert is pickled and coated with a primer prior to assembly. The aluminium insert is then glued to the C-frames using an epoxy resin with a filler. A steel pin is inserted into the aluminium insert. During assembly of the wings to the glider the steel pins slide into the opposite wing and the positions of the two spars are secured with another pin that goes through the middle of both spars; see Figure 3.

Figure 2: Schematic of the cross-section of the spar. (Photo: NLR)

- With loss of adhesion between the GFRP spar and the aluminium insert the load is transferred to a small line of contact at the end of the spar and the top of the aluminium insert and a small line of contact at the bottom of the aluminium insert towards the middle of the spar. This would result in much higher local stresses in the C frames and in the wrapping at the end of the spar.

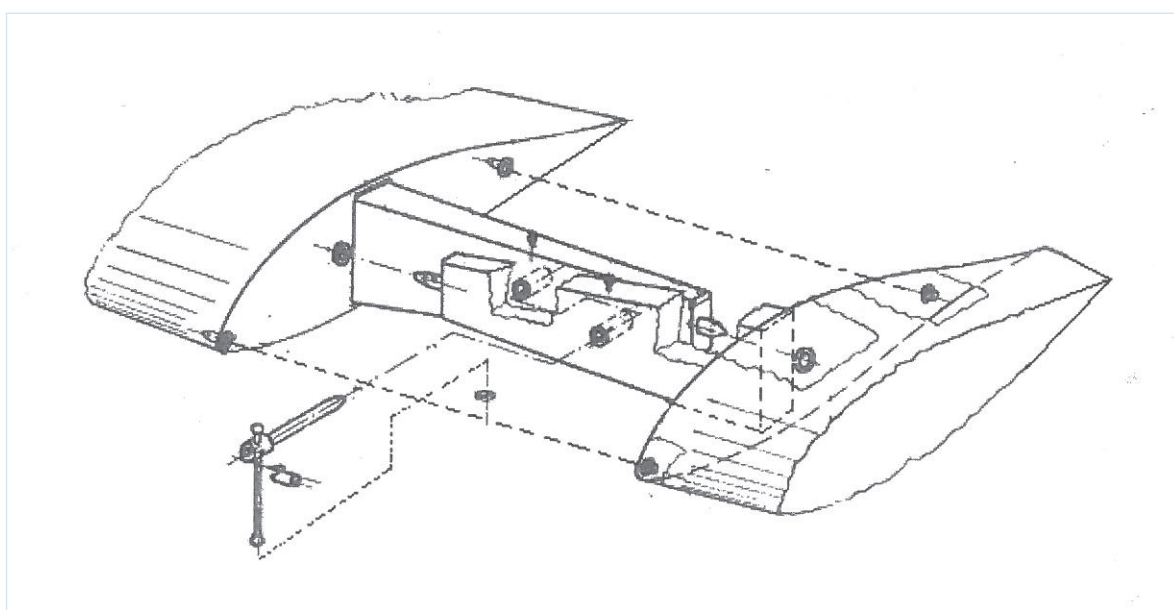
Figure 3: Representation of how both wings are mounted to each other via the spars. (Photo: Allstar PZL Glider)
