DUTCH
SAFETY BOARD

Accident in loading pipe of trailing suction hopper dredger Scelveringhe

The Hague, November 2018

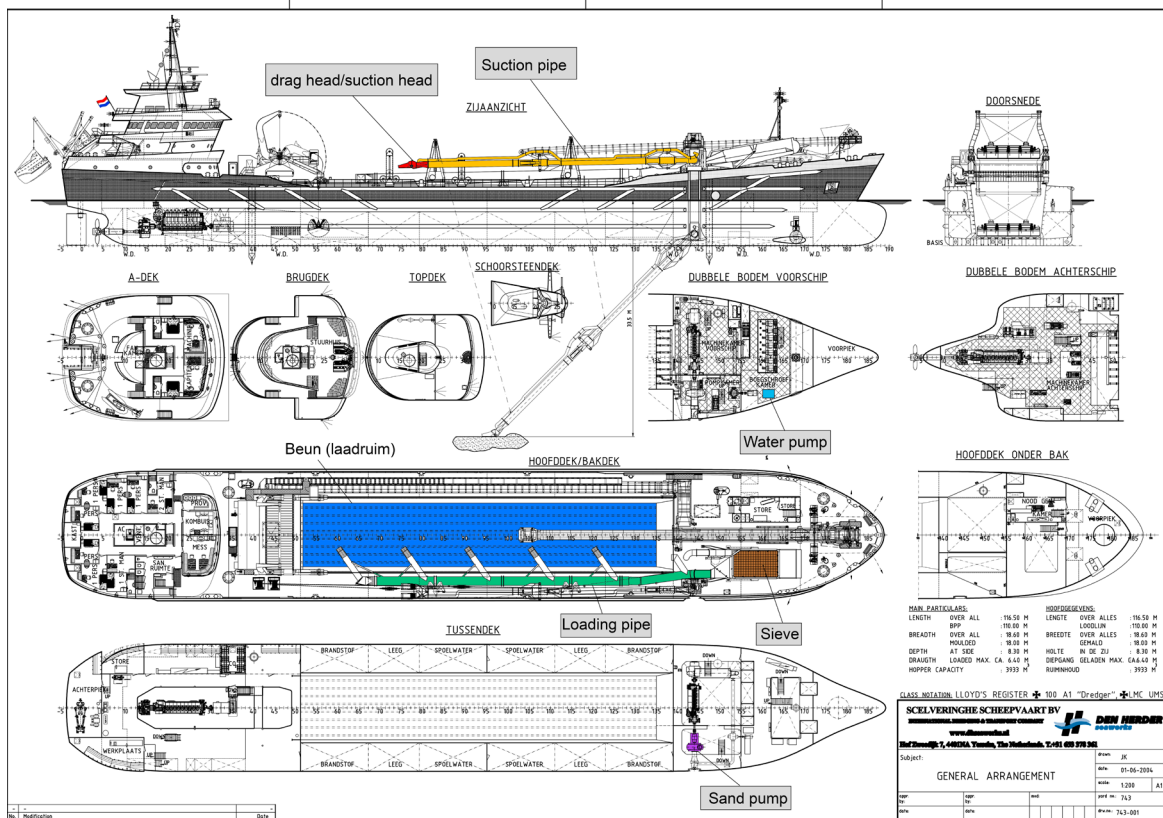
The Scelveringhe is a trailing suction hopper dredger: a vessel that sucks material (mainly sand and gravel) from the seabed. On board the vessel is a suction installation, consisting of a large suction pipe with suction head through which sand and gravel are pumped from the seabed together with seawater via the loading installation (sieve and loading pipe) into the hold (also known as the barge) using a sand pump (see Figure 1).

Figure 1: Drawing of the Scelveringhe showing the suction installation (suction head, suction pipe and sand pump) and the loading installation (sieve and loading pipe). (Source: DHS)

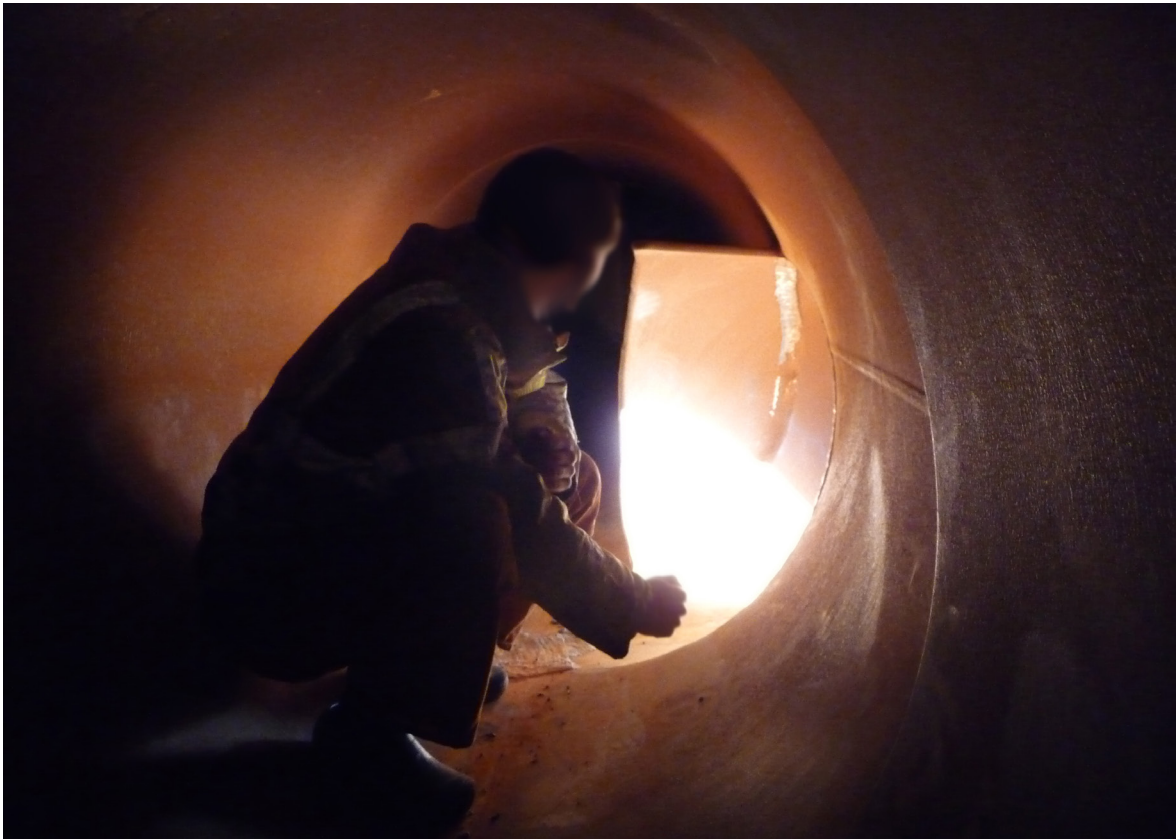
The abrasive action of the mixture of sand and water means the system is very maintenance intensive. Welders are regularly required to carry out maintenance work on the loading installation (see Figure 2).

Figure 2: Inside of the loading pipe, during welding.

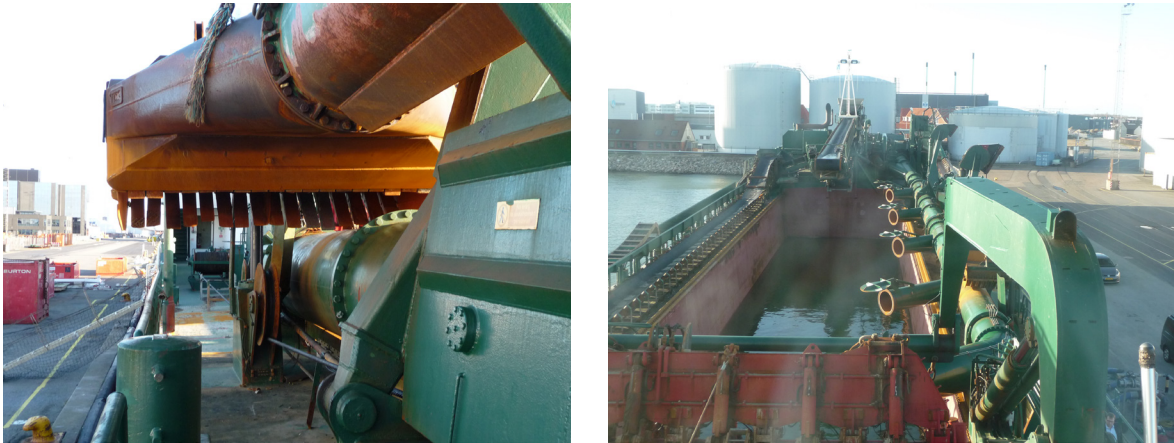
At 17.35 hours, the captain supervised the starting up of the water pump and examined the hold, to point out where the water would emerge from. A few seconds after water started flowing into the hold via the loading pipe, the captain saw a person (the experienced welder) being washed into the hold through one of the water jets (from loading pipe number 4, see Figure 3). The captain immediately ordered the water pump to be shut down, and approximately 2 seconds later, the water stopped flowing. The captain then ordered the relief captain to go down from the bridge and to throw a lifebuoy into the hold, and the general alarm was sounded.

Due to the oscillation of the vessel, the water in the hold was washed backwards and forwards, and the victim disappeared under water, after having risen to the surface several times. Despite repeated attempts to dredge the hold, the crew was unable to retrieve the crew member from the hold. After approximately 45 minutes, the crew halted its efforts. By this time it had also become clear that the other welder had managed to find a secure handhold in the pipe, as a result of which he had not been washed into the hold and had been able to pull himself to safety.

Figure 3: Suction head (left) and cargo hold with loading pipe (right).
