PRELIMINARY REPORT

Classification:	Accident
Aircraft type and registration:	Boeing 737-800, TC-JGE
Number and type of engines:	2 CFM-56-7B26 turbofan engines
Year of manufacture:	2002
Date and time: ¹	25 February 2009, 10.26 hrs
Location:	1,5 km North of runway 18R "Polderbaan" Amsterdam Airport Schiphol
Type of flight:	Commercial air transport (passengers)
Occupants:	crew - 7 passengers - 128
Fatalities:	crew - 4 passengers - 5
Injuries:	crew - 3 passengers - 83
Nature of damage:	Aircraft destroyed
Information source:	Dutch Safety Board

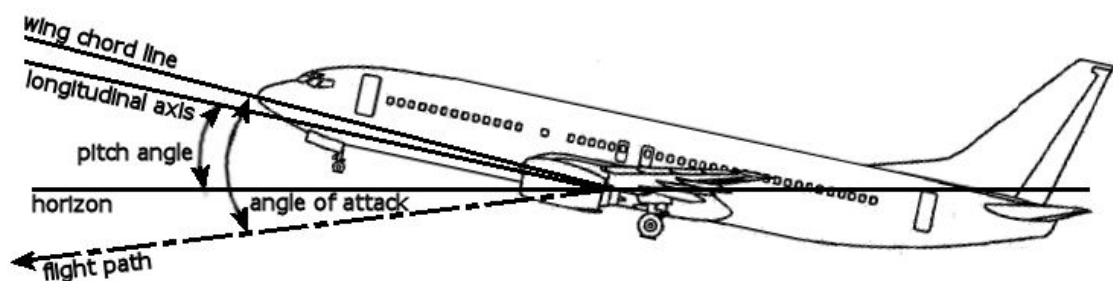
At approximately 770 feet, the crew set the selected airspeed to 144 knots. At that moment the actual airspeed was 144 knots. The autothrottle system should have maintained the speed selected by the crew but, with the thrust levers at idle and the autothrottle system still in the retard mode, speed continued to decay. Because the automatic pilot wanted to maintain the glide scope, the automatic flight system, in response, commanded increasing nose up pitch and applied nose up stabiliser trim.

The stick shakers activated at approximately 460 feet, warning the crew that the angle of attack (AOA) was too high. The data of the digital flight data recorder show that the thrust levers were immediately advanced but moved back to idle. When the thrust levers returned to idle, the autothrottle was disengaged. Whether these actions were performed by the crew or automatically is still under investigation. At that moment, the speed was approximately 110 knots, the pitch angle was approximately 11° Aircraft Nose Up (ANU) and the recorded AOA was approximately 20°.

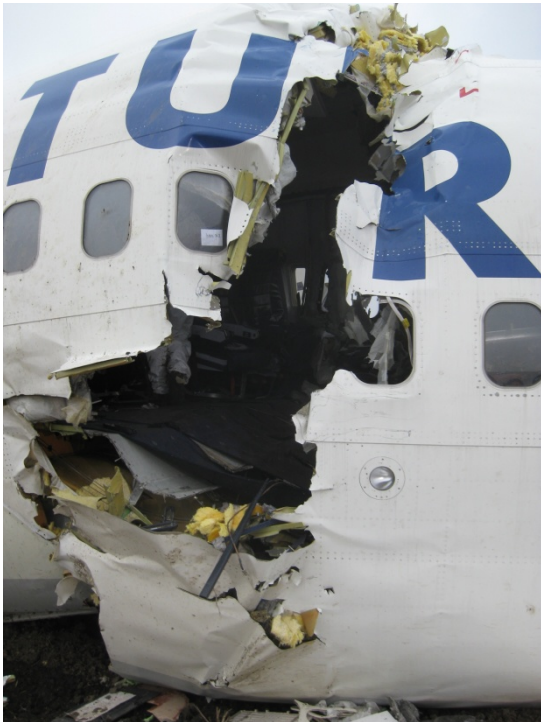
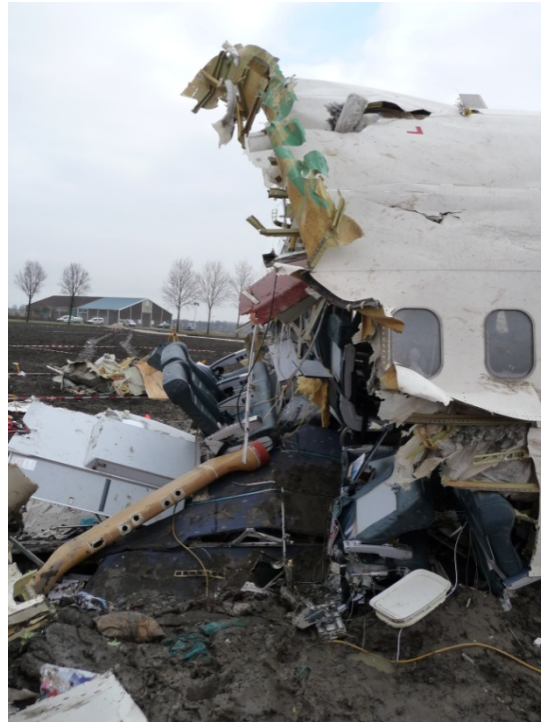
The aircraft impacted farmland 1,5 km north of the Runway 18R threshold. The wreckage trail was approximately 100 m long and along a heading of approximately 160° magnetic. The initial impact ground marks are consistent with the shape of the aft part of the fuselage.

The horizontal stabilizer and the main landing gear were separated from the aircraft and located near the initial impact point. The left and right engines had separated from the aircraft and were found some distance away. The aft fuselage, with vertical stabilizer, was broken circumferentially forward of the aft passenger doors and had sustained significant damage. The fuselage had ruptured at the right side forward of the wings. The forward fuselage section, which contained the cockpit and seat rows 1 to 7, had been significantly disrupted. The rear fuselage section was broken circumferentially around row 28 (the rear-most row of seats on the left-hand side of the aircraft. At the right-hand side at the rear is a row 29).
