DUTCH
SAFETY BOARD

Preliminary report/Safety Alert

Loss of engine power after take-off

The Hague, December 2021

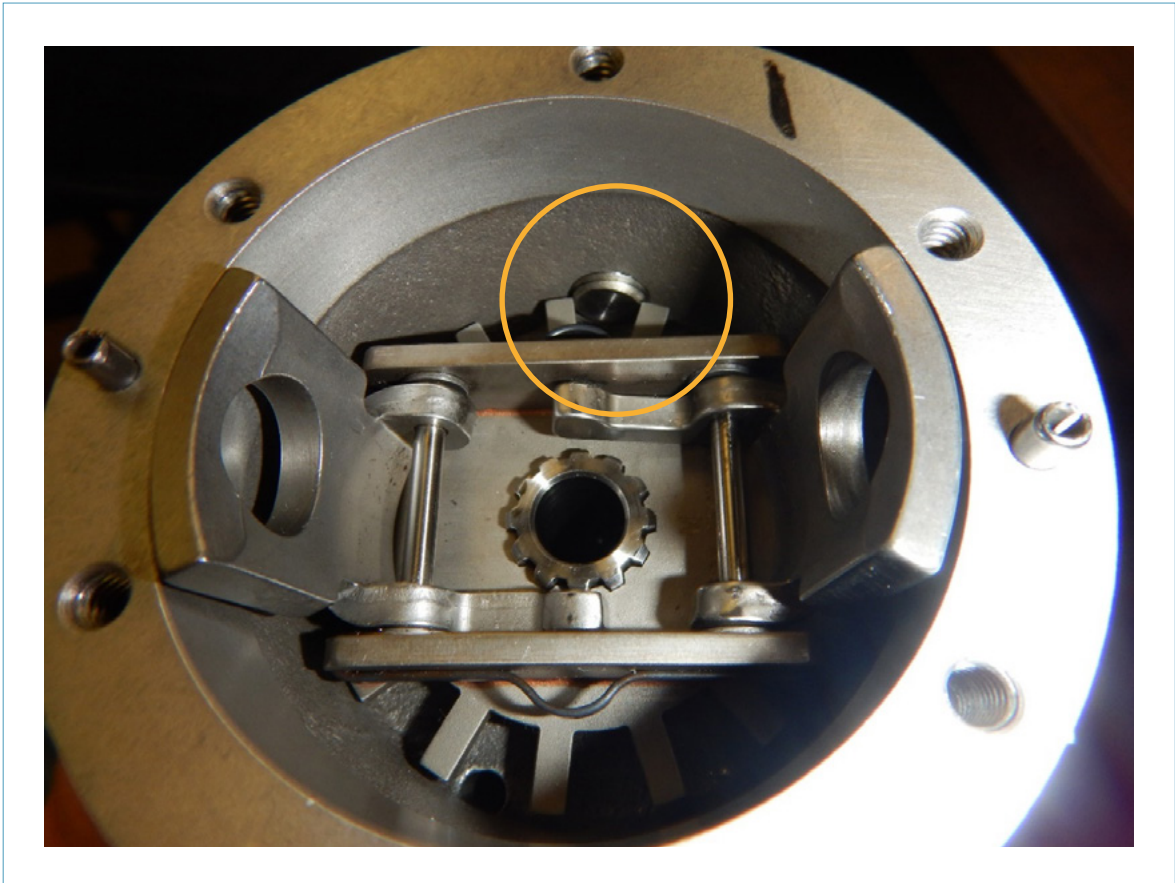
An undamaged toothed gear with monopole positioned in between teeth (Source: Honeywell)

During the investigation it was demonstrated that it is possible to position the pickup end of the monopole in between the teeth of the toothed gear. In such case, it was determined that loosening it by a half turn is insufficient to ensure free rotation of the toothed gear.

At this stage the Dutch Safety Board does not issue a recommendation, but expects that Honeywell and Woodward inform their customers and take preventive measures where necessary.
