DUTCH  
SAFETY BOARD

# Quarterly Aviation Report

January - March 2019

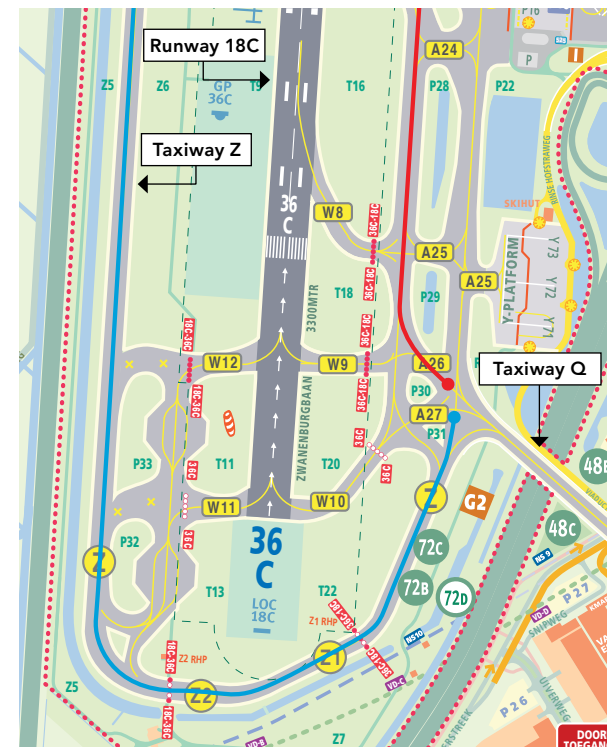
An Airbus A320 (red line in the figure with the route of both aircraft) landed on runway 18C in the evening; air traffic control gave permission to taxi to the parking position at pier C via taxiway Q (Quebec). In approaching taxiway Q the crew was also instructed to give way to another Airbus A320 (blue line in figure with the route of both aircraft) approaching from the right via taxiway Z (Zulu). The crew of the latter A320 was told that the (recently landed) A320 would let them pass. Both aircraft approached the taxiway crossing. However, the crew of the first, recently landed A320 did not give way, forcing the crew of the other A320 to come to an emergency stop. The two aircraft passed within a very short distance of each other.

The route of both aircraft based on the radar data. (Source: ATC the Netherlands)

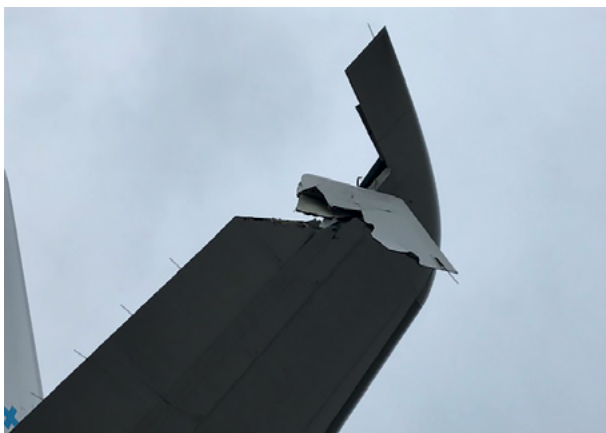
As a Boeing 747 was pushed back from gate E7 to taxiway A14, a collision with a Boeing 787 occurred. The Boeing 787 had been pushed back from gate F8 earlier and was stationary on taxiway A16. Both pushbacks were performed after permission had been obtained from air traffic control. A winglet of the Boeing 747 was damaged, as well as the horizontal stabiliser of the Boeing 787. No persons were injured.

The damaged horizontal stabiliser. (Source: AAS)

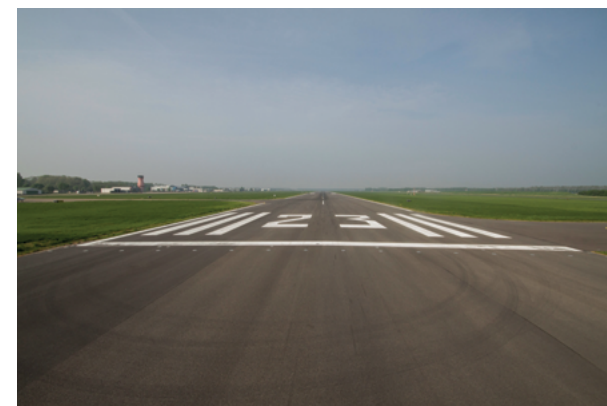
The Rans S-6S landed on runway 23. The Diamond HK-36 TC, which was on final approach behind the Rans, overflew the Rans and landed further down the runway. The pilot of a third aircraft, a Diamond HK-36 TTC, on its final approach as this incident occurred, performed a go-around.

Runway 23 at Lelystad Airport. (Source: Lelystad Airport)

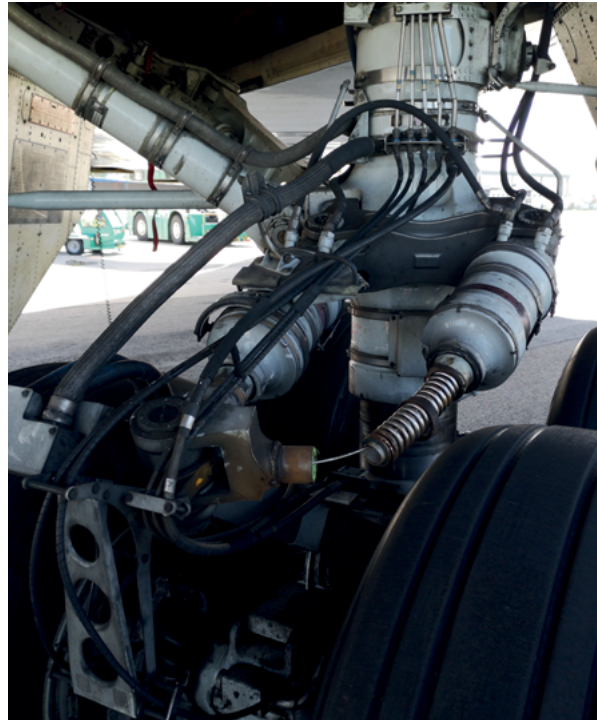
As a Boeing 747-400F, a Dutch registered cargo aircraft, taxied to its parking position at Ministro Pistarini International Airport in Argentina, one of the steering actuators in the right main landing gear failed. The aircraft came to a full stop on the taxiway and could not be towed to its parking position until its cargo had been unloaded.

Right main landing gear. (Source: JIAAC)

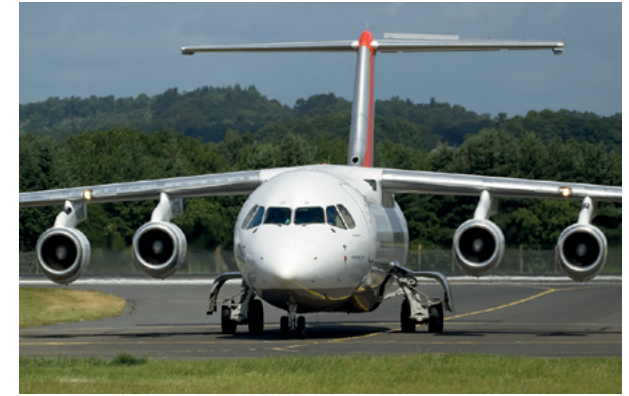
The BAe Avro RJ85 was about to undertake a scheduled flight from Amsterdam Airport Schiphol to London City Airport. The aircraft was given a pushback from gate D24 to taxiway A8. After the first engine was started, the pushback tug positioned the aircraft's nose gear. After this, it advanced several metres to allow the crew to continue the starting procedure. As the fourth engine was started, the brake pressure suddenly failed and the aircraft rolled forward. The aircraft collided with the pushback tug and suffered considerable damage to the fuselage. There were no injuries.

The investigation showed that the occurrence was caused in part by an unusually fast hydraulic pressure drop in the parking brake system due to failure of one or both motorised valves in the parking brake system. This led to a sudden pressure drop, probably because the fluid in the hydraulic accumulator ran out and no pressure could be brought to bear.

Archive photograph EI-RJT. (Source: McFadyen)

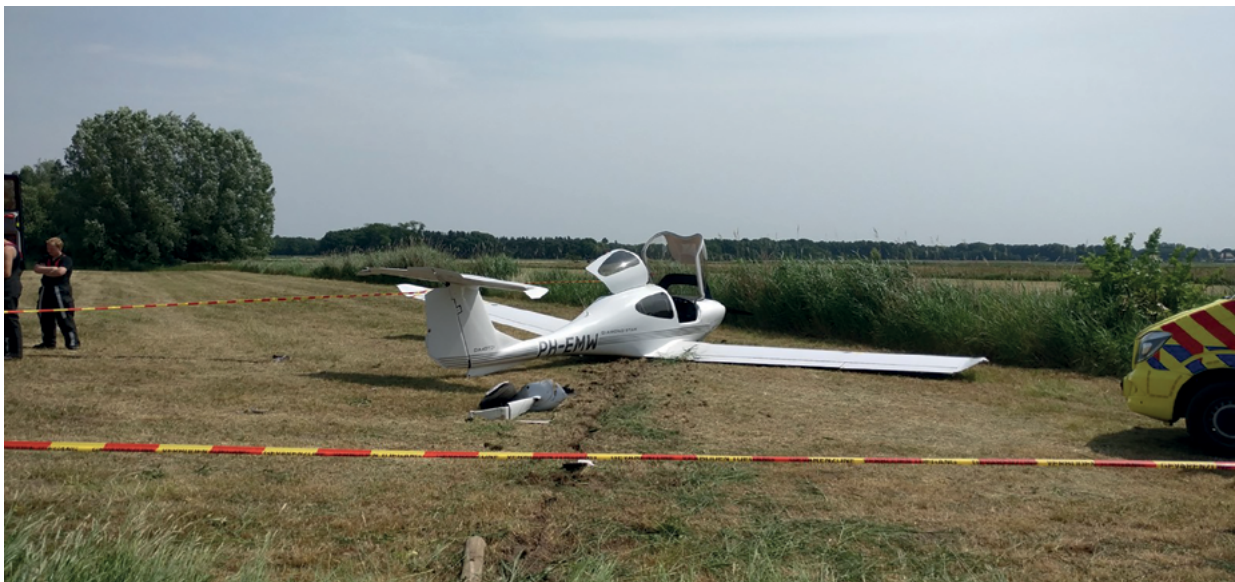
There were two persons on board: the pilot and a ground engineer. The ground engineer was on board because he wanted to check the results of a repair during the flight. While in flight, the engine speed started to fluctuate. The available engine power dropped and was insufficient to maintain adequate air speed and altitude, forcing the pilot to perform an emergency landing. When landing near the village of Haaren, the aircraft hit the side of a ditch, which caused the landing gear and propeller blades to break off. Both occupants were unharmed.

It was found that the engine trouble was probably caused by a damaged connection between the engine and the Full Authority Digital Engine Control (FADEC) system, which is mounted underneath the pilot's seat. A connector of the connecting cable on the side of the FADEC was found to be damaged. The damage was caused by the connector having been attached incorrectly during previous maintenance work. The damage had not been noticed when the FADEC present in the aircraft during the accident flight was installed.

PH-EMW after the accident. (Source: R. van Dooren)

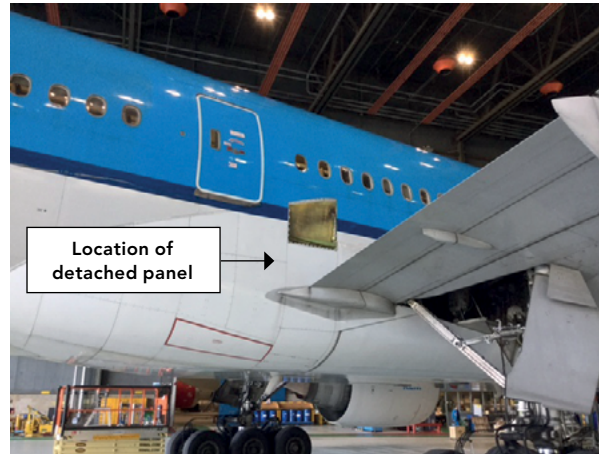
The Boeing 777 took off from Kansai International Airport (Osaka, Japan). Its destination was Amsterdam Airport Schiphol. While gaining altitude over Osaka, the aircraft lost a fuselage panel measuring 107 centimetres (length) by 108 centimetres (maximum height). The plastic panel with an approximate weight of 4.3 kilograms fell on a car driving through the city of Osaka, resulting in damage to the car. The driver, who was alone in the car, was uninjured. The aircraft continued its flight to Schiphol, where it landed without any problems.

The investigation by the Japan Transport Safety Board (JTSB) showed that the bracing that held the front top corner of the panel in place had probably ruptured. This resulted in an opening between the top corner of the panel and the fuselage. The pressure of the incoming airflow and vibrations then caused the panel to detach from the fuselage.

*The detached panel. (Source: Airline)*

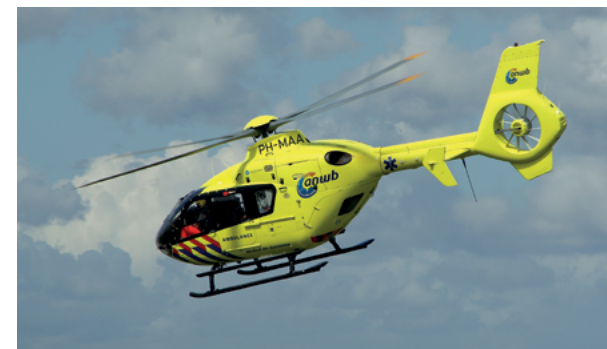
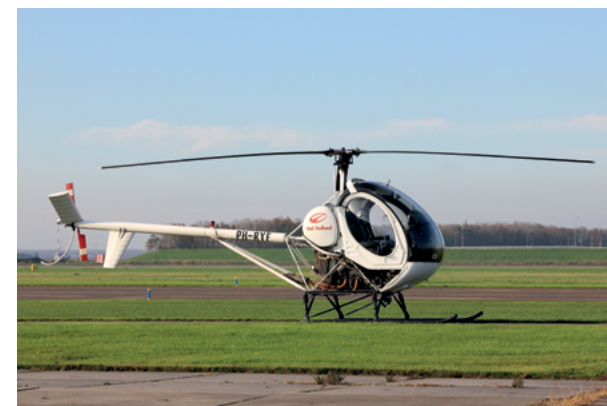
The Eurocopter helicopter was on a flight from the HEMS<sup>1</sup> site in Leidschendam to Amsterdam Heliport. Visibility exceeded 10 kilometres. Over Voorhout, at an altitude of 800 feet in uncontrolled airspace, the pilot noticed another helicopter approaching from the right at a slightly lower altitude. From the Eurocopter's perspective, the latter was just below the horizon, making it less easy to see. The Eurocopter's pilot performed an evasive manoeuvre to avoid a collision. The second helicopter passed in front of the Eurocopter at an estimated horizontal distance of 50 to 100 metres. The Eurocopter's pilot stated that the other helicopter was a white Hughes 269C.

Shortly before the incident, the Eurocopter's pilot had switched his radio frequency from Amsterdam Flight Information Centre to Schiphol Tower West. The TCAS<sup>2</sup> on board the Eurocopter did not generate an alert. Despite being equipped with a transponder, the Hughes was not visible on the radar screens of Air Traffic Control the Netherlands at the time of the incident. The reason has not been established. The company operating the Hughes stated that no mention of anything out of the ordinary regarding the transponder's operation had been made in the period surrounding the day of the incident. The Dutch Safety Board did not investigate the transponder.

Since the Hughes 269C was not visible on the radar screens and the Hughes' pilot had not contacted the Amsterdam Flight Information Centre, the centre was not aware of the flight and was unable to provide traffic information to the pilots of both helicopters as they approached each other.

Archive photograph Eurocopter. (Source: H. Wadman)

Archive photograph Hughes. (Source: H. Wadman)

The incident occurred in uncontrolled airspace, where pilots are themselves responsible for maintaining an adequate distance from other aircraft in order to prevent collisions. It is highly recommended that all pilots of motorised aircraft flying under the Schiphol TMA 1 tune in to the frequency of the Amsterdam Flight Information Centre (FIC, 124.300 MHz) or contact the centre. The FIC provides information about traffic near the aircraft if it is known to the FIC. Aircraft flying in Dutch airspace are required to use their transponder. If, when they join the FIC frequency, the aircraft transponder is not visible on the radar screen, the FIC's air traffic controller can notify the pilot of the aircraft.

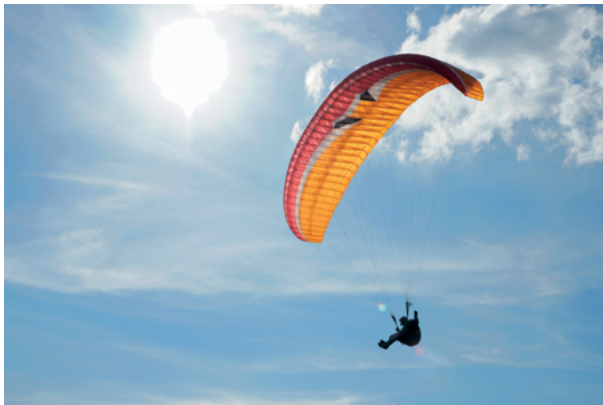
A paraglider pilot was on his first flight of the season. After a winch launch, he detached the cable and flew a short circuit to land near his starting position. The pilot had a relatively high forward speed and descent rate. Just before the landing, he got out of the seat in order to land. On landing, his left leg hit the ground slightly earlier than his right leg, causing the left leg to break in three places. The pilot was taken to hospital by ambulance.

Mac Para Muse III. (Source: Manufacturer Mac Para)
