DUTCH
SAFETY BOARD

Quarterly Aviation Report

Januari - March 2020

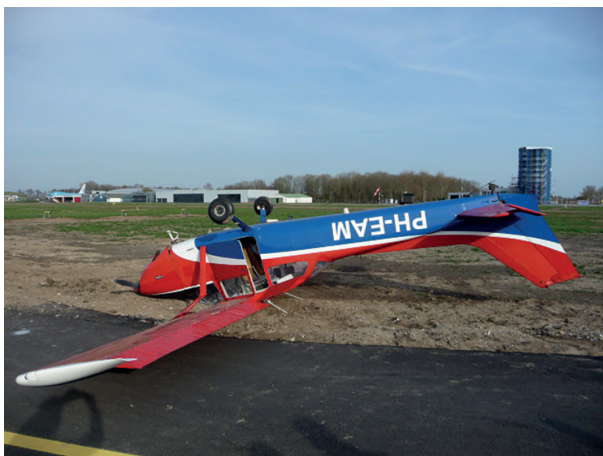
The pilot and his passenger in a Reims Aviation F172N, registered as PH-EAM, flew from Central Zeeland Airport to Lelystad Airport. During a crosswind landing the pilot lost control over the aircraft, whereupon it veered off to the left leaving the paved runway and turning over its nose. It came to a stop in an inverted position without injuries to the occupants. The nose wheel strut was broken, one propeller blade was bent and the wings of the aircraft were damaged.

The pilot lost control, because he did not apply the proper technique for a crosswind landing. Consequently, during landing roll out the left main wheel came off the runway whilst the remaining wheels no longer aligned with the direction of movement. The investigation revealed that the pilot experienced a significantly stronger crosswind than he had anticipated.

PH-EAM after the runway excursion

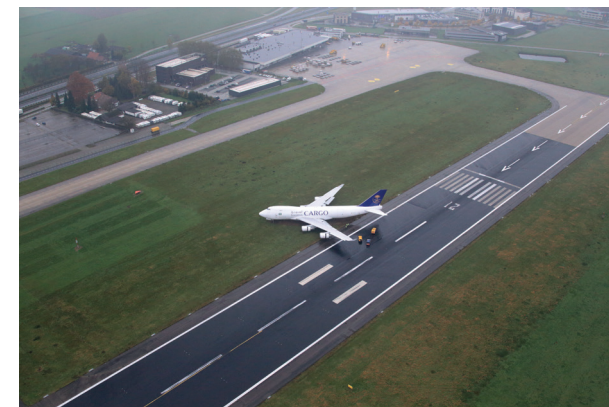
Attempts to steer the aircraft back to the centreline by means of nose wheel steering and differential braking, were unsuccessful. It veered off the runway and continued on into the soft ground on the right-hand side of the runway where it came to a standstill. None of the crew was injured. The aircraft sustained substantial damage.

The only way to arrest a deviation resulting from asymmetric thrust below the speed at which the rudder becomes effective, is to promptly retard the thrust levers to idle. That has not happened in this occurrence; it took about eight seconds for the thrust levers to be retarded. The crew deviated from standard procedures. This was probably caused by the 'startle effect' on the crew and the use of noise cancelling headsets.

The loss of engine thrust was caused by a compressor stall. The cause of the compressor stall has not been extensively investigated.

The Boeing 747-400 after the runway excursion. (Source: Dutch Aviation Police)
