DUTCH
SAFETY BOARD

Quarterly Aviation Report

Januari - March 2020

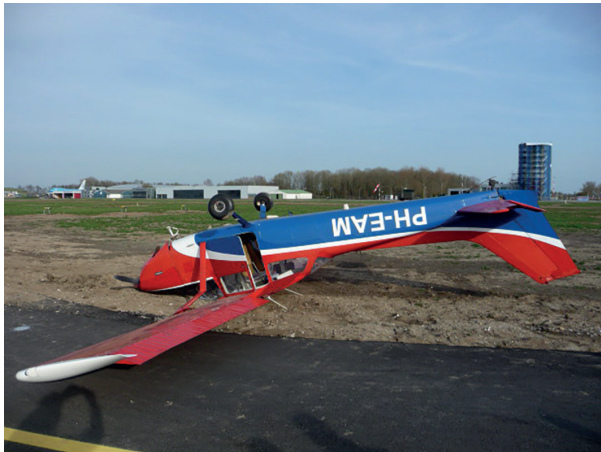
The pilot and his passenger in a Reims Aviation F172N, registered as PH-EAM, flew from Central Zeeland Airport to Lelystad Airport. During a crosswind landing the pilot lost control over the aircraft, whereupon it veered off to the left leaving the paved runway and turning over its nose. It came to a stop in an inverted position without injuries to the occupants. The nose wheel strut was broken, one propeller blade was bent and the wings of the aircraft were damaged.

The pilot lost control, because he did not apply the proper technique for a crosswind landing. Consequently, during landing roll out the left main wheel came off the runway whilst the remaining wheels no longer aligned with the direction of movement. The investigation revealed that the pilot experienced a significantly stronger crosswind than he had anticipated.

PH-EAM after the runway excursion

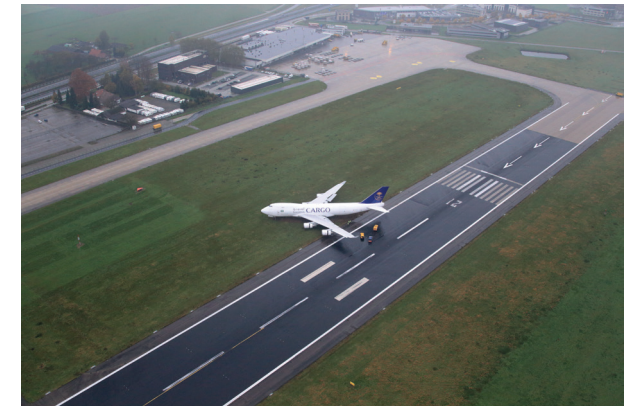
The Boeing 747-400 ERF was scheduled to make a cargo flight from Maastricht Aachen Airport in the Netherlands to King Abdulaziz International Airport in Jeddah. The captain, who was pilot flying, taxied to Runway 21 and initiated a rolling take-off. He advanced the thrust levers and, when the engines had stabilised, he pushed the TO/GA switches, causing the engines to accelerate to the selected take-off thrust. The aircraft had accelerated to approximately 30 knots when a bang sounded and the outboard engine on the right side (engine #4) suddenly lost power. The aircraft veered to the right due to the resultant asymmetric thrust. The captain did not hear the bang and was surprised by the change of direction.

Attempts to steer the aircraft back to the centreline by means of nose wheel steering and differential braking, were unsuccessful. It veered off the runway and continued on into the soft ground on the right-hand side of the runway where it came to a standstill. None of the crew was injured. The aircraft sustained substantial damage.

The only way to arrest a deviation resulting from asymmetric thrust below the speed at which the rudder becomes effective, is to promptly retard the thrust levers to idle. That has not happened in this occurrence; it took about eight seconds for the thrust levers to be retarded. The crew deviated from standard procedures. This was probably caused by the 'startle effect' on the crew and the use of noise cancelling headsets.

The loss of engine thrust was caused by a compressor stall. The cause of the compressor stall has not been extensively investigated.

The Boeing 747-400 after the runway excursion. (Source: Dutch Aviation Police)

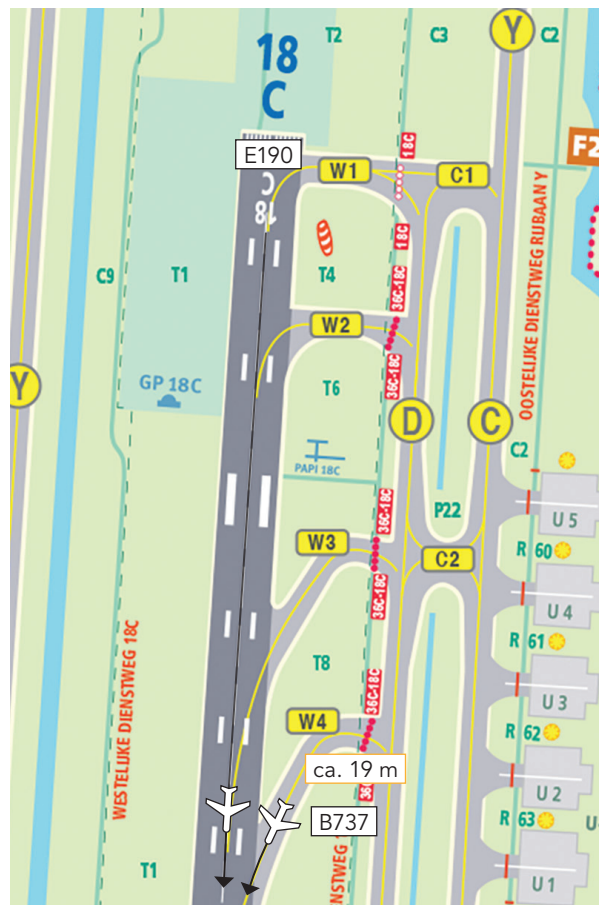
An Embraer ERJ 190-100 STD (hereinafter: E190) stationary at the start of runway 18C was given take-off clearance while a Boeing 737-800 (hereinafter: B737) had also been given clearance to line up for an intersection take-off on the same runway, via high speed exit W4. After hearing the take-off clearance issued to the E190, the crew of the B737 stopped past the hold short line and reported via the radio that they were located 'on the runway'. The runway controller then also issued a take-off clearance to the B737. The crew of the E190 had started the take-off roll when they saw that the B737 was clear of the runway, but broke off their take-off when they heard that the B737 had also been given clearance to take off. Shortly afterwards, the Runway Incursion Alerting System Schiphol (RIASS) sounded a warning in the air traffic control tower and the runway controller withdrew the clearance to the E190. The E190 passed the B737 that was stood stationary at

Section of runway 18C with intersections and position of the B737 during the passage of the E190

the boundary line of the intersection and the runway, at a speed of approximately 85 knots and a separation of approximately 19 metres.

The take-off clearance to the E190 resulted in a potential (collision) hazardous situation because both aircraft – due to their different start positions – were simultaneously given authorized access to the same section of the runway, where high-energy aircraft movements take place. In this situation, the RIASS was revealed to not be an effective safety barrier; the system in fact only generated an alarm after the E190 had already started to decelerate, on its

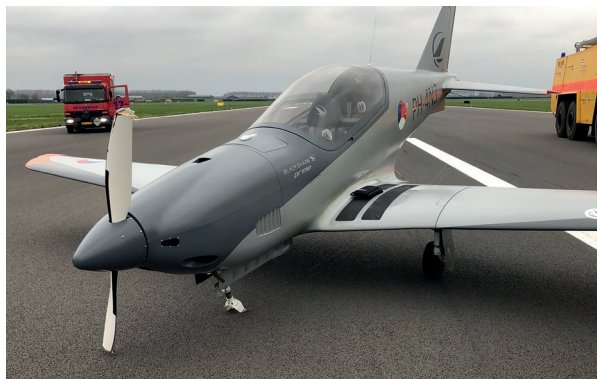
The single-engined microlight aeroplane (MLA) completed a landing on runway 05 at Lelystad Airport at around 16.25 hours. Following landing, the nose wheel suffered a flat tyre causing the wheel axle to come loose and the wheel to become detached from the landing gear leg. The landing gear leg of the aircraft then dragged over the asphalt of the runway, before the aircraft eventually coming to a standstill resting on the leg. The two occupants were unharmed. The landing gear leg and propeller of the aircraft were seriously damaged. The runway surface was also damaged by the drag marks of the landing gear leg.

The Blackshape after the landing. (Source: Lelystad Airport)
