DUTCH
SAFETY BOARD

Quarterly Aviation Report

January - March 2021

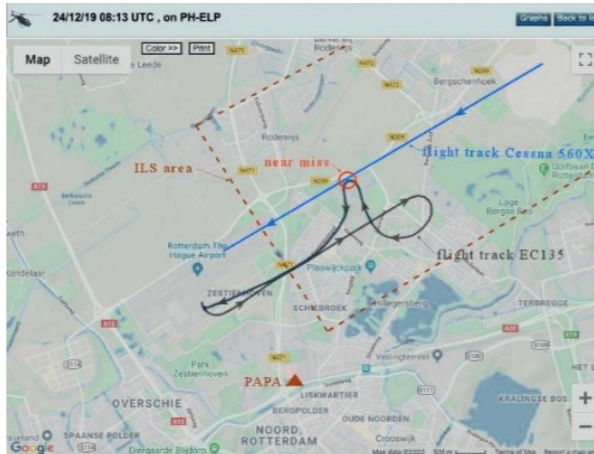
Route EC135 (black, source: ANWB MAA / Helisafe.aero. UMS EC135²) and Cessna 560XL (blue, source: LVNL), 2D-plot. ILS area: red dashed line.

The tower controller asked the pilot for his position and he replied that he was still flying left of the ILS. Shortly after, the pilot saw the approach lights of runway 24 and realised that he had turned too far and immediately made a steep turn to the left. At that moment, the Cessna passed the helicopter at the same altitude (300 feet) and less than 100 metres apart. The Cessna’s pilot saw the helicopter only at the last minute. Both aircraft made a safe landing and there was no damage nor any injuries.

The helicopter was cleared by the tower controller to stay clear from the ILS area. The read back of the clearance by the pilot was incorrect and incomplete, but was not corrected by the tower controller.

When an aircraft is approaching on the ILS, the ILS area (see figure) must be clear of non-ILS traffic. It is the responsibility of air traffic control to ensure this. The flight was cleared by the tower controller under SVFR conditions. The tower controller must separate such a flight from approaching IFR traffic (in this case the Cessna), as if they were both IFR flights.³ The standard SVFR departure is via way point PAPA. Radar data shows that almost the entire flight of the EC135 took place well within the boundaries of the ILS area.

LVNL and ANWB MAA performed internal investigations. Both organisations improved procedures to prevent reoccurrence. LVNL updated and published the procedures regarding special VFR traffic and announced to ensure awareness of the procedures within LVNL and beyond. The ILS area and the accuracy of the approach radar at low altitude were further clarified. ANWB MAA improved Crew Resource Management procedures and reminded flight crews about the locations of ILS areas on airports that are used by the HEMS crews.

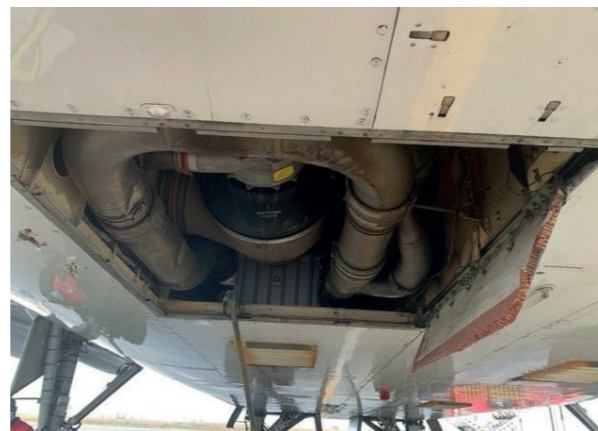
The Boeing 747 departed for a cargo flight from Amsterdam Airport Schiphol to Jomo Kenyatta International Airport in Kenya. During the climb to cruising altitude - around 12,000 feet - the pilots heard a noise. After consultation, they decided to continue the flight to the final destination. Upon arrival in Kenya, it was found that a panel on the underside of the aircraft's fuselage had broken off. It is suspected that this panel came loose during the climb and was lost over the Netherlands.

The location of the lost panel.

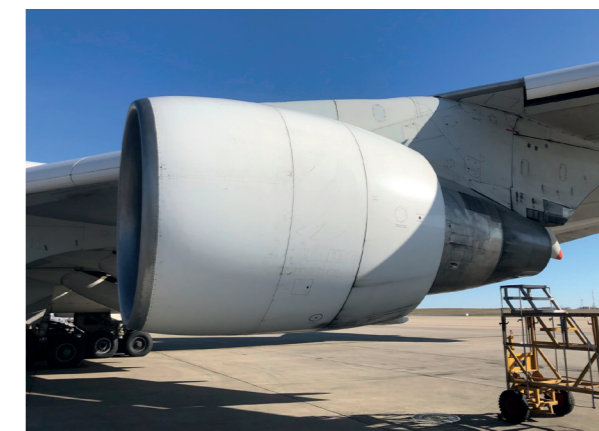
Shortly after takeoff from Maastricht Aachen Airport, one engine of the cargo aeroplane encountered a failure. The aeroplane lost some parts of the engine above the village of Meerssen. This resulted in two people suffering from minor injuries and, among other things, damage to some cars. The crew then diverted to Liege Airport in Belgium and made a safe landing.

The affected engine of the aircraft.

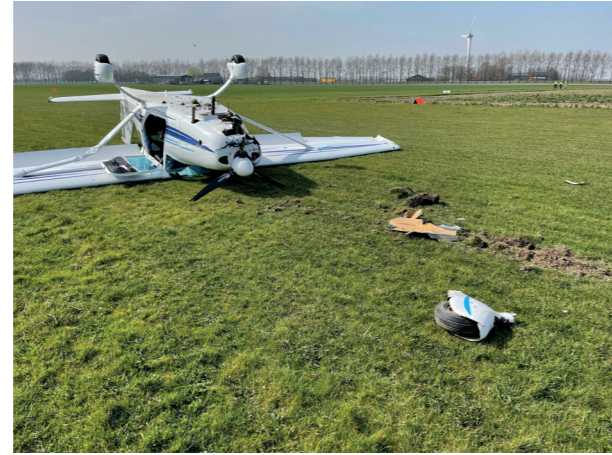
During landing the TL-3000 Sirius, a *microlight aeroplane*, flipped over and came to a halt upside down. The pilot was unharmed. The aeroplane was substantially damaged.

The aircraft after landing. (Source: Veiligheidscommissie Middenmeer)

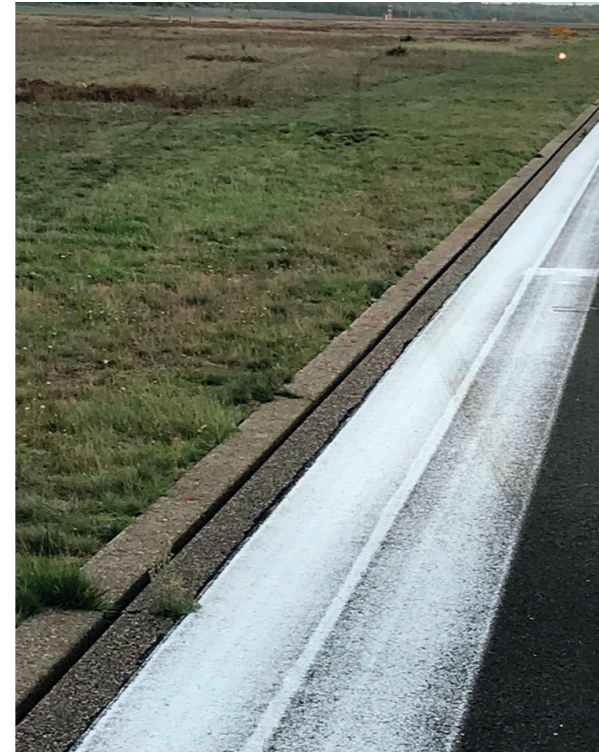
The captain of the Dutch-registered aircraft, with three crew members and one passenger on board, aborted his takeoff run at a speed of approximately 130 knots. The aircraft then left the runway. After approximately 530 metres, the pilot succeeded in returning the aircraft to the runway. The aircraft sustained minor damage. The occupants were unharmed. The runway excursion occurred as a result of the switching on of the gust lock system, which locked the control surfaces, causing the pilots to temporarily lose control of the aircraft.

Traces runway excursion. (Source: BFU)

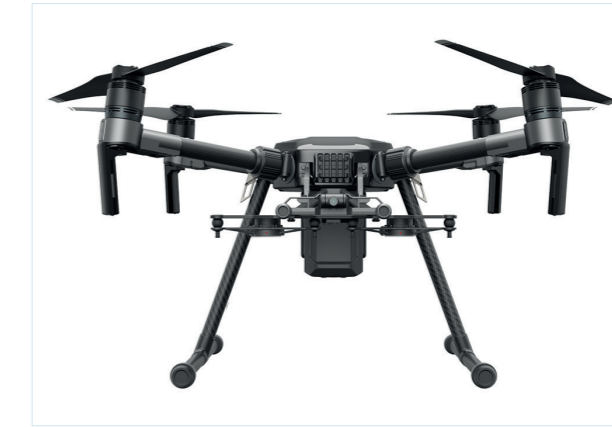
DJI M210 UAS. (Source: Skytools)

The unusual values of parameters related to motor number 4 and its associated ESC and the distinctive movement (a spinning motion) of the UAS during the crash indicate a problem with ESC number 4. In the absence of the UAS and detailed flight data, the exact cause of the propulsion system problem cannot be determined for this accident. According to an analysis carried out by the manufacturer, the available data is insufficient to determine the cause of motor 4's failure. Despite several requests from the Dutch Safety Board, the manufacturer has not produced a detailed analysis of the data from the RC, nor has it validated this data or converted it into a readable format. The Dutch Safety Board has used a third-party program to convert the data for the purposes of its own analysis.

The moist (light rain/drizzle) environmental conditions at the time of the occurrence, in combination with the prevailing wind and turbulence, may have contributed to the failure of the ESC. The reports of safety investigations into other Matrice 200-series UAS occurrences reveal a history of damage to the electronics (such as the ESC) due to moisture penetration.⁸ The manufacturer states that the UAS concerned has an IP43⁹ protection rating. Accordingly, in the User Manual, the manufacturer states that the UAS may only be flown in light rain ('do not fly when the amount of rainfall exceeds 10mm/day'). However, the manufacturer does not translate the protection rating into operational weather limits. The operator's manual only makes a general reference to the IP43 protection rating. It does not specify operational rainfall limits for the UAS in question.

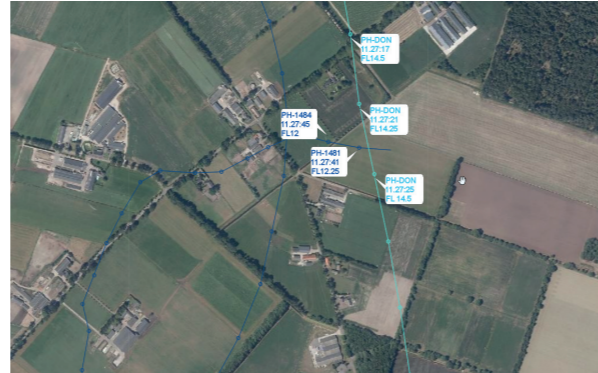
Radar images revealed that the flight paths of the two aircraft did indeed cross. PH-DON flew past and in front of PH-1484. PH-1484 crossed the flight path of PH-DON after approximately 16 seconds. Because the transponder in PH-1484 was only activated following the winch launch, the aircraft only appeared on the radar at an altitude of approximately 1,200 feet, several seconds after crossing the flight path of PH-DON. It is therefore not possible to determine the precise separation between the two aircraft at that moment. Taking into account the speed of the two aircraft, the horizontal separation between the two was between 300 and 400 metres. The vertical difference between the aircraft was less than 200 feet. Because the pilot of PH-1484 uncoupled the launch cable early, and initiated a descent, the vertical separation never fell below this value.

- The radar altitudes are based on the standard air pressure of 1013.2 hPa. The air pressure at the time was in fact 1014 hPa, so that the altitudes, calculated from sea level, were approximately 27 feet higher than the indicated altitudes.
- The altitude of both aircraft is shown in flight levels, showing the altitude per 100 feet.
- The altitude of the glider is shown in metres in the text, as is normal practice in the glider world.

Aerial photo showing the headings of both aircraft. (Source: LVNL)
