DUTCH
SAFETY BOARD

Quarterly Aviation Report

January - March 2022

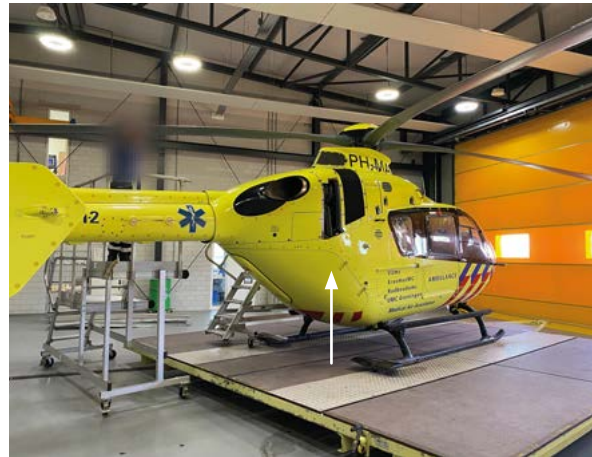
The air ambulance helicopter had taken off from Groningen Airport Eelde; a short time later, the crew returned to the airport because the assignment to which they had been directed was cancelled. During the return flight, the crew heard an unfamiliar noise. The remainder of the flight was uneventful. During the inspection of the helicopter after landing, it was found that it had lost an engine inspection panel (approximately 60 by 30 cm).

The helicopter with the missing engine inspection panel. (Source: ANWB MAA)

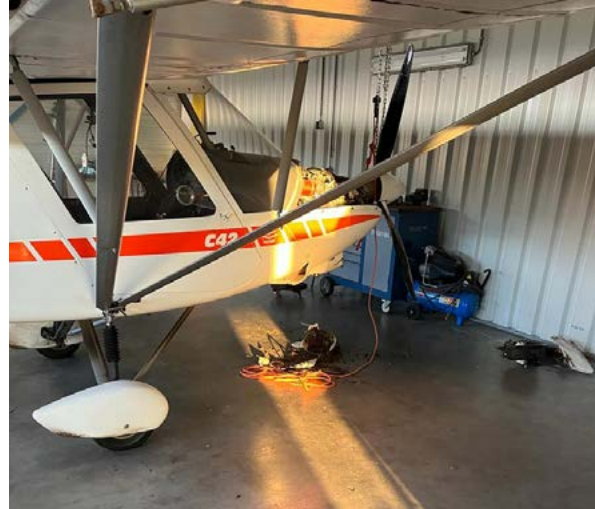
The microlight aeroplane made a hard landing on Runway 06, whereby the nose wheel broke off and the propeller was damaged. The two occupants were unharmed.

The damaged aircraft. (Source: flying club)

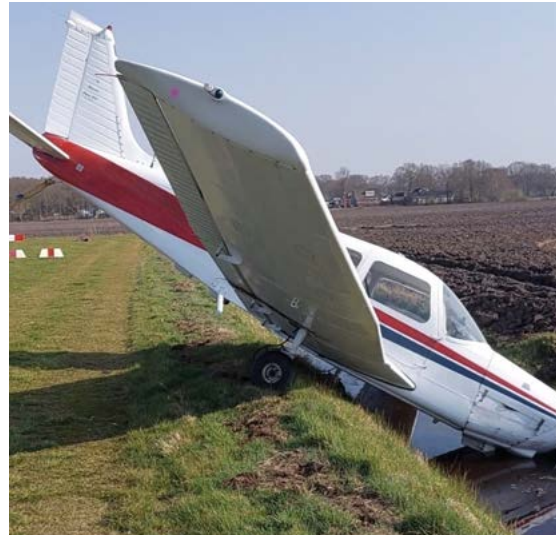
The pilot lost control of the Piper while landing on Runway 13. The aircraft went off the runway, and came to rest with its nose in a ditch. The pilot was unharmed. The aircraft suffered damage.

The Piper following the runway excursion. (Source: Dutch aviation police)

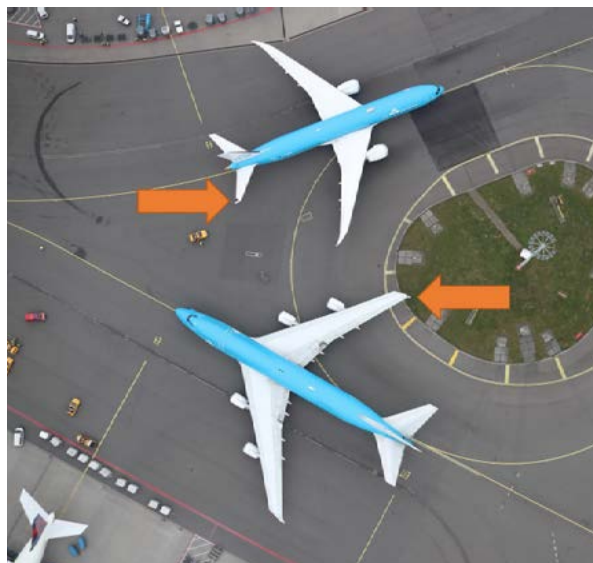
Ground Control had issued a long pushback clearance to the B787. The flight crew passed this clearance on to the pushback driver. The driver positioned the B787 approximately 20 meters beyond the pushback limit line on the taxiway. Shortly after, a B747 also received clearance to commence pushback. Following his pushback clearance to the B747, the ground controller realised that this pushback would possibly bring the B747 close to the B787, so he issued a cautionary message to the B747 flight crew. The transmission of this message was partially blocked out by another transmission. There was no readback of the message by the flight crew of the B747, and the ground controller did not act on the missing readback. As a result, the message was not forwarded to the B747 pushback truck driver. The pushback truck driver of the B747 was not aware of the long pushback of the B787. From his position, he could not determine the exact position of this aircraft on the manoeuvring area and during the push his view on the B787 was obstructed by the engines of the B747.

Top view of the position of the aircraft after the accident. The arrows indicate the damaged aircraft parts. (Source: Dutch aviation police)

The undocumented long pushback procedure used in this accident was not an assessed and aligned procedure within the sector parties at Schiphol. The non-standard pushback of the B787 introduced non-standard conditions the pushback truck driver of the B747 was not aware of. Deviating from standard procedures is not an uncommon practice for air traffic controllers at Schiphol, as was also noted in previous investigations of the Dutch Safety Board, such as the 2017 Schiphol investigation. The reason for deviating from the standard pushback procedure was to ensure an efficient flow of traffic.

This deviation, however, introduced risks as separation margins were no longer ensured. The non-standard pushback of the B787 implied a temporary restriction of other traffic in its vicinity. The mitigation action implemented by the ground controller – issuance of a cautionary message – was not effective, as the transmission of this message was blocked. The assessment of the taxiway behind the aircraft and the issuance of conflict-free pushback clearances is the responsibility of Ground Control and cannot be delegated to a pushback truck driver. A pushback clearance should only be issued when adequate separation can be guaranteed.

The use of standard pushback procedures with known obstacle clearances and separation margins is the main barrier to ensure sufficient clearance in pushback operations. It is therefore essential that in case of deviations from the standard procedure, the risks are recognized and mitigating actions are put in place effectively. As a result, in case of deviations from standard procedures, it may be necessary to temporarily stop other traffic movements.

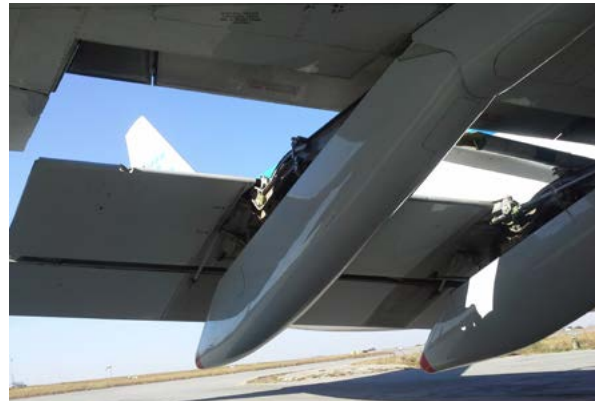
The investigation found that the right wing inboard foreflap of PH-CKA failed and partly separated, because of a fatigue crack failure of the foreflap outboard fitting lug. The fatigue crack was caused by pitting corrosion. The pitting corrosion had formed because of moisture that had accumulated between the inside of the foreflap fitting lug and the outside of the fitting lug bearing for over a long period of time.

The cause of PH-CKA's inboard foreflap outboard fitting failure is similar to other investigated occurrences concerning inboard foreflap separations, that occurred with the Boeing 747 series aircraft in the past.

About one year prior to the failure of PH-CKA's right wing inboard foreflap outboard fitting lug, the foreflap outboard fitting lug bearing was replaced during a regular D-check because of migration of the bearing. At that time, it was likely that a progressed form of pitting corrosion was present on the inside of the fitting lug. This corrosion was not discovered during the replacement. Therefore, the Dutch Safety Board emphasises that investigating the cause of anomalies of aircraft parts according to maintenance manuals and by observing standard maintenance practices is vital to ensure system safety.

*The right wing trailing edge inboard flap system and damage.
(Source: owner of the aircraft)*

Boeing issued Alert Service Bulletin 747-57A2367 on 15 November 2019 to further improve the reliability and the safe operation of the inboard foreflap and related parts of the inboard trailing edge flap system. This alert service bulletin requires replacement of the inboard foreflap outboard fitting lug at an interval that is well before the expected time of failure. On 30 March 2021, the Federal Aviation Authority mandated with Airworthiness Directive 2021-02-15 the maintenance requirements from Alert Service Bulletin 747-57A2367. This measure as imposed by the airworthiness directive has been incorporated after a prolonged period with various maintenance measures to improve the Boeing 747 inboard trailing edge flap system. The Dutch Safety Board considers that the alert service bulletin requirements and the mandatory compliance as imposed by the airworthiness directive are adequate to prevent future inboard foreflap outboard fitting lug failures. Hence, the Dutch Safety Board does not issue recommendations.

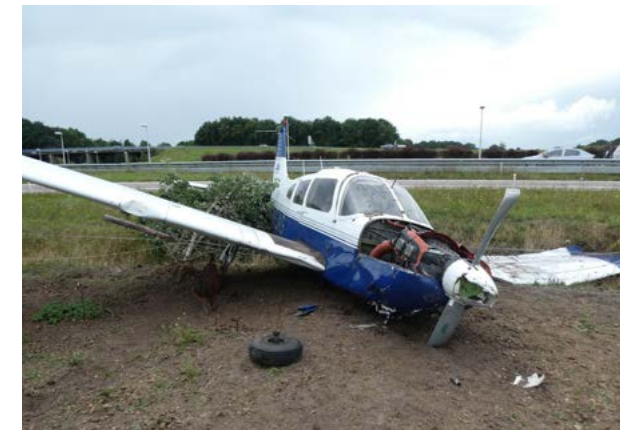
No clear agreements had been made before and during the instruction flight on who would steer the aircraft during the touch-and-go. The instructor stated that he would make the landing, while the student thought he was going to perform the touch-and-go. Simultaneous steering inputs on the yoke of both the flight instructor and the student lead to an aft held position of the yoke, and with that a nose's high attitude and high angle of attack during the touch-and-go.

As a result, the takeoff roll caused a considerable amount of drag that could not or hardly be compensated by engine power and consequently led to a takeoff with the airspeed being too low. When the aircraft ultimately became airborne at low altitude, the aircraft banked, struck the ground with the right wing, made a 180 degree-turn and came to rest outside the borders of the airport.

The PA-28-181 after the accident.

The high mass of the aircraft and the aft center of gravity had a negative effect on the flight characteristics of the aircraft. Following the accident, the flying school has taken measures to prevent instructors from instructing on types of aircraft with which they have limited experience.

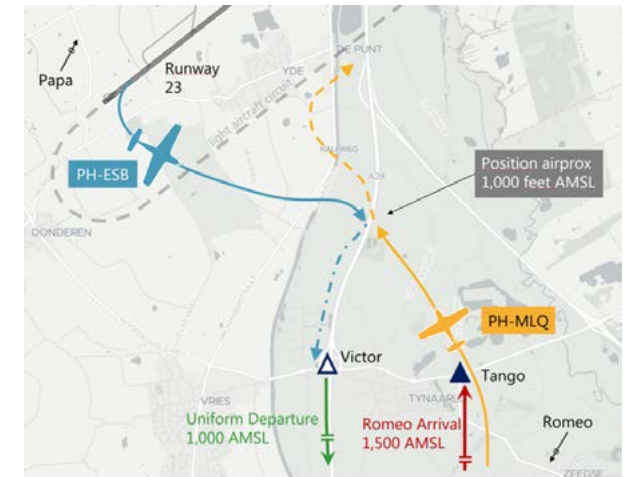
Following takeoff, PH-ESB (hereinafter ESB) flew on a southeasterly heading and climbed to 1,000 feet AMSL for a Uniform Departure (see figure). At approximately the same moment, PH-MLQ (hereinafter MLQ) passed point Romeo for a Romeo Arrival at an altitude of 1,500 AMSL. MLQ then reported above point Tango; the traffic controller cleared MLQ to join the downwind leg from Runway 23. A short time later, the traffic controller issued traffic information to MLQ about an aircraft that was flying a Uniform Departure via point Papa. The traffic controller then issued traffic information to ESB about an aircraft that was flying downwind from point Tango at 1,000 AMSL; ESB confirmed receipt of this information.

After the trainee pilot in MLQ had passed point Tango, he asked for permission to descend to circuit height; the traffic controller confirmed consent. During the descent, the trainee pilot of MLQ saw that ESB was approaching from the front left; he halted his descent and completed a gentle turn to the right. Immediately afterwards, the instructor of ESB saw MLQ, and made a sharp turn to the right, to avoid a collision. The aircraft passed each other at a separation of around 150 metres. The instructor on board ESB informed the traffic controller that the two aircraft had come close to each other. Following the airprox, the two aircraft continued their flight, without further incident.

Flight tracks of PH-MLQ and PH-ESB and the position of the airprox.

The investigation revealed that the following factors contributed to the occurrence of the airprox. The clearance issued by the traffic controller to MLQ to descend to the circuit height of 1,000 feet AMSL after passing point Tango, while ESB was flying at an altitude of 1,000 feet AMSL towards MLQ, on a southeasterly heading. The unclear traffic information about ESB to MLQ, which meant that the trainee pilot on th MLQ acquired a different impression of the position of ESB. The moderate flying visibility also meant that the instructor of ESB only observed MLQ at a late stage, and that navigating ESB to point Victor was made more difficult.

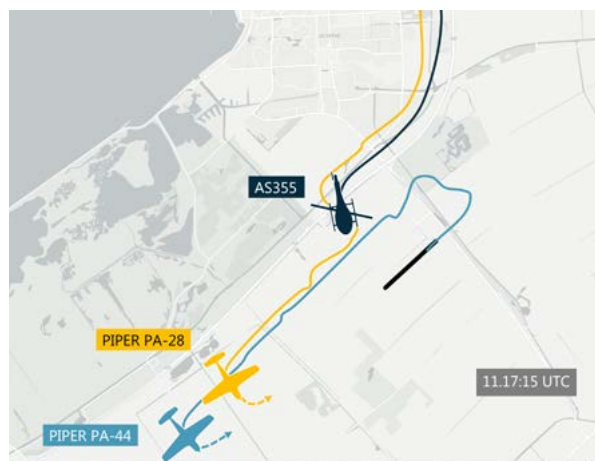
Runway 05 was in use at Lelystad Airport. PH-SAE, a Piper PA-44, with two persons on board had made a touch-and-go and stayed in the VFR training circuit at an altitude of 500 feet above mean sea level (AMSL). PH-UGS, a Piper PA-28, entered the circuit on downwind behind PH-SAE (standard circuit at 1,000 feet AMSL). The PA-44 did not make a downwind call⁷, whereupon the tower controller finally instructed the PA-44 to turn to base, see first figure. The PA-44 then flew on an extremely extended downwind. The tower controller informed the PA-28 that he was number two, with number one ahead of him flying on base. The pilot of the PA-28 stated afterwards he had not heard this message and was not aware of the PA-44 flying in front of him. Radar data indicates that shortly after the PA-44 turned to base, the PA-28 also turned to base - without having heard a sequence number - followed by a turn to final. The pilot of the PA-28 reported flying on final to the tower controller.

Both aircraft turning from base to final. (Source of data: LVNL)

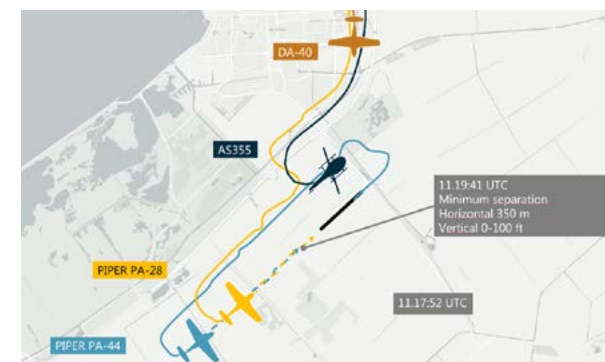
The pilot of the PA-44 then reported that the PA-28 was flying shortly in front of them on final, see second figure. Consequently, the controller instructed the PA-28 to make a go-around. The minimum horizontal separation between the two aircraft was 350 metres at about the same altitude.

Both aircraft on final and the airprox. (Source of data: LVNL)

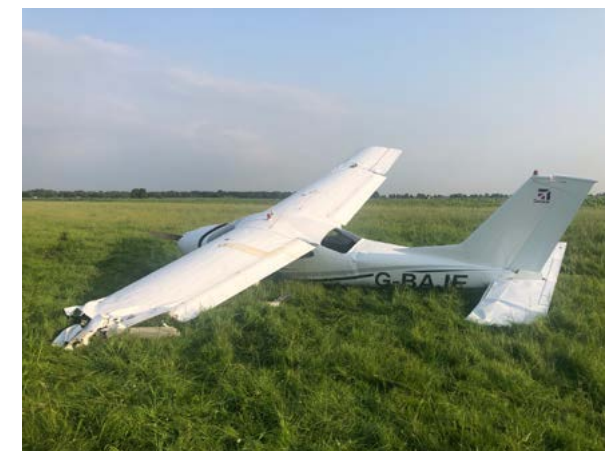
The cause of the left-hand rolling movement the aircraft made shortly before the landing could not be determined with certainty. The meteorological conditions may have contributed to the occurrence of the accident.

The crashed aircraft.

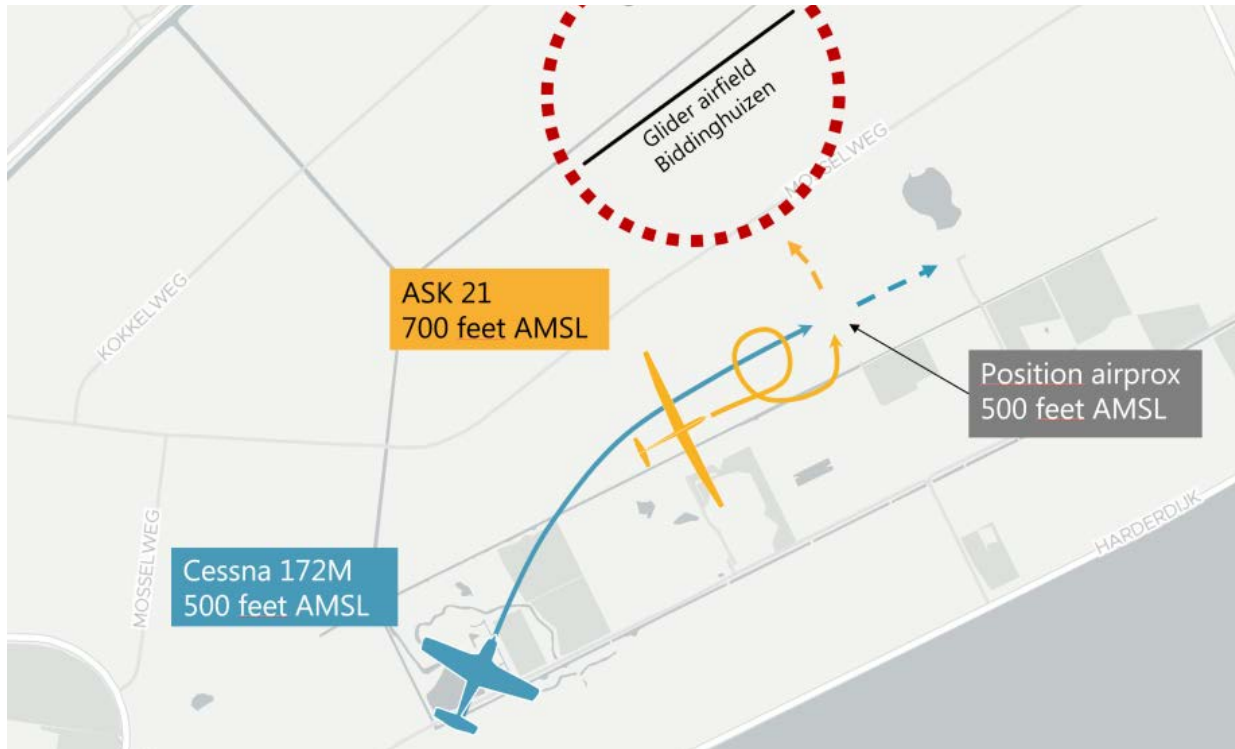
The ASK 21 took up a position to enter the circuit of Biddinghuizen glider airfield (see figure). The glider was flying at an altitude of 700 feet AMSL, and was descending to the circuit starting point in a left-hand turn. Just previously, the Cessna 172M was flying at an altitude of 500 feet AMSL, around 3 kilometres to the southwest of Biddinghuizen glider airfield. The Cessna approached the ASK 21 from a southwesterly direction. At the moment that the pilot of the ASK 21 turned towards the circuit starting point, he observed the Cessna passing below him, from left to right. He estimated that the vertical separation between the two aircraft was around 10 metres. The pilot of the Cessna observed the ASK 21 at the moment that it passed just above the nose of his aircraft, flying from right to left. The pilot of the Cessna therefore pointed the nose of the aircraft downwards. After the airprox, both aircraft continued their flight.

Flight paths of the ASK 21 and the Cessna 172M and the position of the airprox. (Source of data: LVNL)

In order to reduce the risk of a collision or an airprox between a motorised aircraft and a glider above or near a glider airfield, it is recommended that the locations where gliders can be winch launched (and/or tow launched) and their immediate vicinity are avoided, and not overflowed (under all circumstances not below the heights, indicated in the AIP, that a glider can reach during a winch launch).
