DUTCH
SAFETY BOARD

Quarterly Aviation Report

April - June 2021

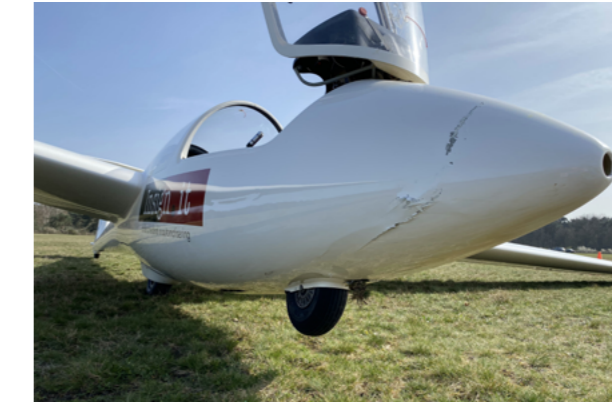
On final, the glider hit a treetop. The glider then made a hard landing and was damaged. The pilot was unharmed.

The glider following the hard landing. (Source: Gliding club)

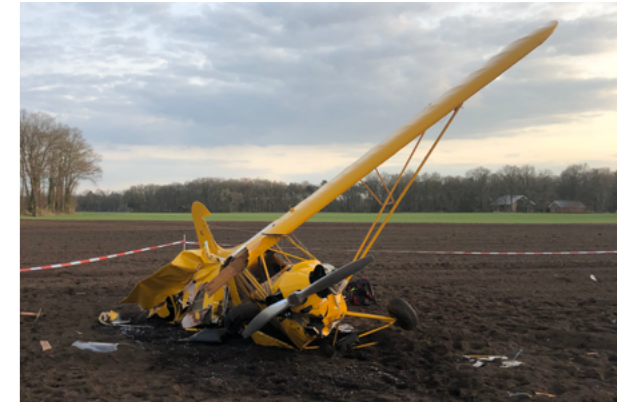
The pilot experienced problems with the control of the aircraft, after which he decided to make an emergency landing. During this landing the aircraft came into contact with a tree and the right wing broke off. The aircraft also sustained damage to the nose and right stabiliser. The pilot was unharmed.

The aircraft following the emergency landing.

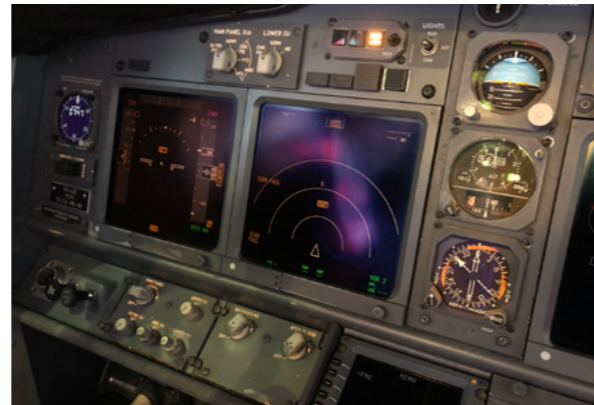
Shortly after takeoff, erroneous altitude and airspeed values were displayed on the captain's and first officer's instruments. The crew was able to reach adequate airspeed and altitude by use of standby instruments and decided to divert to Amsterdam Airport Schiphol, where the aircraft made a safe landing.

Multi-function displays and stand-by instruments.

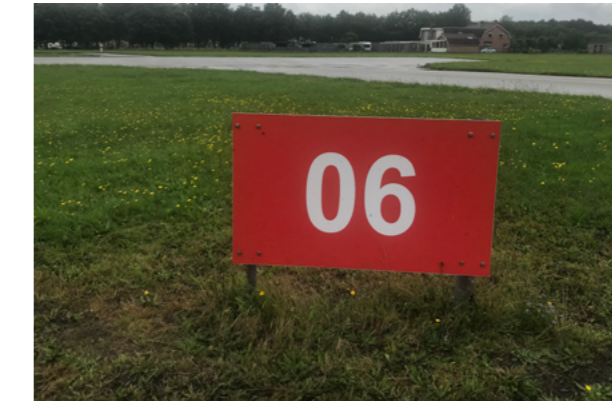
At the time that the runway in use was changed from direction 24 to 06, the F152 was taxiing to the beginning of runway 24. The pilot was informed of the runway change by radio. He did not heed a further call to wait before entering the runway and departed from the then wrong runway 24.

Runway direction 06. (Source: Breda International Airport)

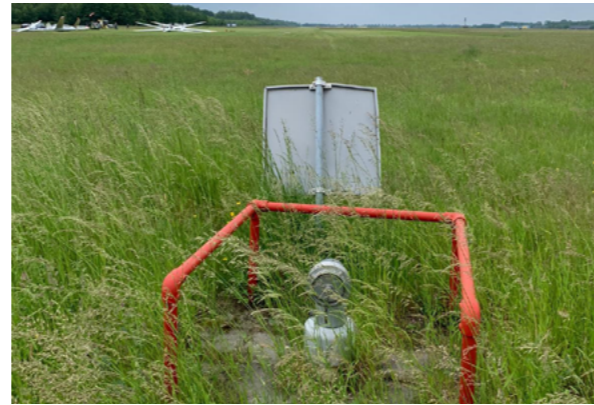
During final approach, the glider's left wing hit a metal sign. The wing sustained damage to the underside. The glider then made a safe landing.

The sign that was hit. (Source: Gliding club)

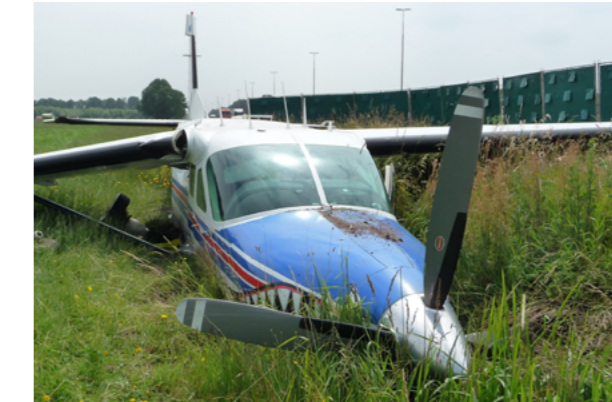
The aircraft took off from Teuge Airport with 1 pilot and 17 parachutists on board. Shortly after takeoff, the aircraft lost engine power, after which the pilot made an emergency landing in a meadow. The aircraft collided with a billboard with the right wing, then made a ground swing and came to a stop against the crash barrier next to the highway. The aircraft was heavily damaged. One parachutist was slightly injured.

The Cessna 208B following the emergency landing.

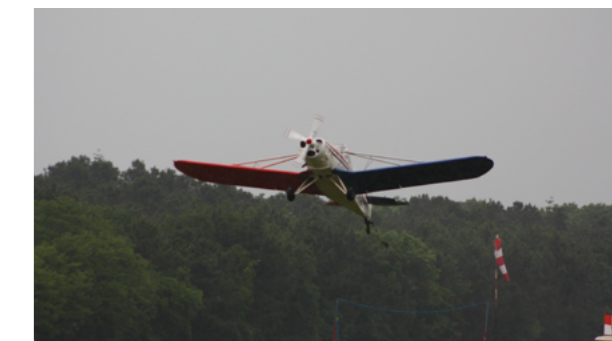
On 31 May 2018 just before 11.00 hours, a Piper PA-25-235 Pawnee took off from Breda International Airport (Seppe) for a banner towing flight. Within the local circuit, the pilot positioned the aeroplane to pick up the banner. Shortly after the pick-up, the aeroplane lost airspeed and started to descend. Just outside the airport boundary, it fell over its right wing and impacted the ground in an almost vertical attitude. The pilot was fatally injured. The aeroplane was destroyed by the crash and subsequent fire.

The following conclusions were drawn. First, the aeroplane stalled and crashed because it was equipped with an improper propeller for banner towing operations. As the aeroplane was flying slowly and the engine did not have enough power to produce sufficient rpm, the propeller could not produce enough thrust for the aeroplane to safely accelerate and climb after the pick-up of the banner. Furthermore, the aeroplane was flown above its maximum take-off weight, which worsened the thrust deficient situation. In this unsafe situation, the experienced pilot had no options to seize back control of the aeroplane.

Banner pick-up accident flight. (Source: De Haan)

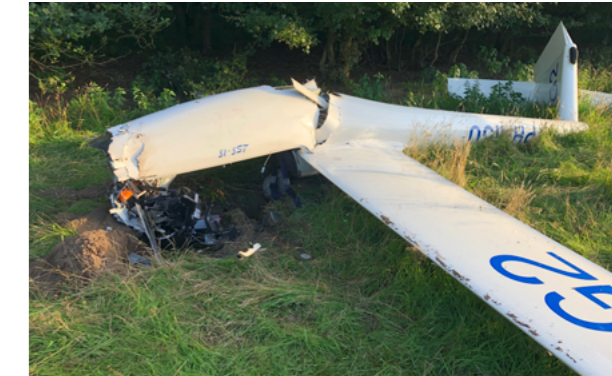
On Sunday 12 July 2020, the Rolladen-Schneider LS8-18, with registration PH-1150, a single seater glider, took off from Gilze-Rijen Air Base by making use of the winch launch method. At an altitude of approximately 200 metres, the cable disconnected prematurely. Witnesses saw the glider lower its nose and a transition to a right hand turn with a steep angle of bank. The glider then attained a nose-down attitude and started to rotate. After approximately two full rotations in the nose-down attitude, the glider crashed into the ground and came to rest upside down. The pilot died due to fatal injuries.

The accident was caused by the pilot not being able to recover from the spin, which was the result of a low airspeed situation, close to the stall speed, which had quickly developed into an asymmetric stall. The low airspeed situation arose after the premature cable release during the winch start. After a premature cable release, the pilot has to carry out the cable release procedure, which, in practice, implies forward moving of the control stick to achieve a normal flying attitude and the corresponding safe speed. The pilot of PH-1150 made a right turn, before the glider had reached a safe speed, causing the right wing to stall. There were no technical defects in the flight controls that have played a role in the accident.

During maintenance of PH-1150, a temporary repair of the molded sleeve of the yellow release handle was made and the routing of the cable of the centre of gravity release hook was adjusted. On the first day of flying with PH-1150 after this work on the cable release mechanism, this was the day before the accident, three premature cable releases took place during winch launches. After the last flight before the accident flight, a breakdown of the temporary repair was observed. A technician who was informed about one premature cable release that day and the breakdown of the repair, checked the release mechanism at the end of that day and found no particularities. It is concluded that the premature cable release during the accident flight was caused by a malfunction of the release mechanism. The exact cause of this malfunction has not been established.

Wreckage of the glider.

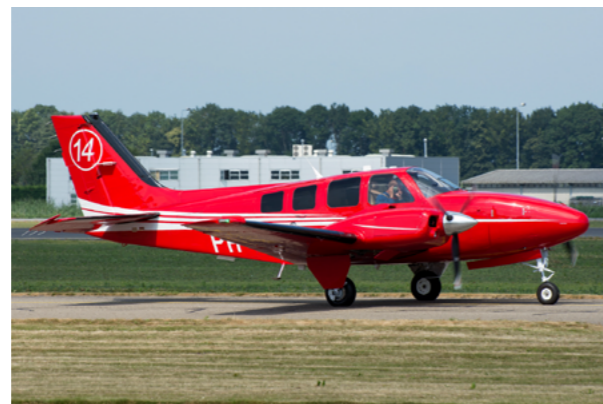
The Dutch registered aircraft, with two occupants on board, had taken off from Lelystad Airport for a training flight. The crew made a go-around at Münster-Osnabrück Airport during which the aircraft crashed. The aircraft came to a stop upside down and was severely damaged. Both occupants were fatally injured.

The accident was caused, because during the final approach with one engine running, the relevant speeds were undershot and the aircraft became uncontrollable due to the initiated go-around.

Archive photo of the Beechcraft G58 Baron. (Source: E. Stam)

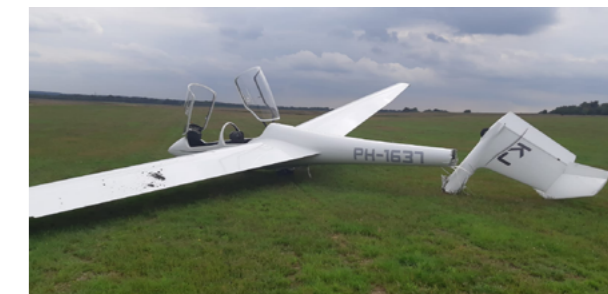
an estimated altitude of approx. 30-50 metres, initiated a sharp slip manoeuvre to the left, with full rudder, the aim of which was to lose additional altitude. During this slip manoeuvre, the nose of the aircraft was pointed downwards, and in the course of the manoeuvre, this downward angle increased. The instructor returned the aircraft to a more or less horizontal position just a few metres above the ground, before making a hard landing in the heather, just in front of the airfield landing area. The aircraft bounced up and landed on its nose, left wing down. The glider continued rolling and rotated through approx. 90 degrees to the left, before coming to a stop on the intended landing area. Following the incident, the instructor suffered a painful right arm and shoulder while the trainee remained unharmed. The tail of the aircraft had broken off, the fuselage was twisted and the nose dented.

The flight data showed that the downwind leg was not flown entirely parallel to the winch path. As a consequence, the circuit flown was somewhat tighter, resulting in a shorter base leg, leaving less time to lose altitude. When the aircraft found itself in final approach, where the terrain in front of the landing area slopes downwards, there was almost no headwind, which resulted in an insufficient angle of descent. Partly because the landing runway is relatively short, the instructor felt it was necessary to carry out a slip manoeuvre. In part, this may have been due to optical illusions caused by the relatively wide landing strip, in combination with the downward sloping terrain ahead of the landing area.

Available film recordings of the final approach of the aircraft show that the slip manoeuvre was initiated at low altitude with full rudder extension. This resulted in a high angle and high speed of descent. Notable was the low pitch attitude during the entire manoeuvre. The slip was

halted at low altitude, with a level pitch attitude; this left insufficient altitude to slow the high speed of descent and subsequently to land. This resulted in a hard landing.

The ASK 21 B after the hard landing. (Source: Dutch Aviation Police)

To carry out a slip manoeuvre with the required precision, it is always important to initiate the manoeuvre gently, and simultaneously keep the nose of the glider above the horizon. It is also vital to have an active awareness of the speed of descent; this should be kept proportional to the flying altitude. At low altitude, the speed of descent should also be low. The manoeuvre should also be terminated gently, at sufficient altitude, at which point the pitch attitude can be lowered, in order to maintain sufficient airspeed.
