DUTCH
SAFETY BOARD

Quarterly Aviation Report

July - September 2021

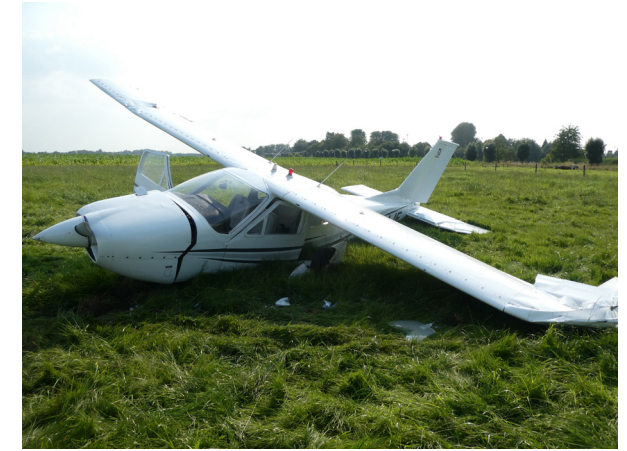
During landing, the flight instructor lost control of the aircraft. The aircraft came to a stop in a meadow adjacent to the airfield and was seriously damaged. The flight instructor suffered minor injuries. The student and a passenger were unharmed.

The crashed aircraft.

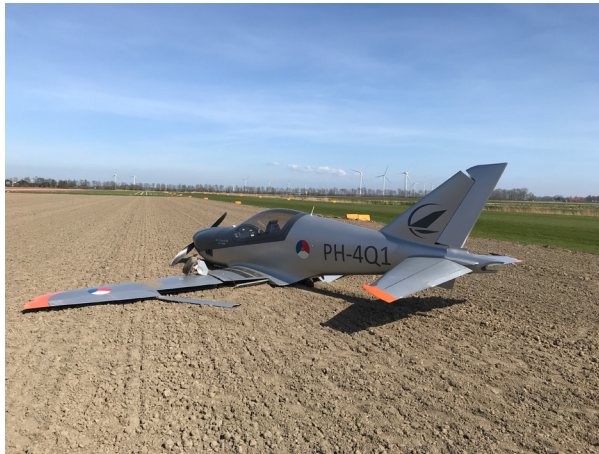
The cause of the accident was an asymmetric stall over the left wing during short final, at which point the pilot lost control of the aircraft. The flight data show that the speed of the aircraft fell from around 70 knots during final to around 53 knots during short final. The pilot then in a short time raised the pitch attitude, at which point the speed fell further to 45 knots. A few seconds later, the nose of the aircraft rose even higher and the left wing stalled. According to the flight data, the aircraft generated an auditive stall warning but the pilot had no memory of this warning.

The Blackshape Prime in the field. (Source: Dutch Aviation Police)

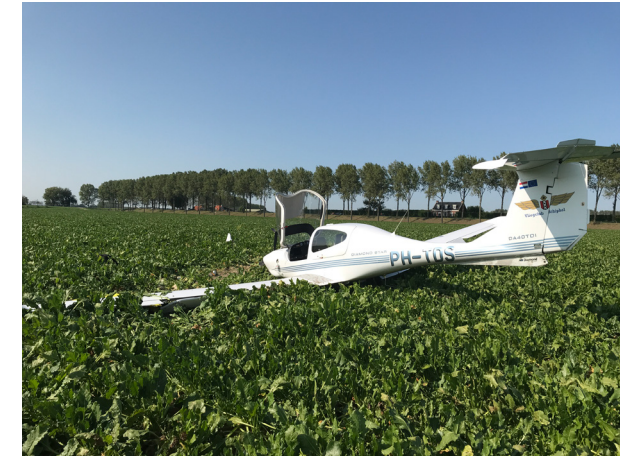
According to the pilot the fuel tanks were full when he departed from Schiphol and after approximately 20 minutes he was flying above the Haringvliet waters. He observed that engine oil pressure decreased, shortly came back a little after which it declined to 'zero'. The piston engine started to malfunction and power fell back after which the engine stopped. At 11.55 hours the pilot issued a Mayday call to Amsterdam Information and reported he had an engine failure. As the pilot was conducting a glide he reached the shore near the village of Den Bommel. The pilot made an emergency landing in a field with crops, which he had initially viewed as grass. The pilot suffered no considerable injuries, the aircraft was substantially damaged.

While reading the before take-off checklist at Schiphol the pilot had not experienced any anomalies on the engine. Despite the decreasing oil pressure as observed by the pilot, it appeared that no engine oil had leaked. The diesel engine¹³ of the manufacturer Continental Aerospace Technologies (formerly Thielert) was relatively new with 196 flight hours. Metal parts were found in the oil filter and the crankshaft appeared to be broken.

PH-TDS after the emergency landing. (Source: Dutch Aviation Police)

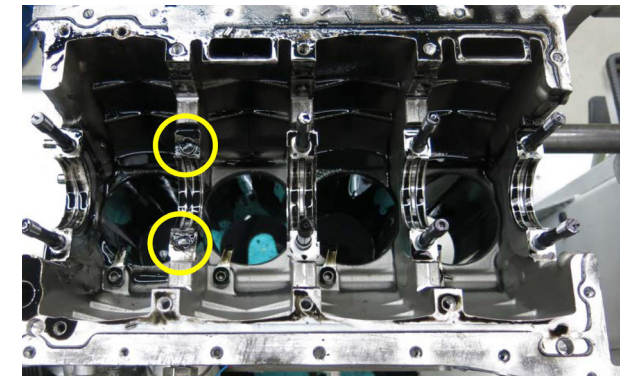
In October 2020 the BFU and the German manufacturer accomplished a further teardown of the engine of PH-TDS. Besides other damage it appeared that stud bolts of one of the crankshaft main bearing caps were broken, see the figure below.

Failed stud bolts of bearing #2.

The damage assessment of the crankshaft and the main bearings of the engine of PH-TDS shows that due to the failure of main bearing #2, the crankshaft no longer appropriately aligned in all the bearings in the engine block. As this caused a cyclic load, the crankshaft ultimately failed due to fatigue and the engine block cracked, making an engine failure inevitable.

To assemble the engine the manufacturer uses four variants of stud bolts. All failed stud bolts were of the same (dark colored) variant and showed fatigue fractures. During the manufacturing process the failed stud bolt had been rolled¹⁴ before the heat treatment whereas the other variants (shiny colored) had been cold rolled after the heat treatment. The shiny colored stud bolts demonstrated a better resistance against fatigue than the dark colored stud bolts.

Although the manufacturer found sufficient safety margin for the dark colored stud bolts in its calculations against fatigue, it can be concluded that the calculation methodology does not take into account all in-service conditions. The assembly process of the engine does not appear to be a factor for the failed stud bolts.

On 18 December 2020 the engine manufacturer issued a Service Bulletin (SB) to owners and maintenance organizations. The SB refers to the engine serial numbers of this type of engine which have been equipped with stud bolts from suspected batches. The manufacturer will replace these stud bolts and has determined the limits of flight hours and time within which this replacement has to be carried out. The efforts of the manufacturer are monitored by the oversight authority EASA, which approved the technical information in the SB.

In September 2021 the BFU reported that 370 engines had been returned to its production facility for inspection. This major safety action of the manufacturer resulted into the discovery of another 17 engines (22 in total when including the in-flight failure cases) with failed stud bolts.

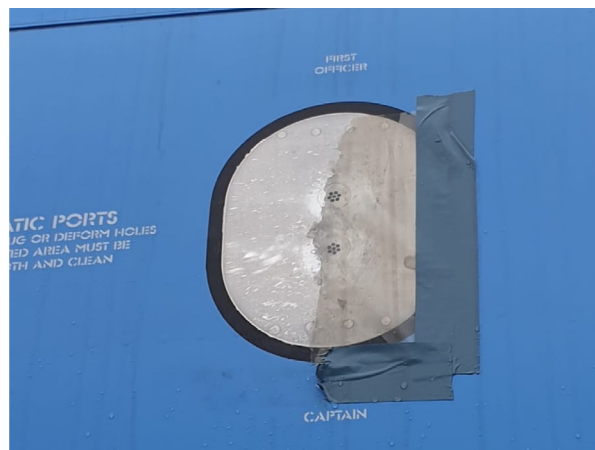
When the aircraft was returned to service, the next maintenance crew did not remove the cover on the primary static port on the right hand side of the aircraft. On the day of the occurrence, the maintenance crew that had prepared the aircraft for flight and the flight crew, did not notice that the static port was still covered during their pre-flight inspections either. Noted that these inspections were performed during hours of darkness.

The incorrect working of the pitot static system causes the presented airspeed and altitude information to become unreliable. These unreliable indications may cause difficulties for the pilots to safely control the aircraft. When these unreliable indications are combined with unfavourable environmental conditions such as cloud layers, the unsafe situation may worsen because pilots are not be able to use outside references -horizon- to aid in controlling the aircraft. During this occurrence the pilots were able to safely fly the aircraft, despite a cloud layer that was present for the majority of the flight. Nevertheless, pitot static system malfunctions have led to serious incidents and accidents in the past. It is therefore emphasized that maintenance and flight crews must verify that the pitot static system is clear of covers, placards or tape during inspections and preparation for flight to ensure the safety of flight.

OO-JAV's right hand side captain's and first officer's pitot static port and remnant of used plastic and tape. (Source: Operator of the aircraft)

The Dutch Safety Board has issued an [interim warning](#) with the aim to raise airlines' and maintenance organisations' awareness to the safety risks that can increase when aircraft are returned to service following a period of storage.

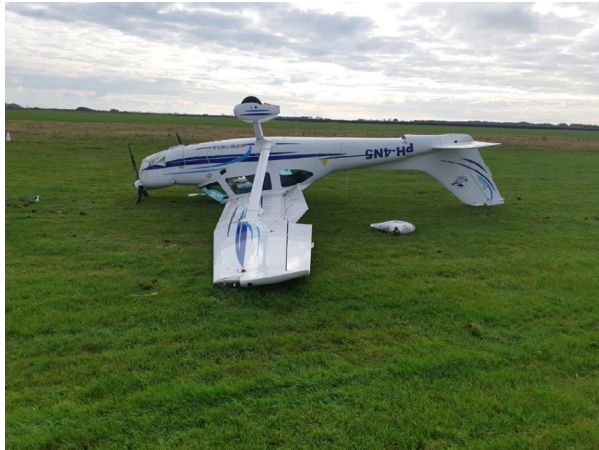
The pilot had departed Middenmeer airfield for a cross-country flight to Ameland Airport. On final approach to Runway 27, a grass runway, the pilot selected full flaps. The airspeed on final was 60 KIAS. On the first touchdown, the aircraft landed with hardly any positive pitch (flare) and bounced. The pilot continued the landing, after which the aircraft bounced a second time. At third touchdown, the nose wheel dug into the ground and subsequently the nose landing gear of the aircraft broke off. The aircraft nosed over and came to rest inverted. The aircraft was substantially damaged. The pilot was slightly injured, but was capable of leaving the aircraft himself.

PH-4N5 after the landing. (Source: Dutch Aviation Police)

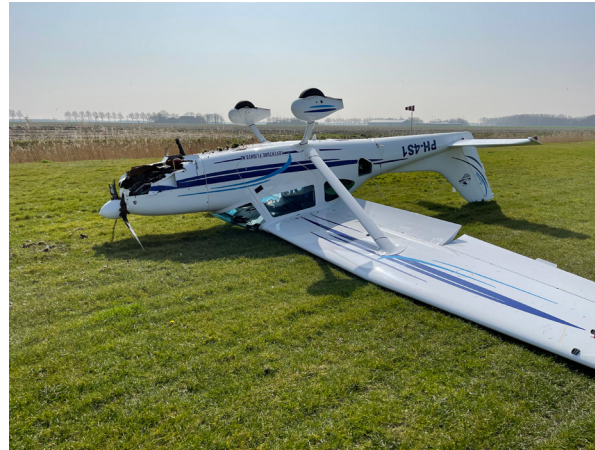
The wind came from the direction 180 degrees at a speed of 4 knots. The instructor was seated by the runway with a radio in his hand. During the landing on grass Runway 23, the aircraft bounced whereupon the pilot performed a go-around. At that same time the instructor told him to go around. After re-joining the circuit, the pilot selected full flaps at the end of downwind. On final the speed was 56 KIAS and the trim was selected a bit forward of the neutral position. When the aircraft was over the landing strip, the instructor told the pilot via the radio to flare and float out quietly. During the flare manoeuvre, the aircraft regained some height, and subsequently made a hard landing. The aircraft bounced up and hit the ground with a nose down attitude. The nose landing gear broke off, the aircraft nosed over and came to rest inverted. The flight instructor rushed to the aircraft and unsuccessfully attempted to open the passenger door. The pilot managed to open the door on his side and exit the aircraft unharmed. The aircraft was severely damaged.

PH-4S1 after the landing. (Source: Middenmeer Safety Committee)

The three similar accidents in the Netherlands (in 2019, 2020 and 2021) with TL-3000 Sirius aircraft all took place during landing and are characterised by a broken-off nose landing gear, followed by the nosing over of the aircraft. The Dutch Safety Board has not further investigated the design of the nose landing gear, because the focus of the investigation was on the operational aspects.

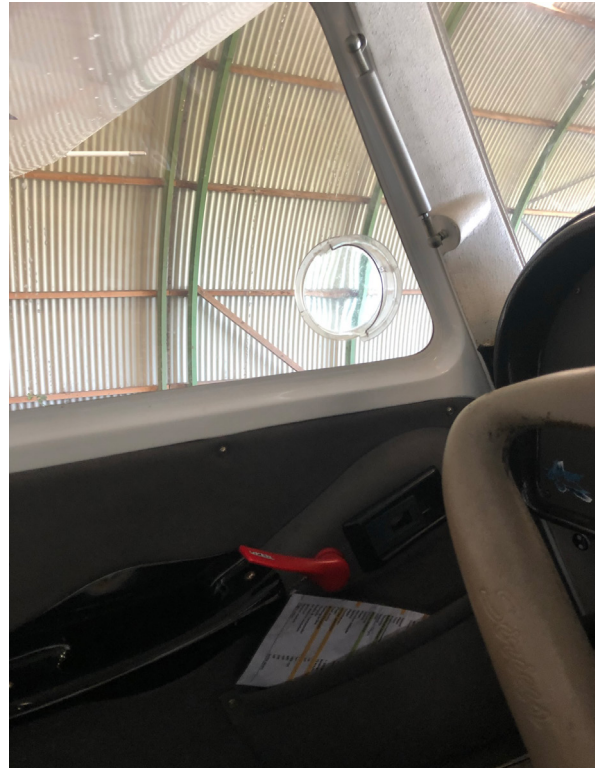
The red lever and round ventilation window.

Following the nose-over at Ameland Airport, the pilot briefly lost consciousness. He was however, able to unlock the door from the inside and exit the aircraft on his own. In the 2021 Middenmeer accident, the instructor was unable to open the passenger door from the outside. However, the pilot subsequently managed to unlock and open the door on his side and exit the aircraft.
