DUTCH
SAFETY BOARD

Quarterly Aviation Report

July - September 2022

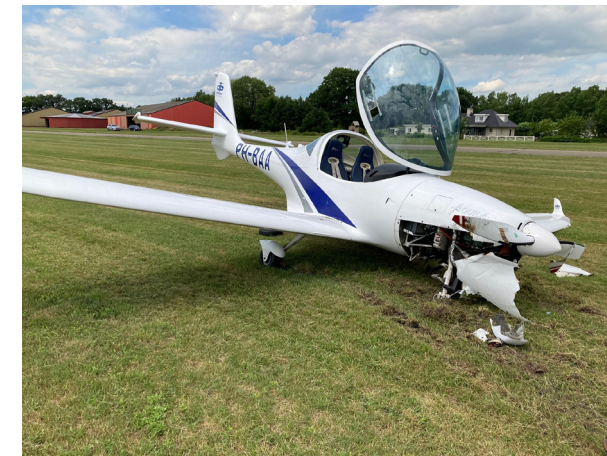
The flight instructor and student pilot were on a training flight. During a touch-and-go in crosswind conditions, a loss of control occurred. The aircraft bounced, rolled to the right and made a ground swing. The aircraft was substantially damaged. Both occupants were uninjured.

The crashed AT01. (Source: Airport Operations, Breda International Airport)

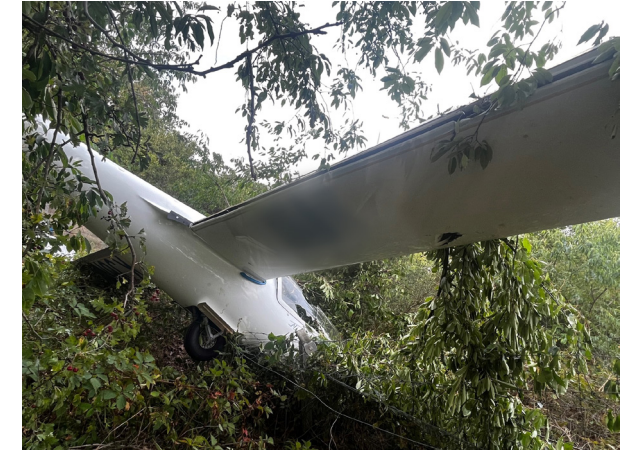
On final, the flap control lever moved unintentionally out of the landing position. The glider then quickly lost height, preventing the pilot from reaching the landing strip. The glider ended up in the trees and was severely damaged. The pilot was unharmed.

The glider in the trees. (Source: Pilot)

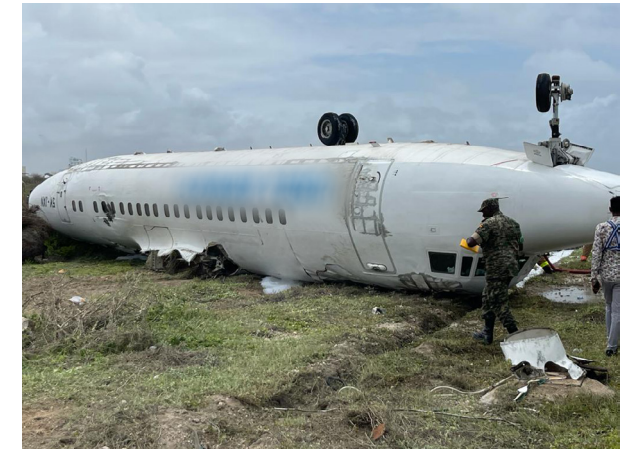
The Fokker 50 was operating a flight from Baidoa to Mogadishu in Somalia. There were 6 crew members and 30 passengers on board. During the final approach to Runway 05, the aircraft experienced windshear at a low altitude, after which the pilots lost control of the aircraft. The Fokker 50 then hit the runway hard and came to a stop on its back. A fire broke out. Three passengers suffered minor injuries. The aircraft sustained heavy damage.

The crashed Fokker 50. (Source: AAIB Somalia)

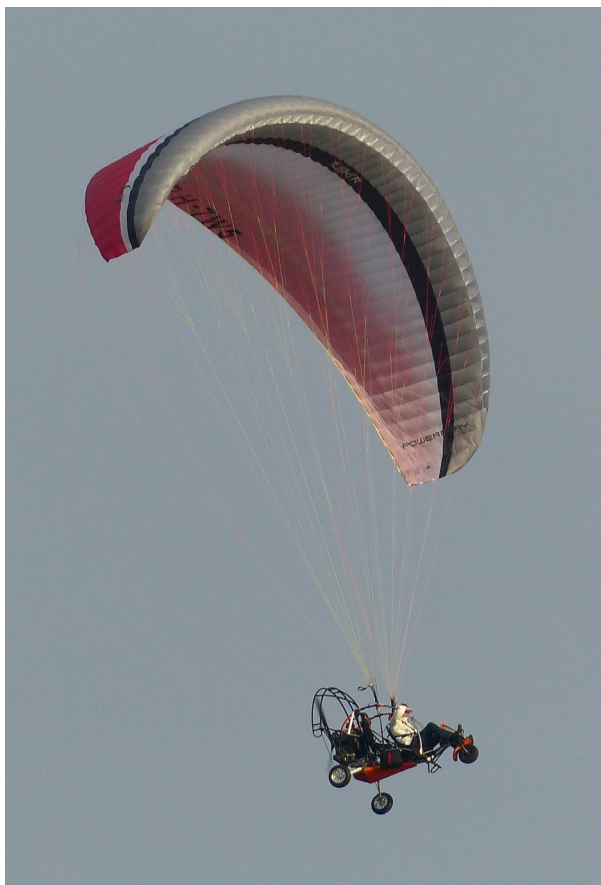
The pilot had purchased the wing during his training. The wing manufacturer Pilot's Manual states among other things that the wing is suitable for experienced, qualified tandem pilots and that the wing is intended for competent pilots only and is not suitable for beginner pilots nor those under training. On the other hand, according to the applicable standards, the wing was classified as a B wing, which means that the wing is suitable for all types of pilots, including pilots in training. The manufacturer stated that this wing was designed and tested as a paragliding wing. The use of this wing for a paramotor trike results in different flying characteristics. Therefore, it is not clear whether the type of wing was suitable for this beginner paramotor trike pilot.

The investigation also revealed that the judicial definition of a powered paraglider is not suitable for a paramotor trike and that a paramotor trike is not mentioned separately in aviation legislation. Paragliding has developed further over the years with the introduction of trikes, but the legislator has not actively followed this development. The result of this is that these paramotor trikes have been flown since approximately 2010 while no legal regulations exist for this form of aviation. The Ministry of Infrastructure and Water Management (I&W) was aware of this and started developing laws and regulations in 2015, in cooperation with the Royal Netherlands Aeronautical Association (KNVvL). Despite KNVvL's insistence, I&W has not yet resolved this situation due to a lack of capacity and priority. Meanwhile, legislation and regulations are being developed in the form of a Decree that is expected to be implemented before the end of 2022. The lack of applicable legislation and regulations had no influence on the occurrence of the accident.

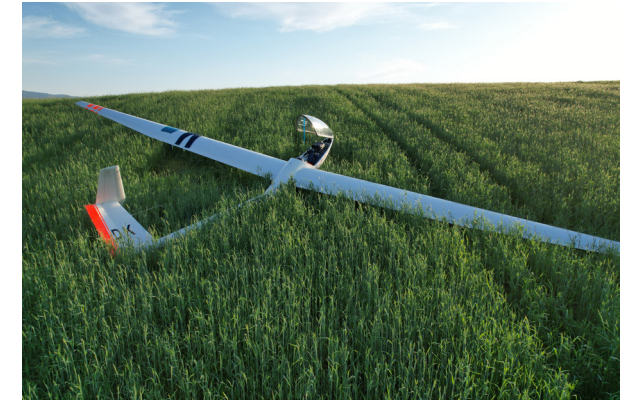
The Transportation Safety Bureau (TSB) of Hungary concluded that the pilot did not correctly assess the terrain characteristics when making the field choice. At lower altitudes, the pilot then failed to notice the steep slopes of the terrain in the intended landing area. He then failed to take the necessary corrective actions. The aircraft's flare happened late, abruptly and was not adapted to the steeply rising ground, the TSB concluded.

The DG-200. (Source: TSB of Hungary)

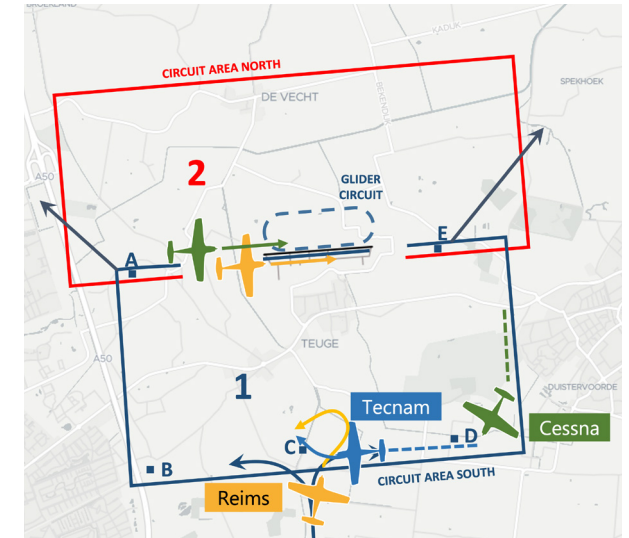
The figure below contains two sketches, each representing the situation at a given moment. See figure, situation 1: While entering the circuit, the pilot of the Reims first initiated a turn to the right, having made a mistake about the runway in use. He then observed the Cessna, which at the time was at the start of its downwind leg. The Tecnam was flying around halfway along the downwind leg when the crew observed the Reims approaching, at the relative position of around 11 o'clock. The Tecnam avoided the Reims by turning to the right, and initiating a climb. The pilot of the Reims steered back to the left, which brought the aircraft closer to the runway than usual.

Circuit area Teuge Airport: situation 1 for downwind and entering traffic, situation 2 for traffic on final.

As the Reims entered the circuit, the Cessna was at the start of the downwind leg. The crew of the Cessna saw the Reims and the Tecnam almost collide. The Tecnam, which was flying in the front, and the Reims each continued their own route on the downwind leg to Runway 08. The instructor in the Cessna observed the Reims completing a wide turn to the left, and had the impression that the Reims intended to leave the circuit area.

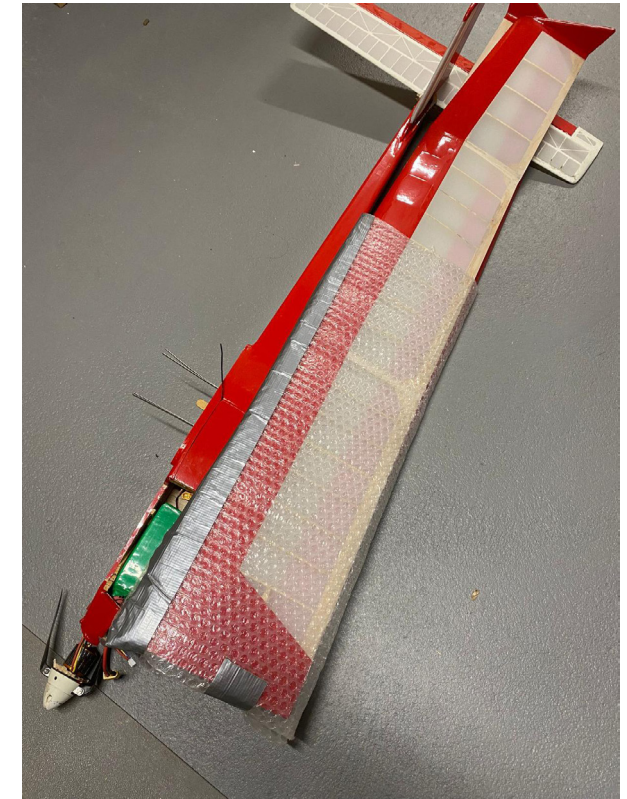
The disassembled model aircraft. (Source: the owner)

The accident was caused by the pilot losing control of the model aircraft. The weather report shows that the weather conditions were unsuitable for making a flight with a model aircraft. The wind velocity was too high to properly control a two-kilogram model aircraft with an electric motor. Although there are no limits to the weather conditions for flying model aircraft, the prevailing wind conditions were sufficient reason not to carry out a flight with such a model aircraft.

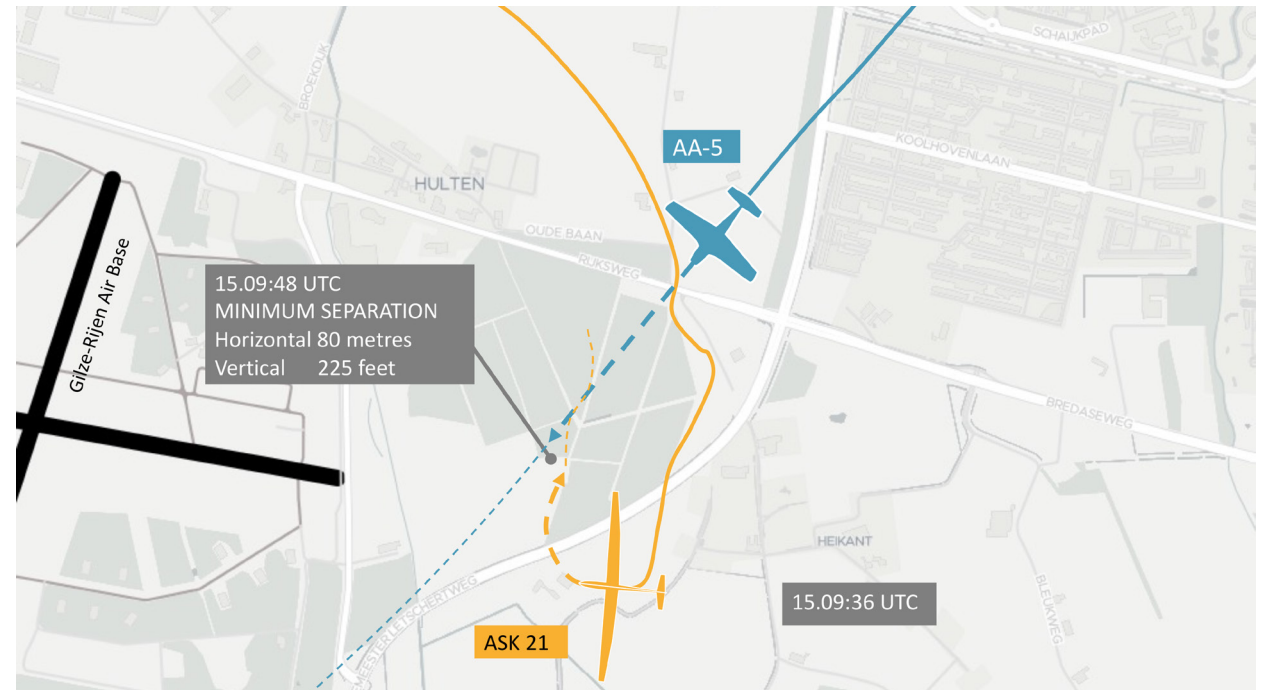
before Dutch Mil Info replied, "flight information service, QNH 1021, later on crossing Gilze is approved". The pilot took this to mean that he had received permission to cross Gilze. The pilot assumed that he had been given clearance, and that no gliding activities were taking place at Gilze, at that time. He subsequently flew over the glider circuit at Gilze-Rijen Airbase, at an altitude of approximately 1,040 feet. PH-1018, an ASK 21, was flying at that time to the east of the airbase, at an altitude of approximately 1,265 feet. According to radar data, the two aircraft approached each other closely. The minimum vertical separation between the two aircraft was approximately 225 feet, and the minimum horizontal separation approximately 80 metres.

The ASK 21 entered the glider circuit at 1,265 feet, while the AA-5 was crossing Gilze-Rijen Air Base at 1,040 feet. (Source: radar data Air Traffic Control the Netherlands (LVNL))

To reduce the risk of an airprox between a motorised aircraft and a glider above or near an aerodrome where glider activities are taking place, it is recommended to avoid these locations and their immediate vicinity, and to not fly across them at low altitude.

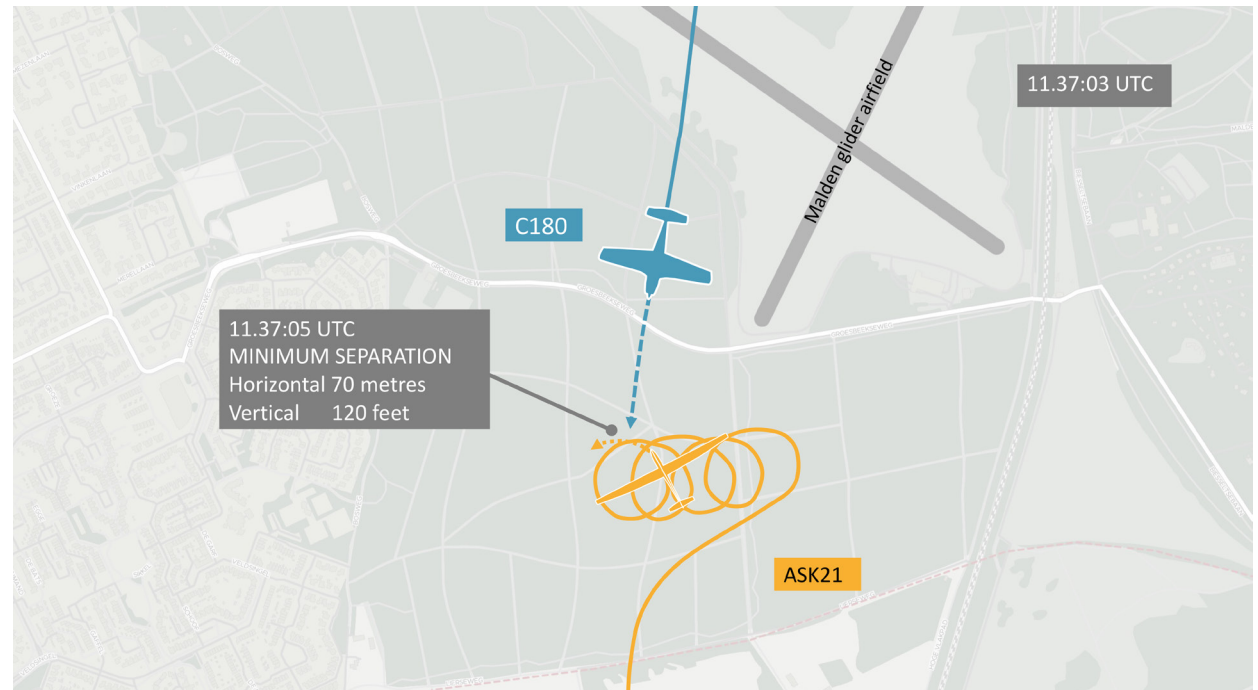
Initially, the pilots observed no other aircraft approaching, but shortly afterwards they suddenly saw a motorised aircraft passing above them, at high speed. The aircraft was flying from left to right over their aircraft, at a vertical separation as estimated by the pilots of less than 20 metres. Because of the speed of the motorised aircraft, the pilots were unable to read the registration.

Reconstruction of the airprox based on the FLARM data. (Source: radar data LVNL)

In his memory, he was flying at an altitude of approximately 2,000 feet over the glider airfield, and was continuing his flight in a southerly direction. He stated that he had not observed the ASK 21. PH-SLA is also equipped with a warning system that issues a warning if any other air traffic is in the vicinity. The pilot stated that this system had not generated a warning of a potential collision risk.

The statement of the experienced pilot of the Cessna 180J revealed that en route to his target, he had deliberately crossed two glider airfields, Terlet and Malden. A concentration of gliders can be expected around glider airfields, in particular in good weather. Although flying across glider airfields is not forbidden, it is recommended that these locations and their immediate vicinity be avoided wherever possible (as previously stated in this report).

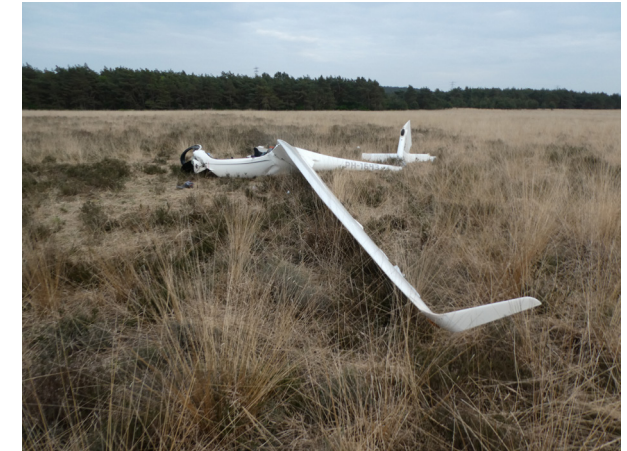
The crashed ASW 28

The winch operator stated that takeoff of the ASW 28 took place as normal: after receiving the light signal, he pulled the winch cable taut, and then selected full power. When he caught sight of the aircraft, he saw that it was a single seater, at which point he reduced power to half. According to the winch operator, however, the winch power dropped off entirely. He then pushed the throttle into the full-power position to once again select full power but according to his statement, the winch motor failed to respond. At that moment, he decided to fully cut back power and to apply the brake to give the pilot the opportunity to correct his aircraft's attitude. He saw that the nose of the glider continued to point upwards, at which point the glider slipped across its left wing and crashed.

The accident was initiated by the loss of power from the winch. Whether this was the result of a technical malfunction or human error never became clear. Although neither before nor after the accident any non-conformities or malfunctions were discovered in the winch, it is not possible to exclude a technical cause.

During glider training, pilots are taught to always be prepared for a broken cable or winch failure. Irrespective of the altitude, in such a situation the following procedure must be implemented: Nose down, Detach, Air brakes closed/locked, Check speed (in Dutch BOKS procedure). Effectively, this means that the pilot should move the control stick forwards, to lower the pitch attitude of the glider below horizontal in order to achieve an appropriate safe (landing) speed. In the event of a cable break or winch failure at low altitude, the pilot then lands the glider straight ahead.

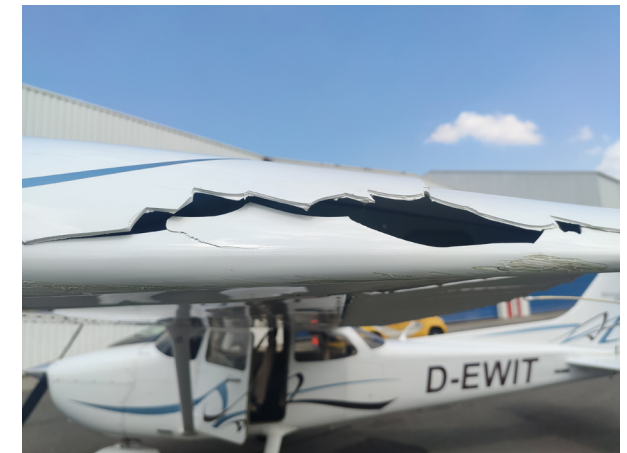
The pilot was conducting a local flight under visual flight rules from Rotterdam The Hague Airport, in his Cessna 172S. He was the only occupant. During the approach to Runway 24, the wind was blowing from the west - from the right-hand side - at a speed of 8 knots. Just prior to and during the landing, the pilot experienced gusting winds; this forced him to make steering corrections, to keep the aircraft on the centreline of the runway. As a result, he lost control of the aircraft; the left-hand wheel came off the runway, and the left wing tip touched the ground. The Cessna eventually returned to the runway. The pilot was unharmed. The aircraft suffered damage to the left wing.

Damage to the left wing. (Source: Airport Operations, Rotterdam The Hague Airport)

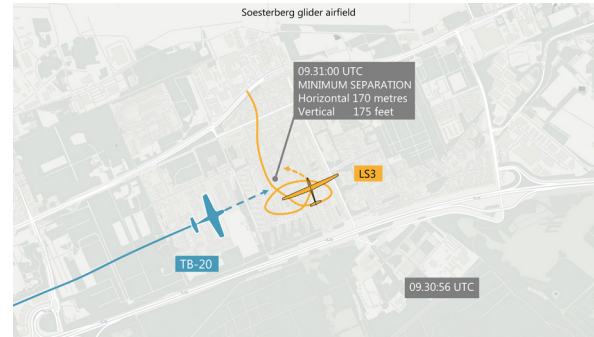
The occurrence was reported by the pilot of the LS3. Radar data revealed that his glider and the TB-20 passed each other with a minimum separation of 175 feet vertical and 170 metres horizontal.

The airprox south of Soesterberg glider airfield. (Source: radar data LVNL)

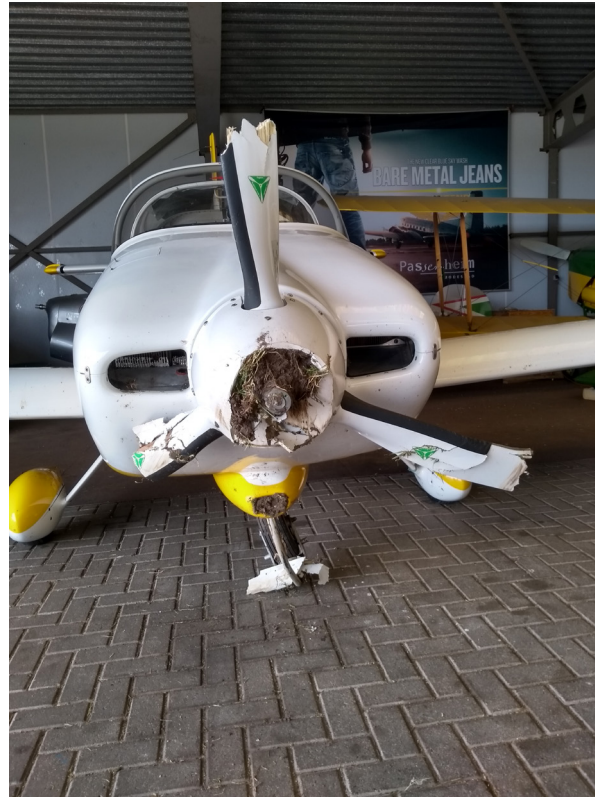
After first touching the ground, his aircraft bounced on two occasions. It then tipped forwards onto its nose, briefly remaining vertical, before falling back onto its main wheels. The aircraft suffered damage to the propeller, the spinner and the nosewheel. The pilot and passenger remained unharmed.

As a rule, it is difficult to correct a bounced landing, because the bounces succeed each other so rapidly. In this case, it took four seconds from the moment of touchdown to the point at which the aircraft became stationary, on its nose. The best remedy for any bounced landing is to initiate a go-around immediately following the first bounce.

The damaged aircraft (Source: aeroplane owner)

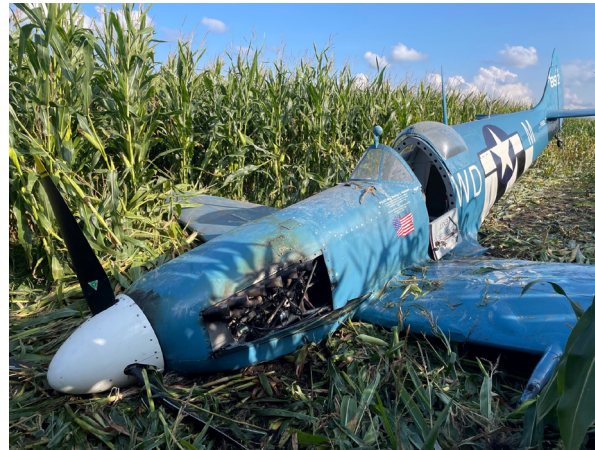
The self-built aircraft, a Spitfire replica, was completing a cross-country flight from Teuge International Airport to Hilversum Airfield. On board were a pilot and a passenger. At Hilversum Airfield, the captain completed a go-around from Runway 36, at which point the right main landing gear was not fully retracted. While the pilot and the passenger attempted to investigate the problem during the downwind leg, the engine management system indicated that there was a problem with the engine. During the downwind leg, just before completing the turn to base, the engine started to run irregularly and pale blue smoke became visible around the exhaust outlets on both sides of the aircraft's nose.

The Spitfire in the cornfield (Source: Pilot)

The pilot issued an emergency call, and succeeded in extending the right-hand landing gear. Shortly afterwards, the engine cut out completely. The Spitfire completed an emergency landing in the cornfield before the beginning of Runway 36. Both occupants remained unharmed. The aircraft was badly damaged.

After the Spitfire was recovered, a hole was discovered in both sides of the engine wall, and a piston rod was found in five pieces, at the bottom of the engine compartment. The Dutch Safety Board has chosen not to investigate the engine failure further.
