DUTCH
SAFETY BOARD

Quarterly Aviation Report

October - December 2018

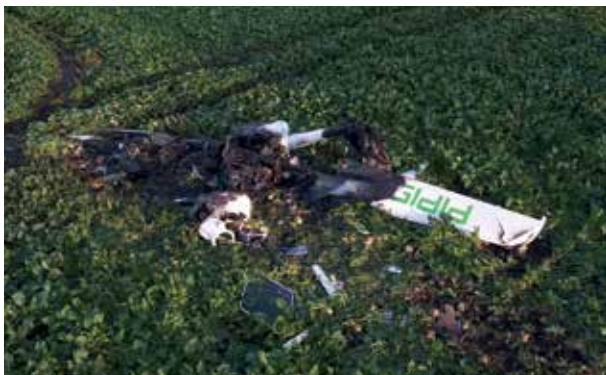
The Pipistrel Alpha Electro, an electrically powered microlight aeroplane (MLA), crashed while the aircraft was in the circuit of Stadskanaal airfield. The pilot, the only person on board, was killed as a result. The MLA completely burned out following the accident.

Accident location. (Source: Aviation Police)

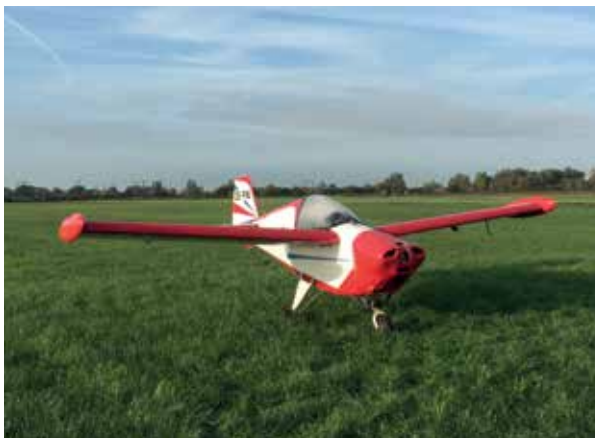
During the flight, the pilot occasionally felt mild vibration in the aircraft. At a certain point, he observed a rise in engine speed. The pilot closed the throttle. When power was reselected, the pilot no longer felt any thrust from the engine. He then noticed that the propeller had disappeared, whereupon he executed an emergency landing in a field. The pilot suffered no injuries. The aircraft suffered no further damage.

The Topsy Nipper following the emergency landing.

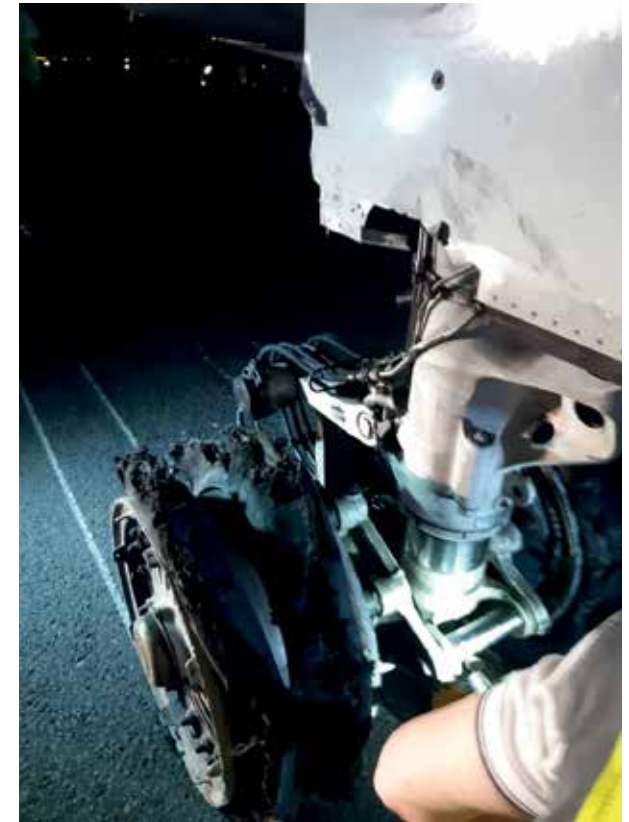
During the take-off run, the crew felt heavy vibration in the right-hand landing gear. The crew decided to continue the take-off and return to Rome Fiumicino Airport, where a safe landing was made. Parts of the tyres were found on the runway. Damage was observed to the right-hand side landing gear and the flap mechanism of the right wing. No one was injured during the incident

Damage to the landing gear. (Source: ANSV)

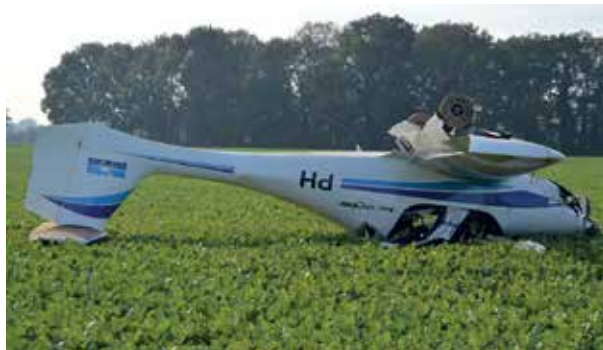
During a flight from Kempen Airport to Münster Osnabrück Airport, just outside the control zone of Niederrhein airport, the microlight aeroplane experienced engine problems. The pilot decided to carry out an emergency landing. The 'grass field' selected by the pilot for the emergency landing subsequently turned out to be a plot of arable land planted with a green manure crop. The soil of the field was too soft to support the aircraft which as a result overturned and came to a standstill on its back. Both persons on board were able to leave the aircraft independently. The pilot and his passenger suffered minor injuries.

The aircraft following the emergency landing. (Source: Kreispolizeibehörde Wesel)

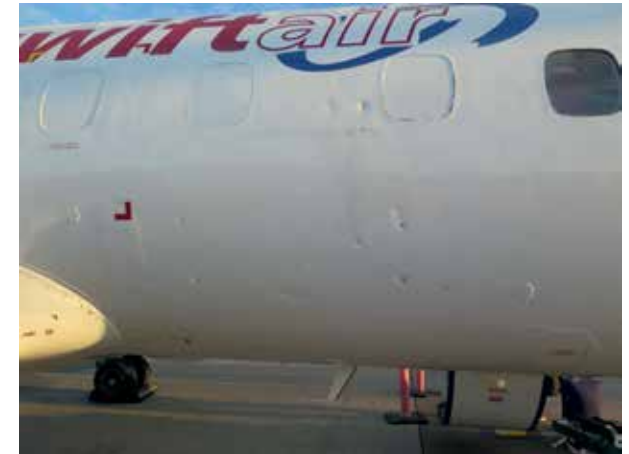
The investigation concluded that the EMB-120 made a misaligned take-off from runway 24 at Amsterdam Airport Schiphol. The pilot had interpreted the right-hand side runway edge lights as the runway centre line lights. During take-off, the nose landing gear had collided with several runway edge lights. As a result the lights broke free and came into contact with parts of the aircraft causing damage to the aircraft. Neither of the pilots noticed this occurrence. Despite the damage suffered, the aircraft was capable of taking off and reaching its destination.

Misaligned take-offs occur throughout the world, and investigations by various authorities have revealed that there are a number of common causes. It was concluded in this investigation that a combination of operational and infrastructural factors contributed to the occurrence. The large turning circle required to align the aircraft on the centre line of the runway, in combination with the interruption of the centre line by taxiway S5 and the absence of centre line lighting on the taxiway contributed to this misaligned take-off. In addition, during the turn from taxiway B to S5 and runway 24, the air crew might have been distracted by the clearance they received from air traffic control.

The damaged fuselage of the Embraer EMB-120ER. (Source: AAIB)

The Dutch Safety Board has recommended the International Civil Aviation Organization (ICAO) to initiate the process, within Annex 14 Volume 1 'Aerodrome Design and Operations', to develop a standard for runway edge lights that would allow pilots to identify them, without reference to other lights or other airfield features. Amsterdam Airport Schiphol is recommended to proactively take measures, in line with the above recommendation to the ICAO, which prevent pilots from interpreting the runway edge lights as the runway centre line lights. Air Traffic Control the Netherlands is recommended, outside the uniform daily period, to allow air traffic access to the runway for take-off only when intersections are used that are equipped with centre line lighting.

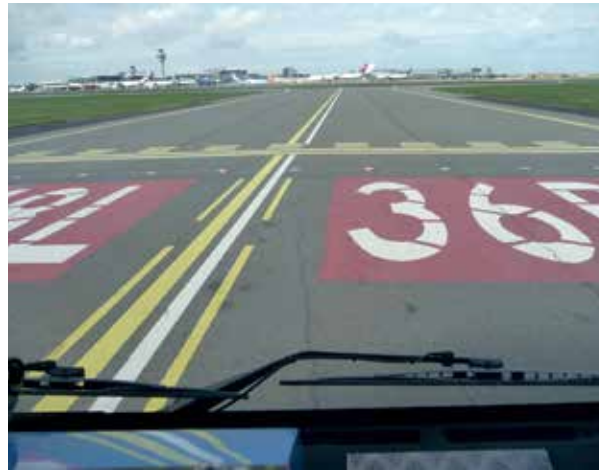
The tug driver and his instructor, who was sitting in the aircraft, did not notice the illuminated warning lights, orange flashing runway guard lights and red stop bar lights at the intersection. Neither of them realised that the runway was currently being used by landing aircraft. The tug combination drove onto the landing runway to cross it. Air traffic control ordered an aircraft that was approaching for a landing on the runway to abort its approach and to initiate a go-around.

The investigation revealed that a number of factors contributed to this runway incursion. Although human errors played a role, safety management measures that should have prevented this runway incursion did not work satisfactorily, either.

Intersection E3 of runway 18L-36R.

Partly as a result of this incident, since 20 May 2016, all runway crossings of both active and non-active runways are handled by LVNL.

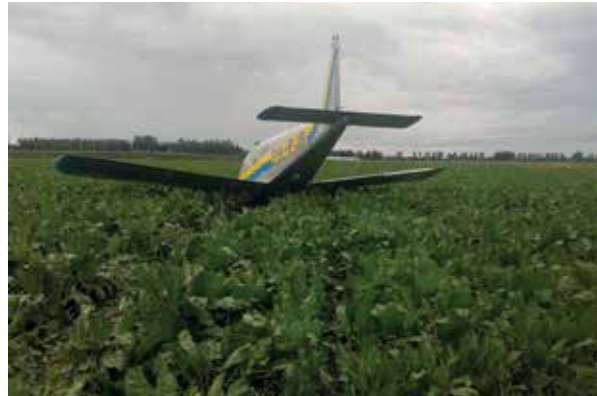
During the landing at Koksijde airbase in Belgium, the single-engined propeller aircraft veered sharply to the left and ran off the runway. The pilot described the first part of the landing as normal. He was unable to correct the turn to the left and the aircraft finally stopped in a field next to the runway. The two persons on board, both Dutch nationals, remained unharmed. Following the landing it was noted that the nose landing gear had broken off, the propeller was bent and the firewall was damaged.

The accident was probably caused when the pilot applied pressure to both brake pedals during or immediately following the landing causing the right-hand wheel to block, resulting in an imbalance between the brake efficiency of both wheels. The right-hand wheel which became blocked braked less than the left-hand wheel, causing the aircraft to turn to the left.

The aircraft following the runway excursion. (Source: AAIU Belgium)

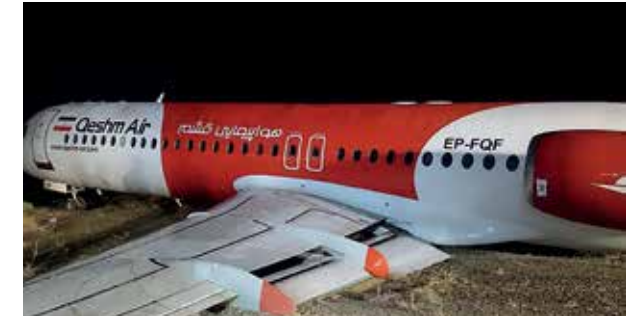
During the approach to runway 31R at Mashad Airport in Iran, there was no indication in the cockpit that the left-hand main landing gear was extended and secured. The crew therefore decided to carry out a go-around. While in a holding pattern, the crew attempted to extend the landing gear but was unable to do so. Eventually, the crew decided to land with the left-hand main landing gear withdrawn. Shortly following the moment of landing, the aircraft lowered onto its left wing and came to a standstill next to the runway. The crew initiated an evacuation. No one on board suffered any injuries. The aircraft suffered damage to the left wing.

The primary cause of the accident was the entering of foreign contamination into the hydraulic system of the left-hand landing gear during maintenance work (C-check). The contamination prevented the correct operation of a valve in the hydraulic system. As a result, the locking mechanism of the left-hand landing gear failed to operate correctly.

- Insufficient supervision of maintenance work on aircraft.
- Lack of experience among maintenance personnel.

The aircraft following the occurrence. (Source: AAIB Iran)

Recommendations were issued to the Iranian civil aviation authorities IRI, the EASA and the airline in question.

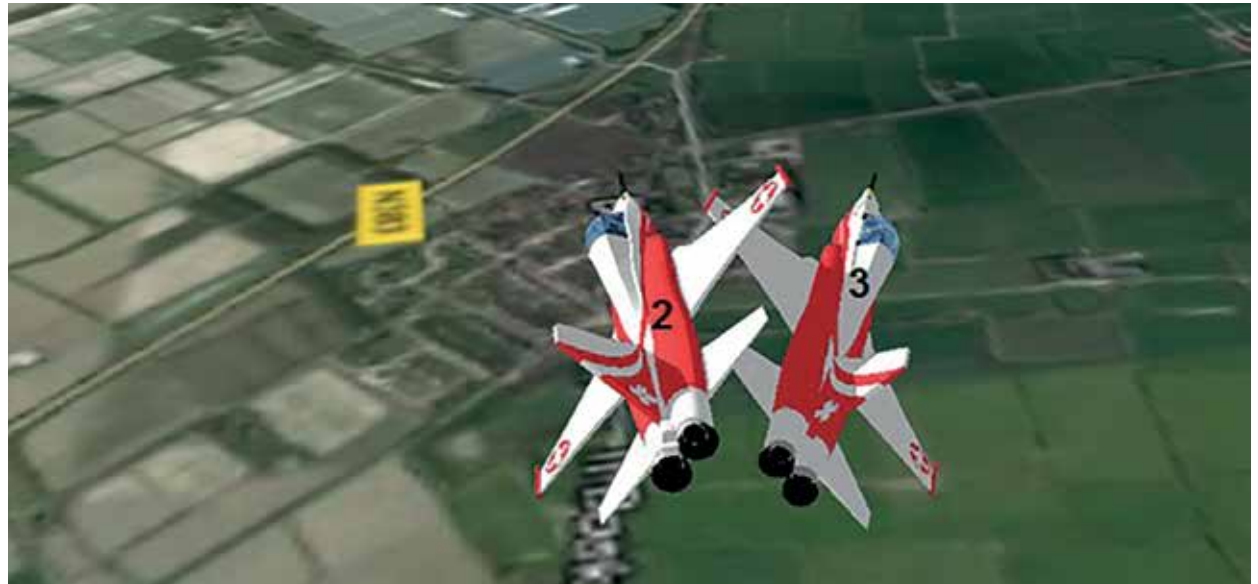
As a result of the collision, the left-hand wing of aircraft number 3 was so badly damaged that the aircraft became uncontrollable. The pilot activated the ejector seat and left the aircraft. Suspended from his parachute he fell through the glass roof of a greenhouse complex, and suffered minor injuries. The ejector seat also fell through the roof of the greenhouse a short distance away. The aircraft crashed into a lake close to a home adjacent to the greenhouse complex.

Estimated position of the two aircraft at the moment of the collision.

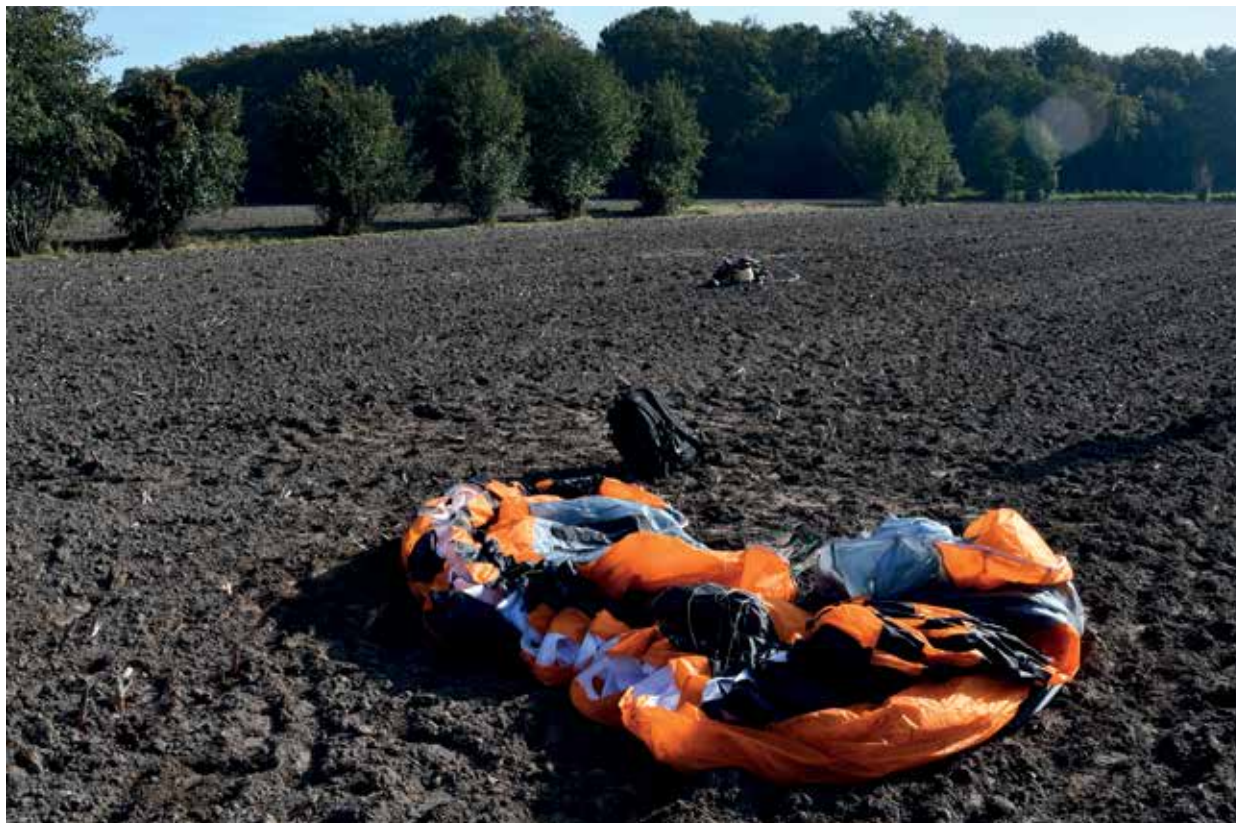
The paramotor then started to turn at a higher rotation speed, at which point the instructor told the trainee to 'raise his hands'. This is a standard steering command. By raising his hands, the pilot lets go of the control and the paraglider flies itself, thereby once again achieving a stable condition, according to the instructor. At that point the paramotor disappeared from the view of the instructor behind the trees and as subsequently emerged, crashed. The trainee stated that when he tried to fly into the wind, the paraglider adopted a 'stall' position, and that he then perhaps selected too much power and at the same time pulled too hard on the steering toggles. The trainee then rotated with his body through around 180 degrees beneath the paraglider as a result of which the lines became twisted. At that time the paramotor was an altitude of approximately 200 metres, and entered a spiral dive and crashed. The trainee suffered lung contusions and injuries to his legs. The paramotor was damaged.

The immediate cause of the crash of the paramotor cannot be identified with certainty. The trainee found himself in a 'twist'. In this situation, the pilot rotates through 180 degrees below the paraglider, and is suspended as it were back to front beneath the paraglider. The trainee may have overcorrected as a consequence; as a result of the twist, the steering lines have more difficulty returning to their neutral position. This may have caused the paramotor to turn further, rather than returning to horizontal flight. As a result, the trainee lost control over the paramotor, and entered a spiral dive.

The paramotor following the crash. (Source: Aviation Police)

Unlike in other aviation sectors, during the first paramotor flight when the trainee controls the aircraft, there is no instructor present who can intervene physically. The Board is therefore convinced that it is of vital importance that prior to their first flight, trainees must be thoroughly informed by the instructor of the most common beginner's errors and (emergency) situations they may face and how to respond. These aspects could also receive (some) attention during a tandem flight prior to the first solo flight.

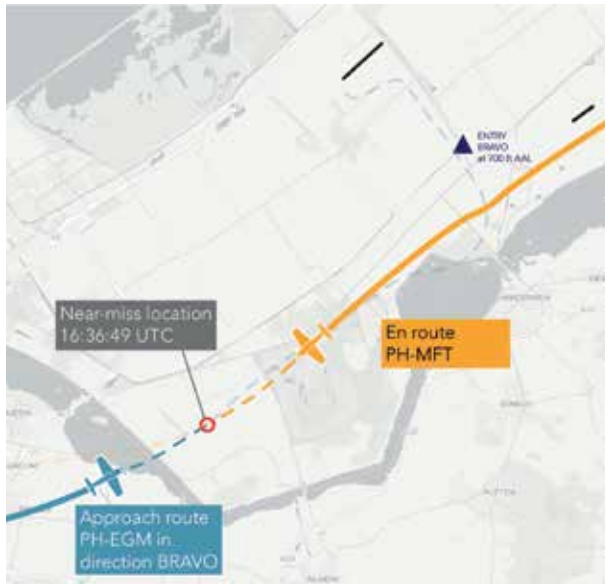
Radar information reveals that both aircraft were flying on a collision course at approx. 9 NM southwest of Bravo. The gradual descent of the Katana meant that at that time, both aircraft were flying at approx. 1,250 feet. The 'see-and-avoid' principle only worked at a late stage, assisted by the warning from the Traffic Avoidance System in the Diamond. The excellent weather conditions (good visibility, sunlight) meant that the effectiveness of strobes and anti-collision lights was reduced.

Routes of PH-EGM and PH-MFT and the location of the near-miss.

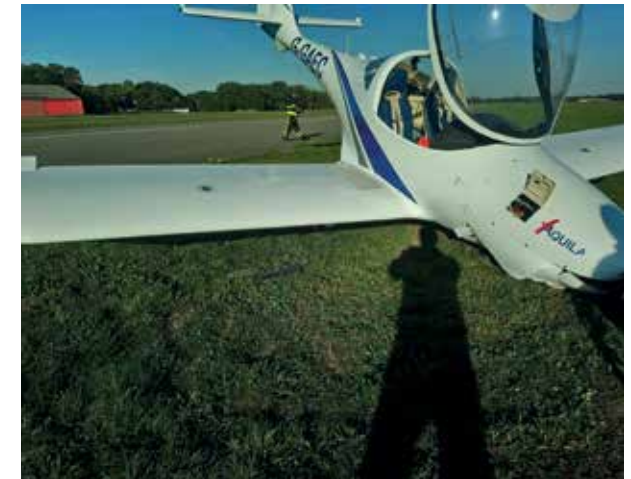
The pilot stated that the aircraft bounced during the landing because the aircraft had flared while the speed of descent was too high. Nonetheless, he decided to continue the landing rather than making a go-around. The Board emphasises that during a landing, the pilot must at all times be prepared to carry out a go-around, in the event that the landing can no longer be safely continued in the circumstances.

The aircraft following the runway excursion. (Source: Breda International Airport)
