DUTCH
SAFETY BOARD

Quarterly Aviation Report

October - December 2020

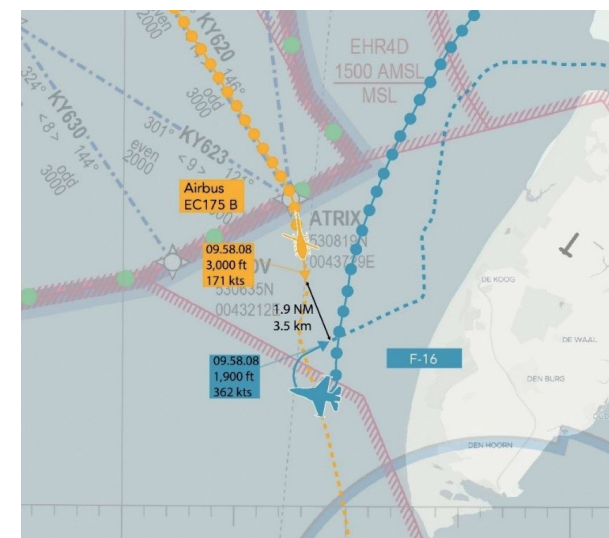
Radar data showed that the F-16 initially approached the helicopter from left to right with an airspeed of approximately 360 knots. The horizontal separation was approximately 3 NM (5.5 km) and vertical separation of 1,700 feet. When the F-16 was in front of the helicopter, it made a right hand turn towards the northeast. During the turn, the horizontal separation was approximately 1.9 NM (3.5 km) and the vertical separation 1,100 feet. After rolling out of the turn, the F-16 climbed to approximately 4,000 feet AMSL in less than 30 seconds. At the same time, the helicopter's ACAS presented the warning. The F-16 pilot was not aware of the proximity of helicopter, as he did not have visual contact. It could not be determined if the helicopter was presented on his on-board radar. The F16 was not equipped with an airborne collision avoidance system.

At the time of the occurrence the helicopter and the F-16 were both flying in the De Kooy Arrival sector of the Nieuw Milligen TMA A. This is class E airspace (from 1,500 feet AMSL to FL065) in which IFR flights are provided with air traffic control service and are separated from other IFR flights. Separation between IFR-VFR, VFR-IFR or VFR-VFR traffic is not provided and is the responsibility of the flight crew. Traffic information about other flights is provided as far as practical. VFR-flights need to maintain a minimal distance of 1,500 m horizontal and 300 m vertical from clouds. The rules for class E airspace further state that provided that the visibility is more than 8 km, the speed limitation (of 250 KIAS) is not applicable to military jet fighters with a minimum air speed of 250 KIAS.

The encounter between the F-16 and the helicopter near waypoint ATRIX, based on radar data. The given altitudes are expressed in QNH. (Source chart: AIS the Netherlands en-route chart ICAO, source background map: OpenStreetMap)

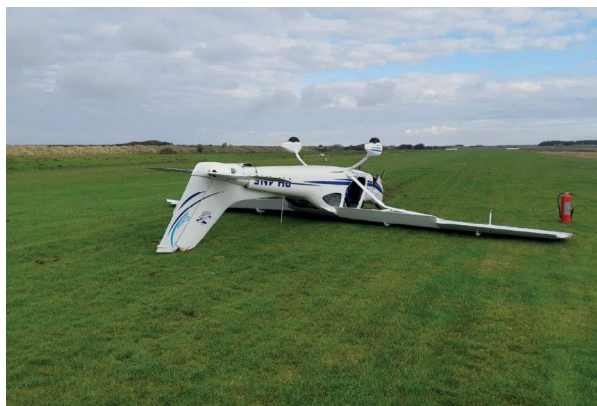
During landing the aeroplane flipped over and came to a halt upside down. The pilot was unharmed. The aeroplane was substantially damaged.

The Sirius after the landing. (Source: Dutch Aviation Police)

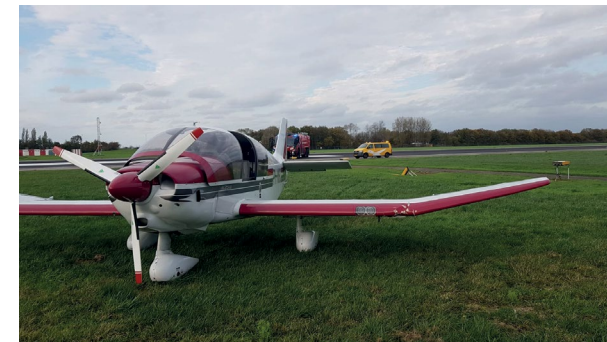
During landing the pilot lost control of the aeroplane, whereupon it veered off the runway and hit a PAPI¹⁰ light unit with the left wing, before it came to a stop. The pilot was unharmed. The aeroplane and the PAPI were damaged.

The aeroplane after the runway excursion. (Source: Airport authorities Rotterdam The Hague Airport)

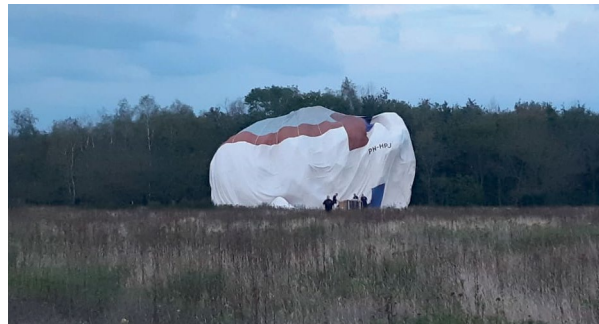
The pilot of the hot air balloon, which had three passengers on board, was forced to make a landing due to rapidly deteriorating weather conditions. In doing so, the balloon ended up in weather conditions that endangered the safety of the occupants. After several landing attempts, the balloon eventually came to a halt with the envelope against a tree line after a landing in which the basket skidded over the ground. During the landing, first the passengers fell out of the balloon's basket. Hereafter, the pilot partly fell out of the balloon's basket. The passengers sustained minor injuries.

The weather conditions caught the pilot by surprise because he had paid insufficient attention to the weather forecast during the flight preparations. The weather forecasts specifically prepared for hot air ballooning mentioned high risk weather conditions. These weather forecasts were not consulted by the pilot. Sources he did consult also indicated unfavourable circumstances, but these were not interpreted as such by him. The decision to carry out the flight was therefore based on an incomplete and outdated weather forecast.

The hot air balloon, against a tree line. (Source: Dutch Aviation Police)

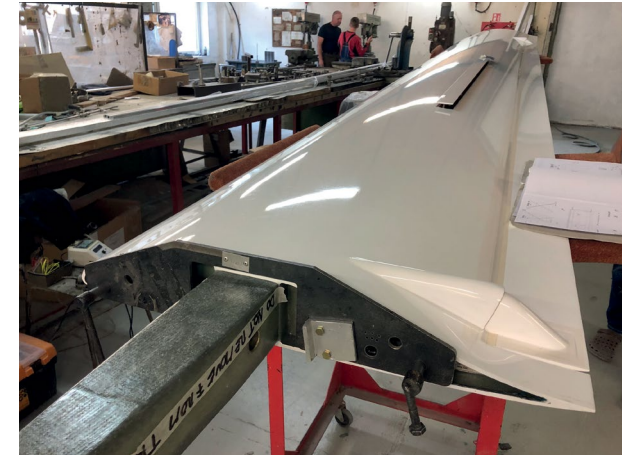
After the occurrence, a glider technician checked the glider; both air brakes opened at that moment, when he pulled the air brakes control lever. The technician did not find a cause for the malfunction of the air brakes control system. The glider had made a total of 16 flights and 39 flight hours. Similar occurrences with this type of glider, where one air brake opened during flight, are not known to the Dutch Safety Board (DSB).

On 13 May 2019 a technician from the aircraft manufacturer JSC "Sportine Aviacija ir Ko" visited the Netherlands to inspect the glider. A cause of the opening of only one air brake during flight could not be determined. On 29 October 2019 the glider was further examined by the manufacturer in the Republic of Lithuania, in presence of the Head of Transport Accident and Incident Investigation Division of the Republic of Lithuania and an investigator of the DSB. Both wings and the air brakes control system and its rigging were inspected. All parts of the air brake system, contained in the wing, were inspected through the inspection holes on the underside of the wing. Again no cause could be determined for the malfunction of the air brakes control system. On 26 August 2020 the manufacturer performed a test flight with PH-1620, which was equipped with cameras. The opening of one air brake could not be reproduced during the test flight. The

The right wing at the manufacturer in Lithuania.

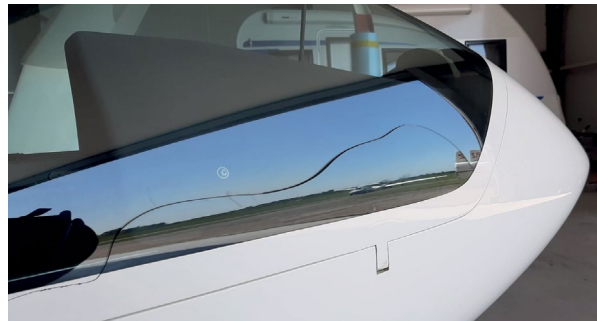
Approaching the airport, the pilot noticed that an aerotow took place from Runway 27. Therefore, he decided to land on Runway 27, instead on Runway 09. At a height of about 10 metres, he made a left turn to an improvised short final for Runway 27. During this turn, the left wingtip contacted the ground, causing the glider to make a traversed landing and a ground loop. The pilot remained unharmed. The glider sustained damage to, amongst others, the canopy and left wing tip wheel.

The pilot was aware of the fact that he attempted the start of the engine at a lower height than 500 metres, which is the minimum height for starting the engine, as prescribed by the club he was a member of. The unsuccessful start and unsuccessful retraction of the engine took his attention away from flying the glider. Despite ending up in an unfavorable position to proceed back to the airport, the pilot decided not to make an off-field landing. Later, the pilot recognized that felt peer pressure from fellow pilots to return to the airport, was an important factor in his decision-making.

The damaged canopy of the Discus bT. (Source: Pilot)

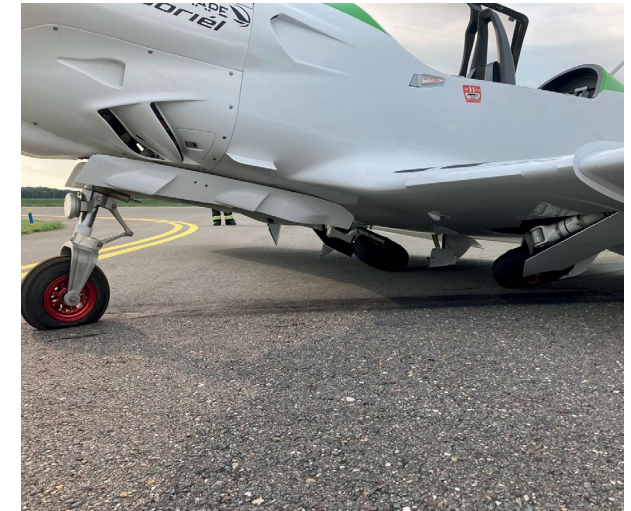
In the PASSENGER mode, the front cockpit landing gear switch controls the landing gear actuator. The manufacturer stated that if the front switch is set to up, the landing gear actuator will be actuated after the key of the mode selector is rotated from TRAINING to PASSENGER. This caused the gear horn to sound. Both landing gear switches were found in the down position after the occurrence. The pilot stated that the front landing gear switch was in the down position during landing and taxiing. In this configuration of the switches, the sequence of events that took place cannot be explained. The manufacturer has verified that the mode selection system was functioning correctly, according to the type design of the aircraft. The key change from TRAINING to PASSENGER position has no effect on the landing gear if the landing gear switches in both cockpits are in the down position. The Dutch Safety Board was unable to determine with certainty what caused the landing gear to collapse.

Collapsed main landing gear. (Source: Lelystad Airport)

After the occurrence, the operator made a memo, as a mitigating action, that the pilot in command of a BS 115 shall read and sign before any flight, to ensure he is familiar with the Airplane Flight Manual and especially with Section 9 – Supplement 1 REAR COCKPIT.

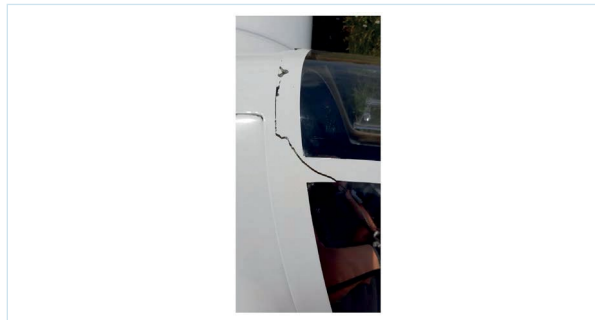
The Safety Management Team (SMT) of the gliding club involved carried out an investigation into the occurrence, and shared the results with the Dutch Safety Board. This investigation showed that the following factors were involved. The vehicle's driver and the field supervisor indicated that they had not expected any gliders to land during that brief period of time. They were focused on measures relating to the COVID-19 pandemic, such as disinfecting gliders and vehicles, and staying 1.5 metres away from other people. This distracted them from their actual tasks. Furthermore, from his position near the take-off dolly, the field supervisor did not have an unrestricted view of the downwind leg for runway 24. The

field supervisor missed the downwind call, because he was placing a tail wheel in a vehicle at the time. Due to the measures relating to the COVID-19 pandemic, no-one was near the take-off dolly. This might explain why no-one heard the downwind call. The SMT's response included recommendations to make members aware of the fact that not flying for extended periods of time results in reduced currency, not only in the air, but also on the ground.

Crack in the edge of the canopy. (Source: Gliding club)

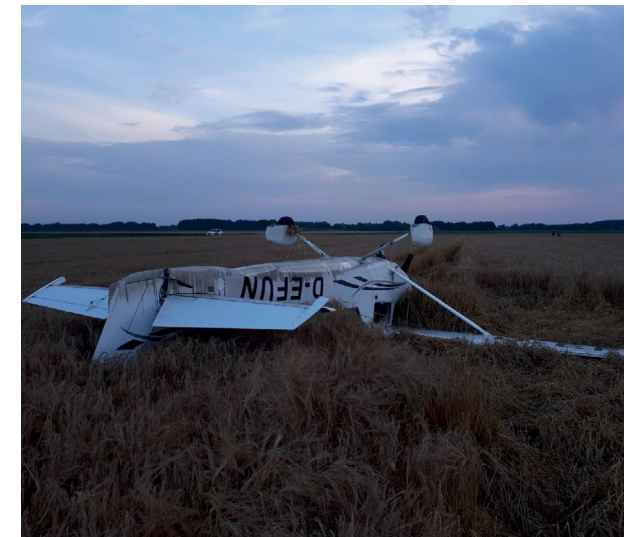
The Cessna departed around 18.15 hours for a flight from Norderney Airport to Borkenberge Airfield. On board were the pilot and a passenger. The pilot had a total flying experience of approximately 219 hours, of which 63 hours on the type concerned. Near the Dollard, when the aircraft was flying at 2,000 feet with a power setting of approximately 1,800 RPM, the pilot smelled oil, which smell grew stronger. At one point, the oil pressure indication was no longer in the green, but in the white sector, close to the red line (indicating zero). The oil temperature indication was still in the green segment. Then the engine lost power and the aircraft was not able to maintain altitude anymore. Subsequently, the pilot decided to perform an emergency landing in a field. During landing, the nose wheel broke off and the aeroplane flipped over and came to rest upside down. Both occupants were unharmed.

In the morning of the day of the accident, oil and fuel had been refilled at Borkenberge Airfield where the aircraft departed. There were no known technical defects to the engine, a Lycoming O-235 L2C. Investigation revealed that a part of the piston in cylinder number 1 had broken off. A piece of piston ring was found in the combustion chamber. The engine had run 2,340 hours and the time between overhaul for the engine was 2,400 hours. A reason for the piston failure and subsequent loss of oil has not been established.

The Cessna A152 after the emergency landing. (Source: Dutch Aviation Police)

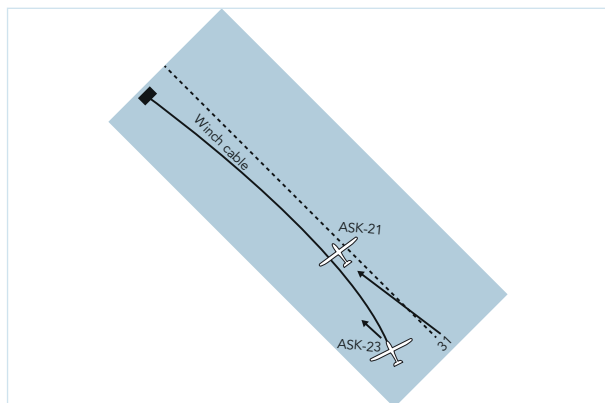
caught up by the wing of the ASK-21. The soloist then flew straight ahead and made a safe landing. The instructor and the student were unharmed. The left wing of the ASK-21 was badly damaged.

The following three factors contributed to the occurrence. First, the wing walker, signals operator, and soloist did not consider the ASK-21's position in the landing field to be unsafe, so they gave the go-ahead for the ASK-23's takeoff. The club in question had no clear guidelines for determining when runways are clear and when take-offs can subsequently be initiated. Second, the cables had been reeled out further into the field than those involved had assumed. Nor had anyone at the takeoff point noticed that the ASK-21 (which was located far down the landing field) was lying across two winch cables. Third, the ASK-23's winch launch was not supervised by an instructor and/or a launch leader – both of whom were doing something else at the time of the occurrence.

The safety committee of the gliding club involved carried out an investigation into the occurrence, and shared the results with the Dutch Safety Board. One of the committee's recommendations concerned the use of a safe sector, which should be free of obstacles during take-offs.

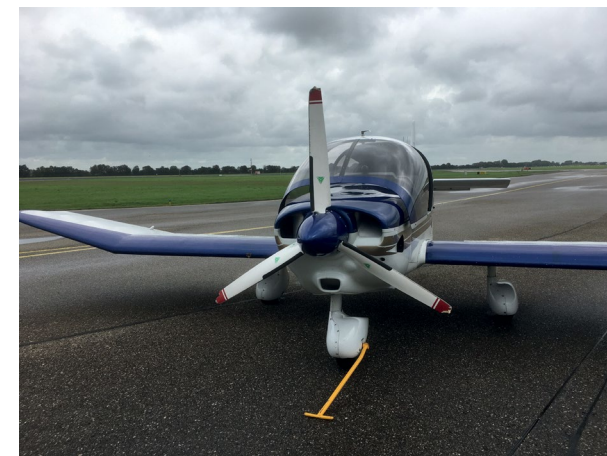
The student stated that he had deviated from his normal routine. On this occasion, he had not parked the aircraft at one of the usual parking positions. After he had obtained clearance for this, he forgot to remove the tow bar. The instructor stated that he had not found it necessary to walk around the aeroplane again, because he knew the student was extremely meticulous and always performed the walk-around check properly. During the braking tests, the aircraft's nosewheel leg was compressed, causing the nose to drop. As a result, it was possible for the propeller blades to hit the tow bar.

The tow bar on the nose wheel. (Source: Instructor)

This occurrence shows that performing the walk-around inspection outdoors, shortly before getting in for an actual flight, reduces the risk that someone might forget to remove the tow bar. Indeed, walking right around the aircraft immediately before boarding, prior to take off, will automatically reduce the risk that things will be forgotten. This includes fuel caps, inspection hatches, luggage hatches, and the like. It is also good practice to always remove the tow bar from the nose wheel after parking the aircraft or leaving it unattended. This will avoid situations in which people become distracted by something or other, and forget to remove it.
