DUTCH
SAFETY BOARD

Quarterly Aviation Report

October - December 2021

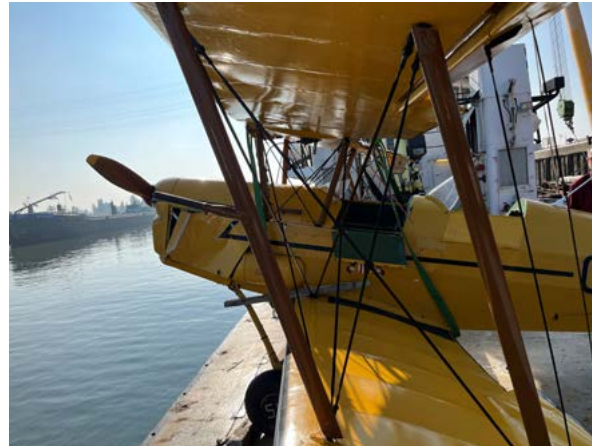
The pilot made a flight from Antwerp International Airport (Belgium) to Midden Zeeland airfield. Over the Westerschelde the engine failed. The pilot made an emergency landing on water, after which the aircraft nosed over. The pilot was unharmed.

The Stampe after the salvage. (Source: Dutch Aviation Police)

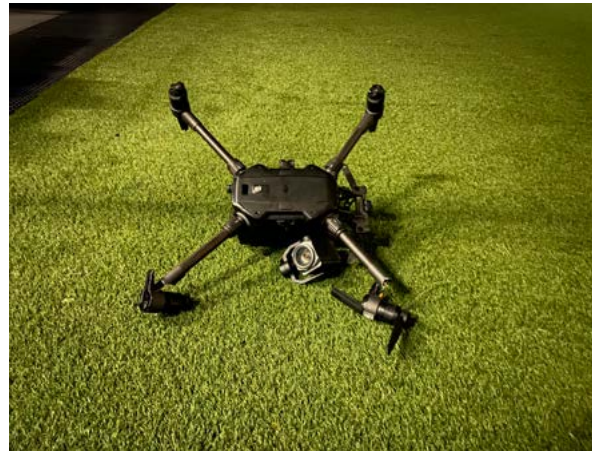
Shortly after take-off, the unmanned aircraft system (UAS, or drone) did not respond to input of the pilot and flew uncontrolled in the direction of the crew. Only seconds later, the UAS crashed. As it fell to the ground, the UAS hit a crew member. The crew member suffered minor injuries. The UAS was substantially damaged.

The crashed UAS. (Source: Police, Team Unmanned Aircraft)

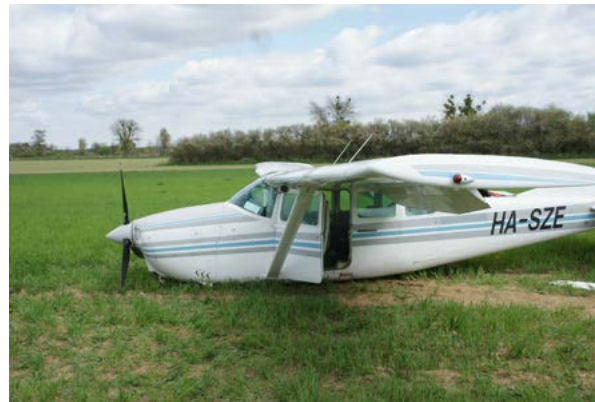
The Cessna 210, which in the past had been registered in the Netherlands, experienced engine problems during the flight from Kaposvar, forcing the pilot to make an emergency landing. The pilot completed the landing with the landing gear raised. The two occupants were unharmed. The aeroplane sustained minor damage. An examination of the engine revealed that the crankshaft in the combustion engine had broken off as a result of excessive engine use. The actual operating hours for the engine had exceeded the time between overhauls specified by the manufacturer²² by more than 20%.

The Cessna following the emergency landing. (Photograph: Hungarian TSB)

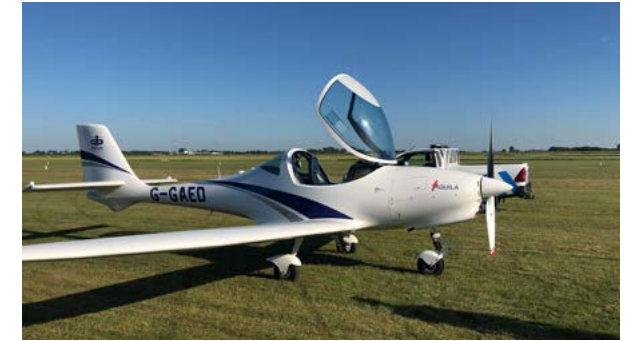
Inspection after the incident revealed the coolant level to be very low in the expansion tank and high in the overflow bottle. No leaks were found in the cooling system. This suggests that a higher than normal amount of coolant had exited through the pressure cap on the expansion tank into the overflow bottle. The low level of coolant in the system caused the engine temperatures to rise above their normal limits.

During teardown examination of the engine, significant knocking²⁴ damage was found on the cylinder #2 piston. The exhaust system of the aircraft was tested by the engine manufacturer and it revealed the system produced exhaust backpressure above the 200 millibar limit as specified in the engine manufacture's installation manual. The measured backpressure was highest at cylinder #2.

The higher backpressure increased the air/fuel mixture temperature and contributed to self-igniting behaviour ('knocking') inside the already hotter than normal engine. A small crack was found on the exhaust manifold connected to cylinder #4. This cylinder is located on the same side of the engine as cylinder #2 and the leaking of high-temperature exhaust gases may have further contributed to the overheating of the engine.

The combination of the aforementioned factors (low coolant level, high outside air temperature, high exhaust backpressure and crack in manifold) led to the engine temperature exceedances, as experienced by the pilot during the incident flight. Further investigation revealed actions have been taken after the occurrence by the engine- and aircraft-manufacturer to prevent similar incidents from reoccurring:

The Aquila after the precautionary landing. (Source: Breda Aviation)

- The inspection of the pressure cap fitted on the cooling system expansion tank, as outlined in the aircraft maintenance manual, was modified to include a procedure to pressurize the cooling system and verify that the relief pressure of the cap falls within specified limits.
- A certification process of a new exhaust muffler system has been initiated. The newly designed exhaust should produce backpressure values below the 200 millibar limit.

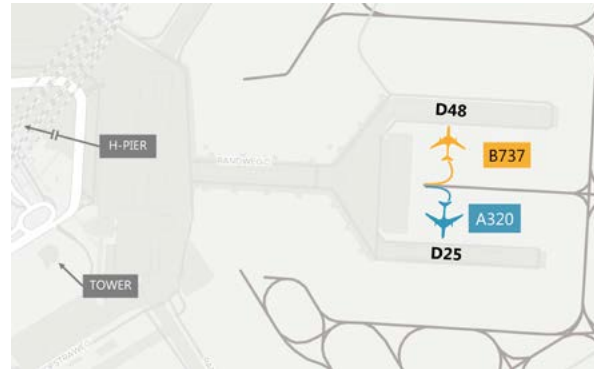
Upon receiving the pushback clearance, the flight crew of the A320 informed the pushback truck driver that they were cleared for pushback.²⁵ The driver started to push the aircraft backwards. He was aware of a B737 at D48 that had its rotating beacon light off, indicating that it had not yet been cleared for a pushback. Further, the B737 was not moving, therefore he continued pushing the A320 and turned it counter clockwise.

Shortly after, the flight crew of the Boeing 737 informed their pushback truck driver that they were cleared for the pushback. The driver visually checked the area left and right of the aircraft for obstacles and pushed the B737 in a straight line backwards. At the point where he wanted to turn the aircraft clockwise onto the taxi line, he saw that the A320 was moving backwards towards his aircraft and immediately braked the pushback truck.

The position of the A320 and B737 just moments before the pushback collision.

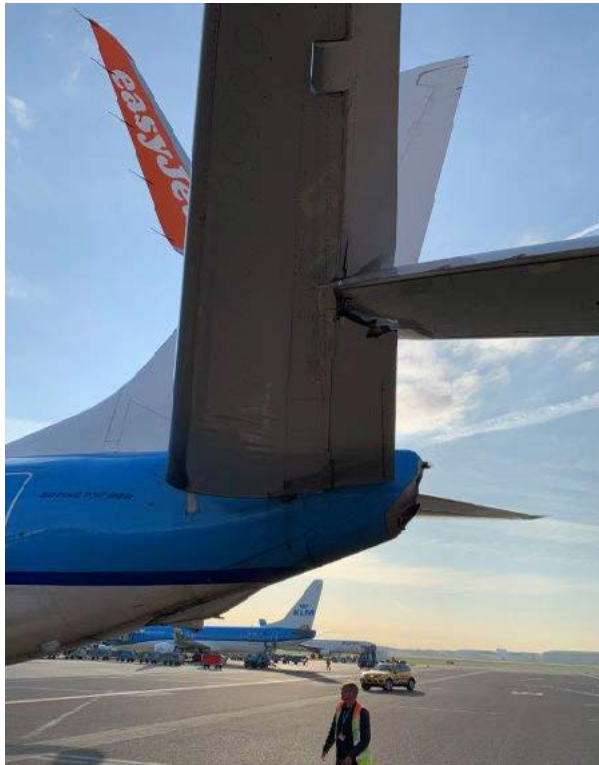
Then, the ground controller tried to stop the A320 by calling Apron Control²⁷, who are located on another floor in the control tower, to ask them to stop the A320. He assumed that the A320 was towed under the control of Apron Control. The interventions taken by the ground controller could not prevent both aircraft from colliding with each other. The B737's left-hand horizontal stabilizer and the left-hand wing of the A320 came into contact. The aircraft were substantially damaged and required major repair.

The collision. (Source: Amsterdam Airport Schiphol)

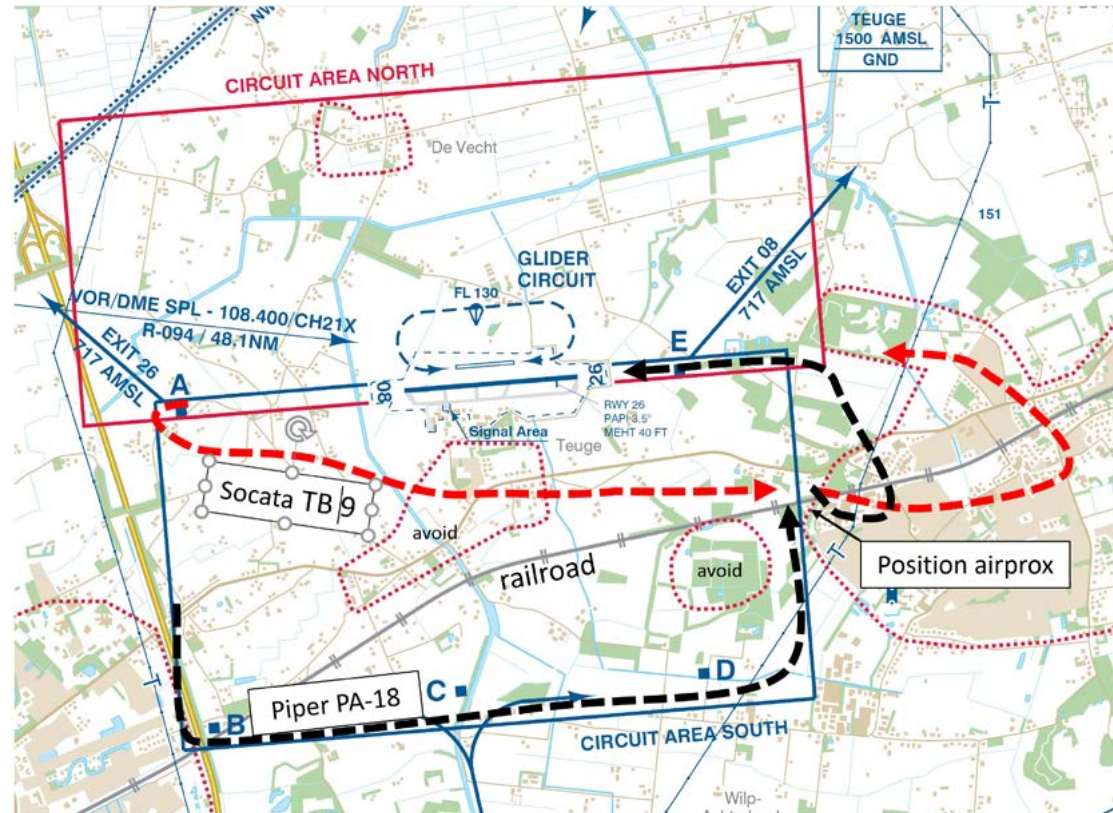
The flight paths and position of the airprox of both aircraft in the VFR circuit at Teuge airfield. (Source: LVNL, edited by Dutch Safety Board)

When the trainee pilot in the Socata started his third circuit following a touch-and-go, from the take-off leg, he turned almost immediately onto the downwind leg (see figure). As a consequence, the aircraft flew to the north of the railway line. At that moment, the Piper was following the circuit marked in the figure. After the Piper had completed the turn to the base leg, the instructor observed almost immediately that the Socata was flying right in front of his aircraft and was approaching rapidly. To avoid a collision, the instructor took over control and initiated a sharp downward turn to the right. The trainee pilot in the Socata failed to observe the Piper at that moment. After the instructor in the Piper had made a call on the radio, the trainee pilot saw the Piper. The two pilots then reoriented themselves. The trainee pilot completed a touch-and-go on Runway 26 before returning to Lelystad Airport. The instructor continued the flight in the circuit at Teuge airfield.

The investigation revealed that the Socata had approached the Piper from an unexpected angle, because the Socata had failed to follow the specified circuit for Teuge airfield. During this circuit and the previous two circuits, the trainee pilot had failed to use the turning point signs on the ground, to follow the contours of the circuit. Instead, he had followed the railway line. As a consequence, not only did he overtake the Piper, but also overflew the areas within the contours of the circuit which should have been avoided (see figure). The circuit at Teuge airfield offers insufficient space for alternative flight paths and must be strictly complied with.

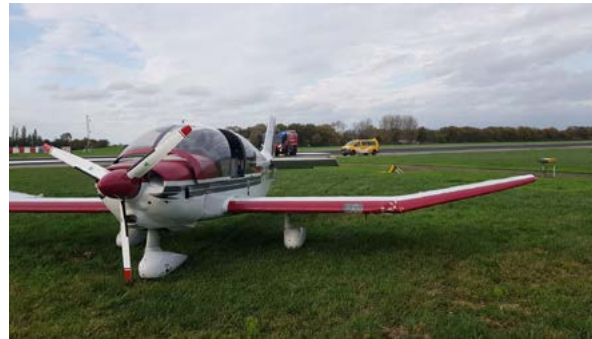
technique can result in what is known as wheelbarrowing. In this phenomenon, most or all of the weight of the aircraft is applied to the nose wheel. This increased weight makes it more difficult to steer the aircraft; as a result, the aircraft tends to easily rotate around the nose wheel. This results in a change of direction of the aircraft. However, an unintended change of direction can also be caused by a malfunction in the nose wheel locking mechanism or the unintended use of the brakes while steering with the rudder pedals.

The aircraft after the runway excursion. (Source: Airport authorities Rotterdam The Hague Airport)

The flying club has adjusted the correct landing technique in close cooperation with the aircraft manufacturer and brought it to the attention of its members.

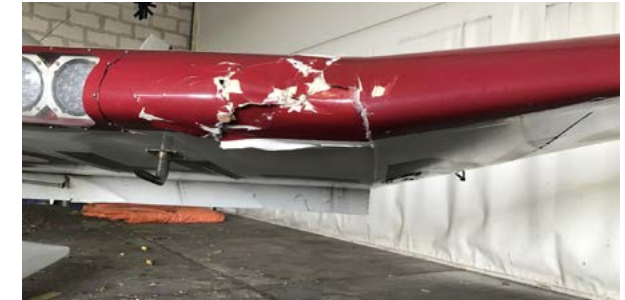
Damage to the left wing. (Source: Dutch Aviation Police)

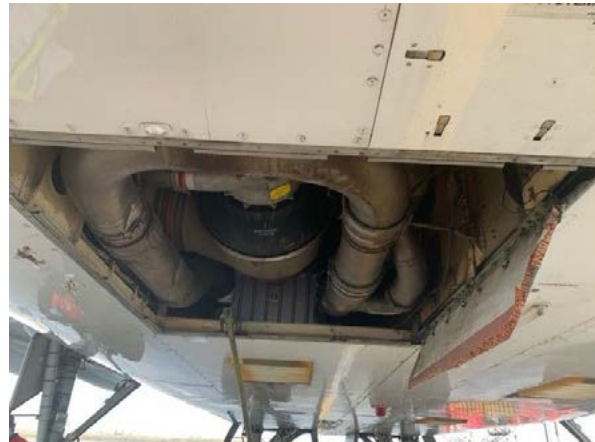
The Boeing 747 departed around 22.20 hours for a cargo flight from Amsterdam Airport Schiphol (hereafter Schiphol) to Jomo Kenyatta International Airport in Kenya. During the climb to cruising altitude – at around 12,000 feet - the flight crew heard a thump. Thereafter they noticed a low humming sound in the cockpit and the cabin. According to the flight crew, all Engine Indicating and Crew Alerting System (EICAS) indications were normal. After consultation with the airline, the flight crew decided to continue the flight. Upon arrival in Kenya, during a walk around check, it was found that an air conditioning access door on the underside of the aircraft's fuselage had broken off. Part of the door was still attached to the aircraft by means of the door hinges; the other part of the door was lost. The departing door parts caused minor damage to the aircraft.

The broken door. (Source: the operator)

Before departure, while the aircraft was standing on the platform, a team of ground engineers performed several maintenance tasks. The team started working on the aircraft two hours after its arrival, which was later than normal. They first performed the daily inspection and the pre-flight inspection. After these inspections they started to repair recorded defects. One of the repair tasks was the change of a turbine bypass valve on air conditioning pack 3, located behind the access door in question. When the assigned engineer to this task opened the door, he assessed it was not possible to finish the work before the scheduled departure time.

The engineer consulted with maintenance control about the shortage of time and it was decided to replace the valve another time and to take the valve on board of the aircraft in case it would be needed at an outstation. As the other two air conditioning packs were functioning, the aircraft could be released according to the Minimum Equipment List (MEL) and the flight could be carried out. Thereafter, the engineer started to close the access door of air conditioning pack 3. However, while doing this, he was interrupted by a fellow engineer. As a result the engineer stopped his activity on the door.

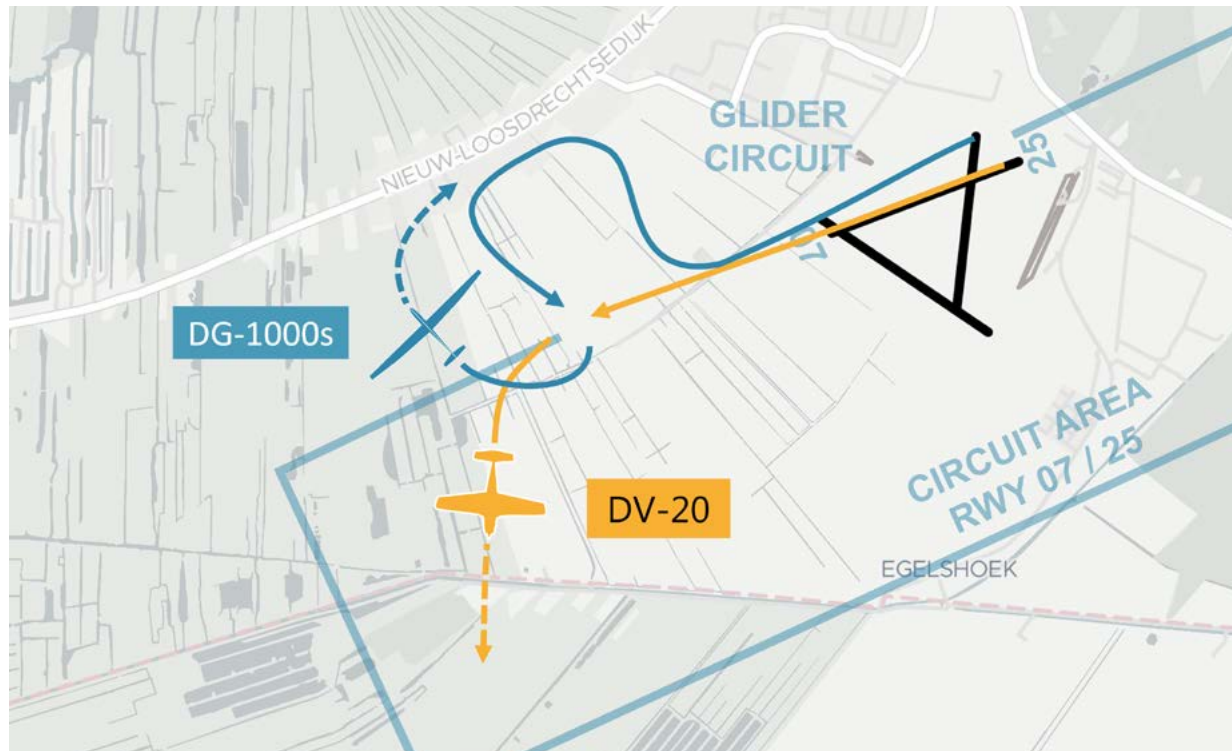
Estimated position of airprox between DG-1000s and DV-20. (Source: Flight paths based on the flight logger software of both aircraft)

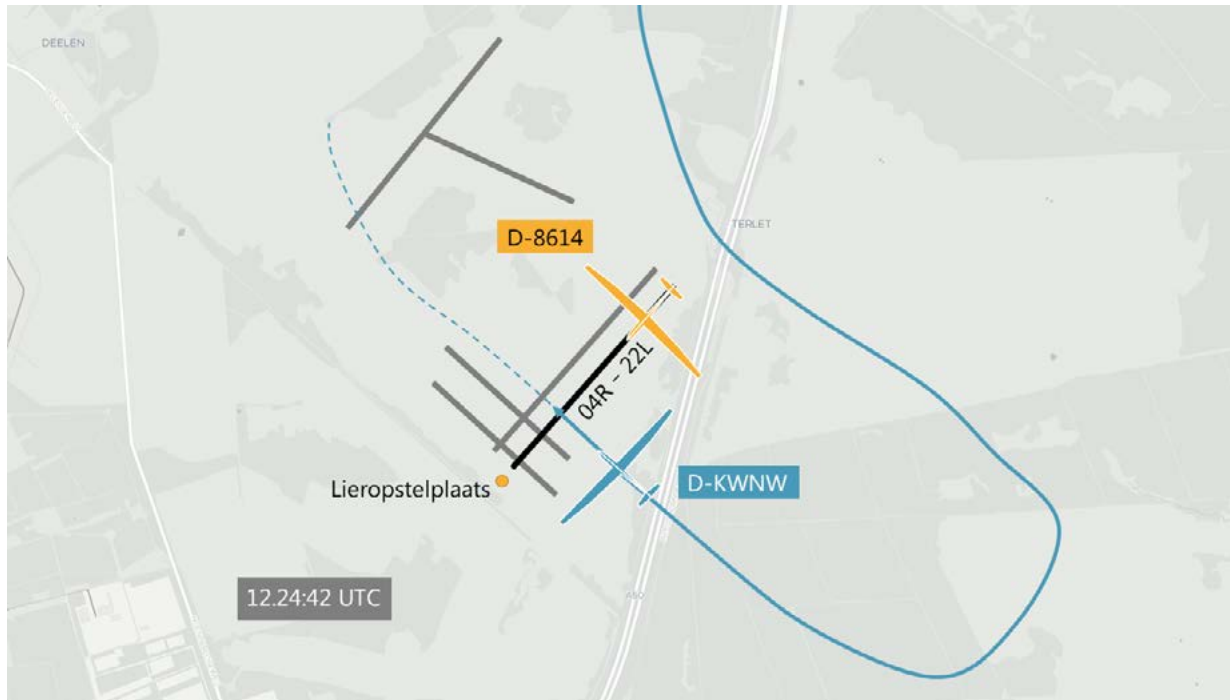
The pilot of the Discus stated that during the crossing/overflying of winch path 22L, no FLARM warnings had been generated. In addition, no (glider) aircraft detected by FLARM were visible on his FLARM display. The K8C was equipped with FLARM.

The flight path of the Discus (D-KWNW). (Source of data: LVNL)

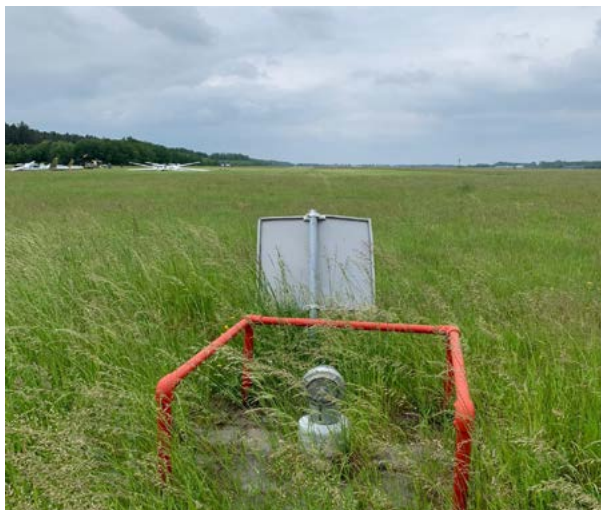
Flying on 'automatic', the pilot had aimed for the taxiway positioned at right angles to the final approach leg, as he would ordinarily have done in the normal situation. This taxiway is located further ahead of the landing field that was in use due to the work on the airfield. As a result, the pilot made a low final approach.

The signpost. (Source: gliding club)
