DUTCH
SAFETY BOARD

Quarterly Aviation Report

October - December 2022

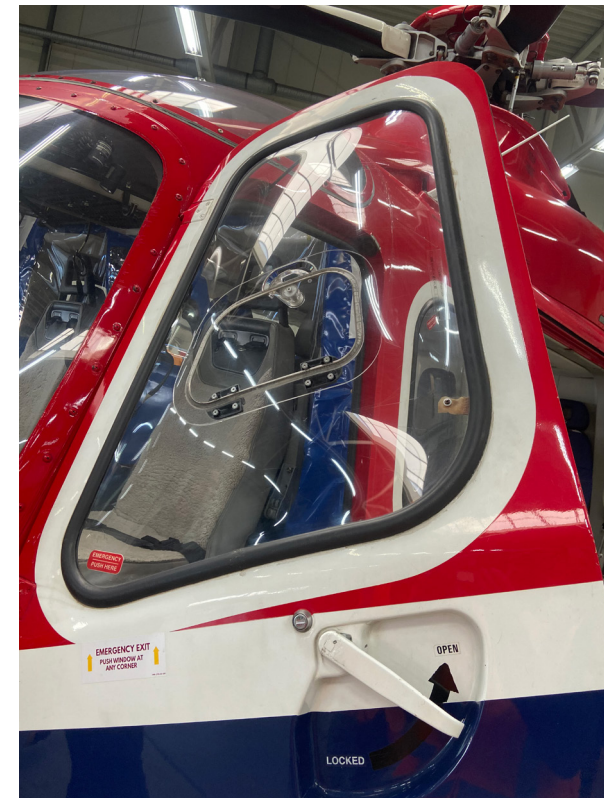
An AgustaWestland AW139 had departed from Den Helder Airport on a post-maintenance check flight. Into the flight an increase in noise level and air flow from the left-hand side was noticed by the flight crew. The left-hand window had fallen from the helicopter. The crew maintained control of the helicopter and landed without further incident at Den Helder Airport. The window was recovered. No persons on the ground were injured, or third party property damaged.

The relevant window of an AW139.

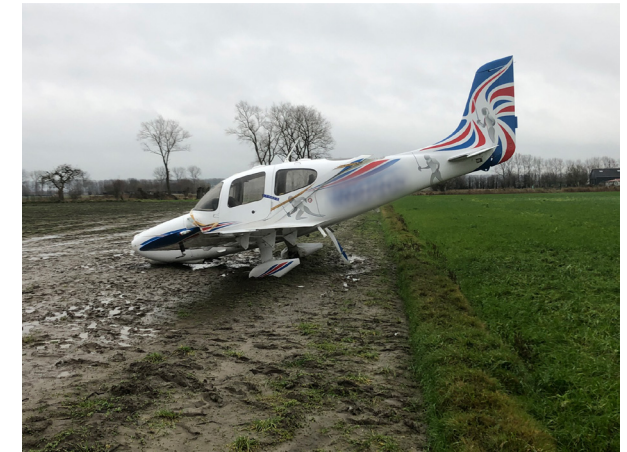
The pilot was the only occupant of the Cirrus on a flight from Mönchengladbach Airport (Germany) to Cambridge City Airport (UK). At an altitude of 10,000 feet (FL100), the pilot experienced engine vibrations and decided to divert to Ostend-Bruges Airport (Belgium). Moments later, the aircraft lost its propeller. The pilot activated the Cirrus Airframe Parachute System near Damme (Belgium), where the aircraft parachuted into a field. The pilot was unharmed. The aircraft sustained damage on landing.

The Cirrus after the emergency landing.

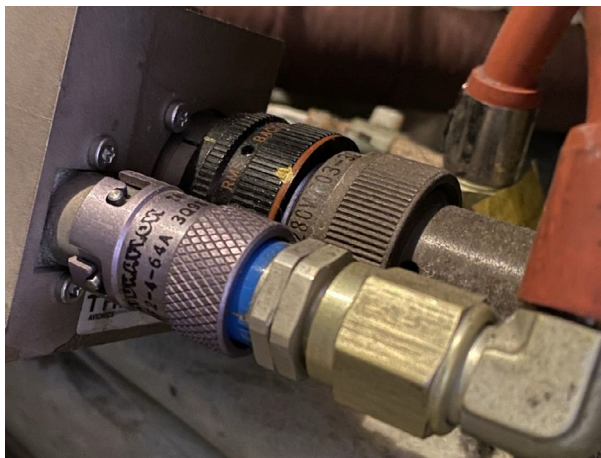
After the aircraft arrived at the gate, the aircraft was inspected by maintenance staff. Eventually, they found three pneumatic quick disconnect fittings (QDF) of the pitot-static system - located in the forward electronic equipment bay and forward cargo bay - disconnected from the air data system.

Connection of the pitot-static lines to the air data system.

The technicians who reconnected the pitot-static lines to the air data system stated that they believed all the AMM tasks and subtasks had been performed by themselves or the apprentice under their supervision. They did not recall who was tasked to connect the QDFs related to this incident. Due to the design of the QDFs, when properly installed, it is highly unlikely they would disconnect by themselves. It is therefore likely the three QDFs were not correctly connected and fully engaged on the lock pins or not connected at all after the flushing procedure. The certifying technician, responsible for verification of this procedure did not notice the improper connections.

The erroneous altitude and airspeed indications that manifested immediately after the aircraft had become airborne, were the result of multiple air data modules not receiving valid static air pressure inputs. Three pitot-static lines were not connected properly to their respective air data modules, because the connecting QDFs were likely not fully engaged on the lock pins or not connected at all after the flushing procedure was performed. This presented the flight crew with a hazardous situation in flight. The associated risk was reduced by the fact that they were flying in good weather conditions during the day and could make use of the aircraft's standby instruments.

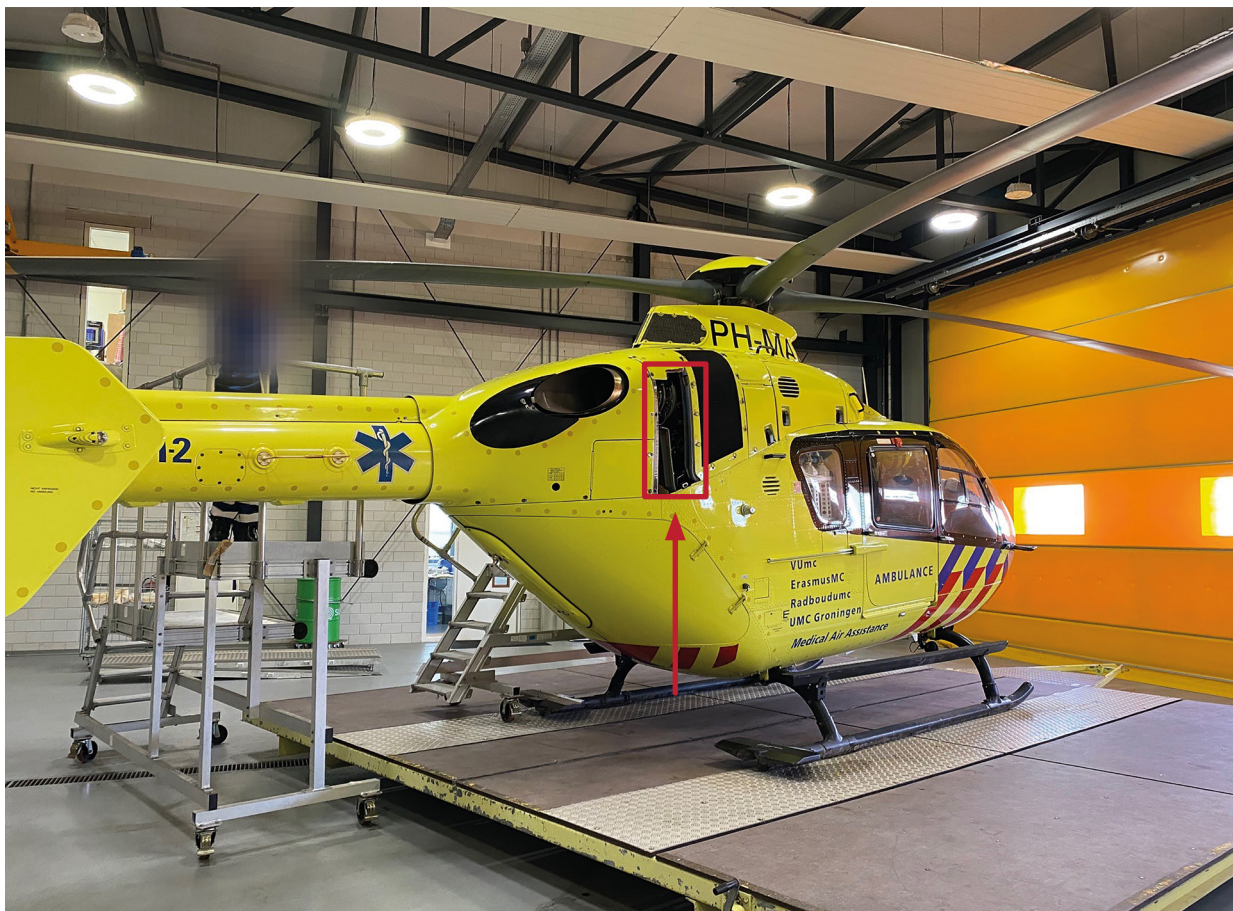
The helicopter with the lost engine inspection panel. (Source: ANWB MAA)

The helicopter took off from Groningen Airport Eelde (EHGG) in a southwesterly direction towards the city of Joure. During the flight, the pilot heard a noise and suspected the helicopter had struck a bird. There were no indications or warnings in the cockpit of a helicopter system malfunction and the commander decided to continue the flight. Shortly thereafter, the scramble that the air ambulance was responding to, was cancelled and the helicopter returned to EHGG. After landing, an engine inspection panel was found missing.

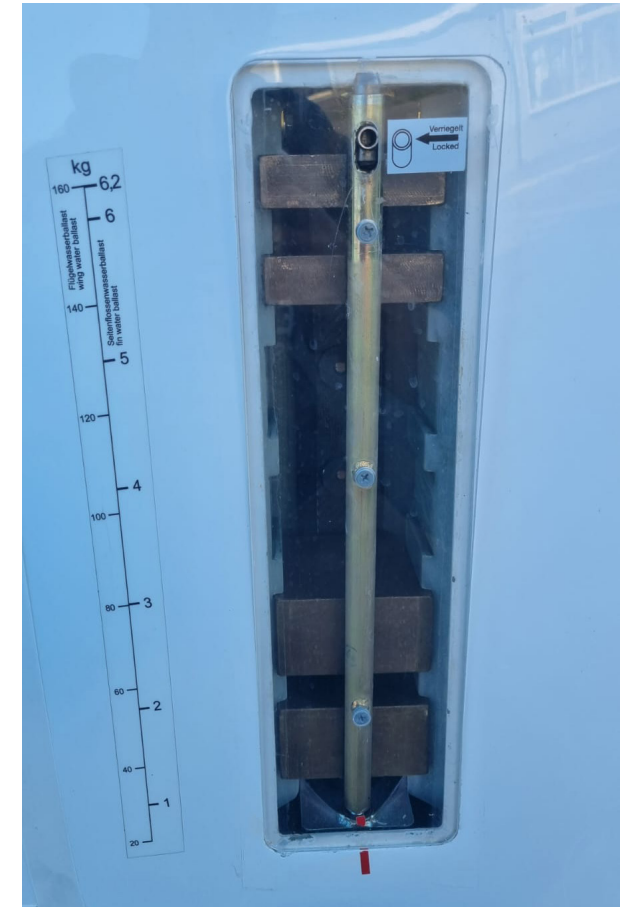
After landing, the glider was found to have lost five trim weights. The weights fell on a camping path and a parked car, which was damaged as a result. The glider was not damaged. The instructor had not experienced any flight control issues during the flight.

No technical defects were found on the glider that could have caused the trim weights to come loose. The cover plate of the ballast box, on which the prescribed placard was applied, was found not to be properly locked after trim weights were mounted in the fin prior to the flight. This caused the control light for the ballast box to flash quickly. The instructor, who was sitting in the rear seat, did not see this. The student did not know what the quick flashing of the light meant. Checking the status of the control light was not a standard part of the cockpit check within the club. As a result, it was possible that no proper action was taken on the quickly flashing light. Even though the cover of the fin ballast box was taped, the cover opened during the recovery exercise and trim weights fell out of the fin. Given the location where the trim weights were found, they probably came loose during the spin recovery exercise.

An example of the box in the fin with four trim weights in it. (Source: gliding club)

The gliding club conducted its own investigation into the occurrence and shared its findings with the Dutch Safety Board. The club's investigation report includes among others the following recommendations: the pilot in command must place and remove the trim weight himself, and adjust the cockpit check to include the checking of the control light. The Board concurs with those recommendations.

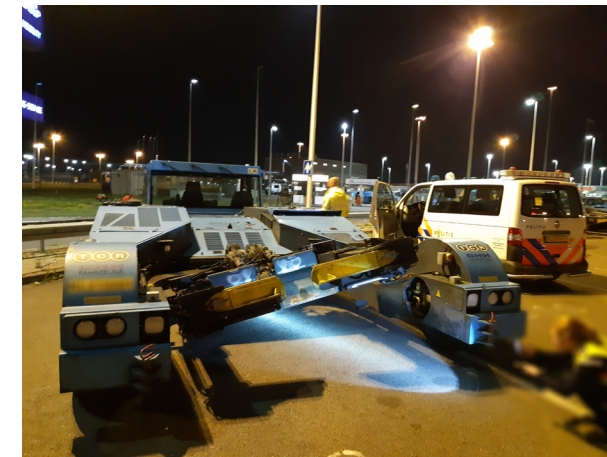
The flight crew felt a vibration and immediately stopped the aircraft. The tug driver was unharmed. The tug was damaged; the aircraft sustained damage to, among other things, the tires of the nose landing gear. The ground controller cleared the flight to taxi back to a gate for further inspection of the damage incurred.

The collision of the aircraft with the tug could take place because the flight crew started taxiing, despite the fact that the pushback tug driver had not yet given the 'all clear' signal to the flight crew to indicate that the way was clear to taxi. The Dutch Safety Board did not further investigate the incident.

The damaged pushback tug. (Source: Dutch aviation police)

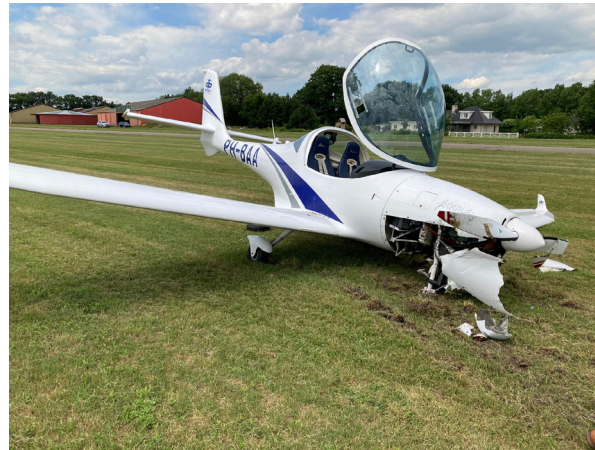
Two seconds after the round out had been initiated, at a height of approximately 2 metres above the runway, the speed had fallen to approximately 50 knots and the stall warning sounded. The speed fell further to around 40 knots, and the aircraft experienced a severe rolling motion to the left. The main landing gear of the aircraft touched the runway in traversing condition, followed by the nose wheel. As the nose wheel sprung in, the main landing gear rose free of the runway, after which the nose of the aircraft came up. The instructor stated that following the initial contact between aircraft and runway, he took back control, selected full power, and attempted to return the aircraft to horizontal flight. The aircraft then rolled to the right, at which point the right wing and nose wheel came into contact with the ground. The aircraft performed a ground loop and came to a standstill in the grass to the right of the runway, having completed a 180 degree turn. Both occupants remained unharmed. The aircraft was substantially damaged.

The crashed AT01. (Source: Airport operations Breda International Airport)
