DUTCH  
SAFETY BOARD

# Quarterly Aviation Report

April - June 2019

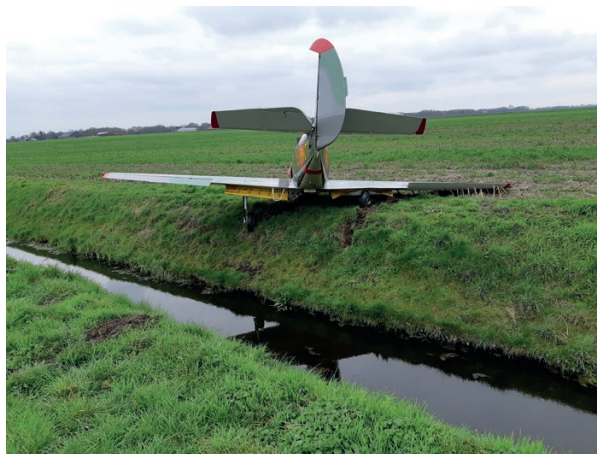
A formation of four Yak-52 aircraft returned from a training flight. The formation leader landed first. The aircraft did not come to a stop before the end of the runway and rode through a ditch. The Yak-52 came to a stop against the slope of the ditch. Both crewmembers were unharmed. The aircraft was damaged.

The Yak-52 after the runway excursion. (Source: Dutch Aviation Police)

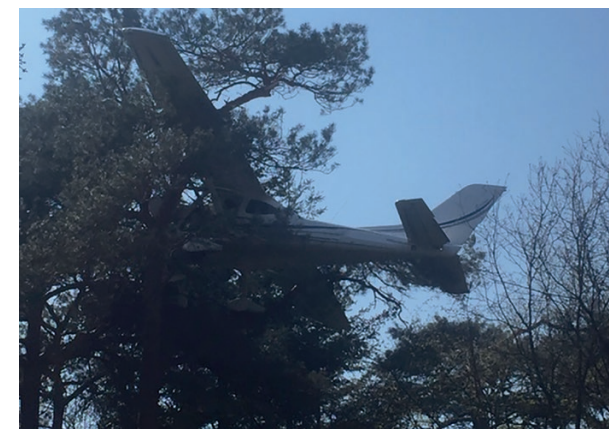
Whilst practising touch-and-gos at Hilversum Airport, the aircraft lost engine power at one point during climb-out in the turn to the crosswind leg. The aircraft ended up in a tree. Both pilots were unharmed. The aircraft was damaged.

The TL-3000 Sirius after it ended up in a tree.

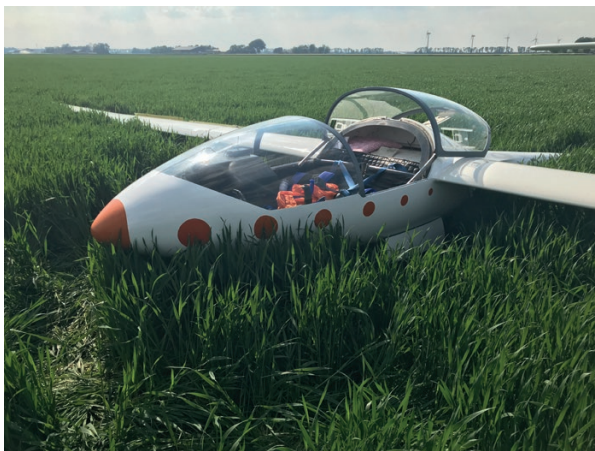
The canopy of Calif A-21S opened during a winch launch. After the winch cable was released from the glider, the pilot and passenger were able to close the canopy again. The pilot returned to the glider airfield but was unable to reach the landing strip, so he opted for an off-field landing. In the course of landing, the glider made a ground loop and was damaged. Both occupants were unharmed. The glider club involved is conducting an investigation.

*The Calif after the off-field landing. (Source: Dutch Aviation Police)*

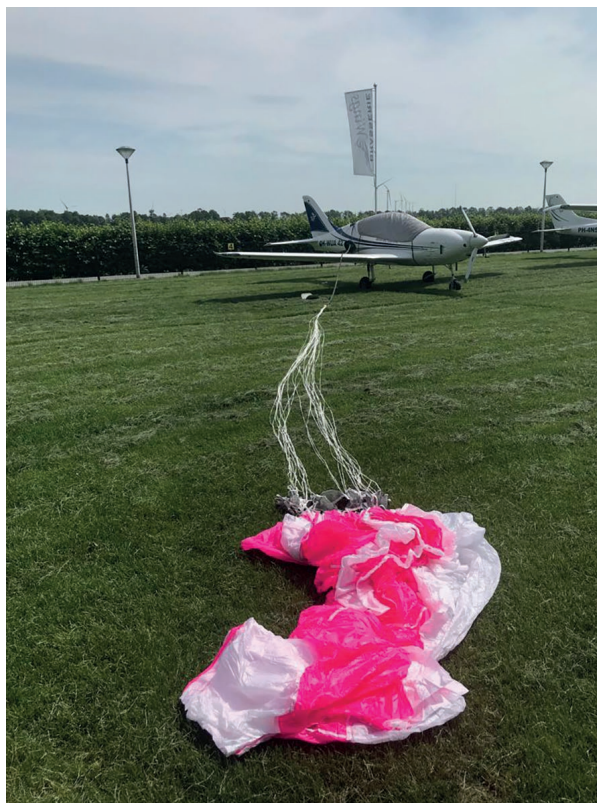
During taxiing, the passenger sitting behind the pilot removed the safety pin from the parachute rescue system at the pilot's request. The passenger then accidentally activated the system, after which the parachute was ejected from its housing by the explosive charge and deployed. Neither of the occupants were injured but the aircraft was severely damaged.

The parachute of the rescue system. (Source: Pilot)

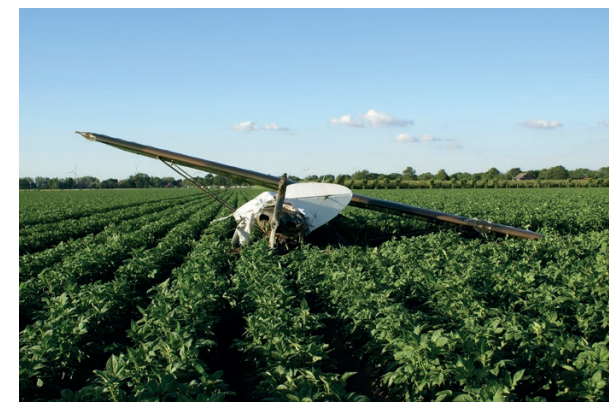
Whilst performing a formation flight, the two aircraft collided. As a result, the Piper PA-18-95 became uncontrollable and crashed. Both occupants were fatally injured. The other aircraft was damaged and managed to make an emergency landing. The pilot was lightly injured; the passenger remained unharmed.

The PA-18-125 after the emergency landing.

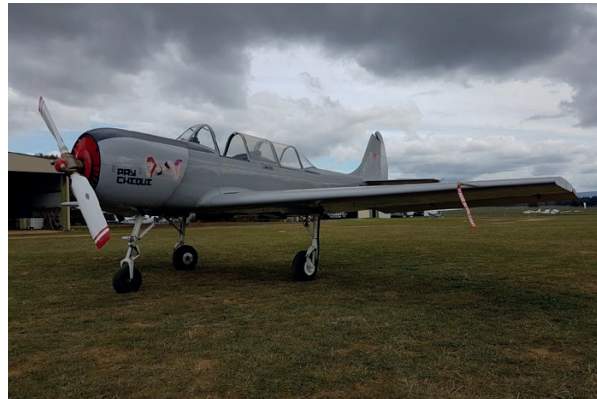
The Yak-52 with the Dutch pilot and one passenger on board was conducting a flight from Southport Airfield, Queensland in Australia. The aircraft crashed into the water, killing both occupants.

The Yak-52. (Source: ATSB)

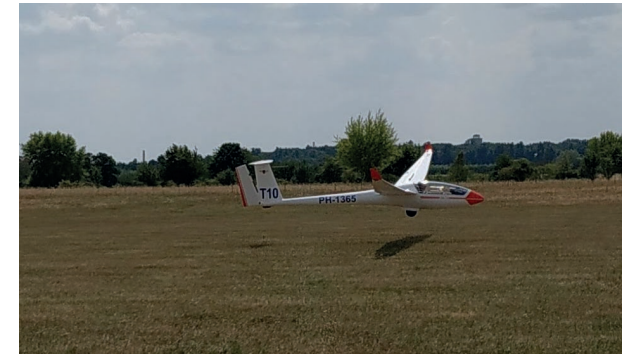
The bolt that is supposed to prevent vertical movement of the rudder had not been reinstalled after being removed during earlier maintenance. It is likely that this was due to inadequate communication between two mechanics. The rudder was disassembled and reassembled several times. The bolt is not visible from outside the glider. Furthermore, the rudder had not been inspected for vertical play prior to the flight in question. The club's report recommends to inspect the rudders for play in all directions in the course of the daily inspection. Furthermore, it recommends establishing maintenance responsibilities unequivocally and conducting a post-maintenance flight control check on the basis of a checklist, which is yet to be defined.

PH-1365 during the landing. (Source: Gliding club)

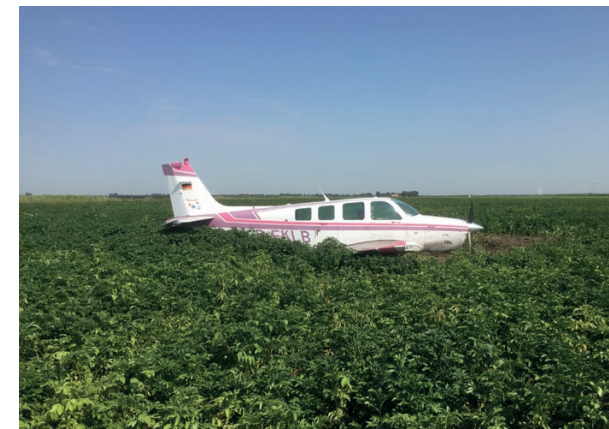
After the accident the engine was shipped to an overhaul shop in Denmark and was disassembled and inspected. One of the push rods was heavily bent. Pistons numbers 1 and 2 were heavily damaged with broken piston rings and metal contamination. Besides this, piston number 1 suffered from the barrel that had separated from the cylinder head. A lot of bigger metal particles were found in the exhaust as well as in the intakes 1 and 2. Heavy damage was also found in the crankcase between cylinders 1 and 2. Cylinder number 1 was further disassembled and checked for a sticking valve resulting from carbon built up, but no evidence was found. Ten spark plugs were functionally tested and nine of them were rejected due to metal contamination build upon the plug's electrodes. Two heavily damaged spark plugs of cylinder number 1 could not be tested because of the damage.

The failure probably started with the separation of the cylinder head from the barrel of cylinder number 1. The remaining damage was consequential.

In 2013 all six cylinders were replaced by repaired ones. Cylinder number 1 was manufactured in 1988, three cylinders in 2003 and two in 2009. Installation of an old but airworthy cylinder is not forbidden but is not advisable. Back in time, separated cylinders were a well-known problem but nowadays it is rare to find one, as a result of metallurgical improvements. Old cylinders lack an individual serial number. The advantage of an individual serial number on parts is that the maintenance history of the parts can be logged and traced.

The Beechcraft A36 Bonanza after the emergency landing.

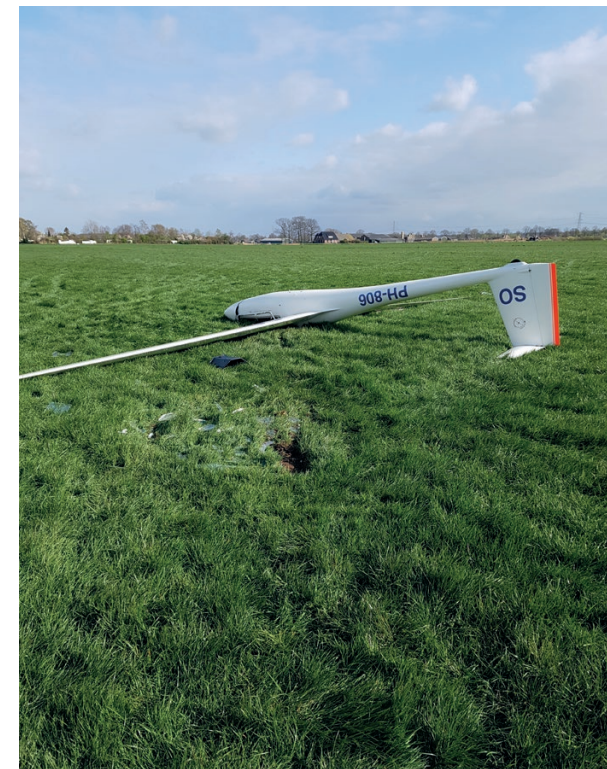
There was a northeasterly wind of about 10 knots. After the pilot performed the cockpit check and the winch cable had been attached to the glider, he notified the wing runner that he was ready for take-off. The pilot stated that his right hand was on the stick and his left hand on the release. After the light signal was activated from the start position, the winch operator applied power and the glider started moving. The wing runner, after having accompanied the glider for several metres, let go of the left tip. The wing runner stated that the glider's right wing dropped after about 5 to 10 metres and started dragging on the grass. Another witness stated that the right wing tip fell to the grass almost immediately after the wing runner let go of the left wing tip. The tip remained in contact with the grass until the moment the glider started to rotate. The left wing came up, the glider rotated and left the ground. A witness stated that the cable remained attached to the glider and the glider rotated right by nearly 90 degrees. When the glider's right wing was still on the ground and the glider was upright, the cable detached. The glider then cartwheeled to the right and hit the ground upside down, with the wings in horizontal position, on the other side of the winch path, under an angle of ca. 20 degrees and then came to a full stop. The longitudinal axis of the glider was parallel to the winch patch with the nose turned towards the winch. The pilot suffered minor injuries. The glider was damaged; the canopy was shattered.

The glider after the accident. (Source: Gliding club)

A wing may drop due to a yaw motion in the early stage of a winch launch. It is important to keep a hand near the release at the start of a winch launch. If a wing threatens to touch the ground while the glider is rolling, the winch cable must be released immediately before the wing hits the ground.

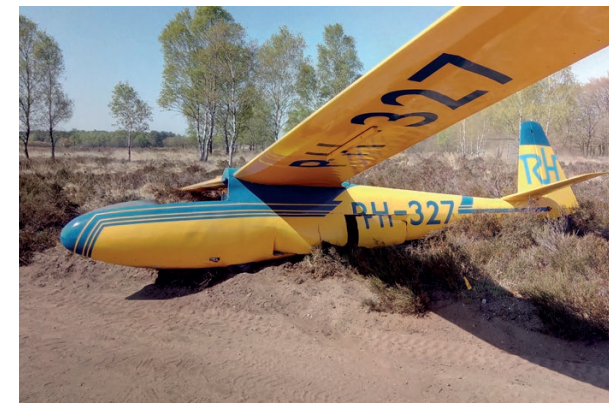
The pilot therefore decided to land in the heath field beneath the base leg. During the landing, the glider hit the raised edge of a sand path, making a 100 degree ground loop.

The glider sustained irreversible damage; the pilot remained unharmed.

The glider after the landing in the heath field in the circuit area. (Source: Pilot)

A good landing starts with a good circuit. The standard circuit, which can be seen as a 'flexible aid', must be flown when conditions are normal. If circumstances warrant it, pilots must deviate from the standard circuit. For instance, one must fly closer to the field and turn into the base leg earlier in the event of strong headwinds or extra descent in the circuit.

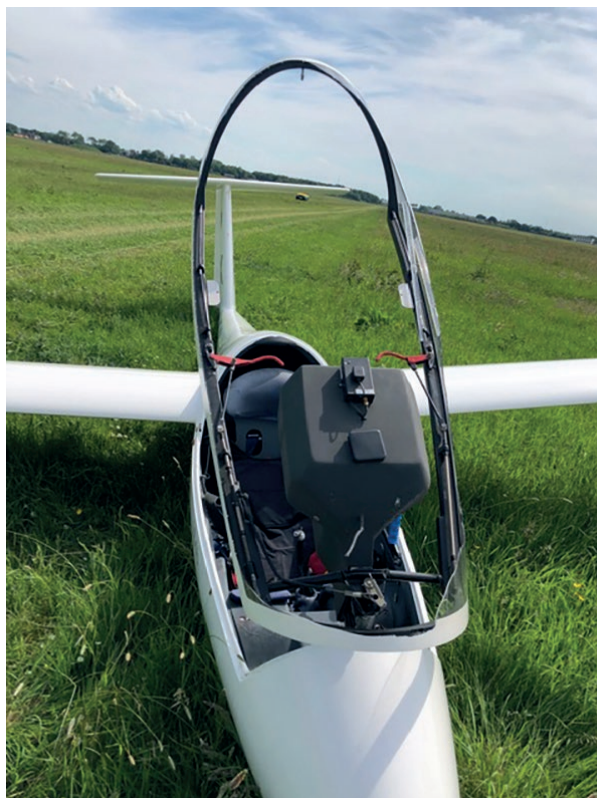
*The glider after the accident. (Source: Gliding club)*

It is also important that the pilot arranges the back of the seat in such a way that he can reach the release handle easily and quickly. This must be verified as part of the cockpit check. While accelerating at the start of the winch launch, the pilot may be pushed back into the seat.

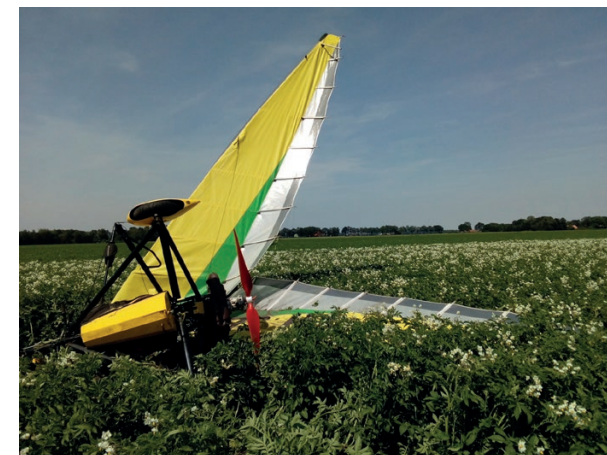
After removing the float chambers of both carburettors, debris including plastic particles was found inside. Further investigation by the aeroplane owner revealed that an Alert Service Bulletin published in 2016 (ASB-2ST-003) had been overlooked and was not implemented. The reason for issuing the ASB was that *"Due to a deviation in the manufacturing process of the floats a partial separation of the outer skin because of resonance vibrations during engine operation may occur.*

Most likely the engine had stopped as a result of a blocked fuel supply resulting from particles in the float chambers.

PH-3E6 after the emergency landing. (Source: G.W. Dijk)
